NC COASTAL LAKE: DE-EUTROPHICATION AND ACCELERATED RESTORATION

AS SEEN IN POND BOSS MAGAZINE: JANUARY/FEBRUARY 2026 EDITION

BACKGROUND

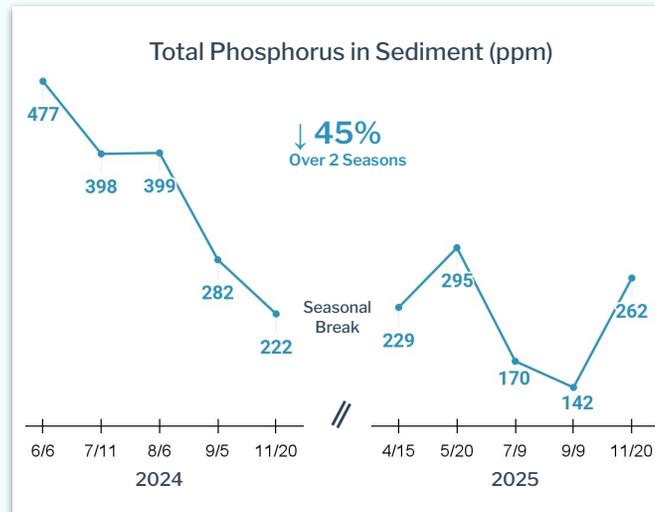
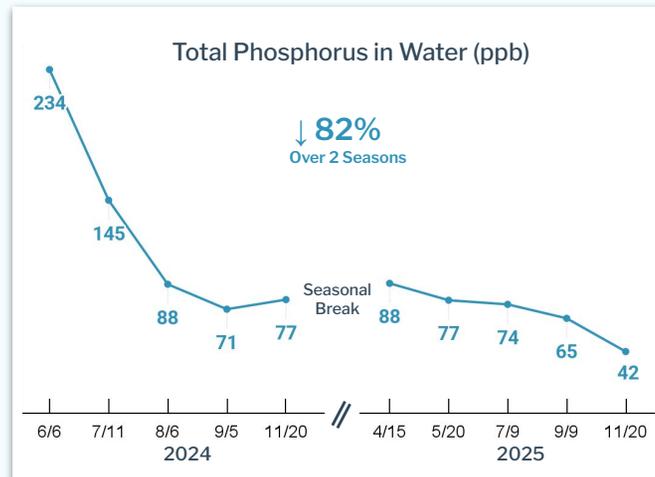
KEY METRICS AND RESULTS

- ▶ Phosphorus in the sediment and water was significantly reduced during the first season and declined further in the second season
- ▶ In the second year the lake supported strong fishery performance and maintained improved aesthetics
- ▶ The partial rebound in sediment TP at the end of 2025 indicates an older sediment layer has been penetrated

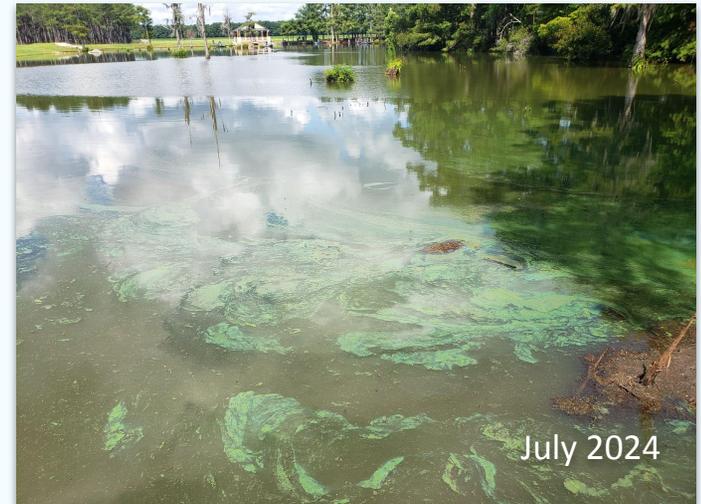
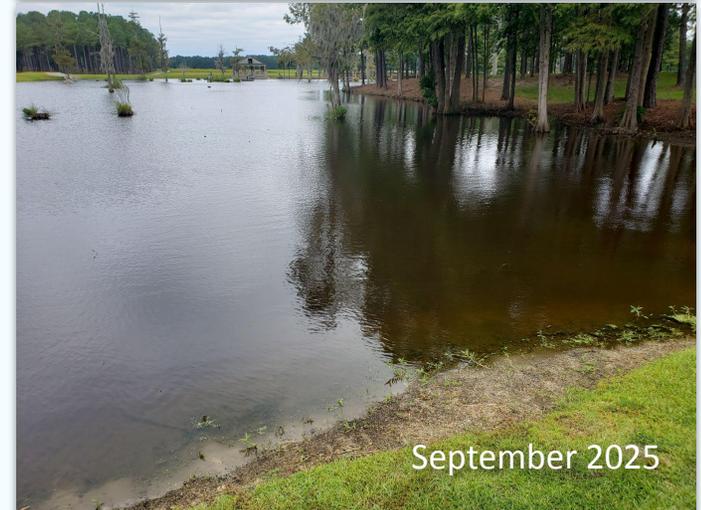
IMPROVED AESTHETICS

By restoring the lake's bottom dissolved oxygen level, TryMarine helped accelerate the decomposition of coarse organic debris.

This visible transformation coincided with a significant and sustained reduction of phosphorus in both the sediment and water column.

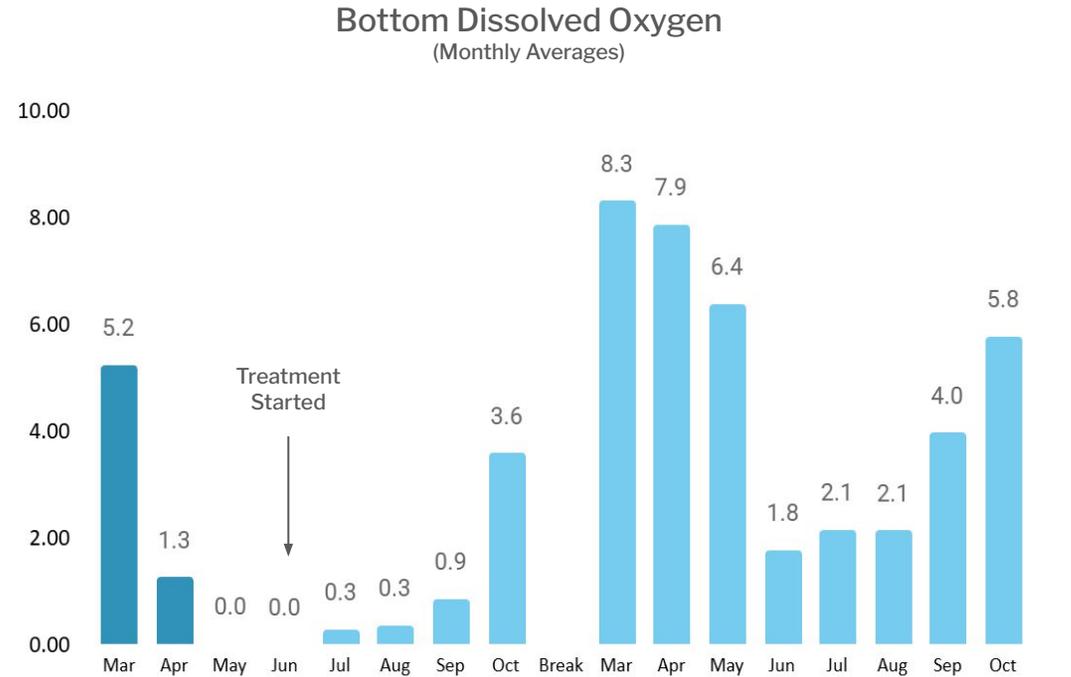
KEY METRICS AND RESULTS

Dissolved oxygen (DO) logs show only 1 month with average bottom DO below 2 in 2025 (June) compared to 6 events in 2024

Each month in 2025 had higher average DO than the same month in 2024

We expect the increasing trend to continue in the 3rd and final year of restoration

- ▶ Sustained higher DO every month since the beginning of treatment
- ▶ The visible breakdown of coarse debris into brown muck, a short time, attests TryMarines capacity to accelerated decomposition
- ▶ Taken together with the sustained reduction in nutrients, this lake shows significant progress towards full restoration as a thriving high end fishery

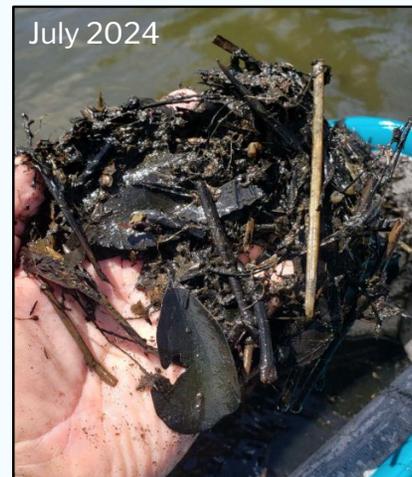
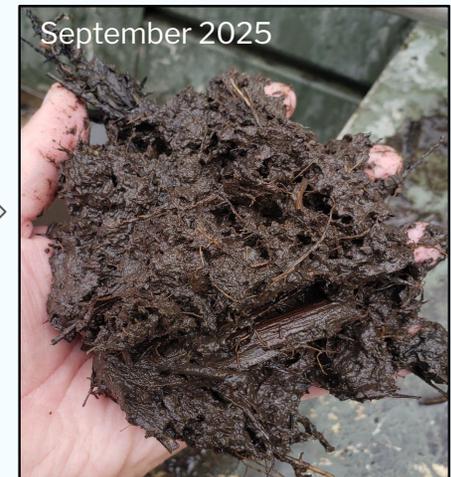
IMPROVED TEXTURE

- ▶ Coarse organic debris broken down into more homogenous, oxygenated sediment
- ▶ Sediment is browner in color, suggesting more oxygen is present
