Polybutene
Piping Systems Association

Polybutene-1 Piping Systems

Answers to Frequently Asked Questions

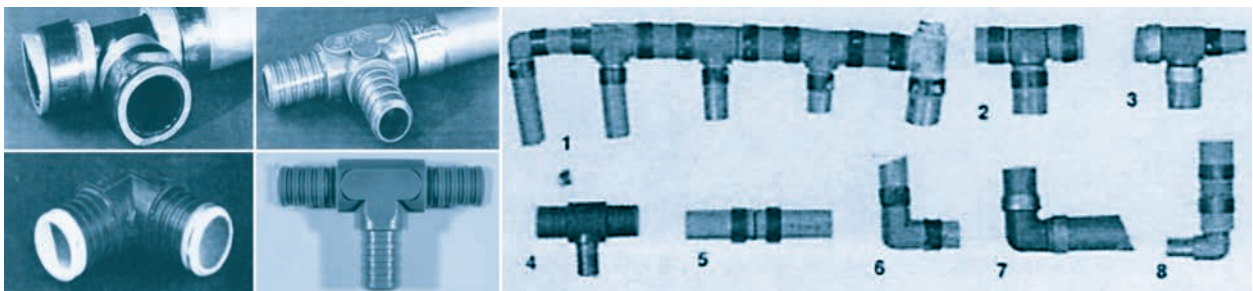
Incompatible and diverse materials and jointing methods attributed in the US legal action to "Polybutylene plumbing systems"

Shown below are some examples of the types of fittings, made from materials other than Polybutene-1, and used in North America which were subject to many of the legal complaints lodged against so-called "Polybutylene plumbing systems."

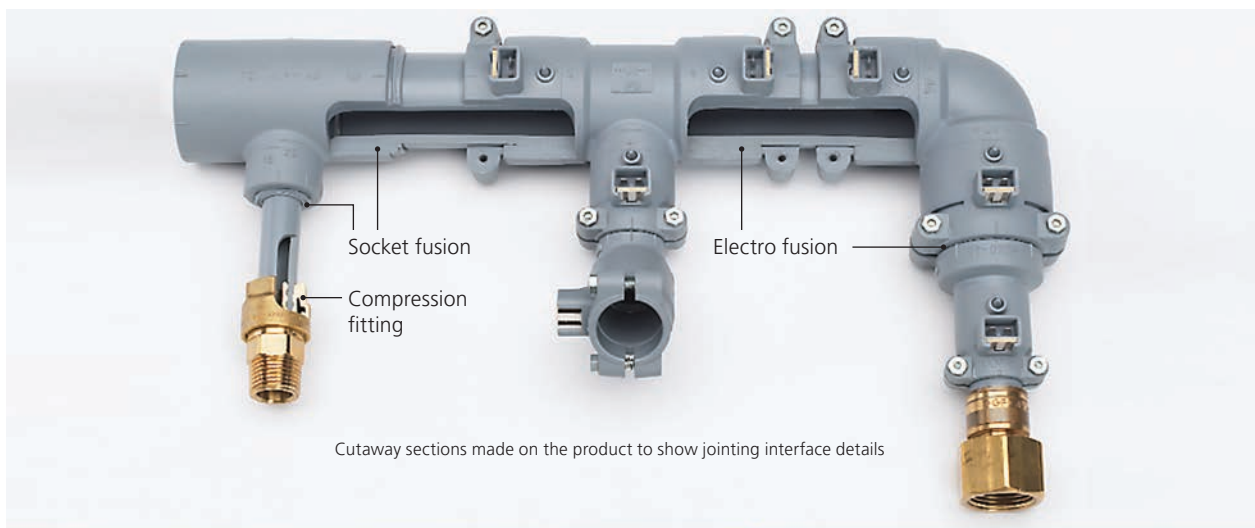
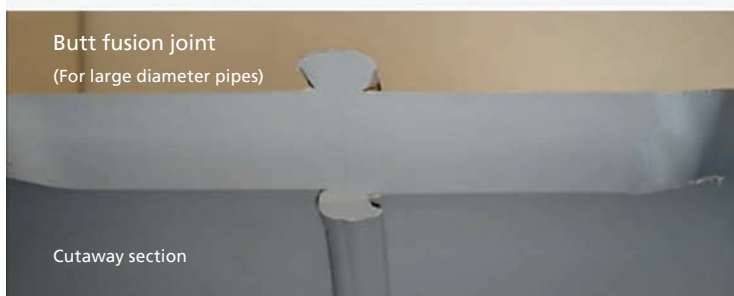
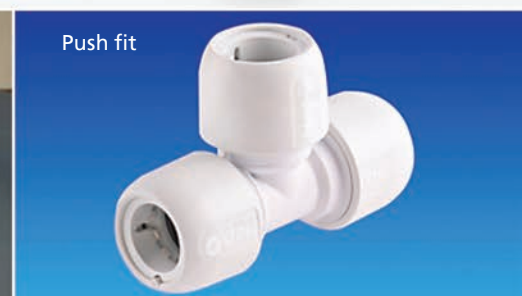
In contrast to the US examples are typical examples (below) of the types of fittings developed over many years which are an integral part of the success of today's Polybutene-1 piping systems in the European and Asian markets.

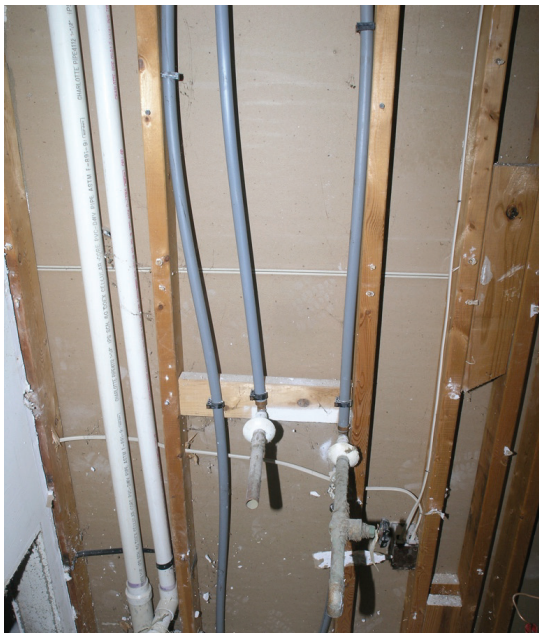
Figure 1. Typical layout of PB piping in a first floor apartment.

During the site inspection, the plumbing connections near the water heater were examined in sixteen units that were undergoing rehabilitation. Table 1 lists the units that were inspected and the samples that were taken. The test samples included four different production date codes for Qest PB pipe and one date code for Vanguard PB pipe. The PB piping entered each apartment building under the concrete slab from a valve box in front of each building. As part of the rehabilitation project, the drywall had been removed in the mechanical room that housed the furnace and water heater. The typical layout of the PB piping is shown in Figures 1 and 2 for one of the first floor apartments and upstairs apartments, respectively.

In general the installation of the PB pipe in the apartment complex was excellent. The tubing was properly secured to studs and was not excessively bent. Approximately 18 inches of copper pipe was present between each water heater and the beginning of the PB hot water piping. The system utilized wrought copper fittings and either Qest or Vanguard 3/4" PB tubing. The crimp ring diameters were

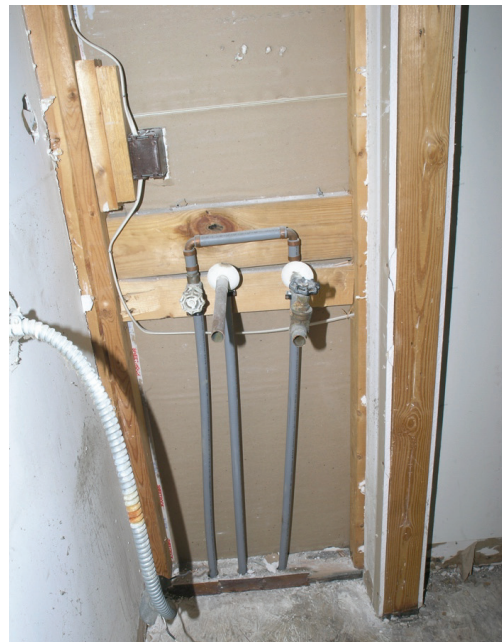
Figure 2. Typical layout of PB piping in a second floor apartment.

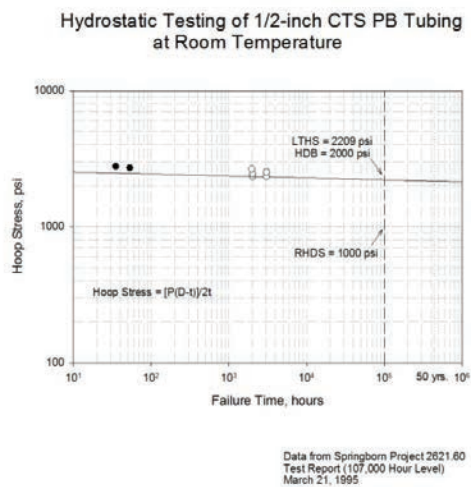
Figure 3. Hydrostatic pressure test results (symbols) superimposed on results of testing of new, unused PB pipe (line).

Hydrostatic stress rupture tests are being performed on samples of the PB pipe removed from the apartment complex. This testing is above and beyond the required 1000-hour sustained pressure tests called out in ASTM D3309 for the pipe. Testing was initiated on the PB pipe samples following the protocol in ASTM D 2837 [6]. In this case testing was initiated to obtain an E-2 data set (per Plastics Pipe Institute TR-3 [7]) to demonstrate how the 18-year-old PB pipe compares to the stress rupture data for new, unused pipe.

The E-2 data set includes a minimum of 10 data points with failure times ranging from 10 to more than 2000 hours. This data was then analyzed according to the procedure in ASTM D2837 to estimate the hydrostatic design basis (HDB) for the PB samples. The data were plotted on a graph with 107,000 hours of long term hydrostatic test data obtained on new, unused PB pipe that was reported by Springborn Laboratories in 1995 [8] (Figure 3). This testing continued for more than 3000 hours and established that the long-term sustained pressure performance of the pipe is comparable to or better than published data on new, unused PB pipes. The pipes have surpassed the expected failure times at the test hoop stresses, as shown in Table 6 below.
