# Case Study

Winchester, TN

Carbon Fiber Horizontal and Vertical Applications

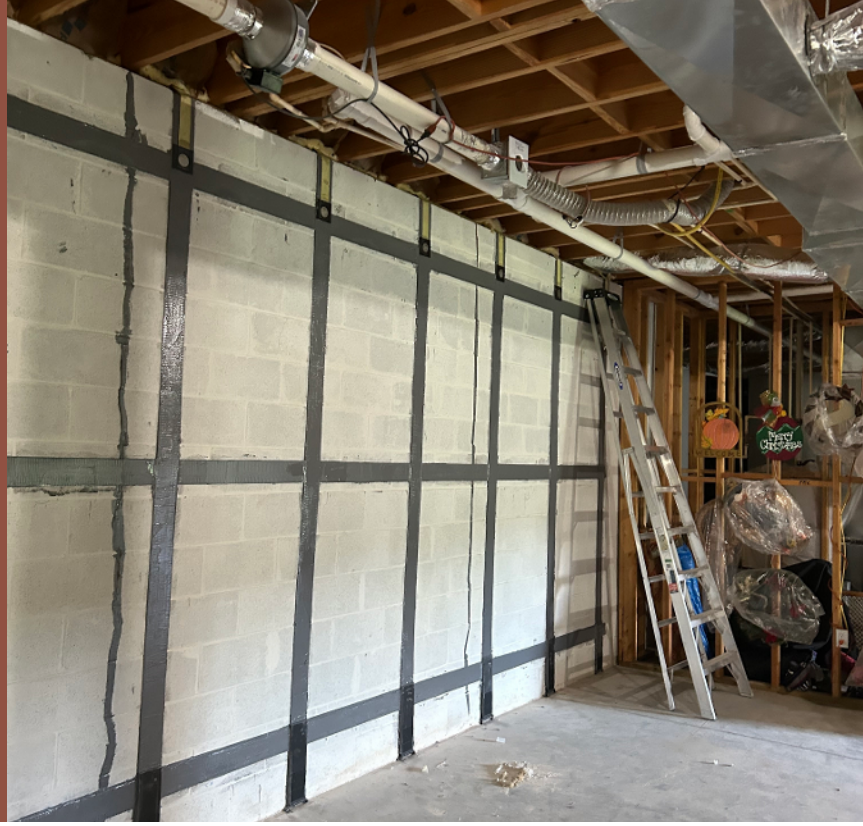
USS was contacted after noticing structural concerns and visible cracking within the foundation walls of the building. The cracks raised concerns about ongoing movement and the long term stability of the basement structure.

During the inspection, the USS team identified cracking throughout the basement wall system. The wall conditions indicated structural stress that required reinforcement to prevent further movement and preserve the integrity of the foundation.

- USS installed eighteen Fortress Carbon Fiber wall straps vertically at 32 inches on center to stabilize the basement wall and prevent additional inward movement. To further strengthen the wall system, additional Fortress Carbon Fiber wall straps were installed horizontally at 4 feet on center, beginning 2 feet from the top of the wall.

- This combined vertical and horizontal reinforcement application permanently stabilized the HCMU basement wall system while providing a non-invasive structural repair solution designed for long-term performance and durability.
