# CASE STUDY

Wilson Street Building

UNITED STRUCTURAL SYSTEMS  
**USS**  
COMMERCIAL DIVISION

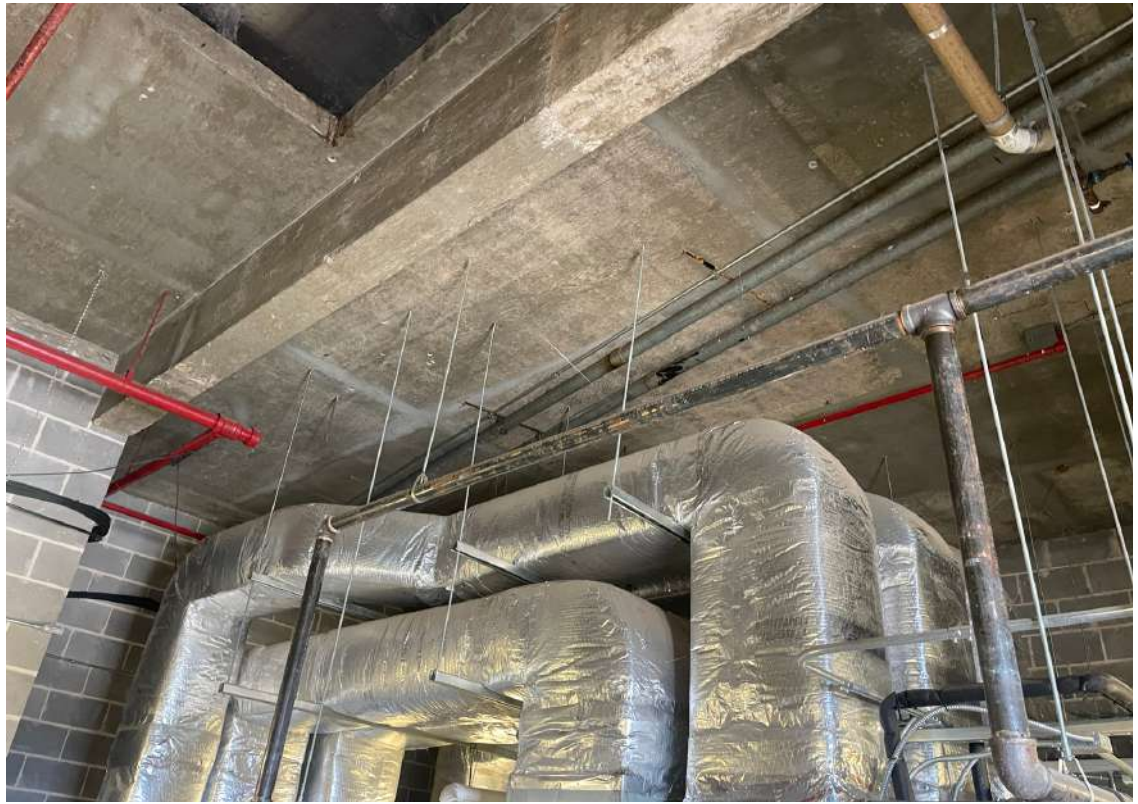
**BEFORE**

- Existing concrete roof slab did not meet strength and deflection requirements for adding 3 cell towers to the roof
- Risk of long-term performance issues due to excessive deflection
- Project required a non-invasive solution that avoided roof demolition
