# SAGGING LINTEL?

## BRICK & LINTEL REPAIR

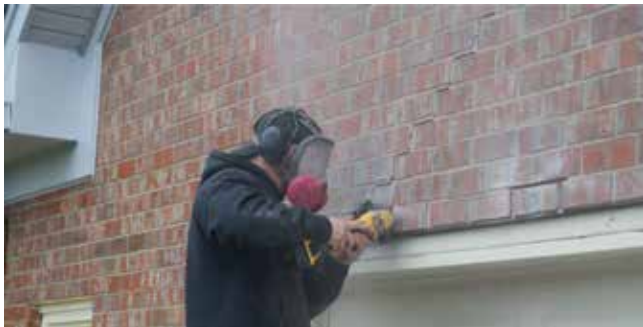
*Bricks are carefully removed to access the lintel.*

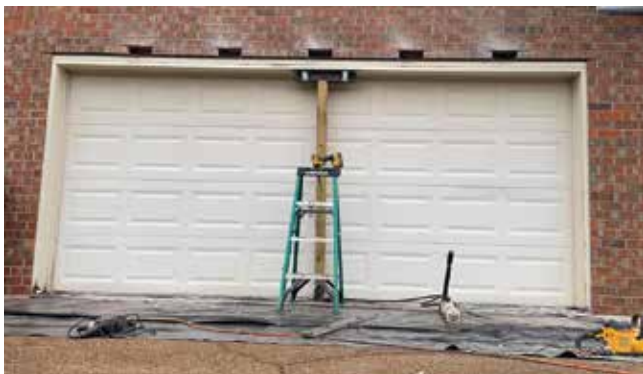
*Additional support is provided during the lintel repair.*

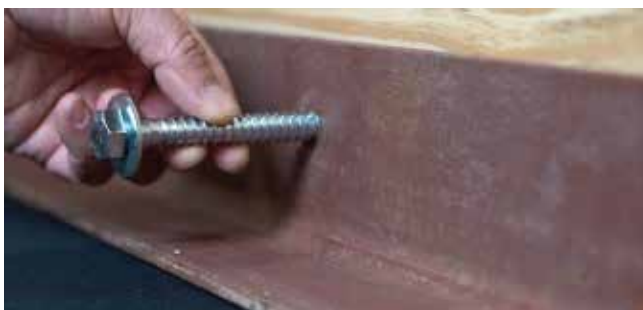
*The lag bolts that are installed hold the lintel in place.*

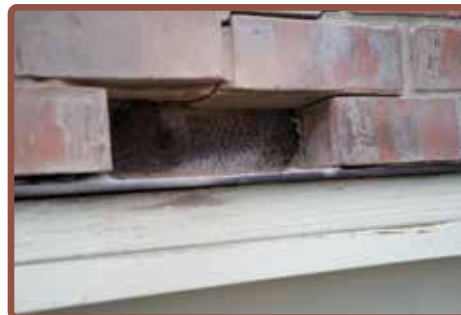
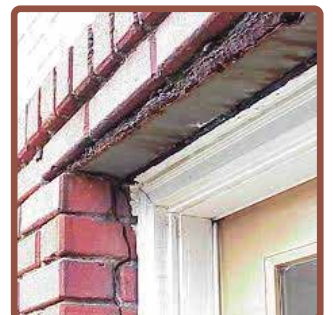
*Removing the brick exposes the lintel. Rusted lintels must be replaced.*

- Foundation piers will not correct a sagging lintel. Piers may only cause more damage and will not correct brick cracks above the garage door opening.
- Horizontal cracks above the opening may point to a rusted lintel. A rusted lintel requires full replacement.
