### 8.3 Case Study in Sustainability: Crystal Beach SCIP House

### 8.3.1 Construction of Crystal Beach SCIP House

### 8.3.2 Crystal Beach House Performance in Hurricane Ike

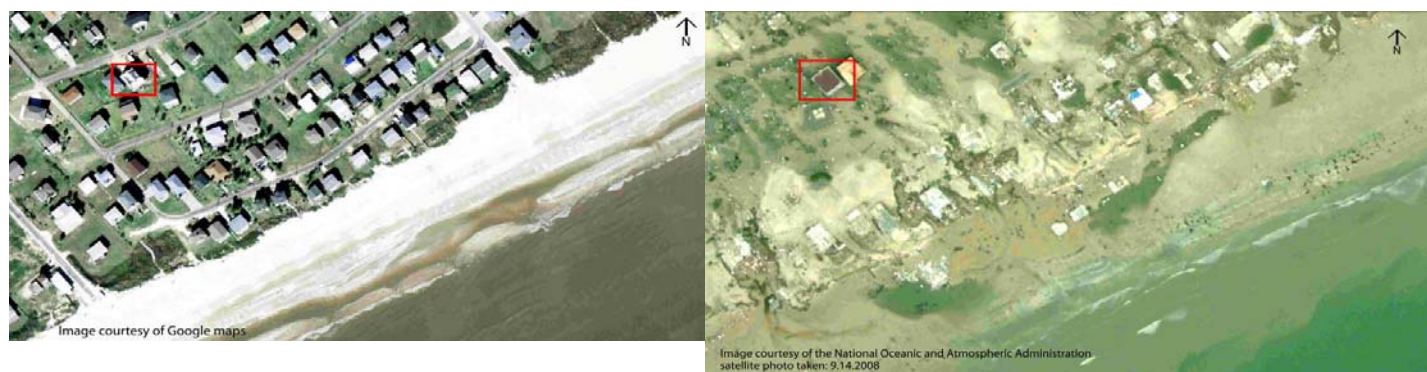
Figure 8.3-1 - Aerial Photograph of the Crystal Beach House Before and After Hurricane Ike

This Crystal Beach house on Bolivar Peninsula, TX, survived the impacts of Hurricane Ike with little overall damage, despite the destroyed homes surrounding it (Figure 8.3-1). Before the storm, this house was situated five rows inland from the beach and is now situated three rows from the beach, but with an unobstructed view of the ocean because the four rows of houses in front were destroyed. In the first two rows of houses, closest to the Gulf, foundations and pilings were mostly obliterated and the ground was heavily scoured in many cases lowering the elevation by 3 to 4 feet<sup>1</sup>. The road and power lines closest to the Gulf are gone and the vegetation line has moved back. Whether the regulatory officials will allow anyone to build back in this heavily scoured zone is unknown.

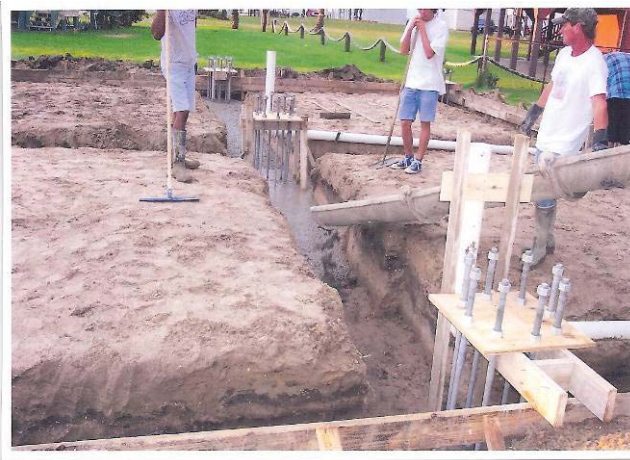
The house is built on a 3-foot-deep by 3-foot-wide concrete strip footing with a 6-inch slab on top. A center 3-foot-deep by 3-foot-wide concrete beam crosses in each direction (Figure 8.3-3). All the concrete for the foundation was poured at one time.

*Figure 8.3-3. Construction photograph shows foundation with nine sets of bolts for the columns. There is a perimeter-grade beam and a center-grade beam. The men on the right are standing on sand at the height of the 6-inch slab. Photo courtesy of Ron Bell*

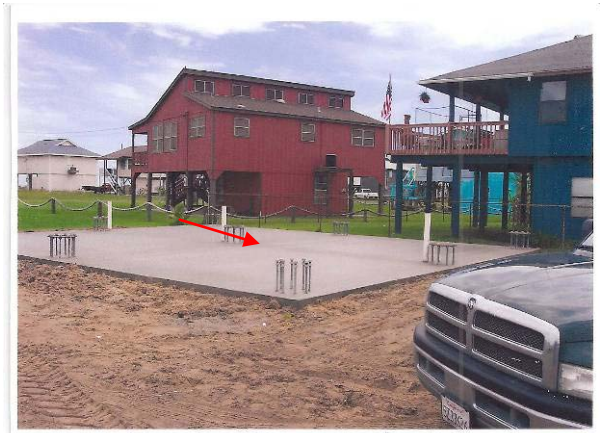
The steel tube columns are spaced at 16 feet, 0 inches on center. The columns are attached to 1-1/8-inch bolts that extend 24 inches deep into the foundation (Figure 8.3-4 and 8.3-5). Rebar extends from the foundation slab into the hallway (stair) panels.

*Figure 8.3-4. Construction photograph shows 24-inch deep bolts extending into the cement foundation (red arrow). The slab extends over the outside concrete foundation. Photo courtesy of Ron Bell.*

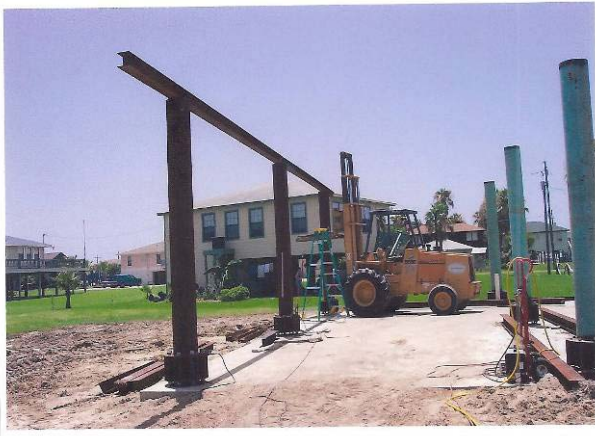
*Figure 8.3-5. Construction photograph shows columns bolted in place. The nuts under the flange are used to level the 6-foot by 6-foot H beam. The rebar that will extend into the first floor vertical walls will be welded to the first floor (elevated) beam shown in the photograph. Photo courtesy of Ron Bell.*

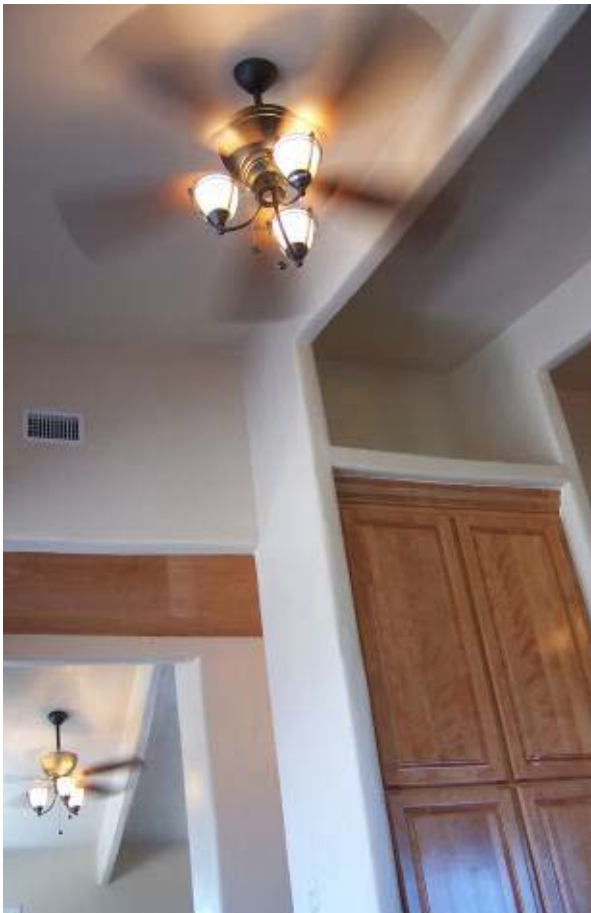
The roof is supported by the exterior walls, interior hallway walls, and SCIP beams. Two SCIP beams, each 18 inches deep with rebar—added for additional strength—follow the slope of the roof and run from the outside wall up to the ridge line of the house (Figure 8.3-6). The roof spans between the SCIP beams are also comprised of SCIPs (Figure 8.3-6); the spans are reinforced with rebar every 16 inches on center on the underside. According to the builder, rebar was added to strengthen the walls and increase the floor loadings to meet the high wind (165 mph) requirements for construction in this hurricane-prone area.

*Figure 8.3-6. The roof SCIP beams are shown above the fans, following the roof slope. The 18-inch deep beams are tied into the 30-inch deep columns that are vertical members in this photograph. The Crystal Beach House used No. 14 gauge wire frame.*

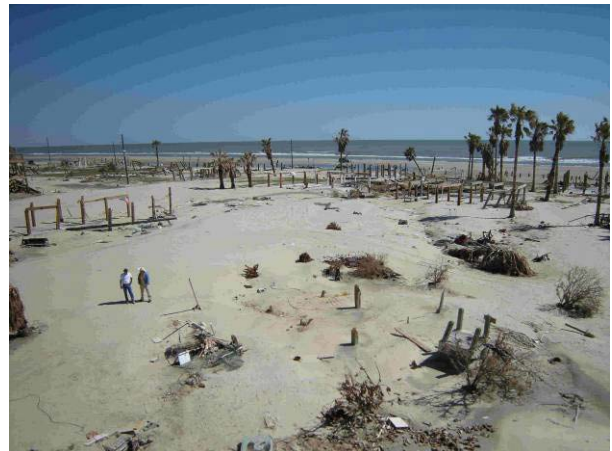
Figure 8.3-8. View looking south towards Ocean, from second floor porch after Hurricane Ike. Four rows of houses were destroyed in front of house 10/18/09 (101809 3720)\_

The Crystal Beach house performed well during Hurricane Ike. The house was originally located five rows of houses back from the Gulf of Mexico— the house now sits approximately three rows inland from the Gulf of Mexico (Figure 8.3-8).

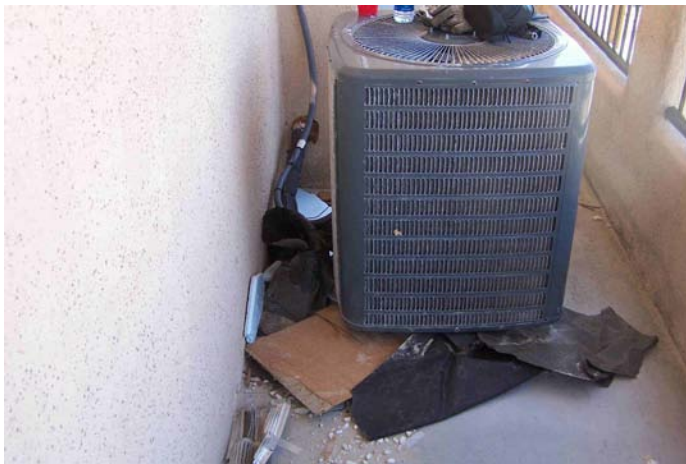
According to an eye witness, this house sustained a significant impact from another house on the Gulf side to the east. Debris found by the owner after the storm also suggests this as the source of some damage. Reportedly, the other house, which had detached from its foundation, floated into this one during the storm surge. After impact, the detached house began to break apart and much of it floated underneath the Crystal Beach house, which sustained minor damage from the impact, with three small cuts in its top surface.

*Figure 8.3-9. Remaining debris on north deck. A small amount of water entered into the Crystal Beach SCIP house because there was so much debris on the decks, the drains plugged up, and water entered below the door.*

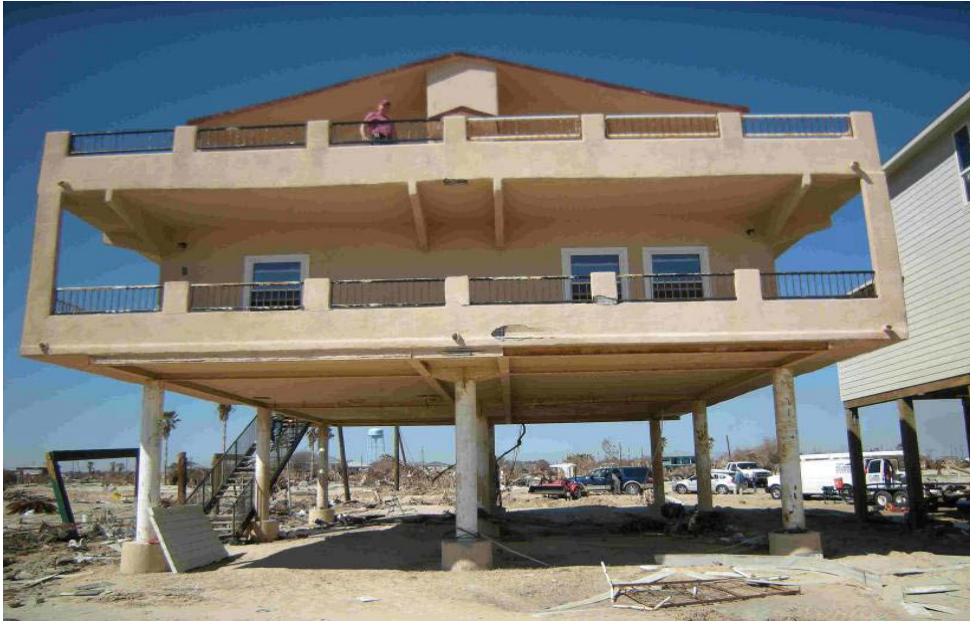
The foundation did not sustain any damage during Hurricane Ike (Figure 8.3-10 and 8.3-11). The 16-foot first floor column spacing of the Crystal Beach SCIP house allowed large debris, including that from the house in front of it, to pass below the house with no damage to the foundation.

Figure 8.3-10. View looking north at the Crystal Beach SCIP house. Figures 8.3-11 to 8.3-14 show close ups of the house.

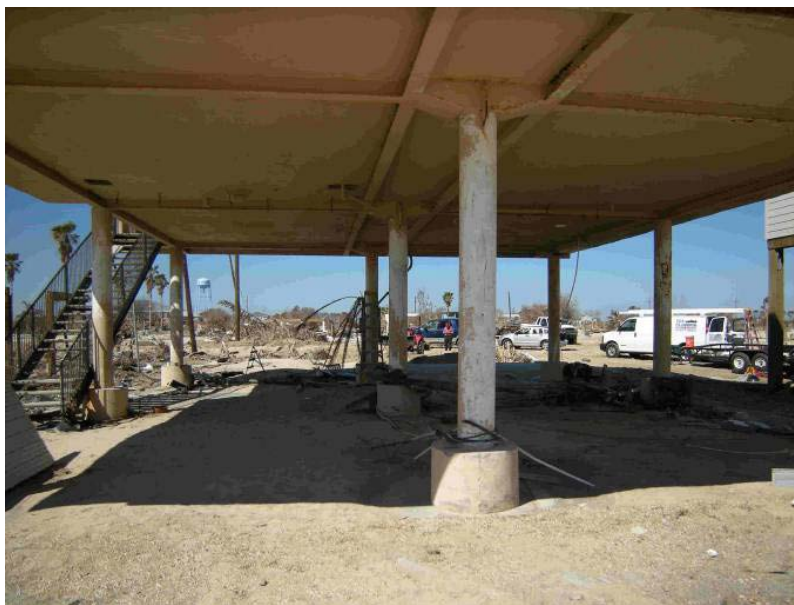
All bolts connecting the columns of the house to the foundation are protected and were not damaged by Ike. In accordance with its design, the connections allowed the house to act as a monolithic structure and withstand high winds and flood.

Figure 8.3-11. (101808d- 3688) View looking north under the house. Foundation of the Crystal Beach SCIP house did not sustain damage from Hurricane Ike.

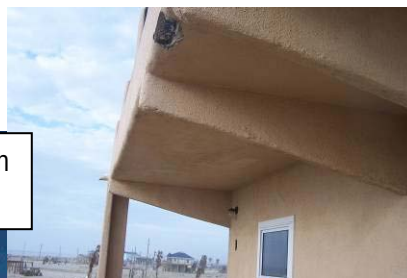
***Walls and Concrete (skins)Cover:*** Two impact holes and one hole as a result of railing bending were observed on the south side. This is the only elevation that sustained damage. One impact hole in the second floor, west side of the house was also observed (Figure 8.3-12). According to the builder, the appearance of the hole was reminiscent of impact holes found during testing of the panels at TTU when the walls were shot with an air cannon. The hole could have been caused by windborne debris or floodborne impact. All the holes were exterior skin impacts to the plaster that did not penetrate the wall. They were subsequently repaired with concrete (Portland cement plaster).

Figure 8.3-12. Impact hole on second floor south elevation, west side.

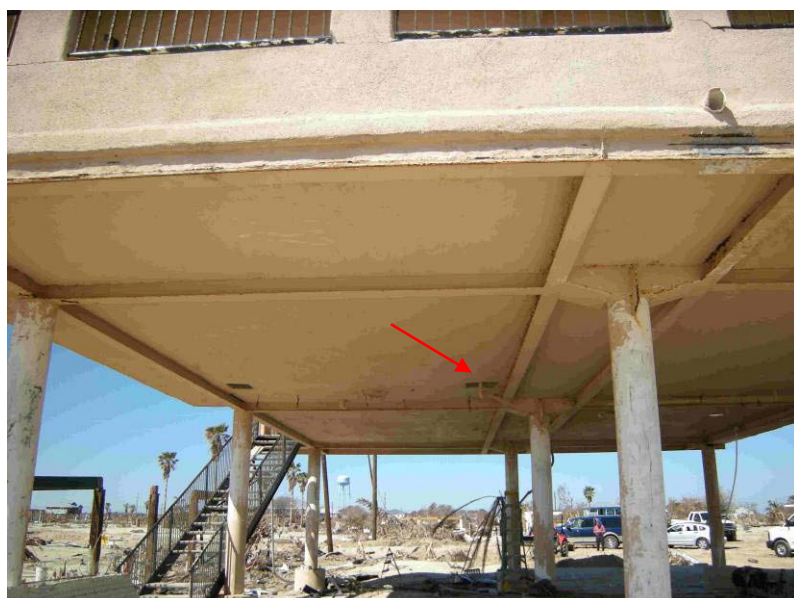
***Utilities:*** The plumbing was damaged when flood-borne debris moved under the house (Figure 8.3-14); replacement cost was expected to be approximately \$1,800. Additionally, minor damage occurred to the power coming into the house, including a broken conduit and a #4 wire that needed to be replaced. The plumbing was exposed and was torn off at its connection to the house. The builder removed the broken fitting and replaced it and the exposed plumbing.

Figure 8.3-14. (10/18/08, (101808d, 3684). View looking north under the house. Foundation of the Crystal Beach SCIP house did not sustain damage from Hurricane Ike. However, minor damage to the underside of the first floor was sustained from floodborne debris
