Conveyor Replacement

Alberta

Mining & Metals

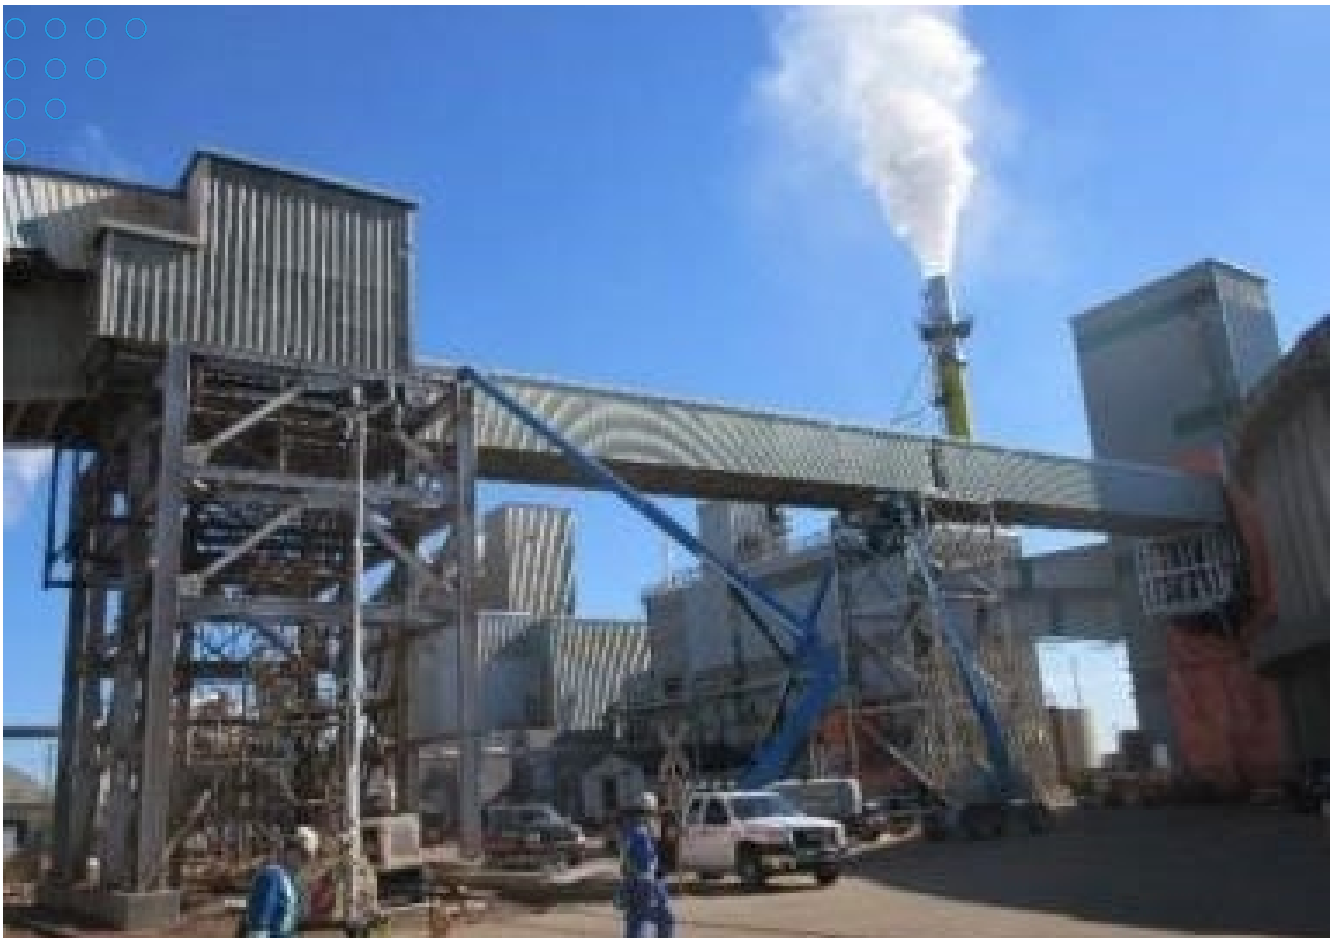
A conveyor gallery required extensive repairs. Rally was engaged to provide engineering and planning expertise for the repair work. Three gallery repair options were considered; a risk analysis was completed for each option's total installed cost (TIC) estimate to quantify the potential for cost variability. The conveyor gallery was ultimately replaced in-kind but with corrosion mitigating upgrades.

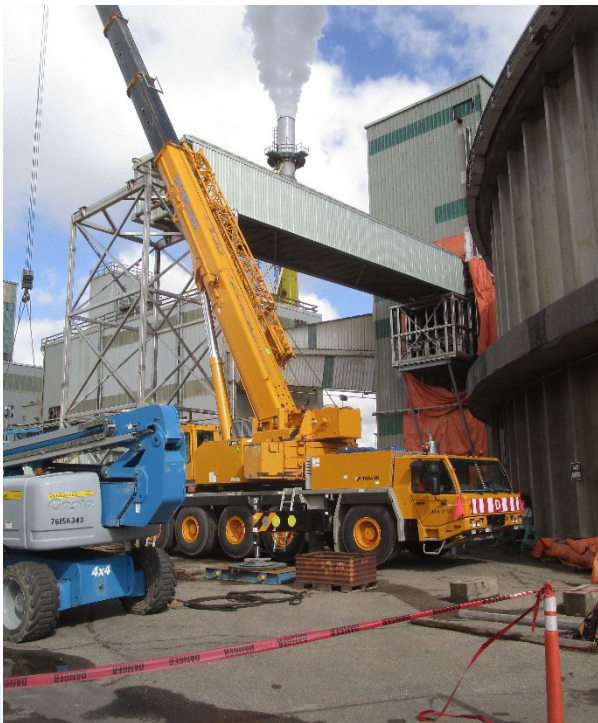
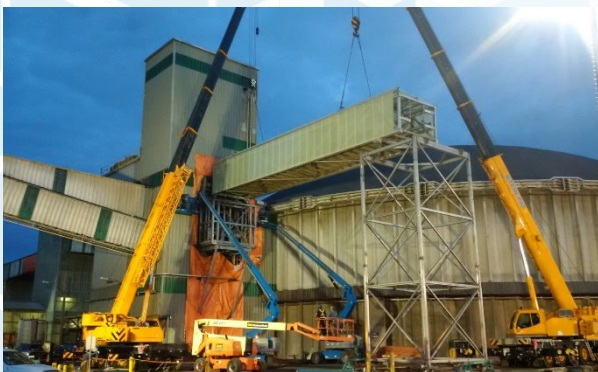
The Client decided to replace the original conveyor in-kind with upgraded materials. The new support structure was designed and fabricated from 304L stainless steel with FRP grating and cladding for greatly improved corrosion resistance.

Rally prepared construction work packages for all aspects of the civil / structural scope including piling, demolition, module fabrication and assembly, and other turnaround work.

Removal of the existing gallery and structure was planned for a brief two-week outage. The design and execution of the work leveraged off-site modular construction to shorten the overall turnaround window.
