# SAGGING LINTEL?

Repair cracked brick above the garage with a routine USS lintel repair.

## BRICK & LINTEL REPAIR

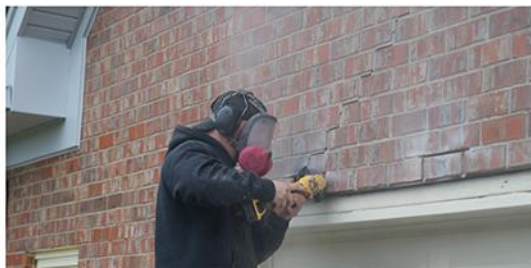
*Bricks are carefully removed to access the lintel.*

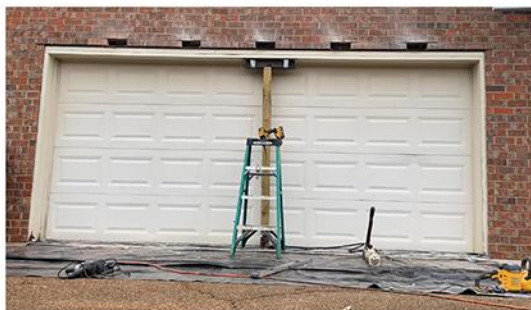
*Additional support is provided during the lintel repair.*

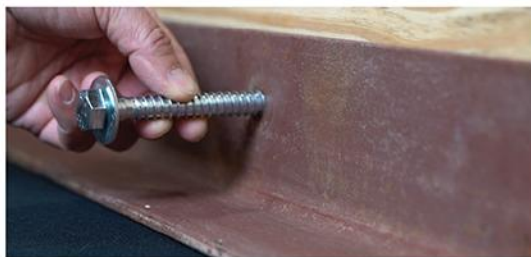
*The lag bolts that are installed hold the lintel in place.*

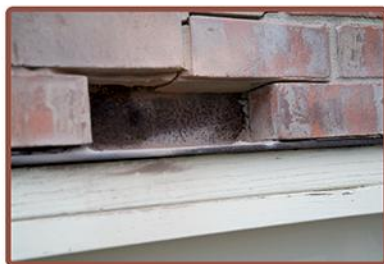
*Removing the brick exposes the lintel. Rusted lintels must be replaced.*

- Foundation piers will not correct a sagging lintel. Piers may only cause more damage and will not correct brick cracks above the garage door opening.
- Horizontal cracks above the opening may point to a rusted lintel. A rusted lintel requires full replacement.
