# SUNSTACK, LLC

## TEST REPORT

TAS 100(A)-95 TESTING ON SSB1 AND SSM, ROOF MOUNT BRACKET

Q8853.02-301-18-R0

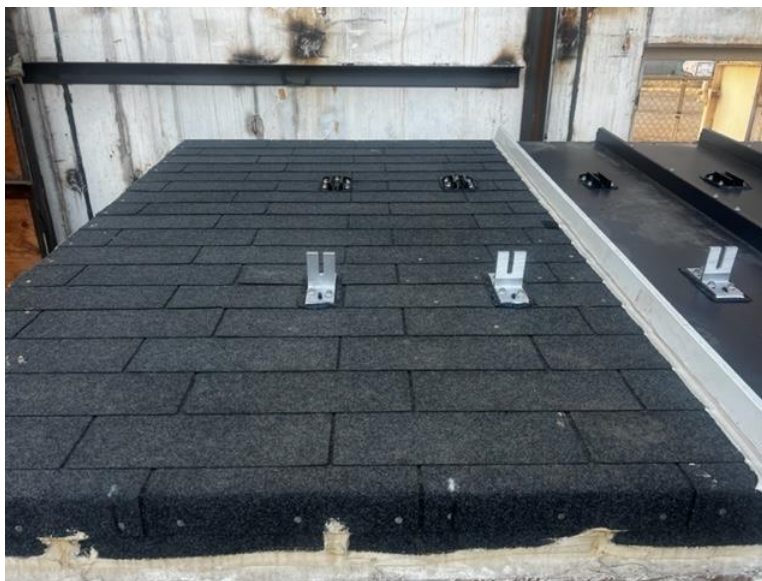
**Photo No. 1**  
**Asphalt Roof Shingle Install**

**Underlayment, and Prepared Roof Covering Description:** Asphalt shingle half of specimen consisted of 7/16" OSB with 30# felt underlayment and architectural asphalt shingles. Metal roofing half of specimen consisted of 7/16" OSB with 30# felt underlayment and mechanically secured metal lap roofing panels.

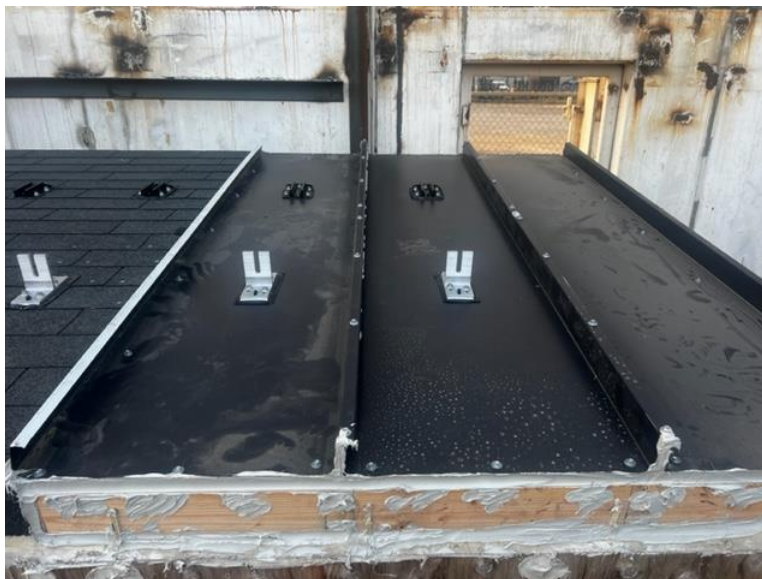
**Photo No. 2**  
**Metal Roof Install**

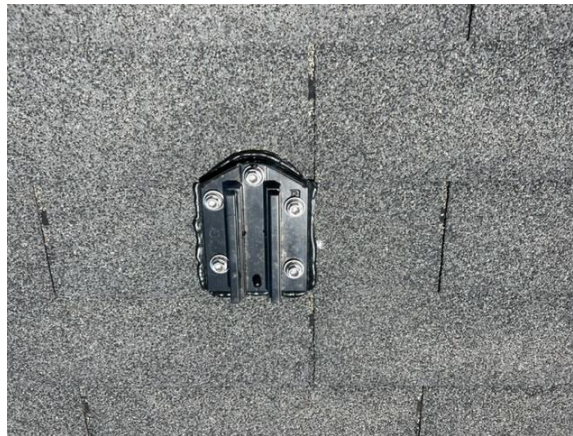
**Photo No. 3**  
**Typical SSB1 Asphalt Shingle Installation**

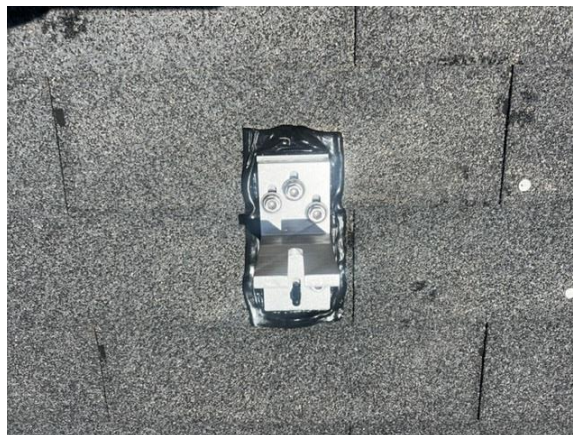
**Photo No. 4**  
**Typical SSM Asphalt Shingle Installation**

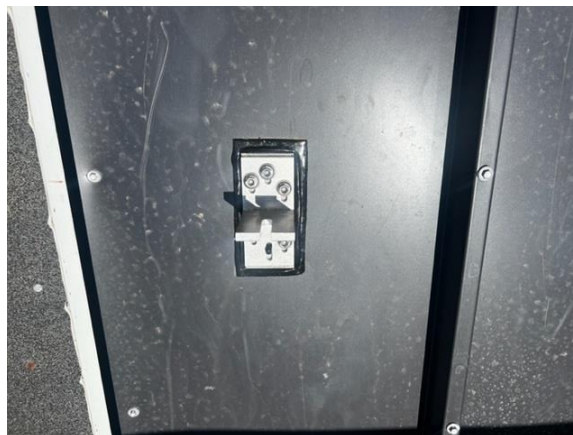
**Photo No. 6**  
**Typical SSM Metal Roof Installation**
