Providing hard-wearing flooring solutions for the Food and Beverage Industry

Belzona Know-How *in Action:*

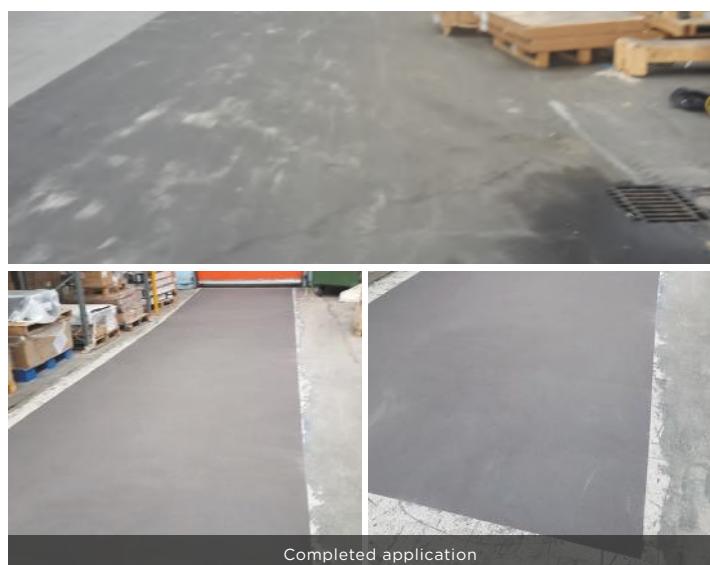
Whisky Bottling Plant, UK

Chemicals were spilling onto the factory floor and attacking the grout between the tiles. This was creating an uneven, hazardous flooring. The plant did not want to experience the downtime that a traditional cementitious repair plus chemical resistant coating would have incurred.

After preparing the surface, the application began with Belzona 4154 (Bulkfill Resin) which was used to repair the larger voids of damaged concrete. This was then overcoated by Belzona 4111 (Magma-Quartz) to restore the original level of the flooring. Finally, Belzona 4311 (Magma CR1) was applied to provide chemical resistance.

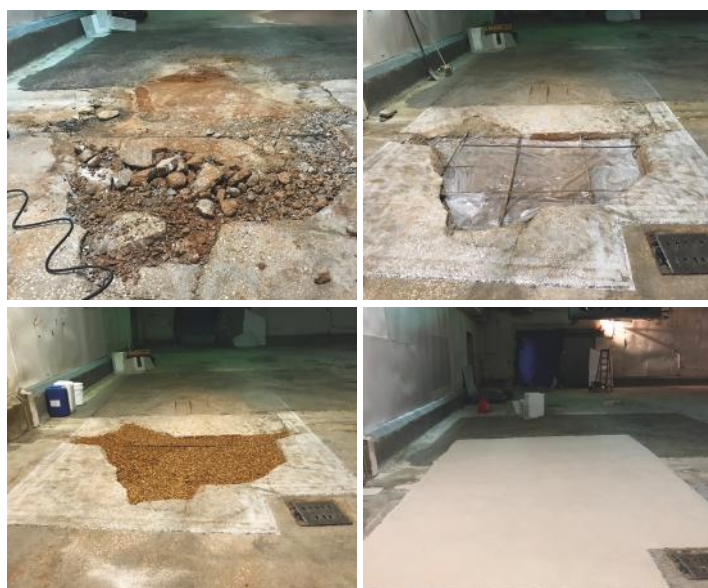
Meat Processing Plant, USA

Chemicals were spilling onto the factory floor and attacking the grout between the tiles. This was creating an uneven, hazardous flooring. The plant did not want to experience the downtime that a traditional cementitious repair plus chemical resistant coating would have incurred.

After preparing the surface, the application began with Belzona 4154 (Bulkfill Resin) which was used to repair the larger voids of damaged concrete. This was then overcoated by Belzona 4111 (Magma-Quartz) to restore the original level of the flooring. Finally, Belzona 4311 (Magma CR1) was applied to provide chemical resistance.
