# HVAC SYSTEMS

*Belzona Protective Coatings and  
Engineering Composites*

# Belzona Solutions for HVAC Systems

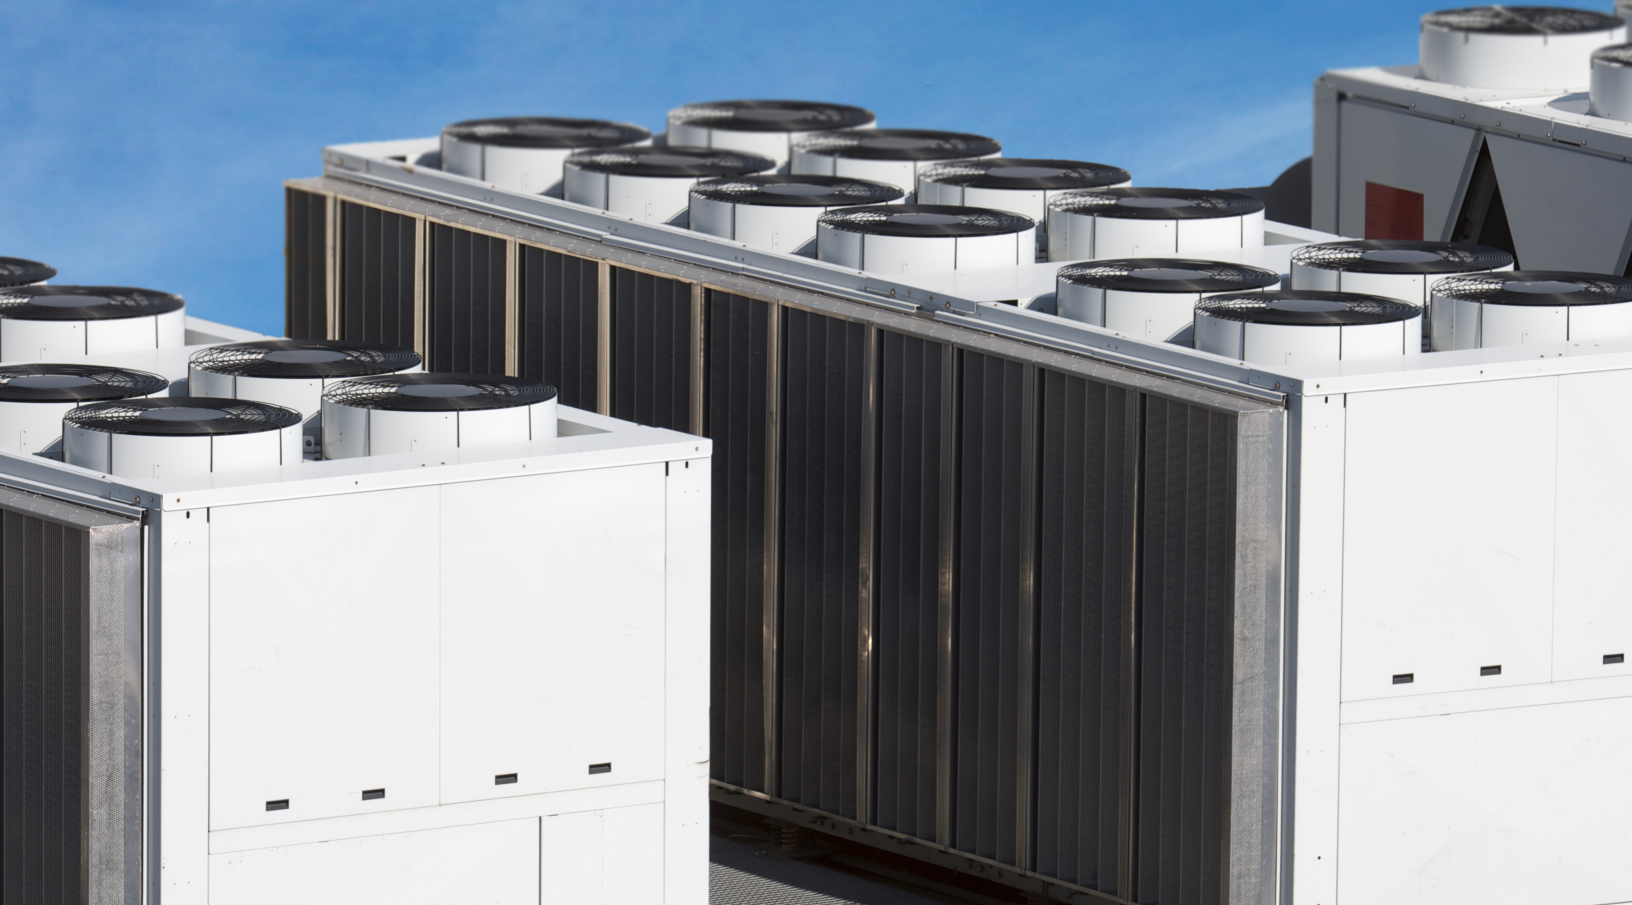
# Repair and Protection of Condenser Water Systems

In areas with a hot climate, large office buildings, hospitals, and schools typically use one or more cooling towers as part of their air conditioning systems. Unlike the large concrete units at power stations, these smaller cooling towers are commonly constructed from galvanized steel and over time suffer from corrosion.

The combination of air, water, chemicals and heat in cooling towers creates a severe corrosive environment. It is common to find perforations and holes and severe metal loss on units in service. In addition, cooling tower fan blades usually suffer from erosion of the leading edge, as well as cracks and flaking on the trailing edge, reducing the overall efficiency of the system.

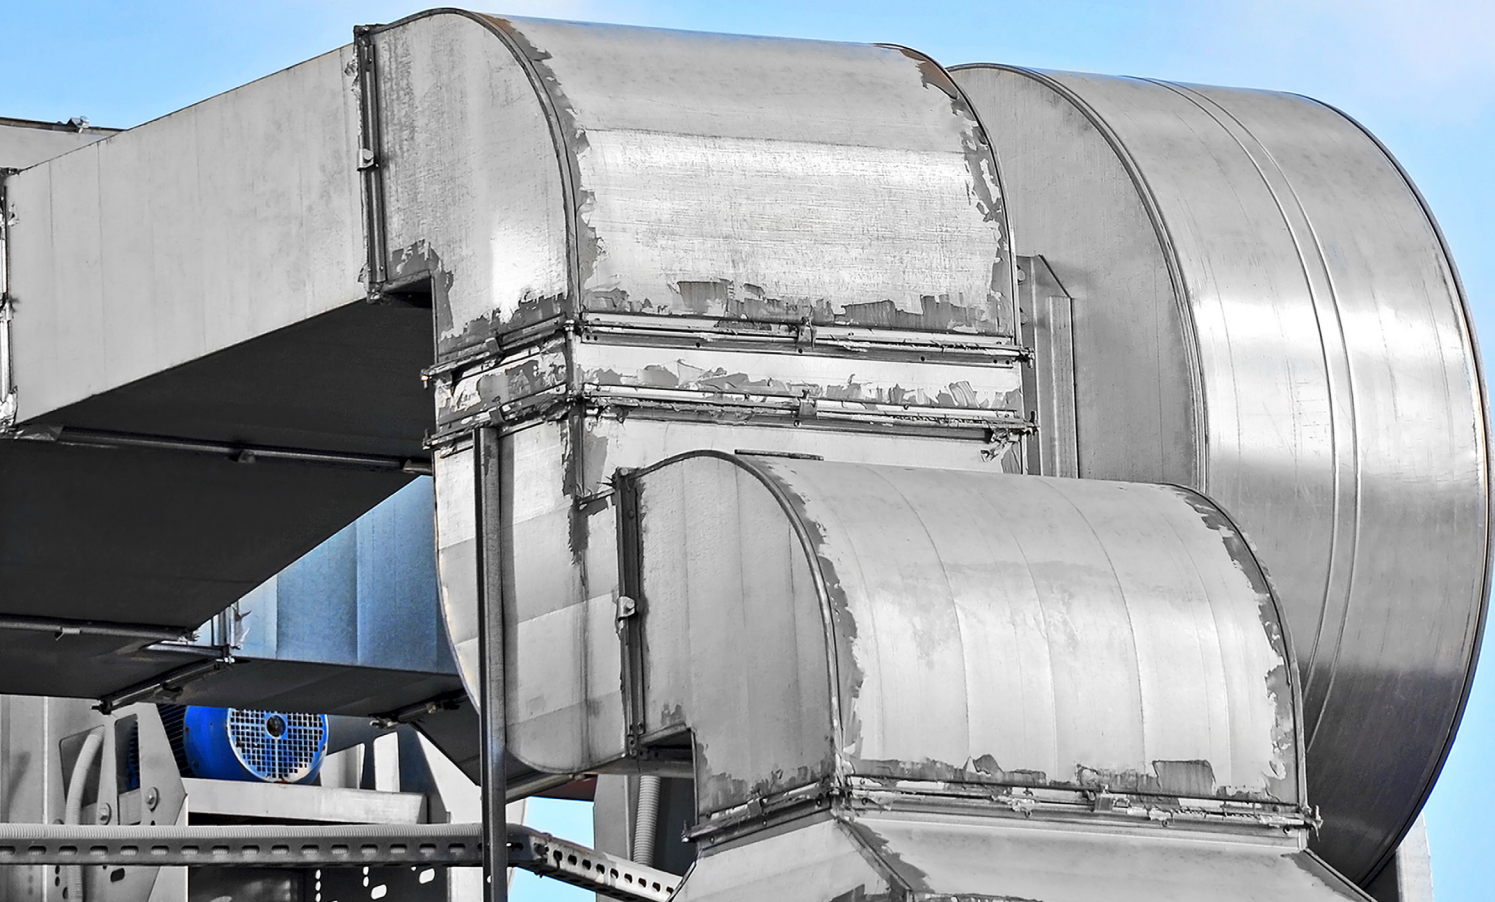
# Protection Against Air and Water Ingress into Ductwork

From internal corrosion, accelerated by water condensation, high temperatures, aggressive cleaning chemicals and microbiological growth, to the failure of joints and seams, maintenance of air handlers and ductwork can prove challenging. Condensation weakens and corrodes the metal of the ducts, which can lead to air leaks and water ingress, and subsequent efficiency losses and operational failure.

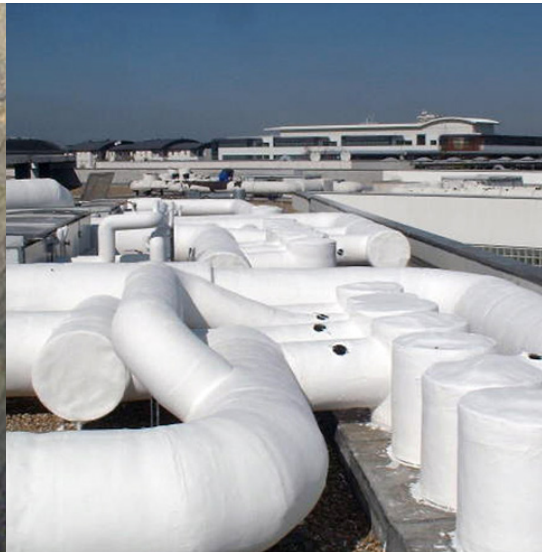
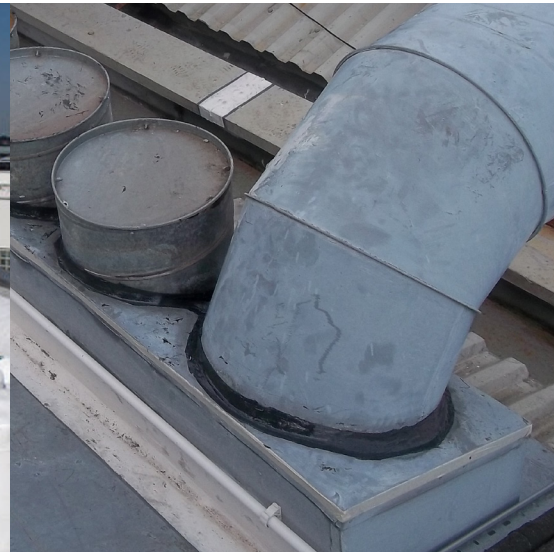
### Metal Loss Repair

Corrosion of surfaces such as condensate drip pans, cooling coil supports and ductwork can cause significant metal loss, leading to thin-wall and even through-wall defects. Belzona's metal repair materials offer a cold-applied alternative to replacement or unwanted hot work repairs.

### Corrosion and Weathering Protection

The coating of interior air handler parts and ductwork prevents future corrosion, avoiding premature failure and replacement. In addition, external encapsulation provides seamless protection at ductwork elbows, T-pieces and complex contours.

### Joint and Seam Sealing

Failure of joints and seams can allow ingress of water and disruption of air flow, affecting the efficiency of the system. Belzona's flexible repair materials can restore joints and seams to give long-lasting solution. Sealing at the interface between the roof and the ductwork can also be achieved with Belzona flexible membranes.
