# FINAL REPORT

Project Title: P53: Effects of Wide Centre Line Treatment on  
Pavements Y1 & Y2 (2015/16 & 2016/17)

ARRB Project No: PRP16038

Client: Queensland Department of Transport and Main Roads

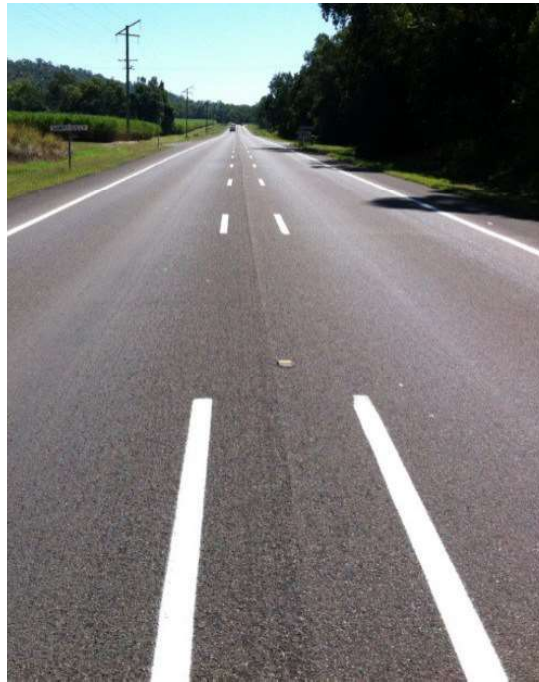
Figure 1.1: Example of a typical wide centre line treatment

In the last two-to-three years, the Queensland Department of Transport and Main Roads (the Department) has trialled and implemented a nominally 1 m wide centre line treatment (WCLT) to reduce the risk of head-on crashes. A typical WCLT layout is shown in Figure 1.1. The photograph was taken along the Bruce Highway on the Townsville – Ingham section (Road 10M Chainage 88.84 km).

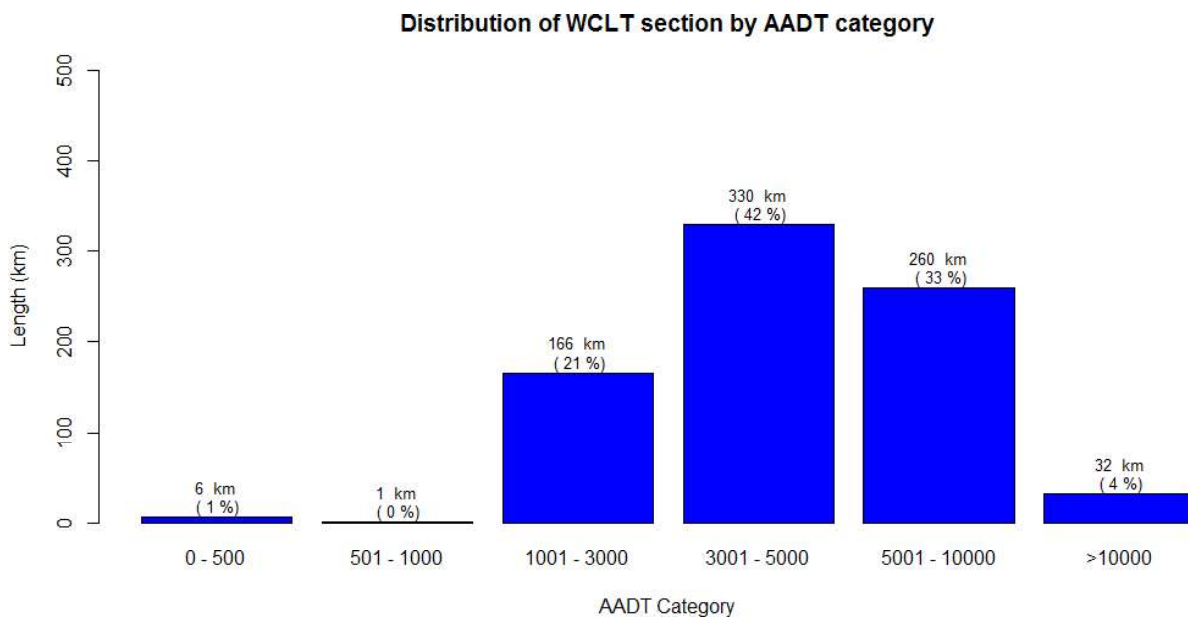
Figure 3.3: Distribution of WCLTs by average annual daily traffic (AADT)

The distribution of WCLT sections across the Districts and the associated traffic volumes is also shown in Figure 3.2 and Figure 3.3. The Mackay/Whitsunday District has the longest total length of WCLTs, totalling 231 km. The Fitzroy District also has a considerable length totalling 215 km that has the treatment. WCLTs have mainly been implemented on two-way, two-lane rural highways in 100 km/h environments, with traffic volumes greater than 1000 vehicles per day. One-third of the WCLT sections have traffic volumes more than 5000 vehicles per day.

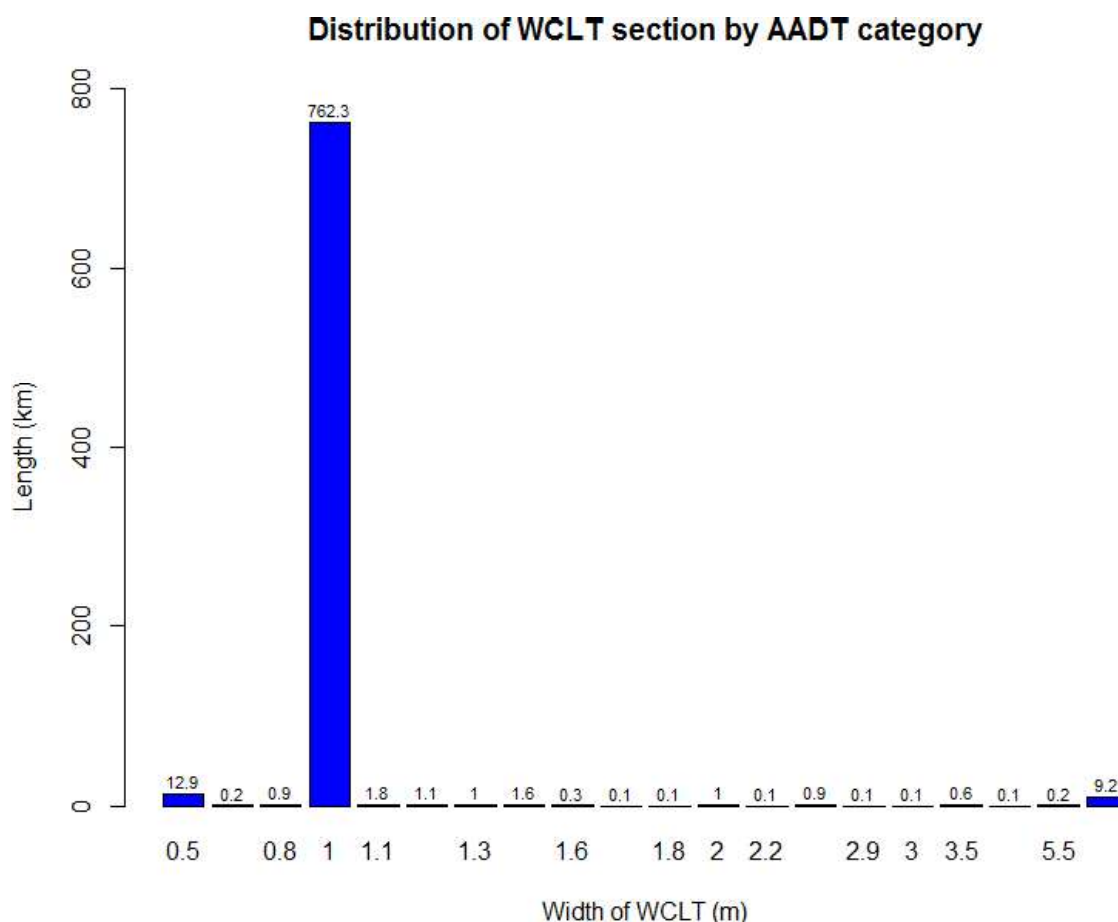
Figure 3.4: WCLTs width distribution

Figure 3.4 presents the distribution of WCLT width according to the ARMIS data provided. It shows that 762 km (96%) of WCLTs are consistent with TN155 by providing a 1m width. In the remaining 4%, the widths range from 0.5 m to 3.5 m.

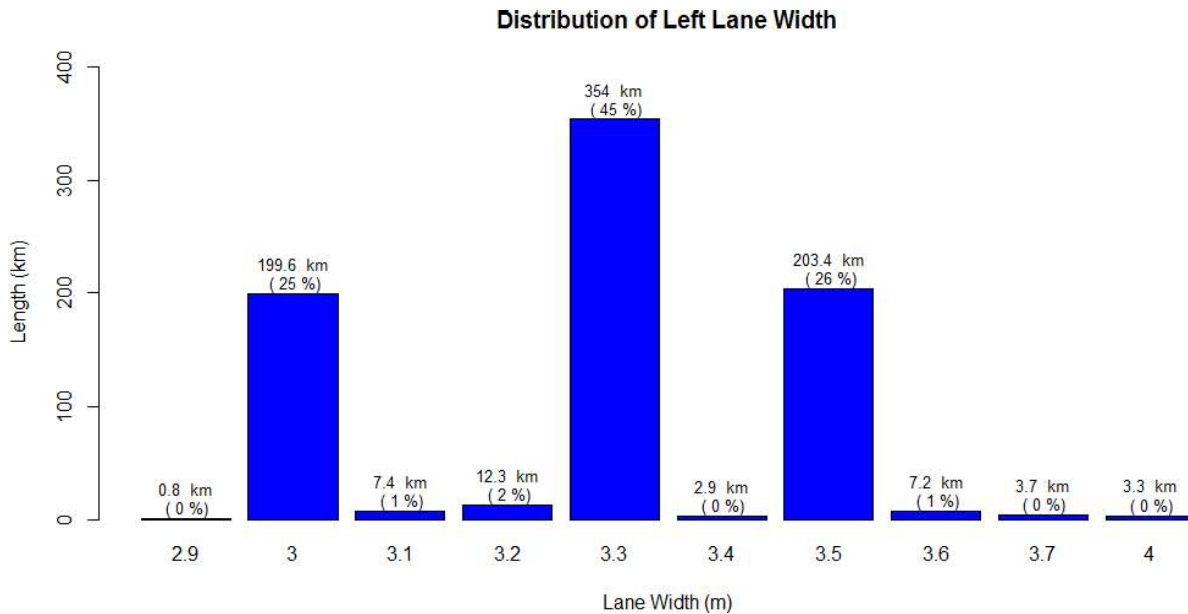
Figure 3.5: Lane width distribution along WCLT sections

A summary of the lane widths and shoulder widths along WCLT sections is provided in Figure 3.5 and Figure 3.6. It shows that the lane widths vary between 2.9 and 4.0 m, with the following distribution:

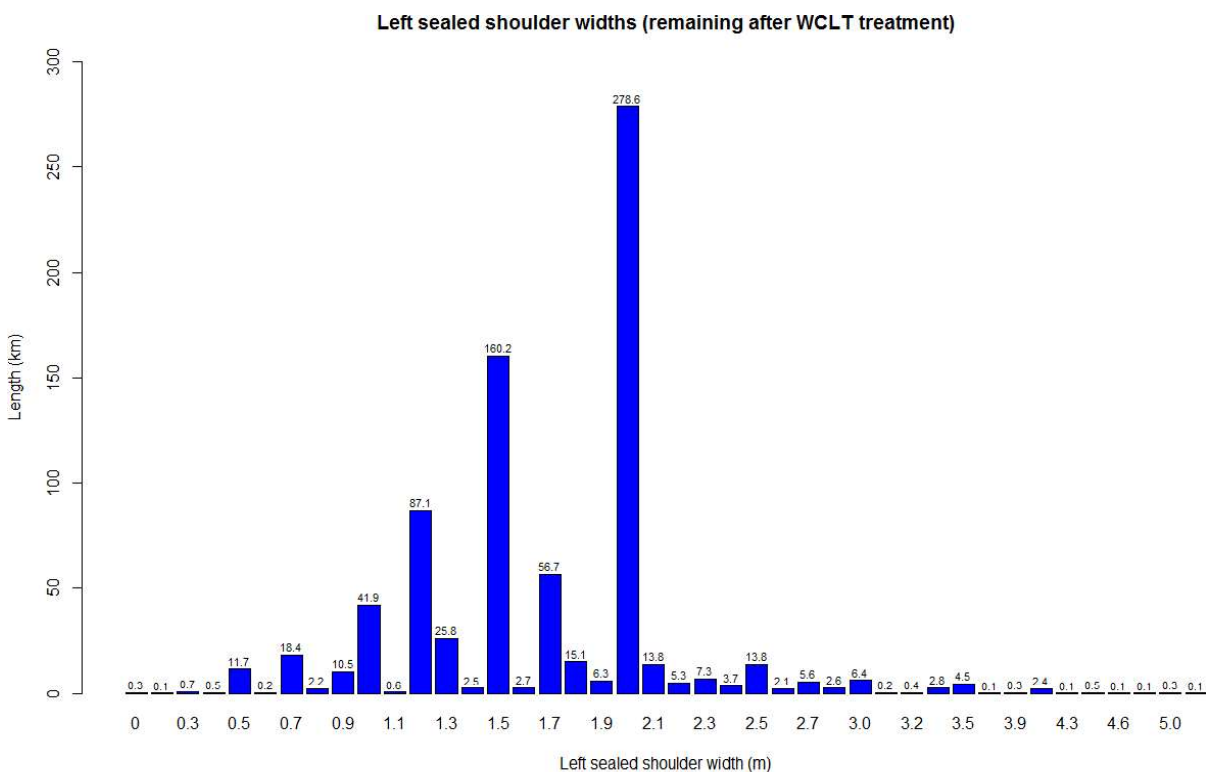
Figure 3.6: Sealed shoulder width distribution along WCLT sections

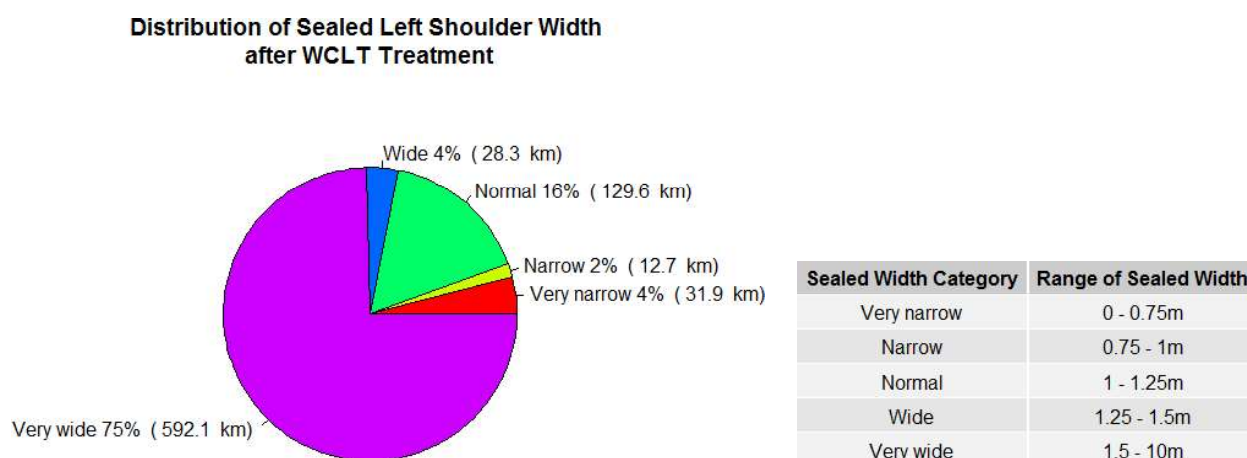
Figure 3.7: Distribution of sealed shoulders by category

Figure 3.7 shows the distribution of the sealed left (outer) shoulder width along the WCLT sections. The data is summarised by grouping the different sealed widths into descriptive categories (i.e. very narrow, narrow, normal, wide and very wide). The majority of the sealed width exceeds 1.5 m after the implementation of the WCLT.

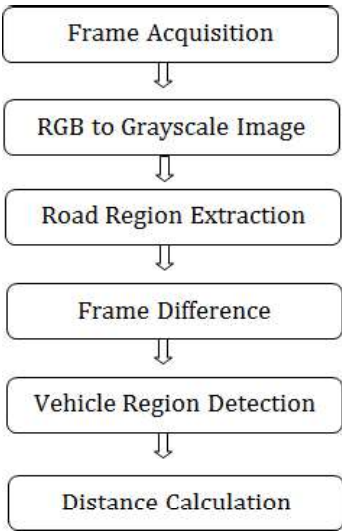
Figure 5.2: Image processing technique adopted in the study

Illustration and sample images for the different image processing steps is shown in Table 5.2. A detailed discussion of the image processing technique can also be found in the CQU research report included in Appendix E.

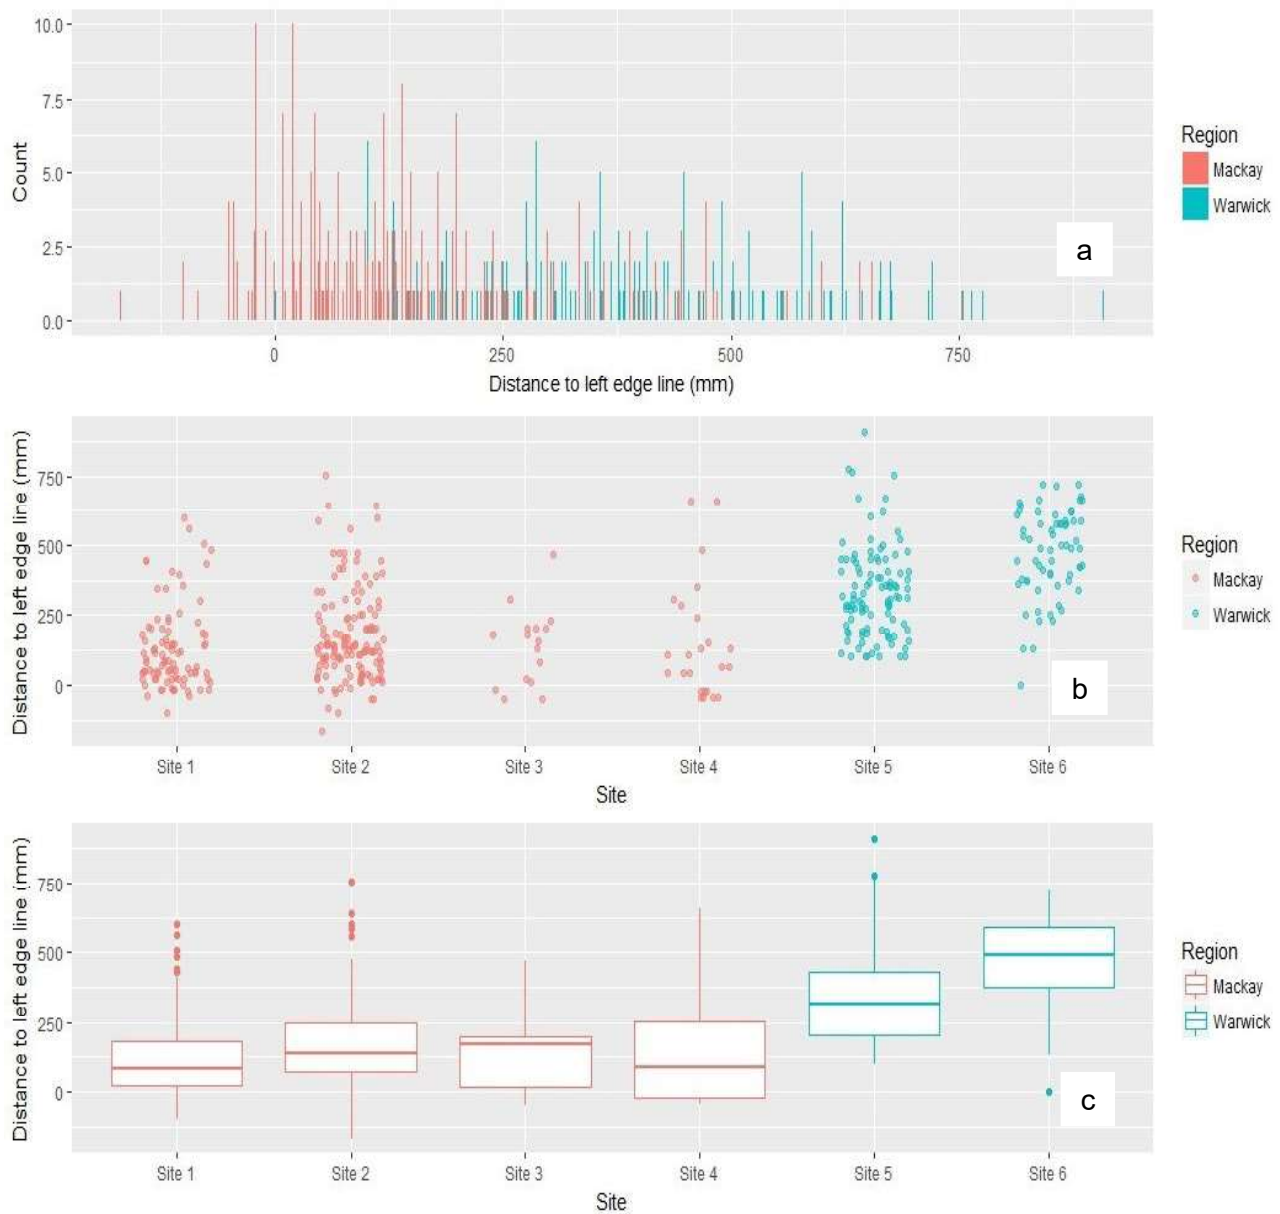
**Figure 5.6: Statistical plots of vehicle wander data collected in all six sites located across the Mackay and Warwick districts**

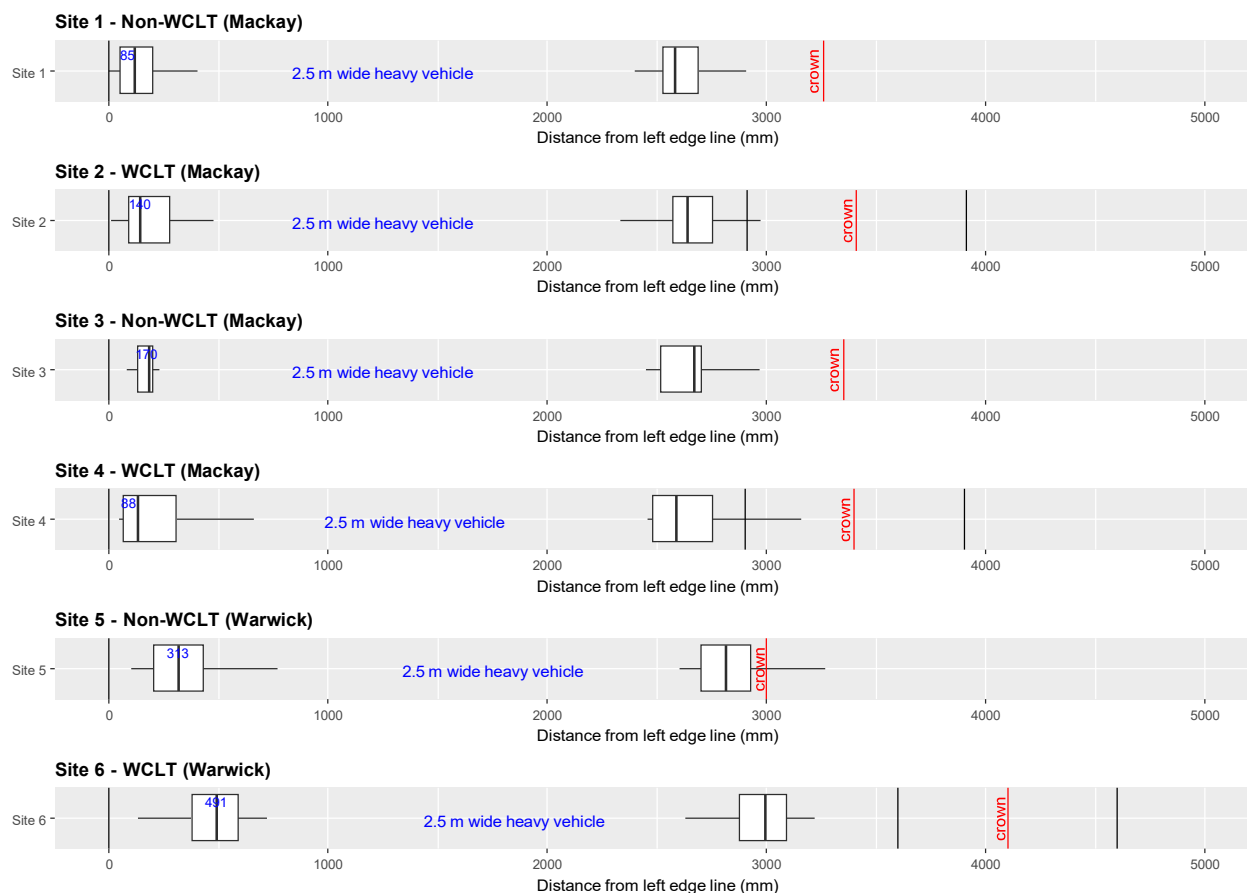
Figure 5.7: Wheel positions and distance from the left edge line

Note: A maximum heavy vehicle width of 2.5 m has been adopted based on dimensions provided by National Heavy Vehicle Regulator (2016).

To better understand the lateral position of the heavy vehicle in relation to the edge line and crown position, the box plot showing the distance from the wheel to the edge line is presented in Figure 5.7 (refer to Figure 5.3 for the legend). A summary of the distance is also presented in Table 5.4.

The median distance from the edge line is generally higher in the WCLT sites than the non-WCLT sites. This is an interesting finding because this observation is contrary to the common belief that heavy vehicles will travel closer to the left edge line after the installation of a WCLT. The observation suggests that the extra space provided by the 1.0 m WCLT median results in additional separation distance between oncoming vehicles and allows the drivers of heavy vehicles to be more confident to travel closer to the median.

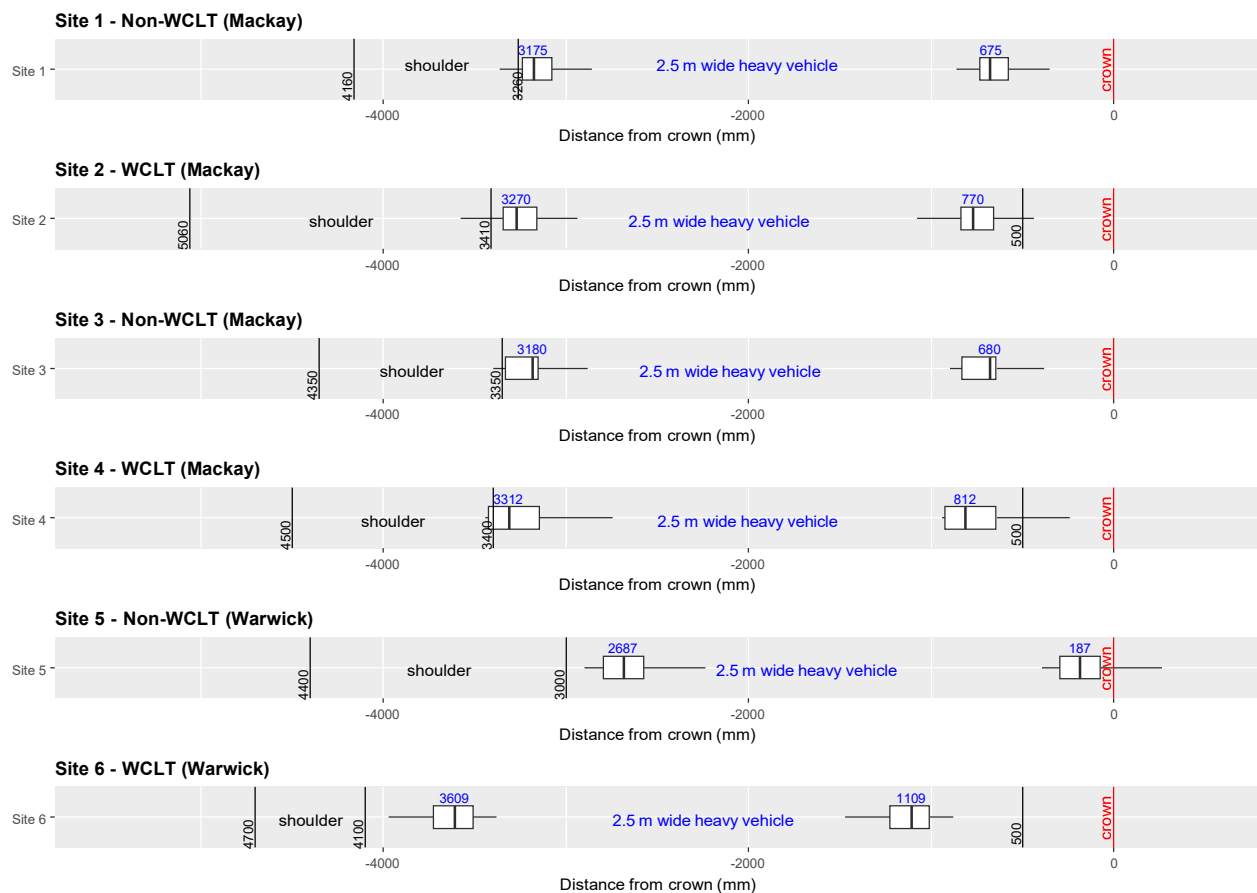
**Figure 5.8: Wheel positions and distance from the road crown**

The data suggests that, as commonly expected, all WCLT sections have the right edge of the wheel travelling further away from the crown. This can be partially explained by the additional 0.5 m width provided by the WCLT. The difference is significant between Site 5 and Site 6, but this can be caused by the significant difference in lane width and the fact that the data collected at Site 6 is at the start of a taper leading to a left-hand slip lane.

For Mackay, the average median distance between the crown and the outer edge of the right wheel for the non-WCLT sections is 678 mm. On the other hand, the average median distance for the WCLT sections is 791 mm. The difference is only 113 mm and is insignificant in relation to the tyre width.

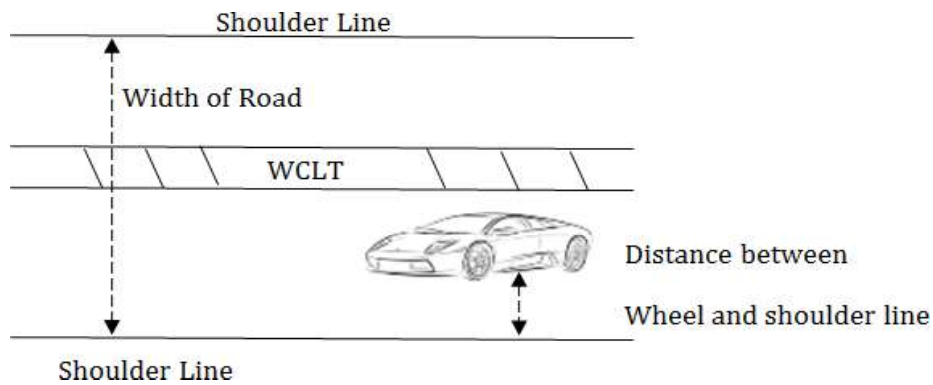
Fig. 3. Geometrical Street Model Encompassing Vehicle and Shoulder Line

The proposed framework is presented in this section. Figure 3 shows the geometric model for our target area. A sketch of the vehicle shows the movement of the vehicle. The captured images in this research were taken by a video camera.

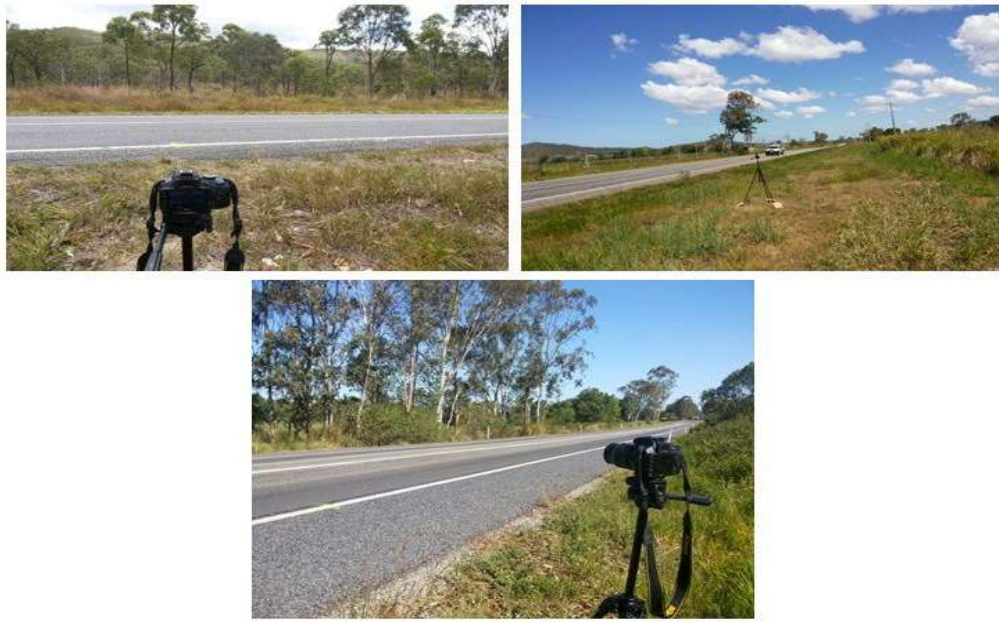
Fig. 6. Camera Setup (Nikon)

Figures 6 and 7 below show some examples of camera setup in the surveyed locations.

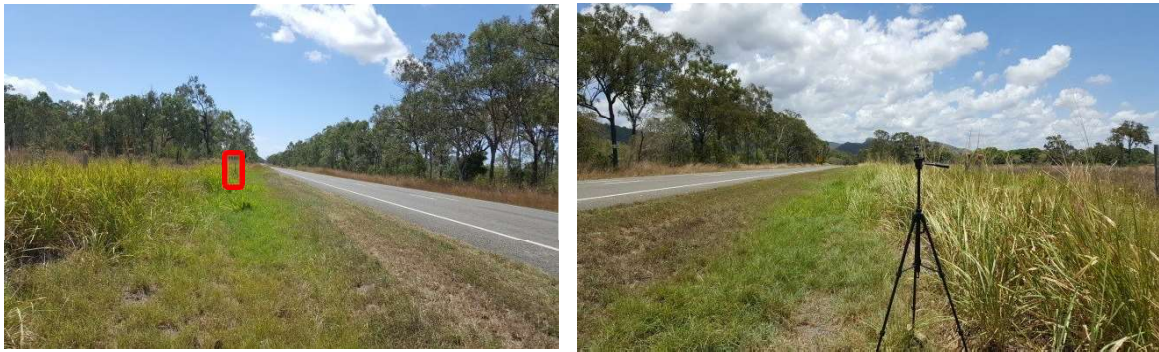
Fig. 7. Camera Setup (GoPro)

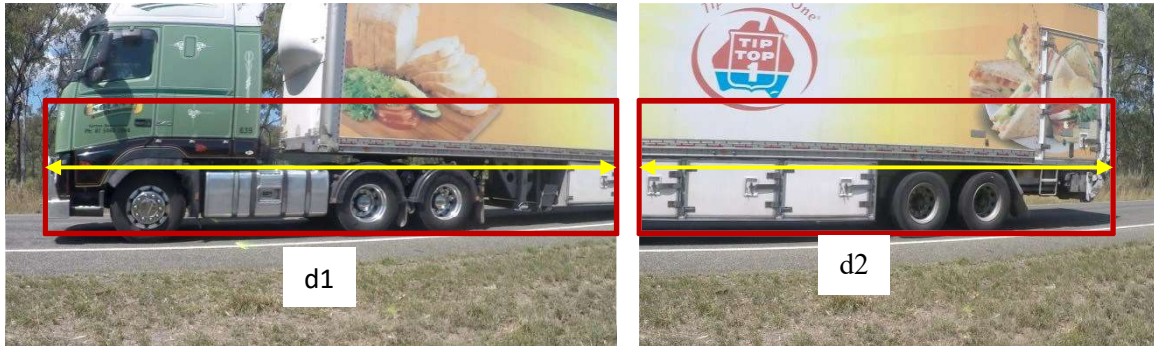
$$\text{Total Vehicle Length } D = d1 + d2$$

Fig. 11. Vehicle Length Calculation (From real image)

and used the information to define the whole vehicle region. We choose the biggest component to define the vehicle region. Later we calculate the bounding box to detect the vehicle length. This length doesn't give us the actual vehicle length so as shown in Figure 11 we need to check the next frame sequence and by similar technique need to find out the vehicle region and keep adding to the previous length.

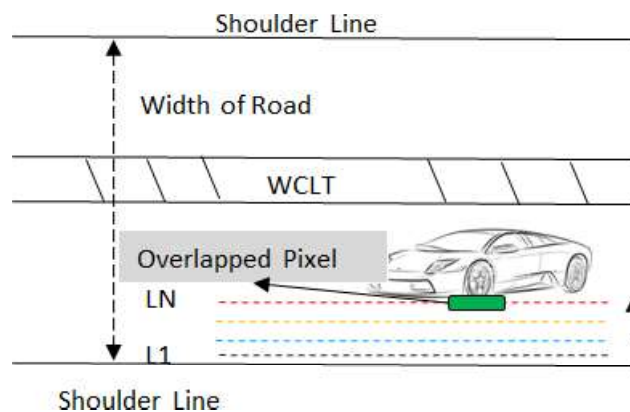
Fig. 12. Distance Calculation Process

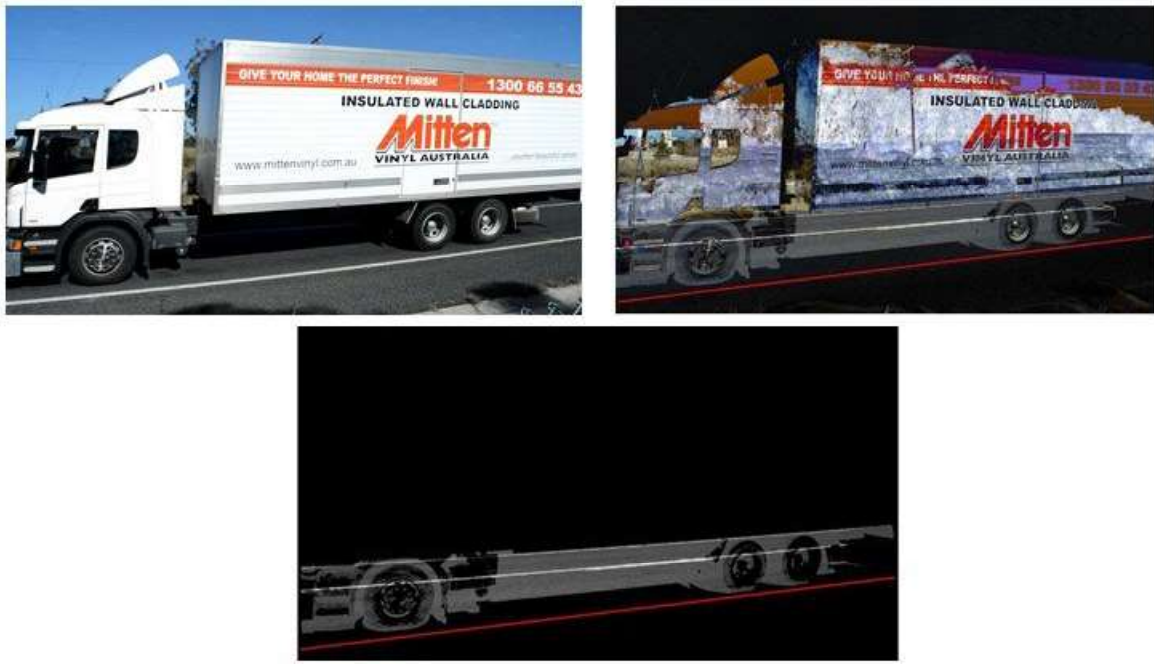
Fig. 13. Distance Calculation from Shoulder line to Wheel

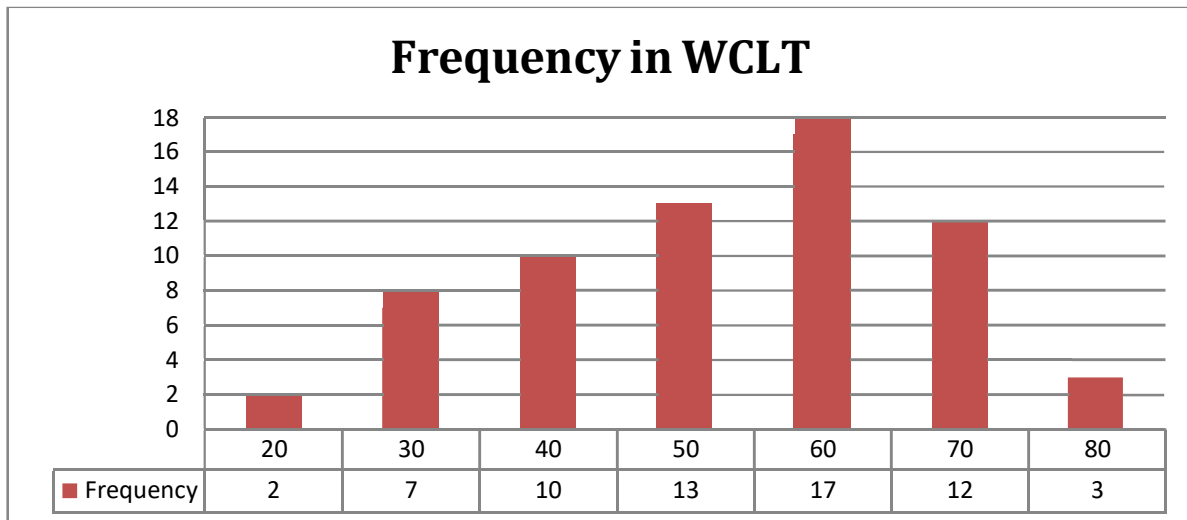
Fig. 18. Frequency on WCLT within different range of distance

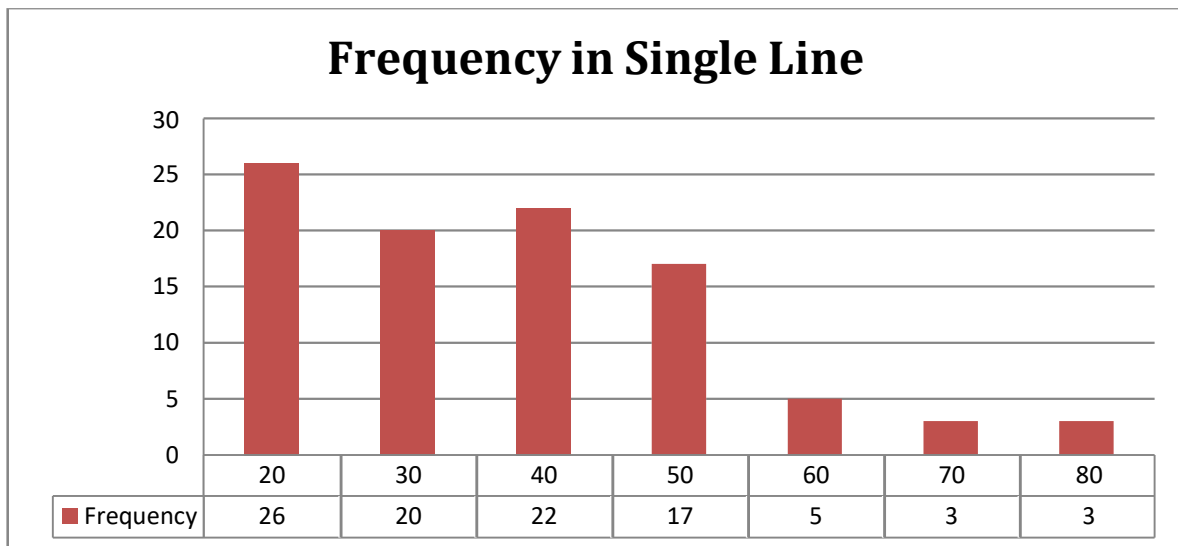
Fig. 19. Frequency on single line within different range of distance

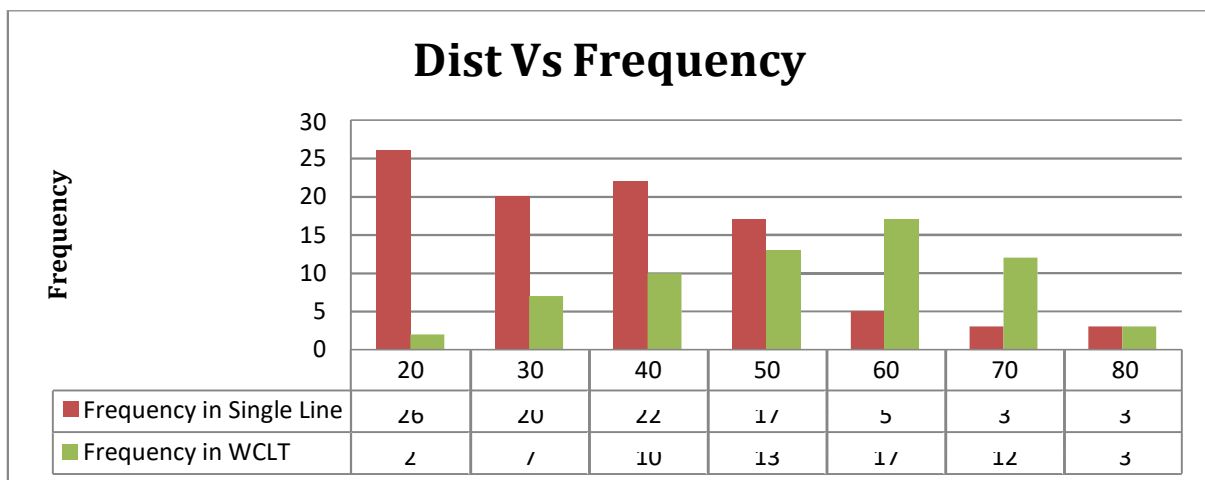
Fig. 20. Comparative analysis of driving behavior on both single line and WCLT within different range of distance

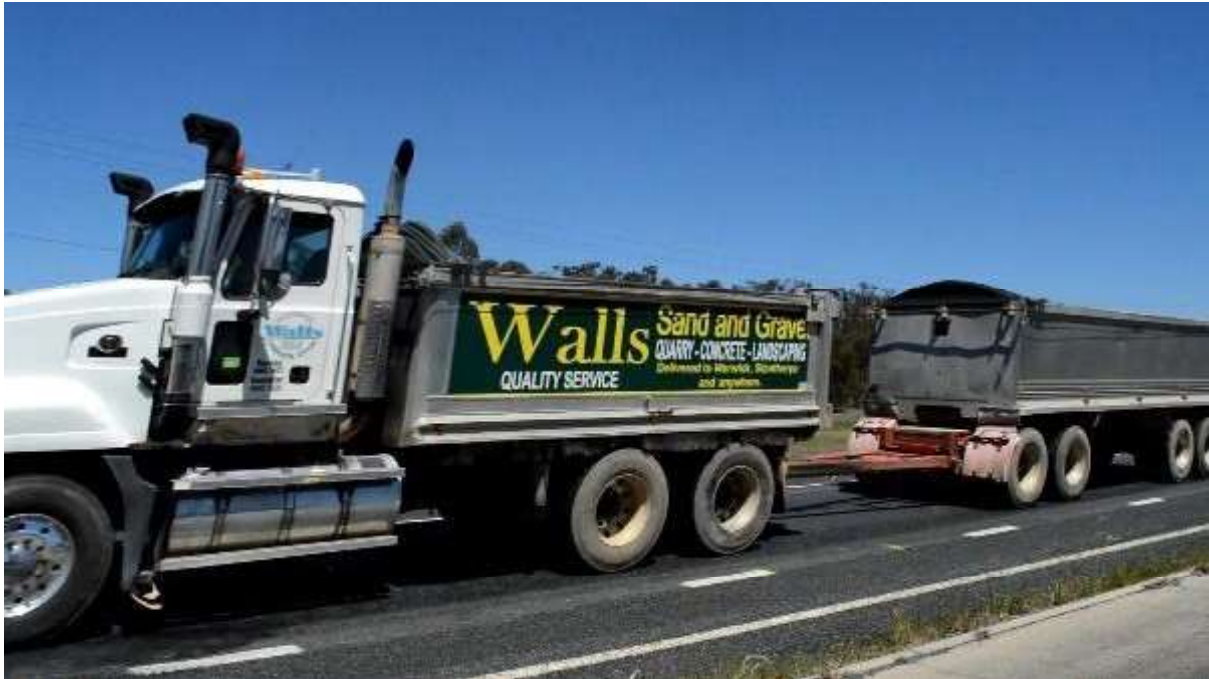
Fig. 21. Driver Behaviour on WCLT (Distance from Shoulder = 50.6 cm)

Figures 21 to 24 show some examples of driving behaviour in Warwick sites. From the images, it is clear that, while there is WCLT, drivers feel more comfortable on driving closer to WCLT, while in the case of single line drivers mostly drive closer to the shoulder line. Although, the behaviour is not obvious for all drivers, there are some cases where driving behaviour changes. But our overall observation and collected samples show that, in most of the cases, driver behaviour follows the first scenario.

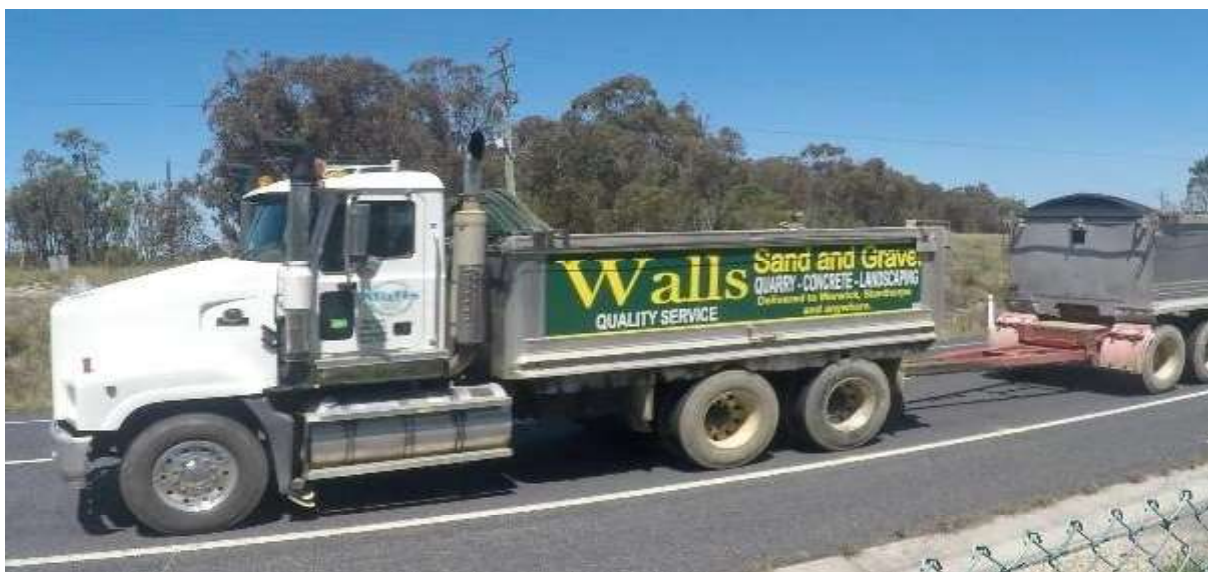
Fig. 22. Driver Behaviour on Single Line (Distance from Shoulder = 20.4 cm)

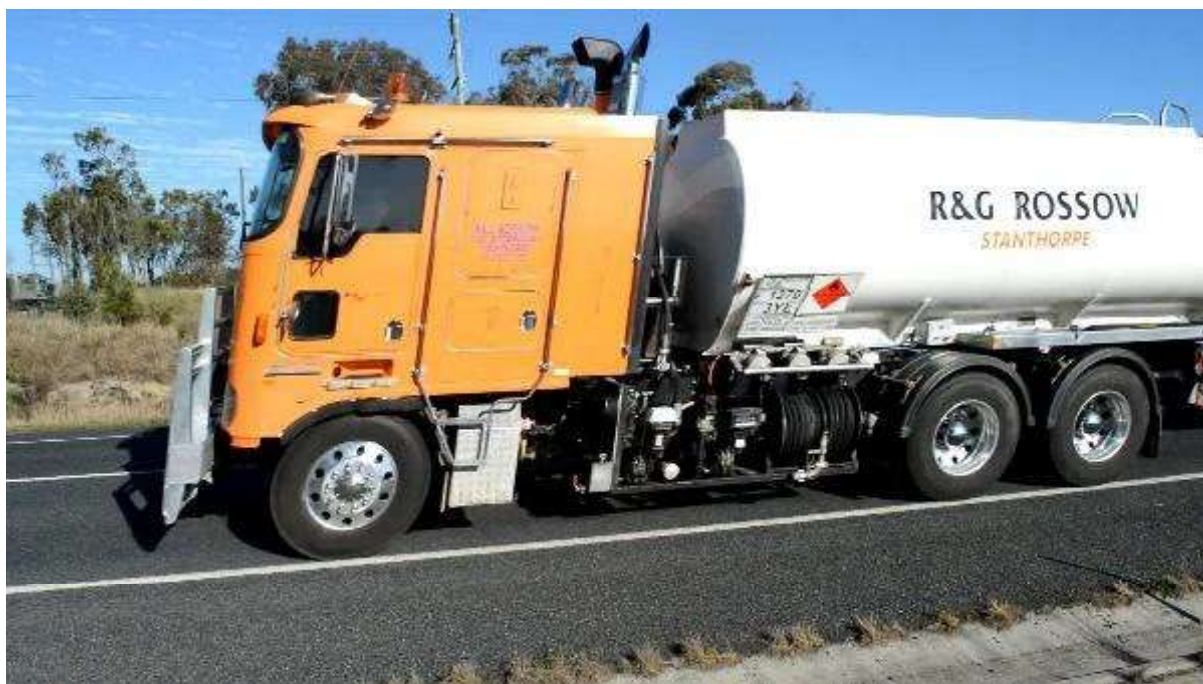
Fig. 23. Driver Behaviour on Single Line (Distance from Shoulder = 2 cm)

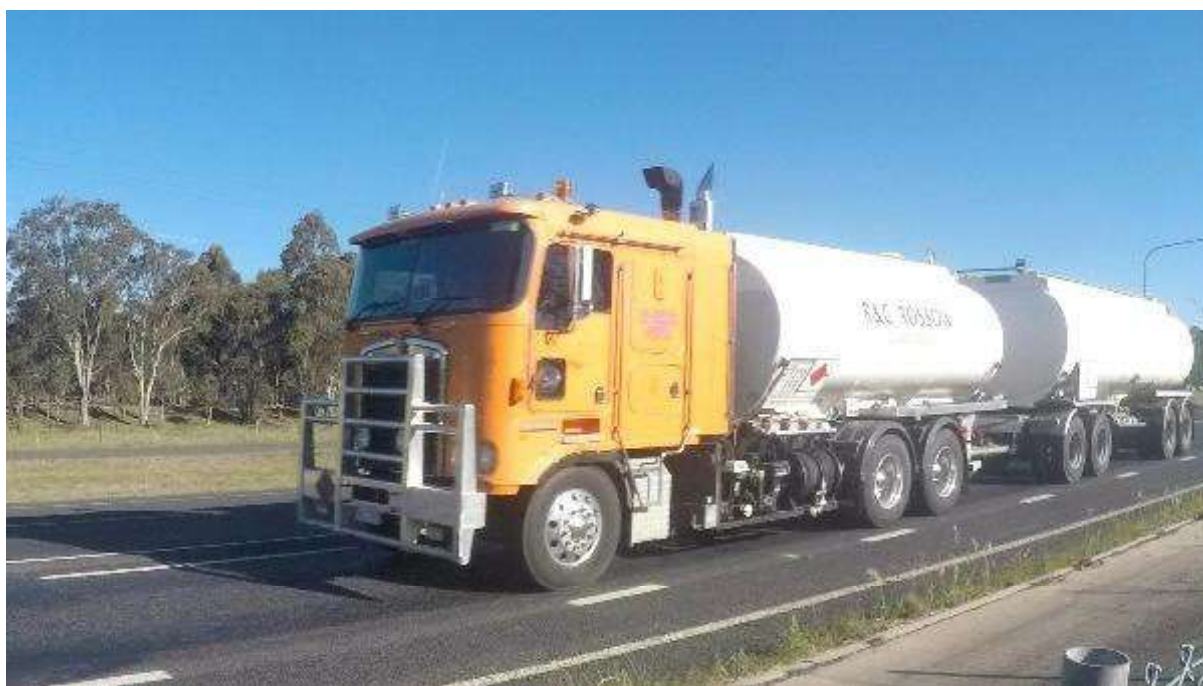
Fig. 24. Driver Behaviour on WCLT (Distance from Shoulder = 32.4 cm)

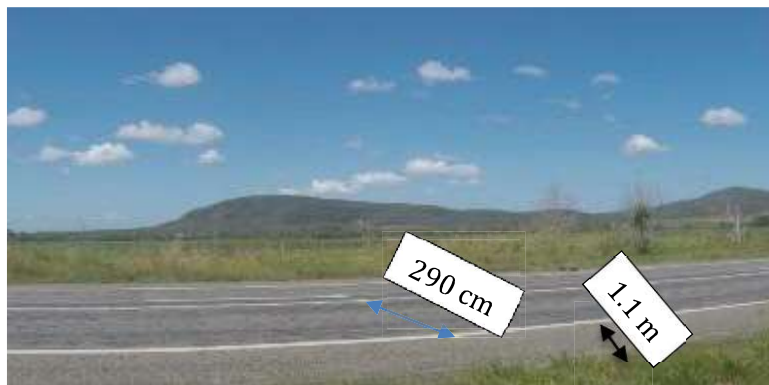
Road Width: 290 cm

1 pixel = 2.19 cm

Fig. 34. Roadside Conditions for Site 4

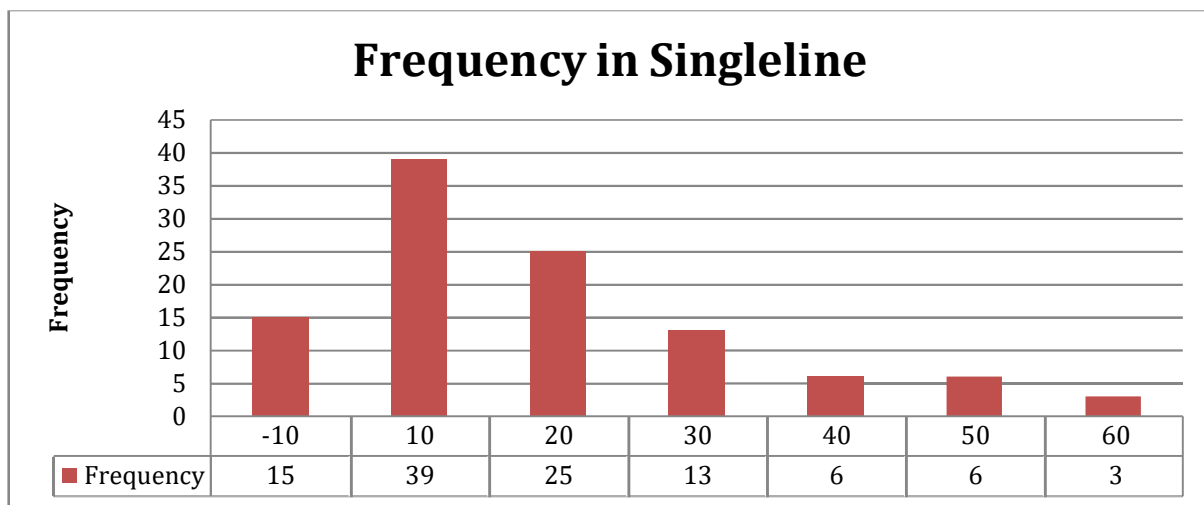
Fig. 36. Frequency on single line within different range of distance

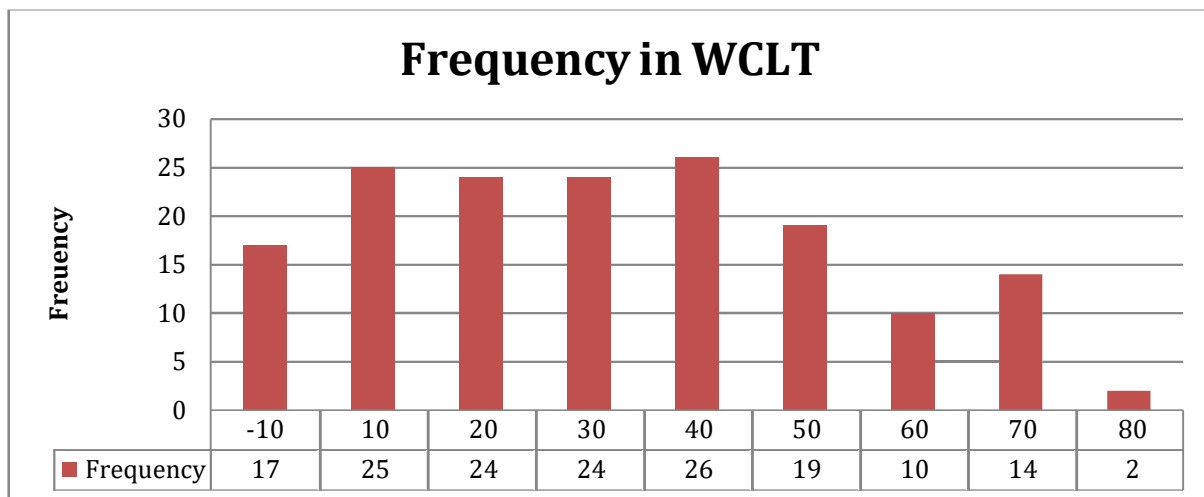
Fig. 37. Frequency on WCLT within different range of distance

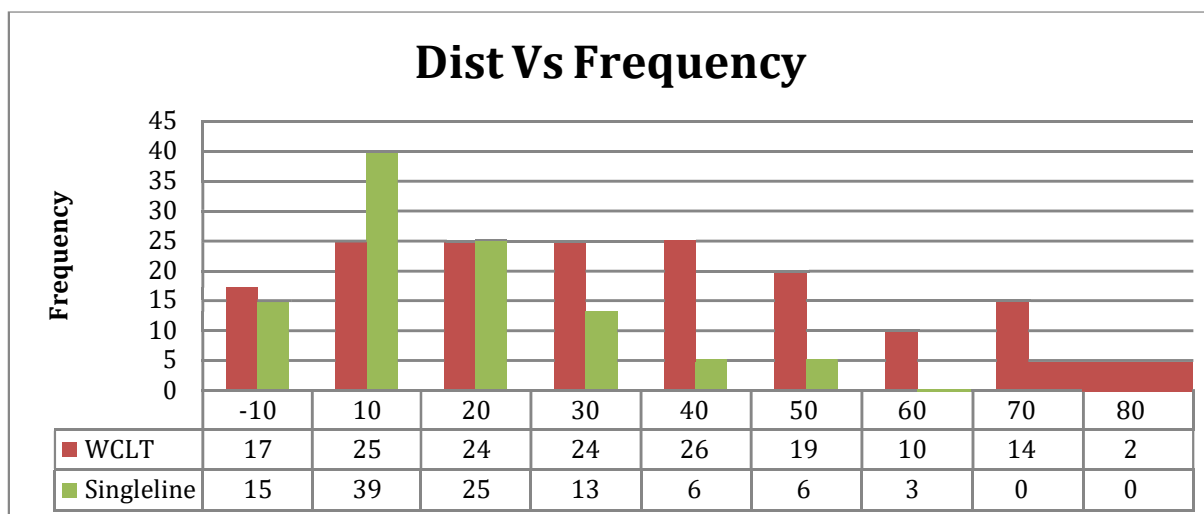
Fig. 38. Comparative analysis of driving behaviour on both single line and WCLT within different range of distance

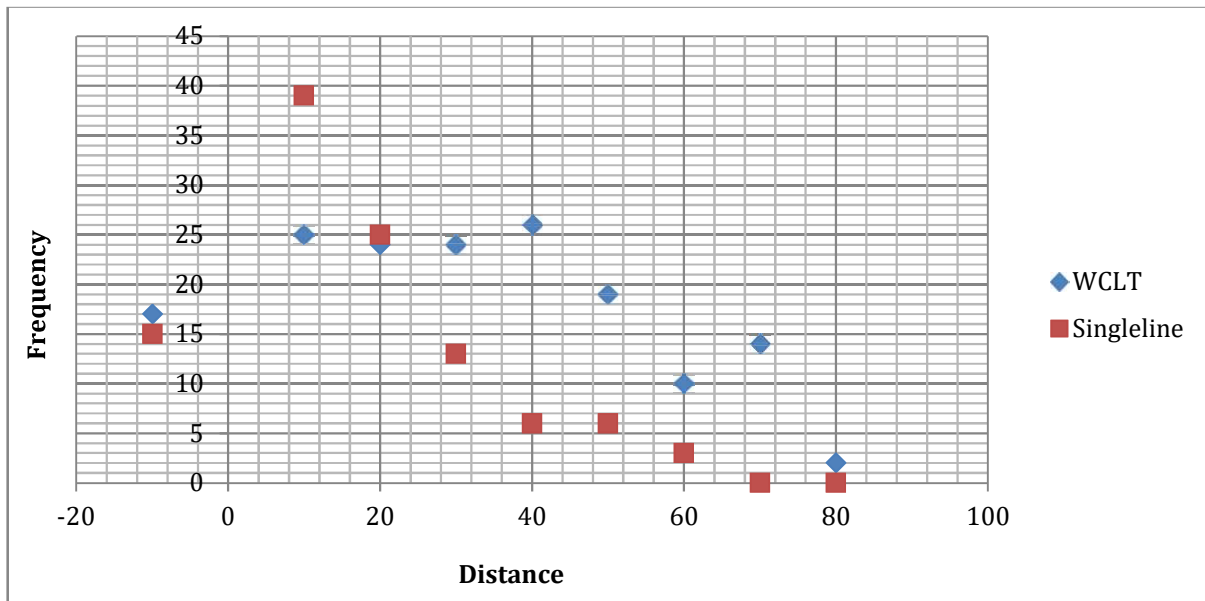
Fig. 45. Overall Driving Behaviour during Mackay Survey

From the above figure, it is clear that distances have a great impact on overall driving behaviour. We plotted the frequency of vehicles with respect to distance for both WCLT and single line. The blue diamond shape represents WCLT and red square shape represents single line. From the figure, it is clear that most of the vehicles driving within 30-60 cm while there is WCLT and most of the vehicles driving within 20 cm while there is single line. Same kind of scenario was found during Warwick survey which is shown in Figure 46.

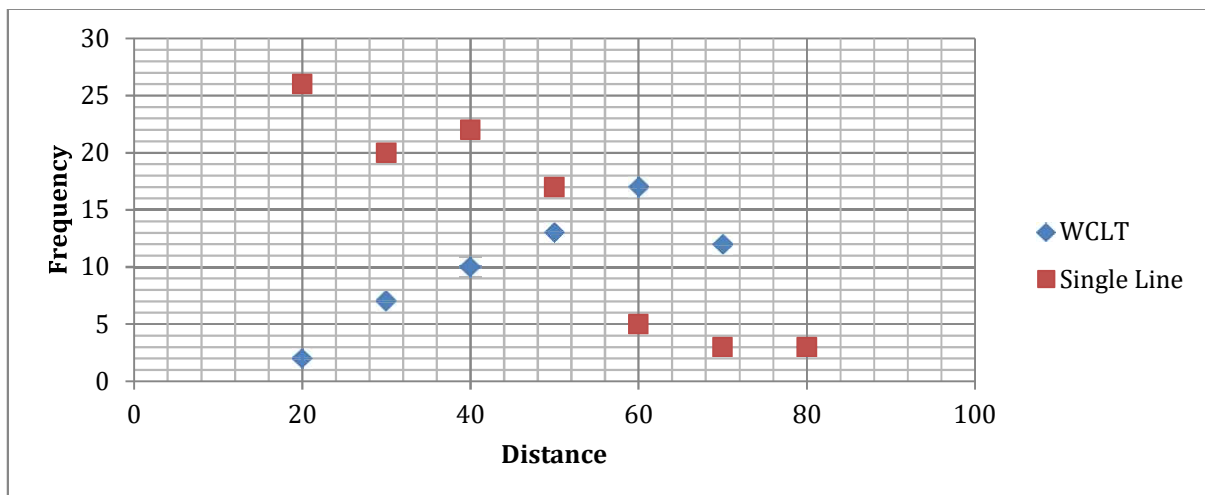
Fig. 46. Overall Driving Behaviour during Warwick Survey
