# FINAL REPORT

## **R54 – Automated Collection of AusRAP Road Attributes using DVR and Pattern Recognition Techniques – Y3 (2019/20)**

ARRB Project No.: 014962

Prepared for: Queensland Department of Transport and Main Roads

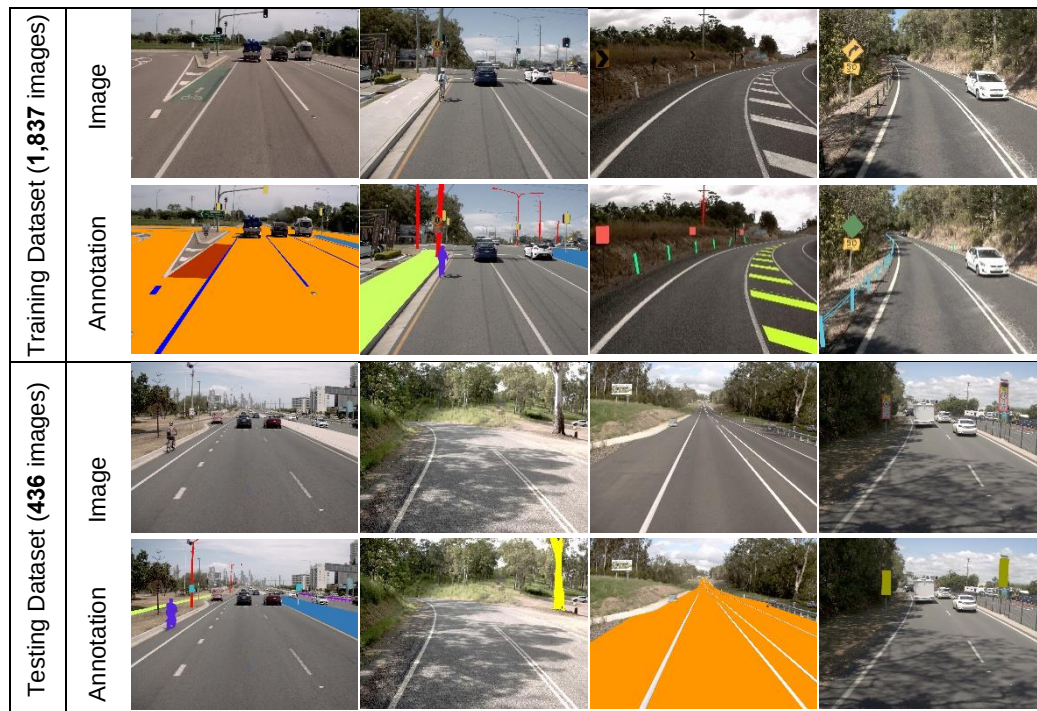
Figure 4.1: Creation of training and testing datasets

A large dataset containing images of the attributes investigated was created for training and testing purposes. Approximately 2,273 images from different locations with different appearances were chosen and manually annotated/labelled, and then the images and annotations were divided into training and testing sets. The training dataset comprises between 40 and 50 frames for each attribute. The testing dataset was totally separate from the training dataset. There were 440 images and their corresponding annotations in the testing dataset, including 5 to 10 frames from each attribute. Some examples of the training and testing datasets are shown in Figure 4.1.

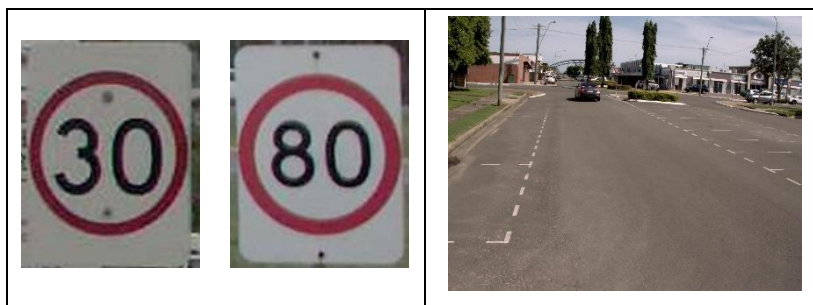
Figure 4.2: Example of attributes with similar shapes and colours

- 2. Similar attributes:** Some attributes are very similar in shape, size and colour, so it was difficult to differentiate them. For example, Figure 4.2 shows (a) attributes with diamond frame and yellow background, (b) speed sign with similar numbers and (c) parking slots with similar colour as lines.

(a) Road signs

(b) 30 and 80 km/h signs

(c) Parking slot and lines

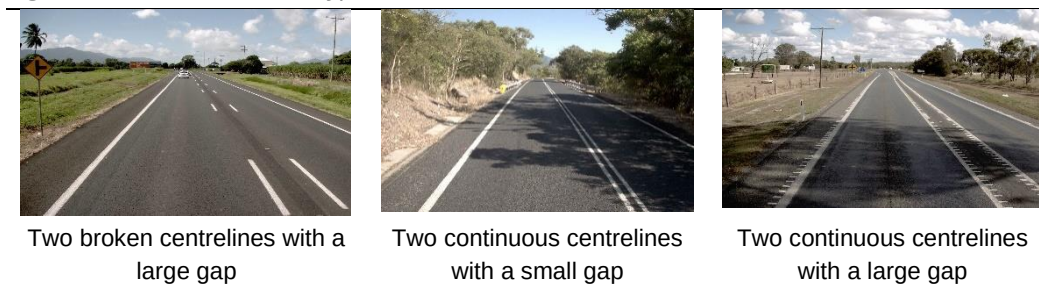
Figure 4.3: Three different types of centrelines

3. **Attribute inconsistency:** Same attributes contain different distances, shapes and colours making them difficult to identify. For example, there are many types of centrelines with different gaps/shapes as shown in Figure 4.3, many types of dedicated bicycle paths (green and white colours) as shown in Figure 4.4, and 5 different types of speed signs as shown in Figure 4.5.

Two broken centrelines with a large gap

Two continuous centrelines with a small gap

Two continuous centrelines with a large gap

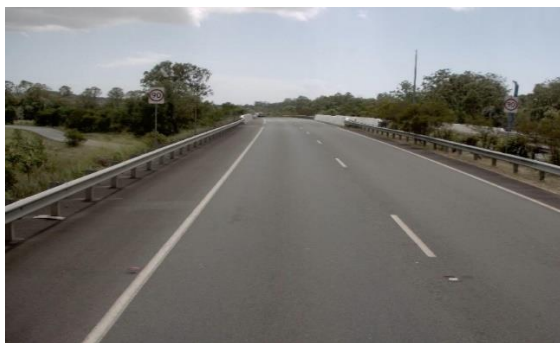
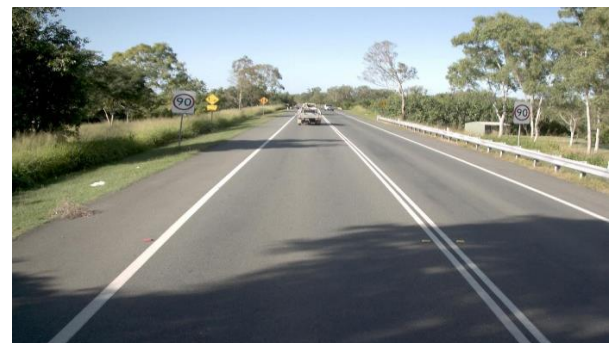
Figure 4.6: Location of attributes as median or right-hand side (RHS)

4. **Median vs RHS:** In some frames, it was difficult to differentiate between the location of the attributes as median or right side of the road as shown in Figure 4.6. It was difficult to say/detect that metal barrier in left frame is a median.

Speed sign 90 and Metal barrier as Median

Speed sign 90 and Metal barrier at RHS

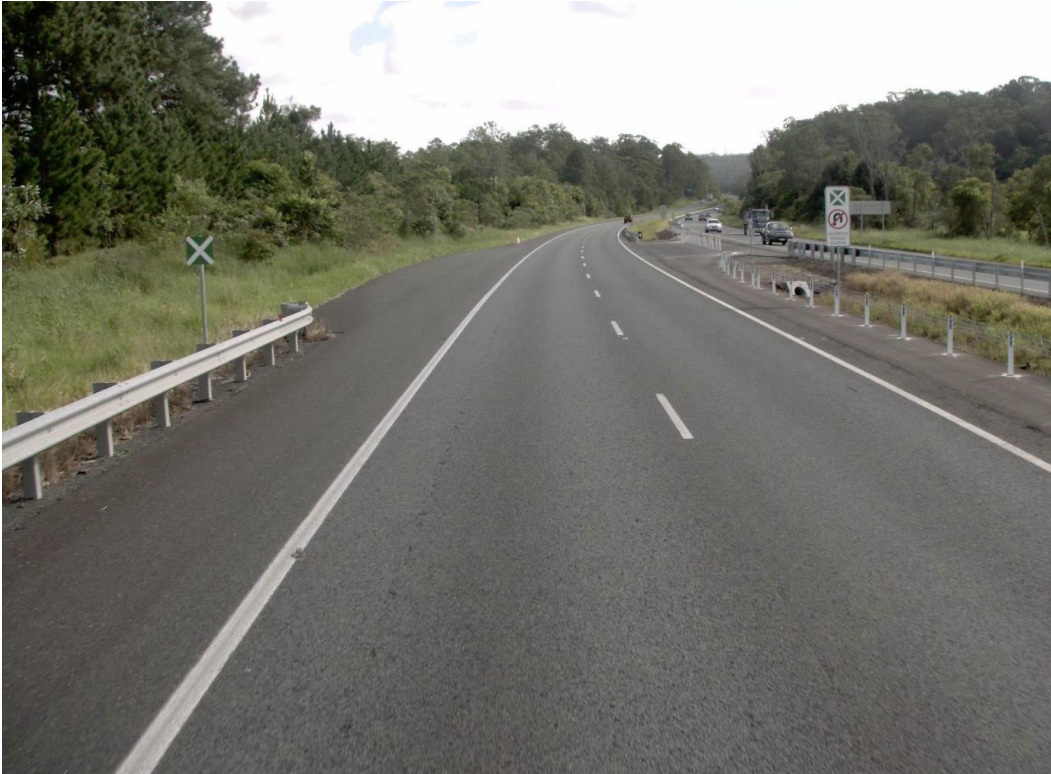
Figure 4.10: Misclassification of no U-turn sign as 60 km/h sign

In addition to wrong aggregation and missing gaps for safety barriers (metal, concrete and wire rope) misclassification of objects at the 10 m frame level impacted negatively on the accuracy at the 100 m level. For example, all speed limit signs on 10A were identified, but due to misclassification of some objects as 60 km/h (Figure 4.10) and 70 km/h (Figure 4.11) signs, the accuracy of reported 110 km/h section was only 67%. The problem with the misclassified objects was ratified by including these signs in the training data in the updated program. This improved the accuracy for reporting 110 km/h at 100 m level to 94% (Appendix B).
