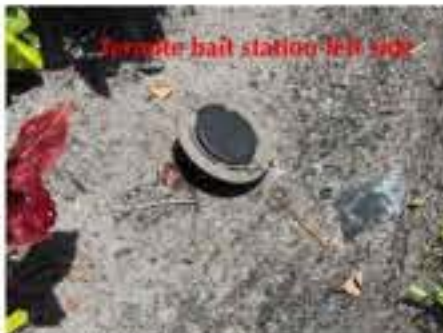
Recommend a pest control contractor update termite bait stations.

Service Bait Stations

Contact a qualified pest control specialist.

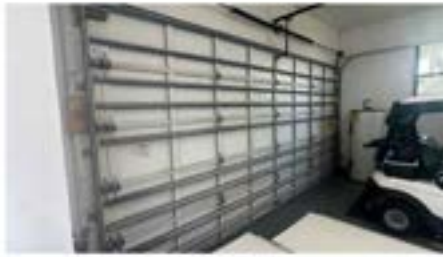
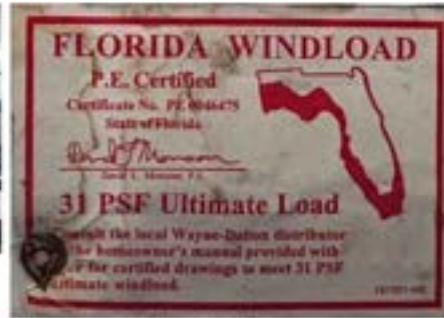
The garage doors have an old wind rating that does not meet current standards for an insurance discount. Review the separate Wind Mitigation Report for a breakdown of the hurricane protection.

Old Wind Rating Sticker

Contact a qualified garage door contractor.

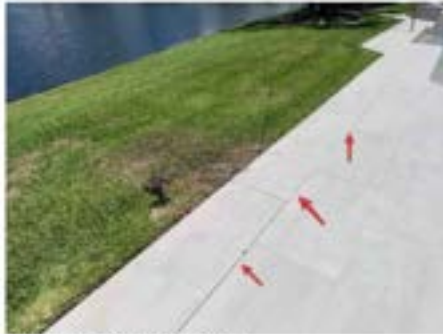
Significant settling and tile deterioration is visible at the rear patio especially at the back. Overtime further deterioration will result. Recommend tile contractor evaluate and repair.

Back Patio Settlement

Contact a qualified tile contractor

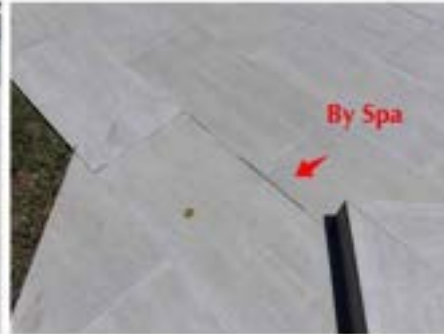
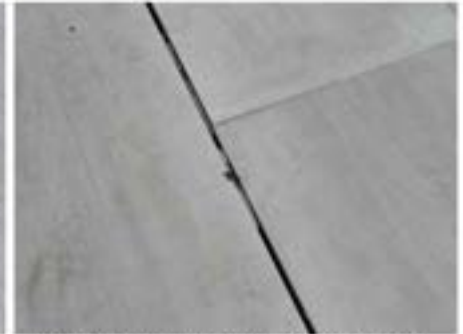
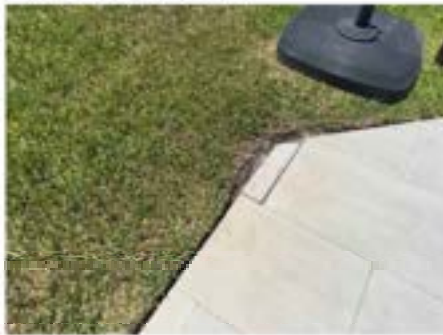
Tile Separation - Grout Deterioration

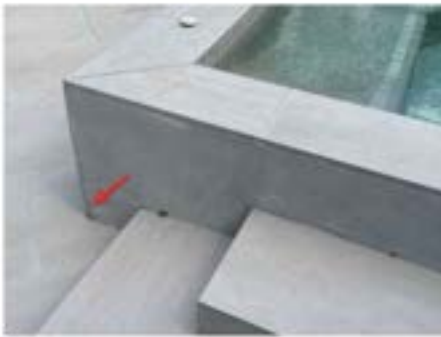
There is visible spider cracking at the rear patio. Recommend a stucco contractor evaluate for repair for any underlying structural or water damage that needs addressing. Possible a skim coat can be applied to eliminate the cracks. The following pictures are examples of what was observed:

Spa

Contact a stucco repair contractor

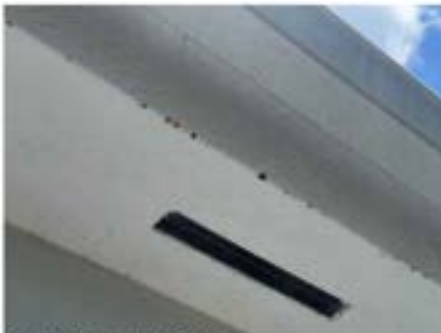
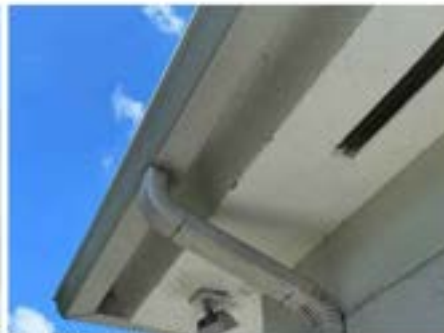
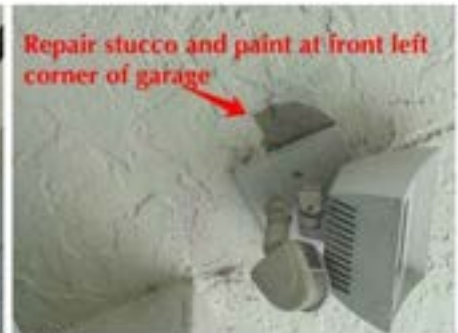
Rust stains need to be removed from the underside of the soffit on the left side of the home. A stucco contractor should evaluate for rust removal and repainting. Repair stucco and paint around left front corner spotlight.

Rust Stains Left Side

Soffit

Contact a stucco repair contractor

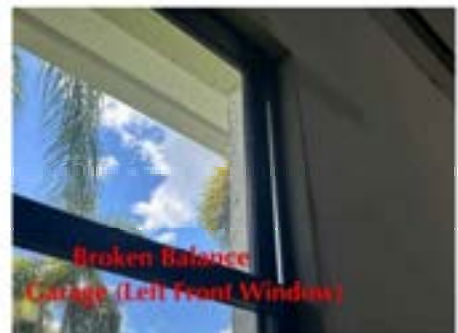
The garage left side window has a broken balance. Repair for smooth operation.

Contact a qualified window repair/installation contractor.

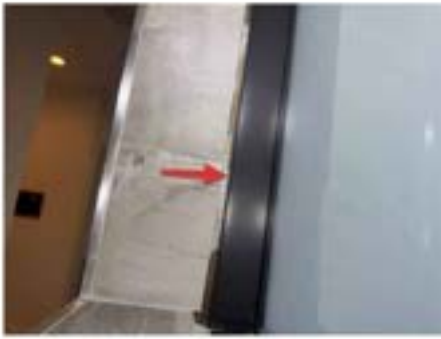
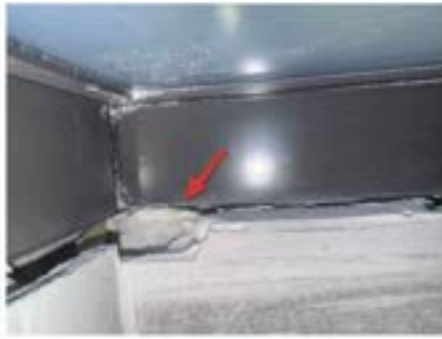
The master shower window interior installation is not complete. There are large gaps between the window frame and the shower tiled wall. This could allow water damage. Recommend a tile contractor complete grout between window frame and tiled wall.

Contact a qualified tile contractor

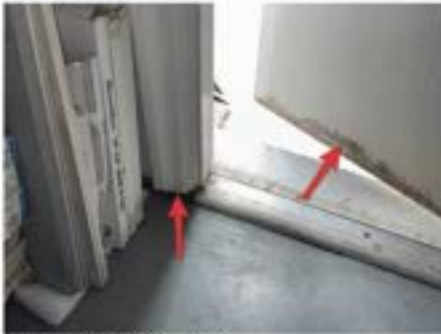
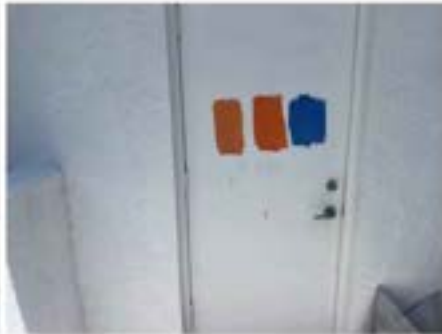
Wood rot damage and water intrusion is visible at the rear garage hinged door jamb. Recommend a painter replace/repair damaged trim and seal/paint the door and jamb to extend life. The door has some test paint samples on it suggesting it will be painted.

Garage Hinged Door

Contact a qualified painting contractor.

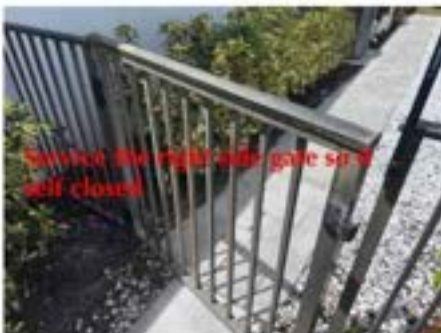
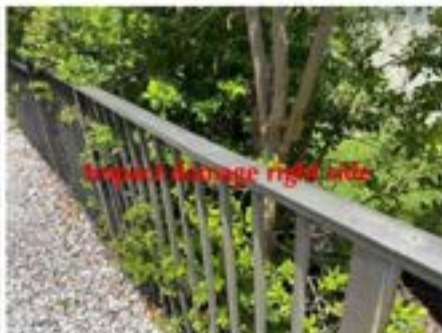
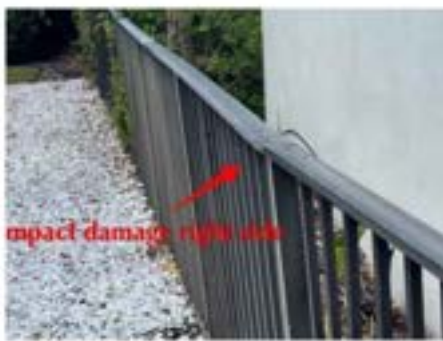
There are areas of fence damage. The fence is functional. The gates also need servicing for self latching for pool safety.

Contact a qualified fencing contractor

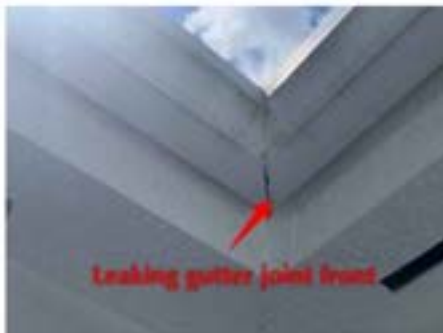
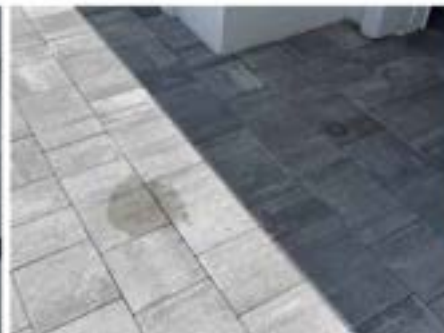
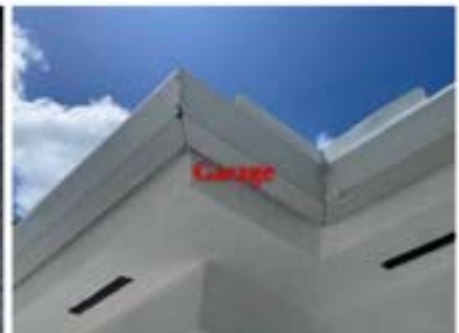
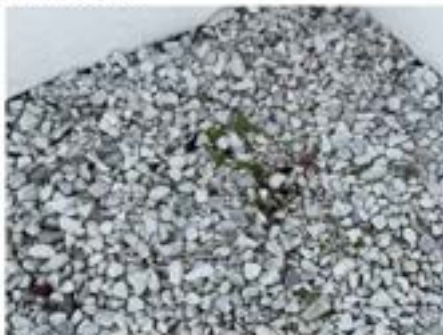
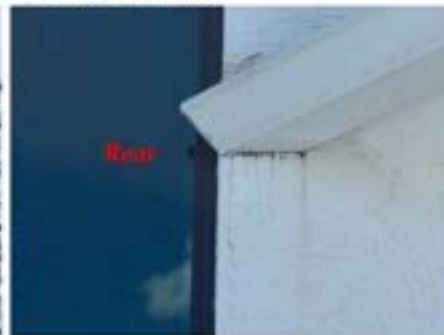
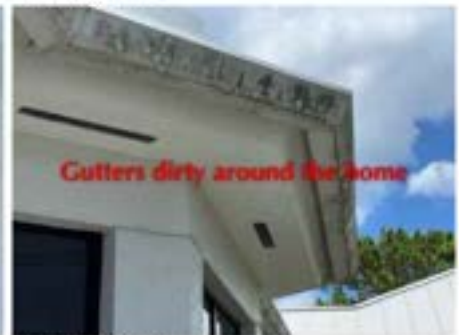
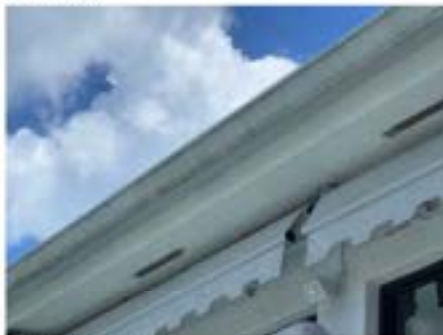
There is evidence that the gutters are leaking at the corners or joints. There is visible staining to the tile/concrete below. The gutters are also dirty with green algae on the surface. Recommend power washing/cleaning. Recommend a handyman seal all the gutter joints.

Leaking joint

Driveway Staining

Staining

Algae Staining

Recommendation  
Contact a qualified handyman.

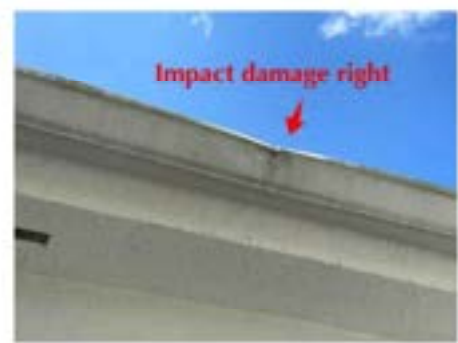
The gutter is damaged on the right side of the home. It appears to be impact damage possibly from a tree. Recommend repair or replace.

Contact a qualified gutter contractor

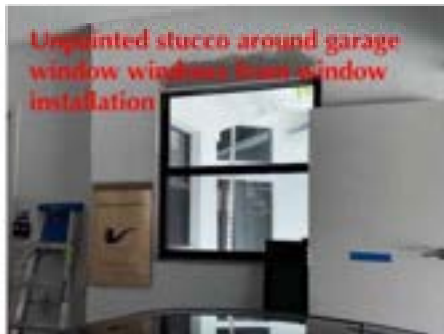
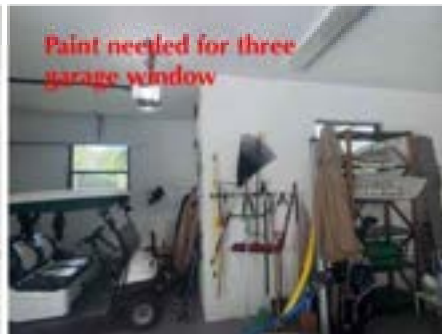
The walls around the newly installed garage windows are not painted showing recent stucco repairs.

Contact a qualified painting contractor.

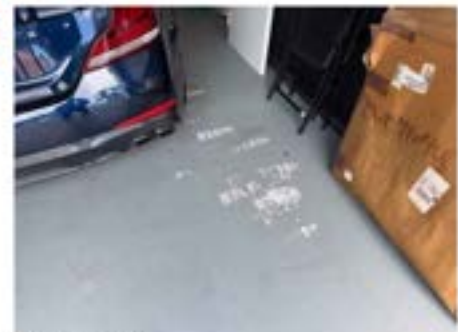
The paint is peeling on the garage floor. Recommend a professional garage floor finisher evaluate for re-coating with a better product and application process for longevity.

Peeling Paint

Contact a qualified professional.

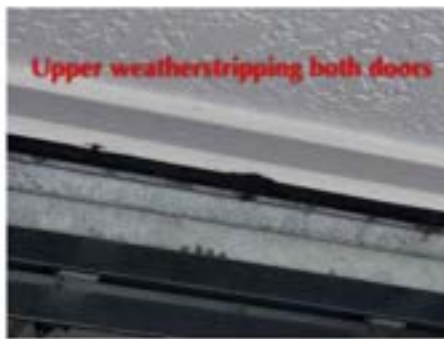
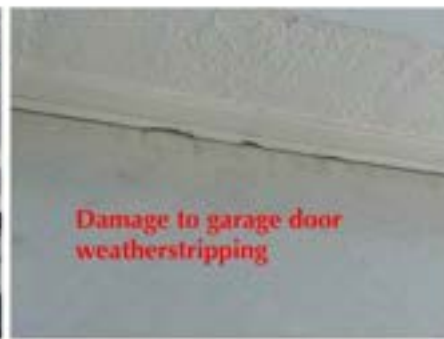
The upper garage door seals for both garage doors is damaged. Recommend replacing.

Upper weatherstripping both doors

Damage to garage door weatherstripping

Contact a handyman or DIY project

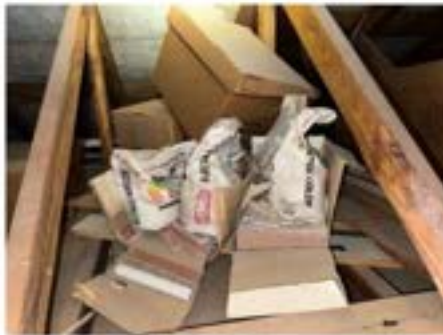
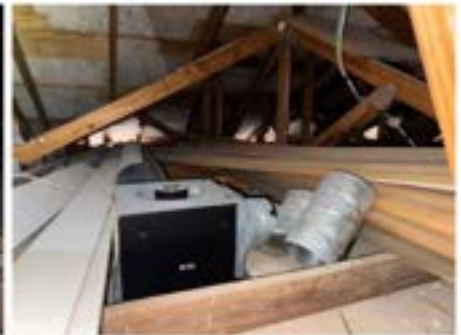
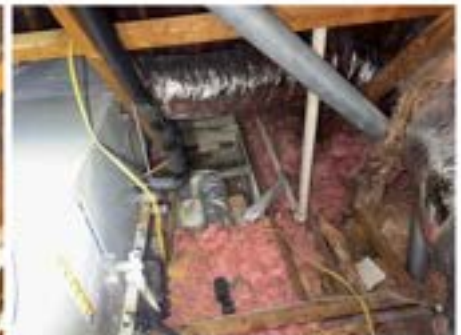
There is old construction debris and old personal items in the garage attic that should be removed. There is also garage in the main area attic near the hatch and air handlers that should be removed.

Construct Debris

Old Ventilation Fan

Contractor Debris Main Attic Area

Contact a qualified professional.

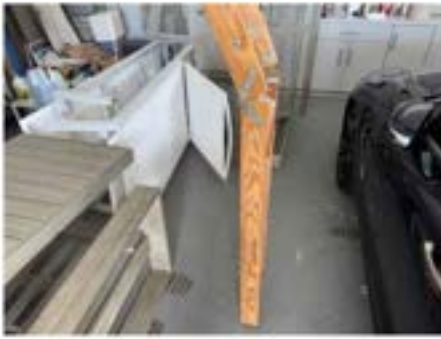
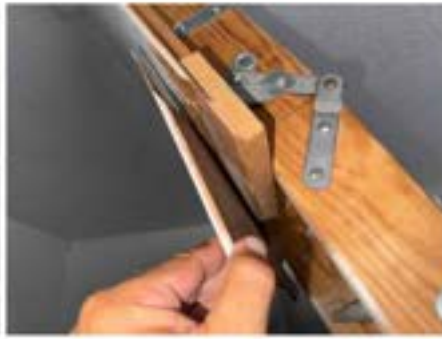
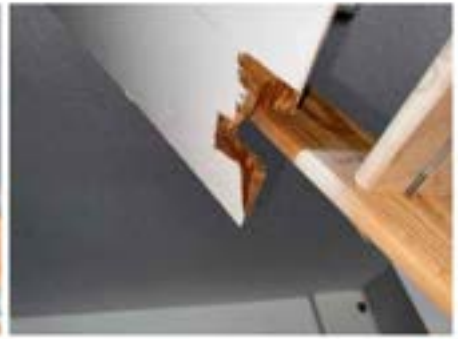
The attic pull down stairs are damaged. The attic pull down stairs should be replaced.

Contact a qualified professional.

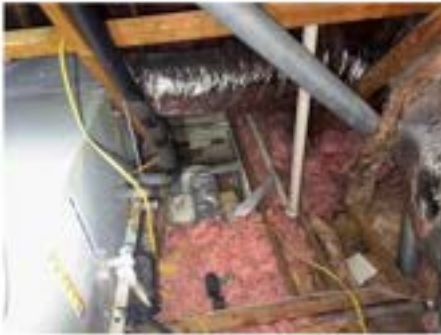
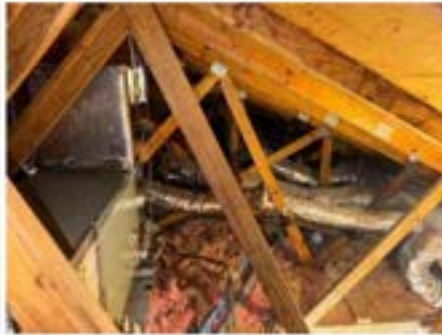
There are areas where contractors moved the insulation to install audio equipment, lighting, HVAC, etc. Recommend a handyman reinstall for efficiency.

Recommendation  
Contact a qualified handyman.

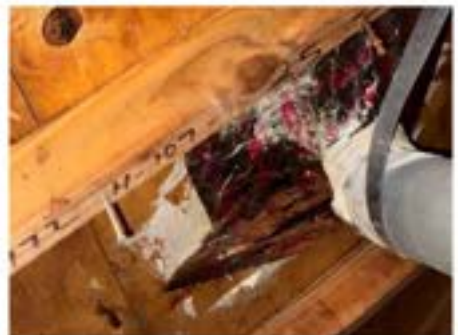
Retape vent pipe near attic air handlers.

Loose Tape

Recommendation  
Contact a qualified professional.

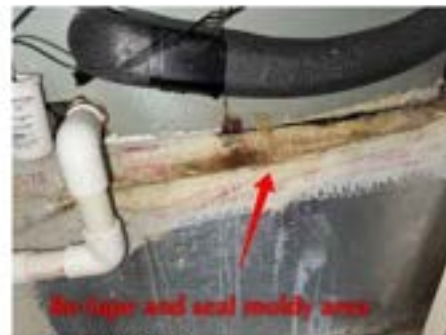
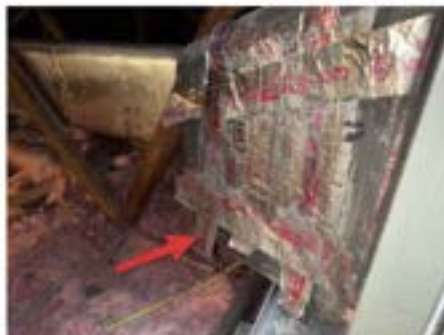
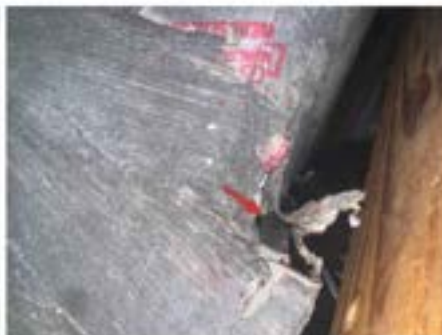
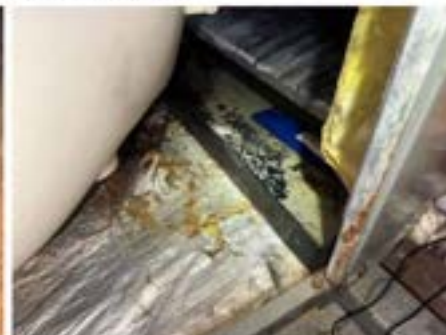
There very significant air leaks to all 3 air handler plenums. Repair for efficiency and to prevent mold growth. All handlers should be serviced and cleaned.

Leaky HVAC #2

Leaky HVAC #3

Clean Air Handlers

Recommendation  
Contact a qualified HVAC professional.

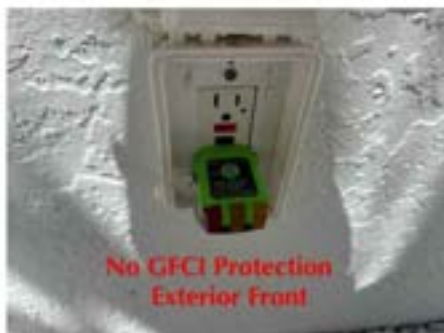
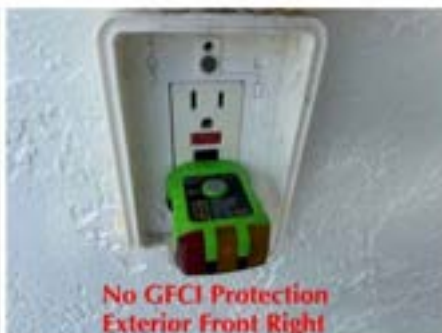
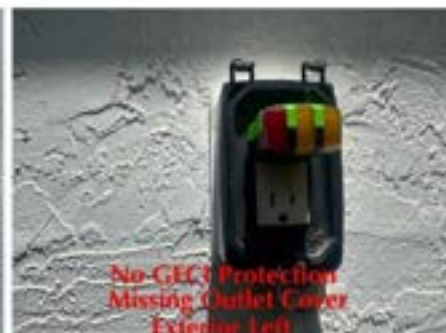
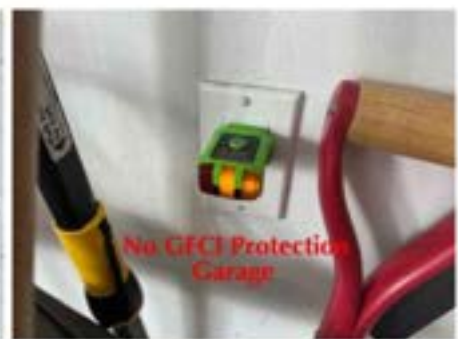
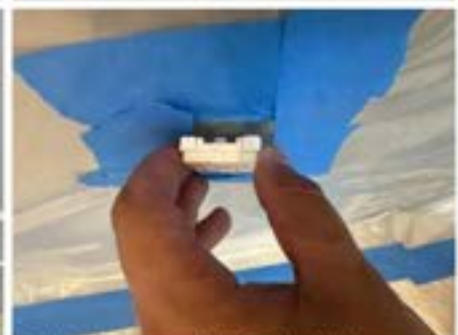
There are receptacles in wet areas that should be GFCI protected for electrical safety. Some of the GFCI protection receptacles are old and not working. Recommend an electrician evaluate all wet areas, i.e. exterior, garage, laundry, kitchen, bar areas with sink, and bathrooms to confirm protection. Make repairs as needed and replace any damage covers.

No Power  
Exterior Left

No Power  
Exterior Front Porch

No GFCI Protection  
Garage

Broken Receptacle in Back Right  
Bedroom

Contact a qualified electrical contractor.

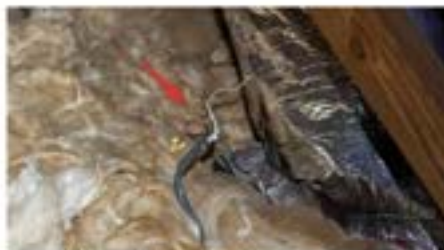
There are branch circuits in the attic space that are unprotected and should be in junction boxes for safety. These appear to be from remodeling and/or audio installers. An electrician should review attic wiring and repair as needed for safety.

Over Main Living Area

Contact a qualified electrical contractor.

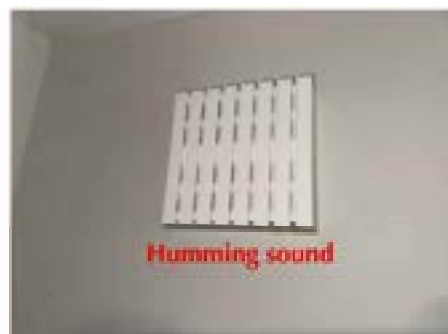
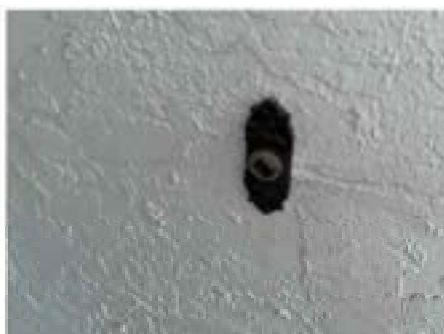
At time of inspection there was a buzzing sound coming from the doorbell chime in the laundry. It was buzzing because the doorbell push button was stuck in. Recommend replacing the button for function to prevent damage to the chime.

Chime

Replace Doorbell Button

Recommendation  
Contact a qualified handyman.

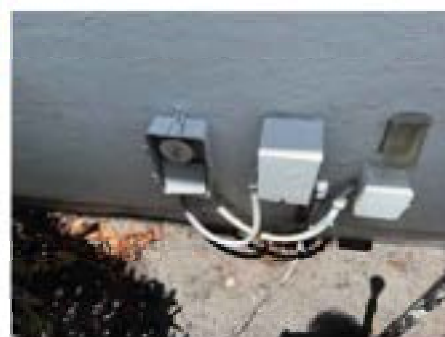
There is an old timer on the left side of the home with a missing cover. The function of this timer was not identified. It looks like an abandoned landscape lighting timer box. Recommend either replacing the timer or removing along with any related equipment if no longer in use.

Old Damaged Timer

Recommendation  
Contact a qualified electrical contractor.

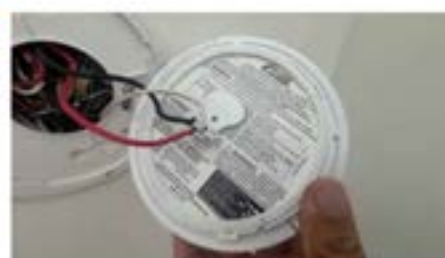
The smoke detectors are 7 years old. Detectors typically have an 8 to 10 years lifespan. Main living areas should have combination direct wire smoke and carbon monoxide detectors. Bedrooms should have direct wire smoke detectors only. Consider proactively replacing.

2018 - Smoke & Carbon Monoxide

Recommendation  
Contact a qualified handyman.

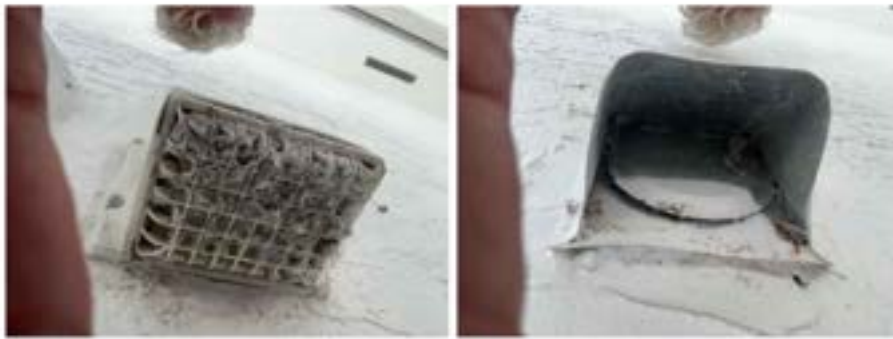
Visible lint debris observed at vent cover. The dryer vent tube and cover duct should be cleaned.

Recommendation  
Contact a qualified handyman.

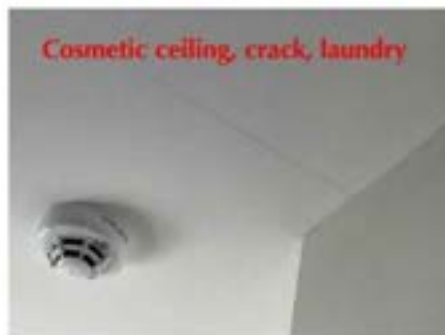
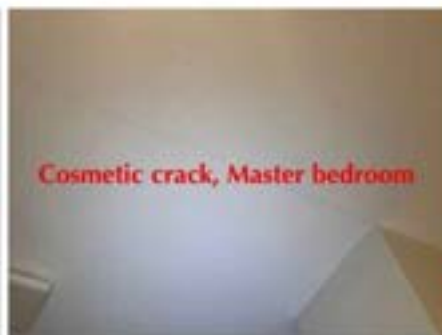
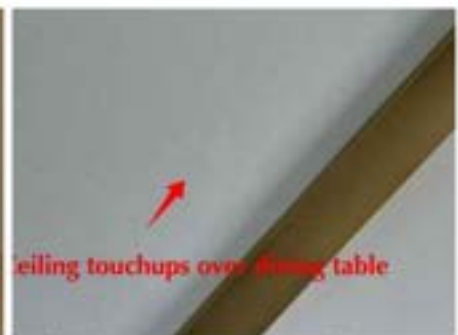
There is some cosmetic cracking to ceilings. The areas are dry. These cracks are typical. Recommend refinishing.

Refinish Ceiling by Dining Table

Contact a qualified painting contractor.

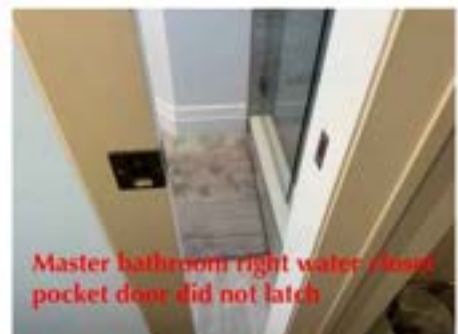
Door doesn't latch properly. Recommend handyman repair latch and/or strike plate.

Contact a qualified handyman.

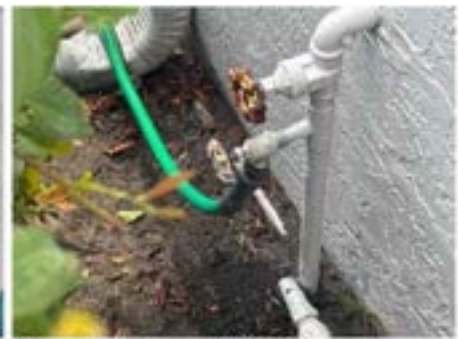
At time of inspection, the pool water level was low. Likely, this is due to the water main being shut off and no water being supplied to the right side hose for the pool service provider to fill the pool. I found a hose on the left side of the home and attached it to the hose bib before the water main. This should be used to maintain the water level. Recommend speaking to the pool contractor about self filling options.

Water level low

Moved Hose to Left Side Bib

Contact a qualified swimming pool contractor

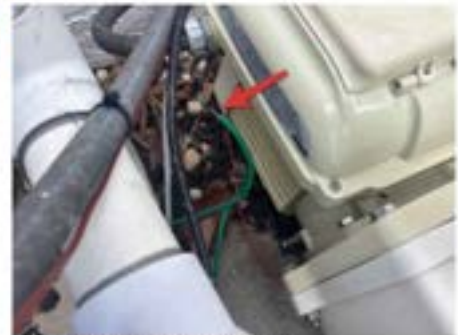
The main pump bonding wire is disconnected and should be reattached for pool safety.

Disconnected Bond Wire

Contact a qualified swimming pool contractor

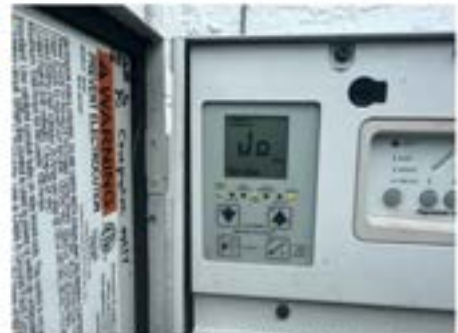
It appears that the salt system is not working. A pool contractor should evaluate and repair.

Service Indicator for Salt Chlorinator

Contact a qualified professional.

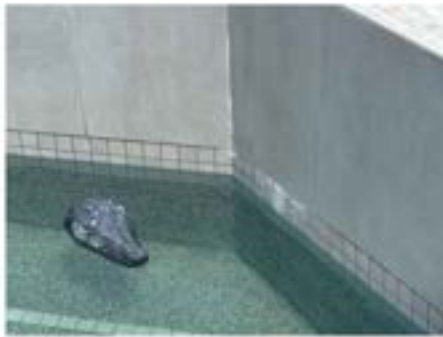
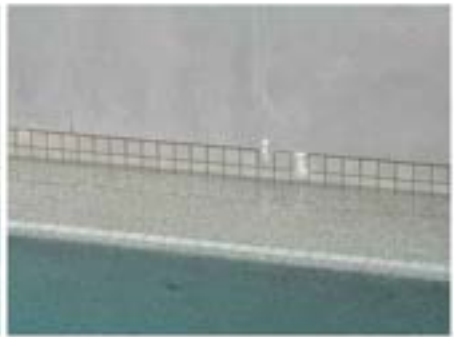
There is visible scaling in multiple areas of the pool tile. Recommend a pool cleaning contractor evaluate and clean. This will likely get worse if not addressed and maintained.

Pool tile scaling is the formation of unsightly white-grey mineral deposits, primarily calcium, on tile surfaces due to imbalanced water chemistry (high pH, high calcium levels) or moisture seeping from retaining walls. To remove it, address water chemistry, then use a pumice stone on wet surfaces for light buildup or specialized calcium removers for tougher stains. For widespread, stubborn deposits, professional cleaning with methods like steam cleaning or bead blasting may be required.

Scaling

Contact a qualified swimming pool contractor

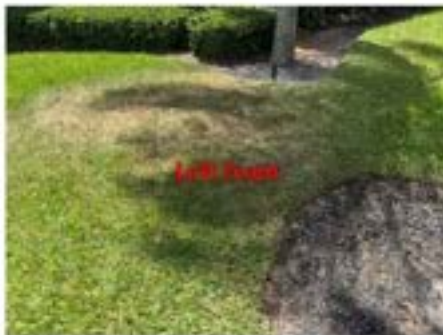
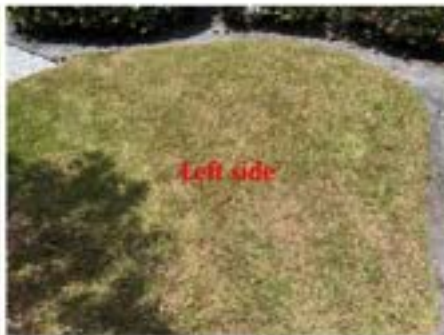
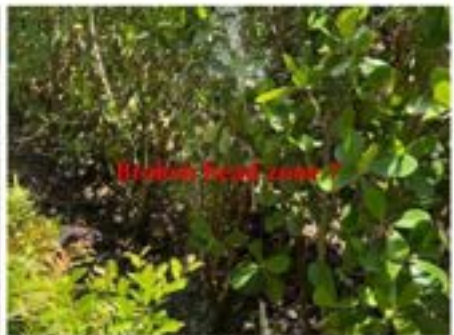
The lawn has some brown spots. An irrigation contractor should evaluate time setting for each zone and check sprinkler heads for proper landscape coverage. There is a broken head on the left side hedge that should be repaired to prevent water loss.

Broken Head Zone 7

Contact a qualified lawn care professional.
