**SUMMARY**

115 Echo Ln, Jupiter, FL 33458  
Dan & Gretchen Valenti c-o Holland Group  
Home Advisory  
10/10/2025

Mike Trapasso  
Internachi Certified Home Inspector  
Trapco Inspections LLC  
5615292891  
[info@trapcoinspections.com](mailto:info@trapcoinspections.com)

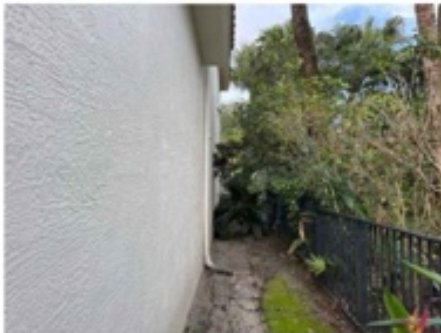
**2.1.1 Vegetation, Grading, Drainage****CUT BACK TREES/SHRUBS**

Trees should be cut back away from the roof, walls and fencing to prevent damage. Trees contacting the roof provide a pathway for rodents to access the attic. The following pictures are examples of what was observed:

Left Side

Contact a qualified tree service company.

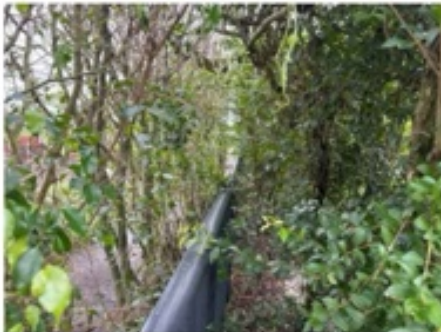
Trim away from fencing

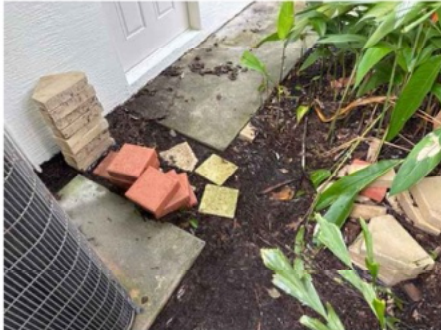
**DEBRIS AROUND HOME**

There is debris, building material, roof tiles, pavers, etc. that should be organized and/or discarded around the property.

Left Side

Contact a qualified handyman.

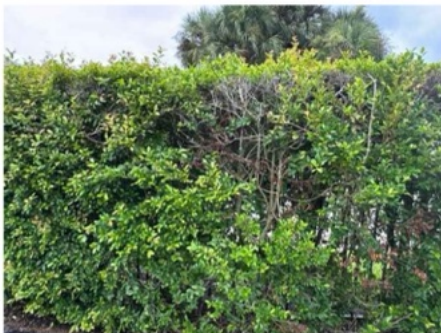
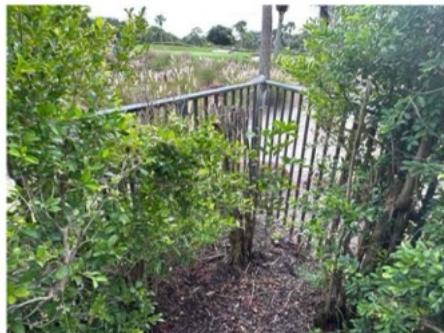
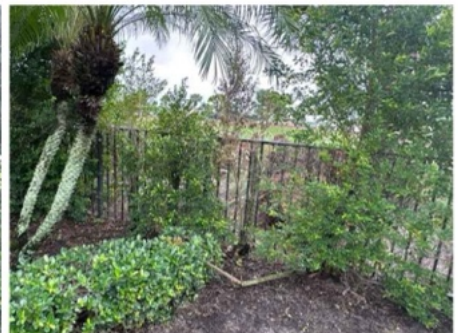
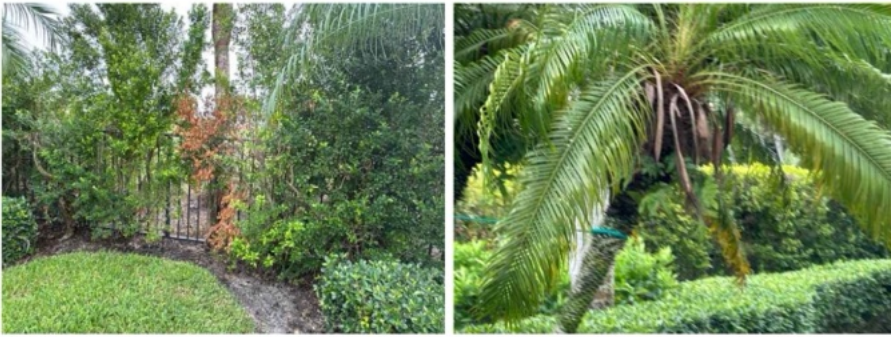
**DEAD VEGETATION**

There are many dead shrubs and branches around the property. Recommend cleanup and removal of dead vegetation.

Contact a qualified lawn care professional.

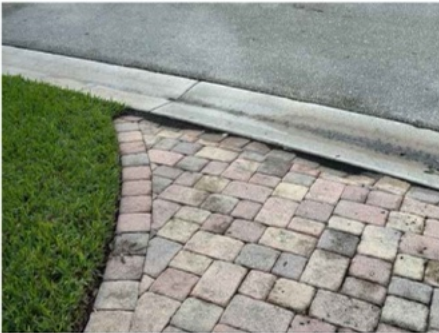
#### **DISPLACED/LOOSE PAVERS/BRICKS**

There is settlement to pavers in the driveway. Recommend a paver contractor reset to prevent trip hazards..

Settlement at street

Contact a qualified masonry professional.

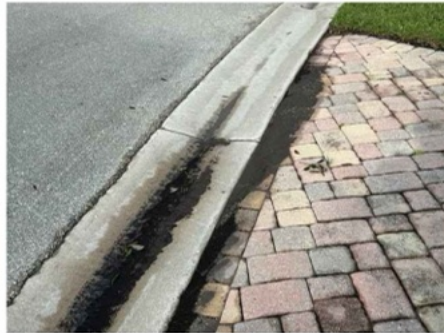
Settlement at street

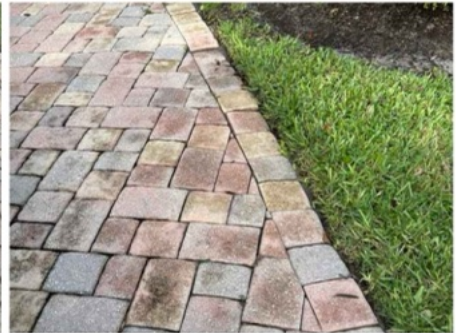
Settlement of edge pavers

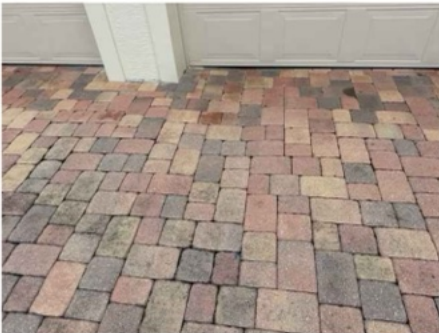
Settlement in front of garage

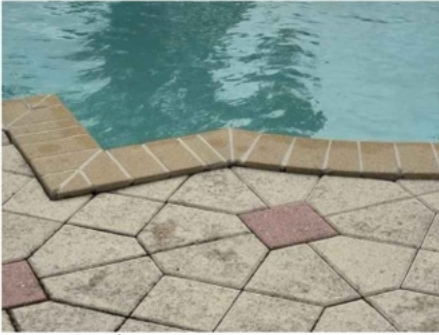
#### **DISPLACED PAVERS/POTENTIAL TRIPPING HAZARD**

There are displaced pavers which may pose a potential tripping hazard. The following pictures are examples of what was observed:

Paver Settlement

Contact a qualified masonry professional.

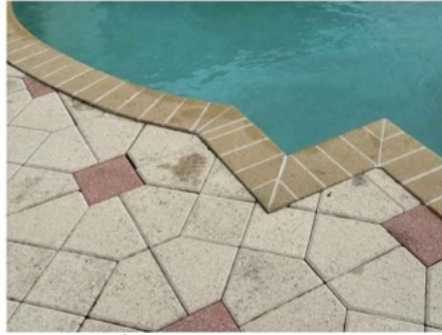
Paver Settlement

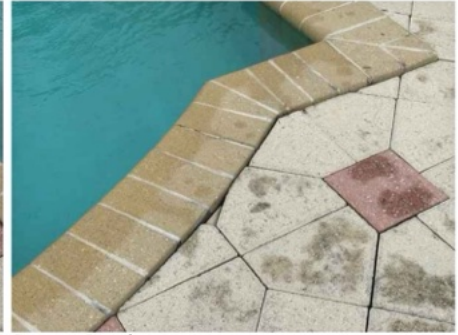
Paver Settlement

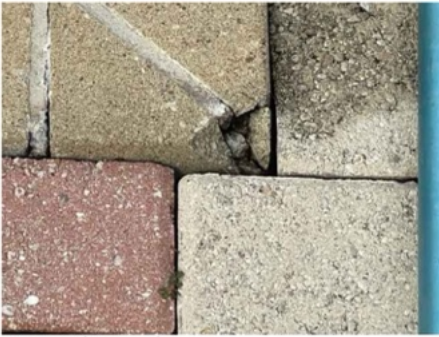
Paver chipped corner

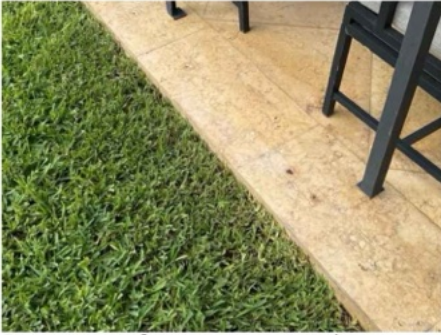
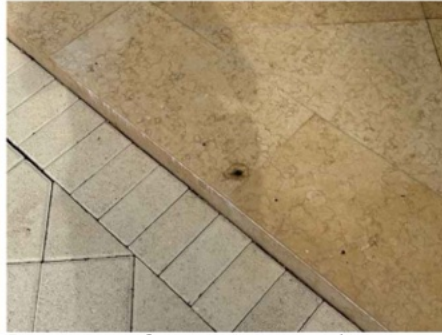
#### PREVIOUS SCREEN ENCLOSURE MOUNTING HARDWARE

There is visible evidence of previous screen enclosure at the rear patio kitchen. Possibly this can be cleaned up with replacement tiles or grout.

Remnants of rusty screen enclosure mounting bolts

Contact a qualified handyman.

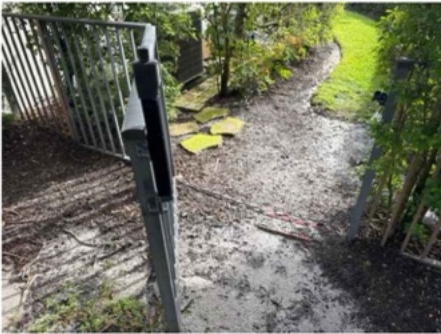
##### **GATE NOT SELF CLOSING**

All rear fence gates should self close for pool safety. This may require adjusting the fence gate and replacing the self closing hinges. There is also some top rail fence damage from contact with over grown vegetation. Recommend trimming vegetation back and a fence contractor repair as needed.

Pool gate not self closing

Contact a qualified fencing contractor

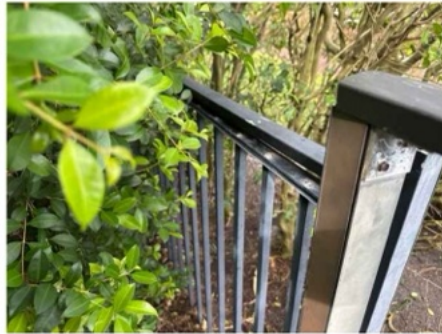
Top rail damage

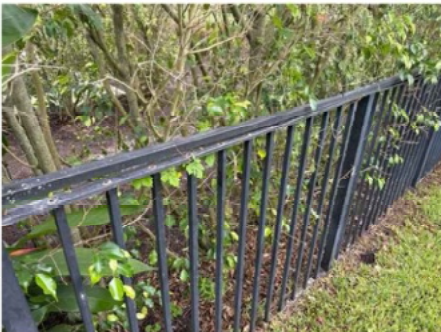
##### **DETACHED ALUMINUM FENCE TOP RAIL**

There is some top rail fence damage from contact with over grown vegetation. Recommend trimming vegetation back and a having a fence contractor repair as needed.

Detached Top Rail Left Side

Contact a qualified fencing contractor

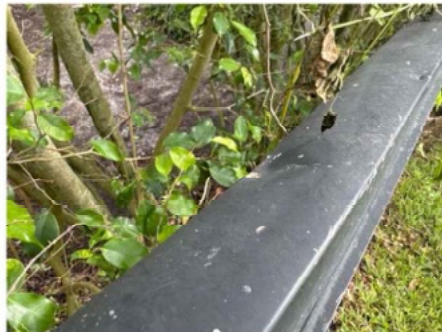
Dented top rail

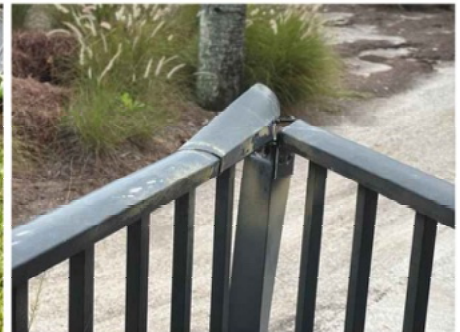
Damaged right rear corner

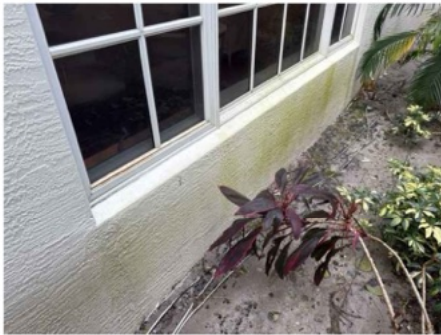
**POWER WASHING NEEDED**

In general, the exterior walls, windows, patios, balconies, etc. need power washing. There are multiple areas of algae on walls and windows from misdirected sprinklers.

Algae - redirect sprinklers

Contact a qualified handyman.

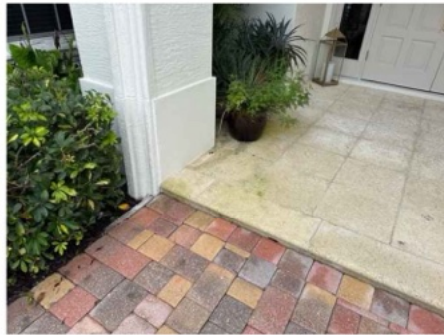
Clean front entrance

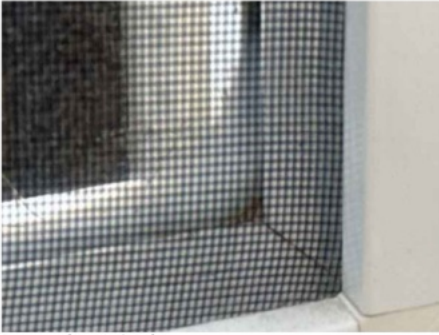
**FAILING SEALS**

Observed some evidence of fogging between the window panes at corners around the home, which indicates a failing seal. Monitor to see if they get worse over time and need replacement.

Laundry window

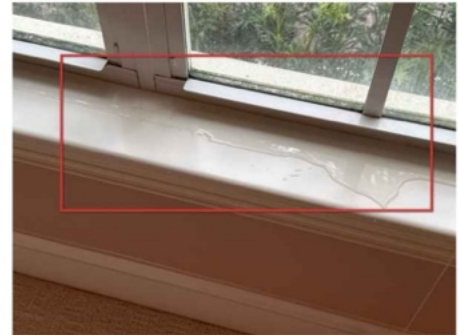
#### **DAMAGED SEALS**

The right side Owner Bedroom window in the hallway had significant water on the window sill. Possibly the water was from our running and testing the sprinklers or recent rain. This window exterior has visible algae on it from sprinkles hitting it. There is also staining and detectable moisture on the interior wall and baseboard suggesting this is an ongoing issue. Recommend an irrigation contractor direct water away from exterior walls. Recommend a window contractor service the window seals and weather stripping. Recommend replacing/remediating any damaged interior building materials around the window.

Water on window sill

Contact a qualified window repair/installation contractor.

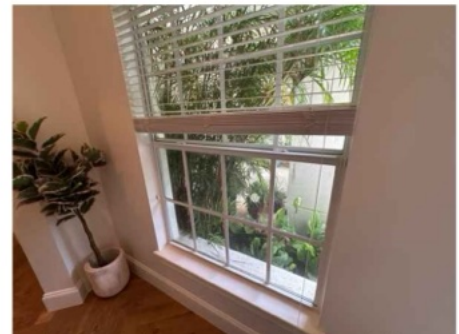
#### **BROKEN BALANCE**

Replace window balances for the window on the left side of the home 1st floor hallway from garage.

Left side hallway, single hung window

Contact a qualified window repair/installation contractor.

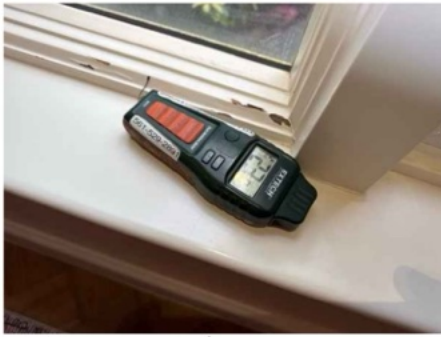
#### **WINDOW LEAK**

There is some visible deterioration to the dining room window trim. Moisture was detected in the area, Recommend a window repair contractor seal, caulk and refinish the window. Recommend an irrigation contractor direct sprinklers away from the window.

Moisture Detected

Contact a qualified window repair/installation contractor.

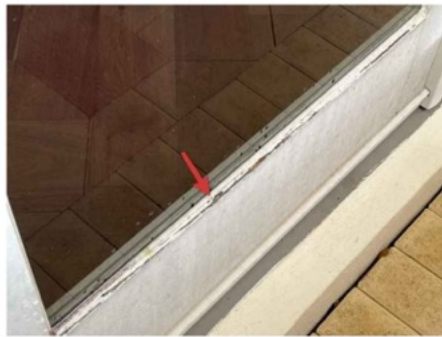
Rear Patio

There is visible deterioration to glazing around the rear living room windows. Recommend cleaning the window. The window framing is worn and stained. Recommend a window repair contractor evaluate glazing for repair to glazing and refinishing if needed..

Contact a qualified window repair/installation contractor.

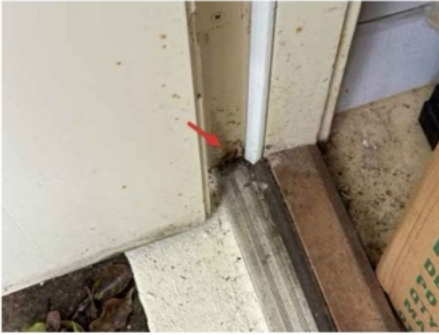
#### JAMB WOOD ROT

There are small areas of wood rot to the garage exterior door jamb. Recommend filling, sealing and refinishing the jamb to extend life.

Garage

Contact a qualified handyman.

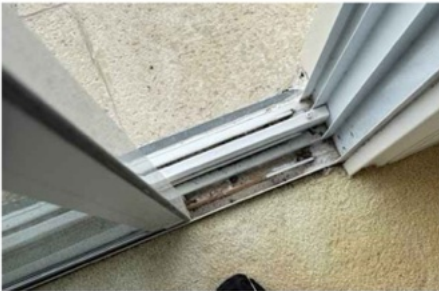
#### SLIDING GLASS DOOR NEEDS SERVICING

Upstairs balcony sliders are difficult to operate. They should be adjusted, cleaned and oiled. They also need rescreening.

Service tracks

Recommendation  
Contact a qualified handyman.

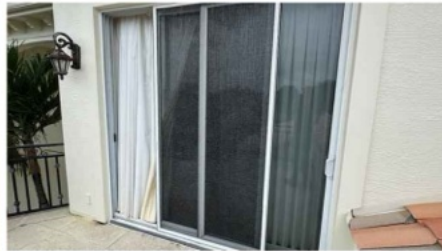
Rescreen

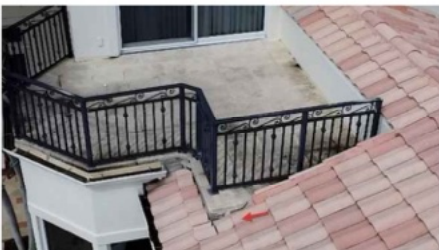
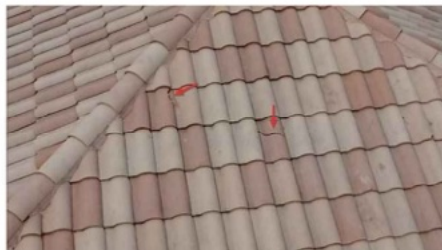
There are multiple cracked and chipped tiles around the roof. This could shorten roof lifespan, lead to leaks and make it difficult to insure the home. Recommend replacing cracked tiles since gluing tiles is a temporary repair due to limited glue life. Recommend mortaring chipped tiles with similar mortar color. A roofing contractor should evaluate the entire roof and make repairs as needed. The following pictures are examples of what was observed:

Recommendation  
Contact a qualified roofing professional.

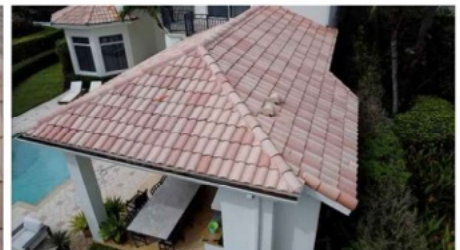
#### TILES CRACKED/BROKEN

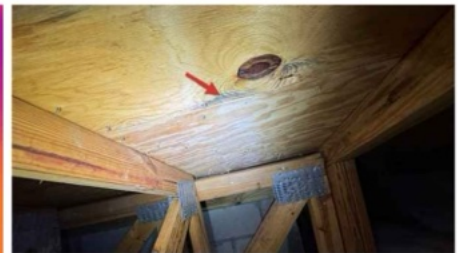
Leak in front of chimney onto living room roof ceiling in front of fire place

Contact a qualified roofing professional.

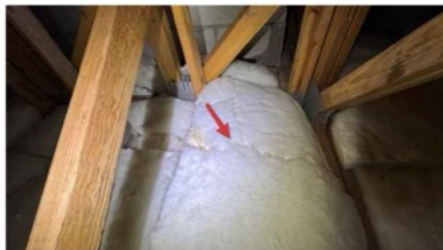
3 active roof leaks were identified. 2 of the leak areas are at the chimney. Moisture was detected with infrared at the living room ceiling by the chimney and the attic insulation/sheathing above. The other chimney leak is on the right side of the chimney and leaking into the soffit area. Another leak is in the master closet near the attic hatch. There is visible evidence of prior leak repairs around the roof. In a roof this age, there could be other active leaks that were not visible during the inspection. Recommend a licensed roofer provide roof replacement options for this old roof..

Wet insulation above living room ceiling

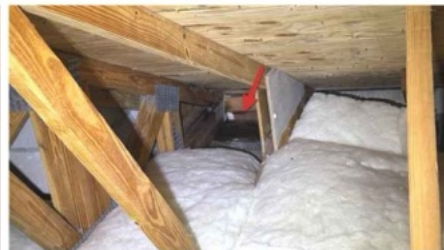
Leak #2 observed in attic in soffit area by chimney above master closet

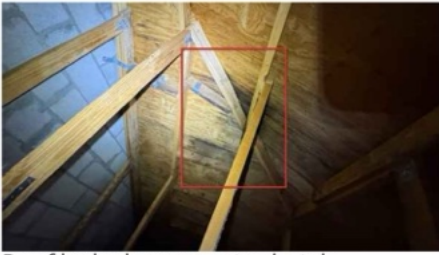
Roof leak above master hatch

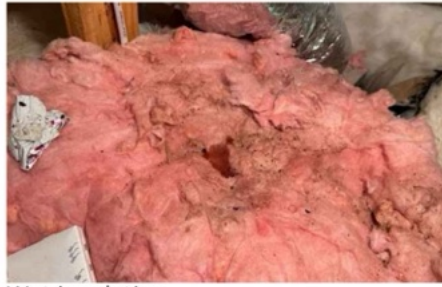
Wet insulation

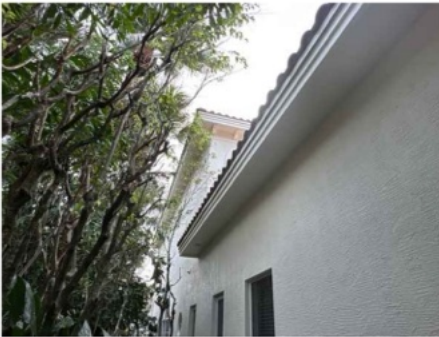
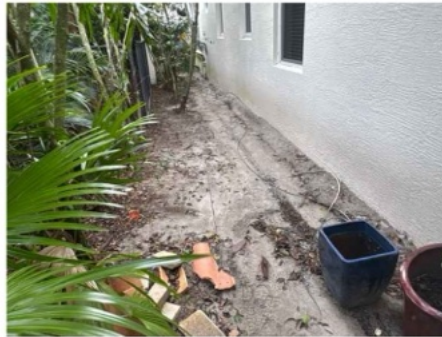
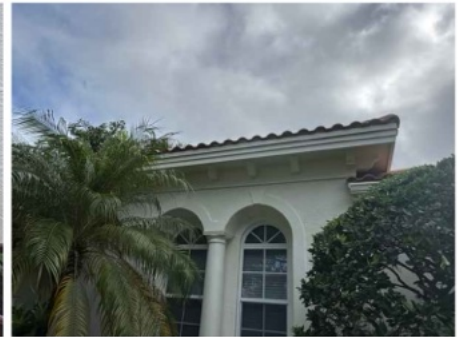
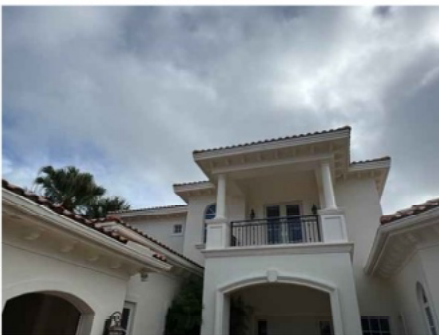
### 5.2.1 Gutters, Scuppers, Eve Trough **PARTIAL GUTTER SYSTEM**

The home has a partial gutter system. We always recommend a full system to keep moisture off walls, mechanical equipment, etc. They also prevent erosion. Gutters should be replaced at time of reroof since they have a similar lifespan.

Contact a qualified gutter contractor

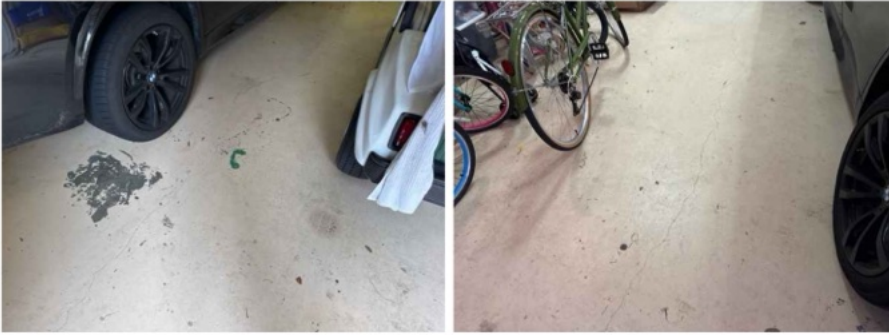
### 6.3.1 Floor **TYPICAL GARAGE FLOOR CRACKING**

The garage floor has typical cosmetic cracking and epoxy wear. Recommend a licensed garage flooring contractor refinish the floors.

Contact a qualified flooring contractor

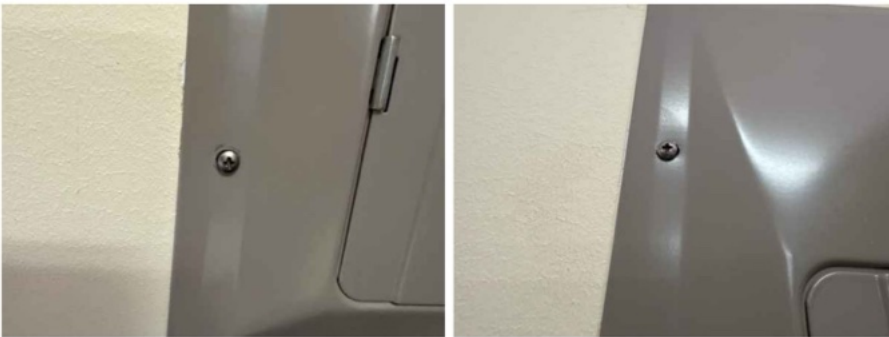
**IMPROPER STYLE SCREWS**

Improper electric panel screws, especially pointed screws, are dangerous because they can pierce wires and energize the panel, leading to shock or electrocution. Correct screws are blunt, fine-thread, or flat-tip and specifically designed for electrical panels to avoid damaging the conductors inside. Always ensure you use the correct screws and consult a qualified electrician if you are unsure about working with an electrical panel.

Recommendation  
Contact a qualified handyman.

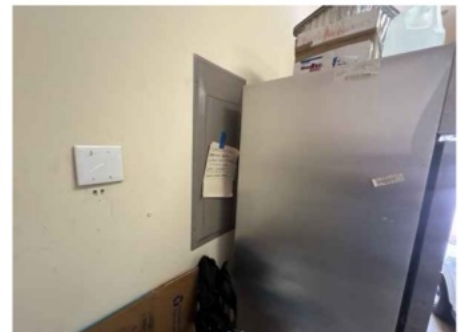
**OBSTRUCTED PANEL**

Electric panels should have a minimum clear space of 30 inches wide, 36 inches deep, and 78 inches high in front of it for safe access. This space, required by the National Electrical Code (NEC) and OSHA, must be free of all obstructions, such as storage, furniture, or plumbing, to prevent shock or fire hazards. The panel door must also be able to open at least 90 degrees without hitting anything.

Recommendation  
Contact a qualified handyman.

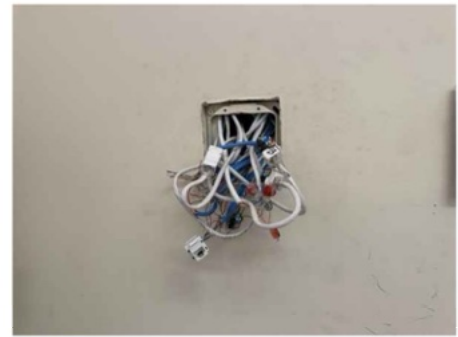
**ENCLOSE LOW-VOLTAGE  
CIRCUITS IN JUNCTION BOX**

Enclose loose wires in a proper junction box.

Recommendation  
Contact a qualified handyman.

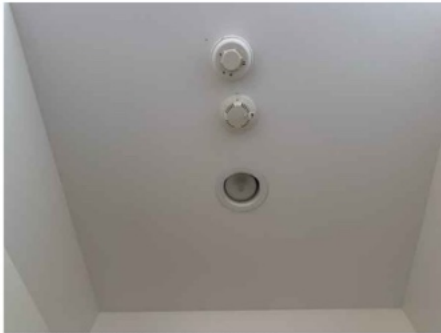
#### LIGHT BULBS OUT

There are incandescent, inconsistent light bulbs out around the home . Consider upgrading all recessed lighting to LED bulb replacements for efficiency and consistency (same warm/cool white lights as desired).

Outside Owner Bedroom

Recommendation  
Contact a qualified handyman.

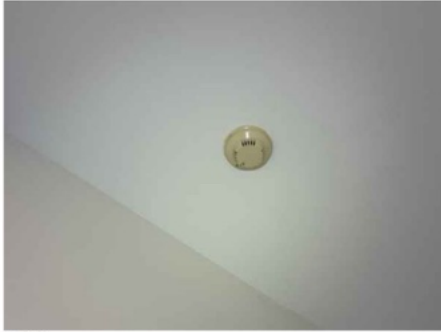
#### OLD SMOKE DETECTORS & NO VERIFIED CARBON MONOXIDE DETECTION

The home has mostly old smoke detectors. Some of the old detectors are of the centrally monitored type which we do not inspect. Recommend an electrician replace all old detectors. Bedrooms should have direct wired smoke detectors with lithium battery backup. Main living areas should be direct wired combination smoke/carbon monoxide detectors with battery backup. Centrally monitored detectors should be evaluated by an alarm contractor.

Old

Contact a qualified electrical contractor.

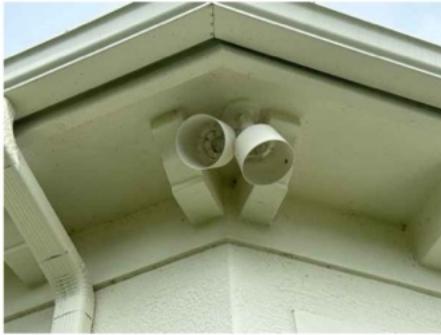
**7.5.2 Fixtures and Receptacles****BULBS OUT/MISSING**

There are some bulbs out/missing around the home that should be replaced for function.

Left Rear Corner

Contact a qualified handyman.

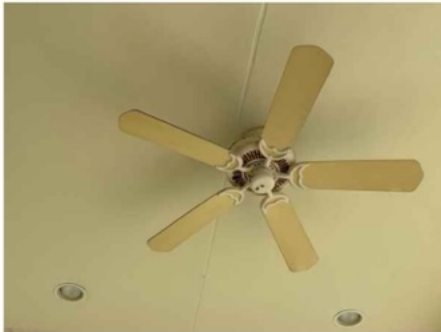
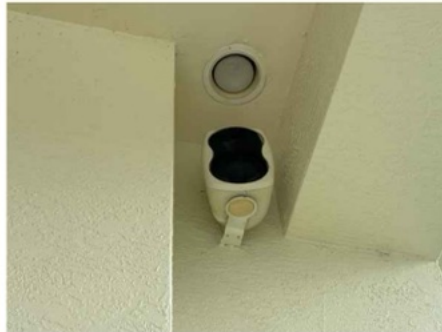
#### DETERIORATED FAN

There is visible deterioration to the patio fan and a missing speaker cover. Recommend repair/replace.

Recommendation  
Contact a qualified handyman.

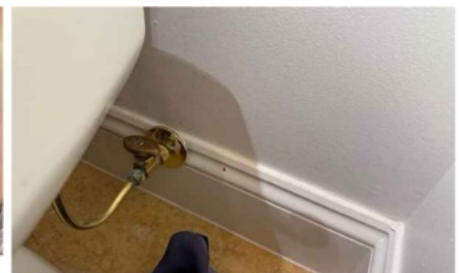
#### SINK AND TOILET SHUTOFF VALVES

Many of the under-sink, toilet and bidet shutoffs are older and corroded. Recommend a plumber update all old and corroded shutoff valves to prevent leaks and water damage. We often report on old shutoffs and updating them is a good idea. Recommend replacing every 10-15 years.

Plumber should also evaluate the bidet since the cold water valve was in the closed position. Possibly there is a leak issue. The following pictures are examples of what was observed:

Bidet cold supply shut off at time of inspection

Recommendation  
Contact a qualified plumbing contractor.

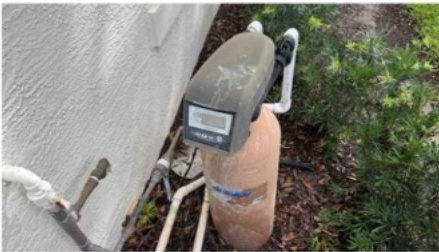
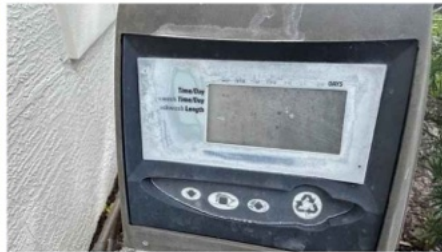
There is an old water filtration system on the left side of the home. These systems are not inspected in a home inspection. The control panel does not appear to be working. Recommend further evaluation by a licensed water filtration company for repair, replacement or removal.

Display not working

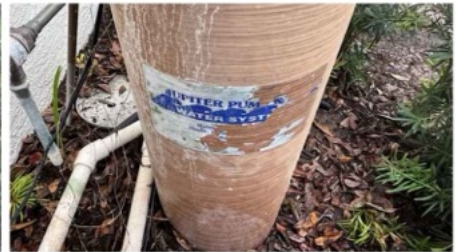
#### **WATER FILTRATION**

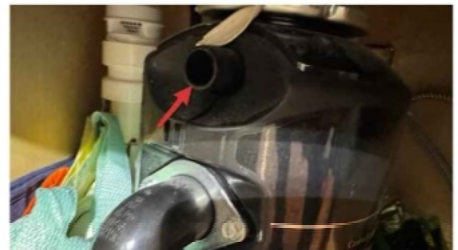
#### **IMPROPER CONNECTION**

The disposal in the kitchen island is missing the cap for the disposal. Since there is no dishwasher, install a fernco cap to prevent water from backing up into the kitchen.

Missing Cap - Island Disposal

Contact a qualified plumbing contractor.

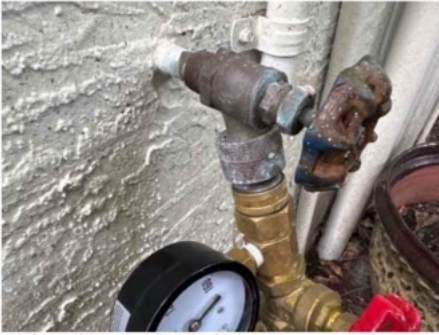
#### **LEAKING HOSE BIBS WHEN TURNED ON**

In general, hose bibs are leaky when turned on at valve stems. One leaks when turned off. Most of the backflow preventers have been removed. Recommend a plumber replace and update all hose bibs. We typically see old hose bibs needing replacement in our inspections.

Left Side - Leaky valve stem

Contact a qualified plumbing contractor.

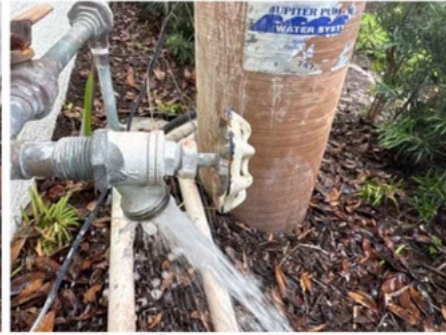
Missing backflow preventer

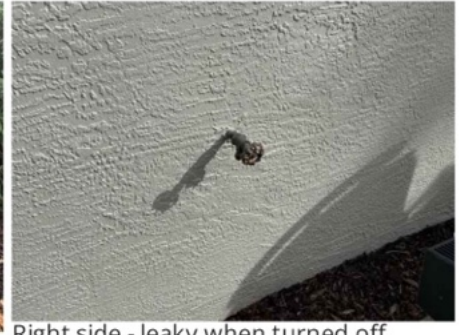
Right side - leaky when turned off

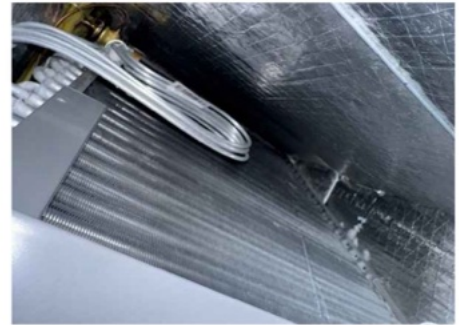
Some Water in Pan

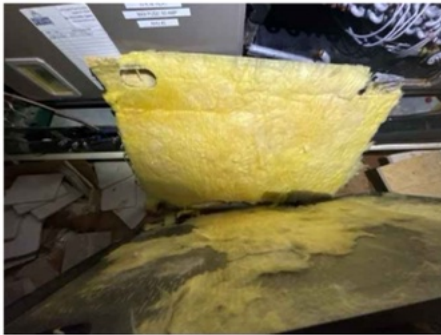
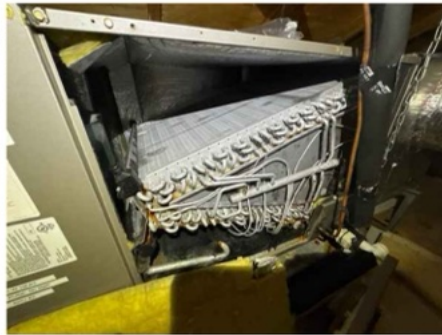
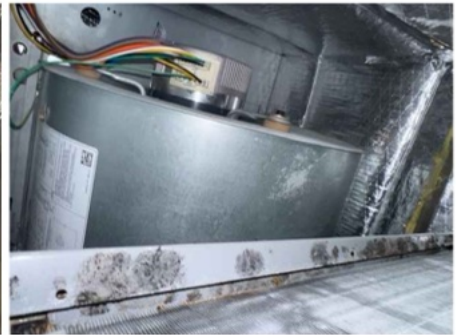
**DAMAGED AIR HANDLER COVER INSULATION**

The air handler servicing the main living area is not cooling properly. The air handler cover insulation is in poor condition and detached from the cover. An HVAC contractor should replace insulation, clean system and repair so that it cools properly.

Contact a qualified HVAC professional.

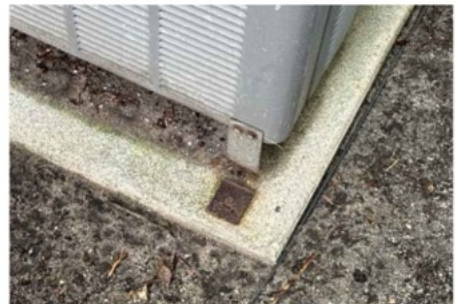
**NOT SECURED TO BASE**

HVAC #3 condenser hurricane strapping is rusted out. Often this is caused by misdirected sprinklers spraying the condenser.

Recommend redirecting sprinklers and securing the condenser to the concrete base.

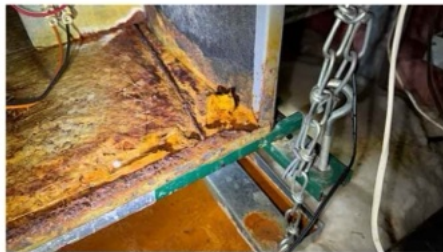
Rust & Deterioration

HVAC #4 condenser hurricane strapping is rusted out. Often this is caused by misdirected sprinklers spraying the condenser.

Recommend redirecting sprinklers and securing the condenser to the concrete base.

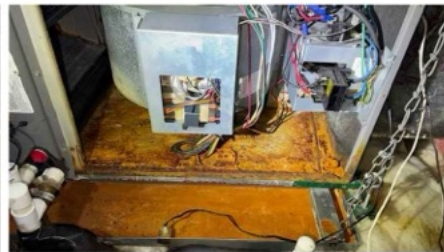
Rust & Deterioration

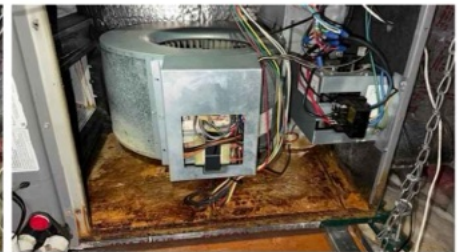
#### **RUST & DETERIORATION IN AIR HANDLER**

There is significant rust and deterioration to the air handler box, drain pan and interior insulation. Recommend an HVAC contractor evaluate for replacement options.

Rust & Deterioration

Contact a qualified HVAC professional.

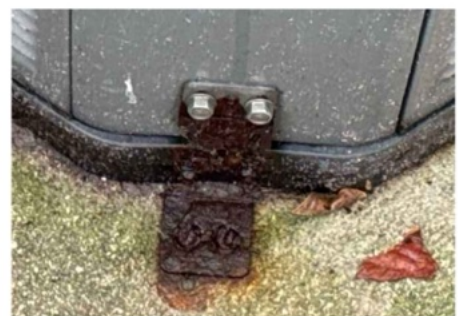
#### **NOT SECURED TO BASE**

Rusted out hurricane straps

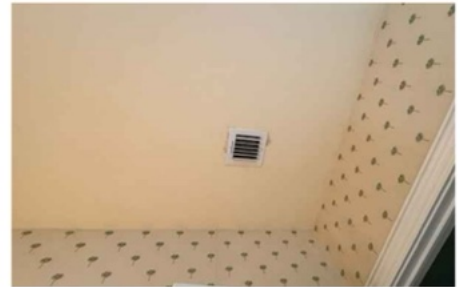
**CLEAN VENT COVER**

Clean vent cover in upstairs front bathroom. Usually water and vinegar or water and Borax can easily remove the staining.

Contact a qualified handyman.

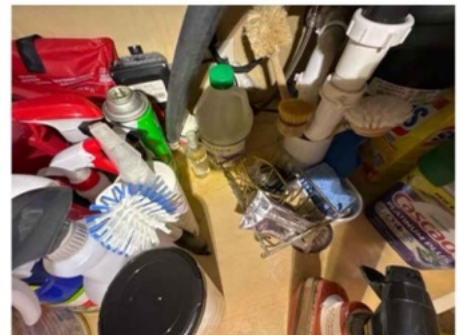
**CABINETS DAMAGED**

The kitchen sink cabinet has visible water damage. The area is now dry. Recommend replacing damaged building material.

Significant caved in damage to kitchen sink cabinet

Contact a qualified handyman.

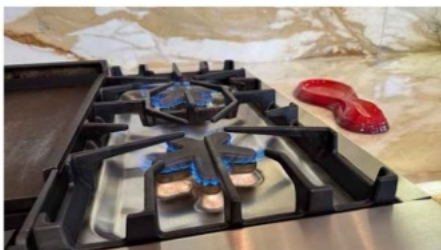
The 2 left side kitchen stove top burners did not light when turned on. Recommend an appliance contractor repair.

2 left burners not lighting

Contact a qualified appliance repair professional.

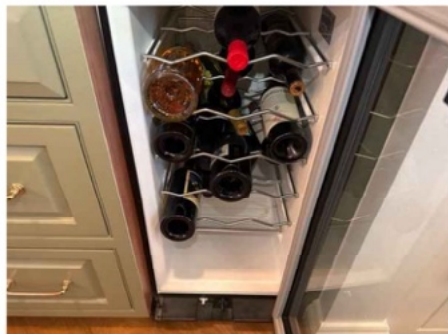
The wine cooler did not appear to operate as it should at the time of the inspection. Possibly it is unplugged. Recommend repair/replace.

Contact a qualified appliance repair professional.

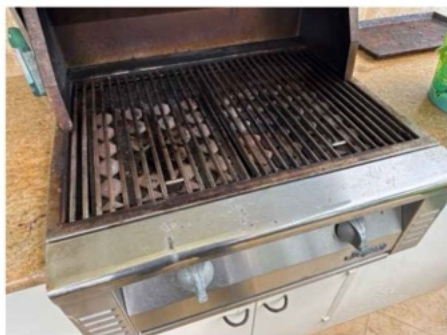
**BURNER NOT LIGHTING**

The grill igniters are not working. Recommend a grill appliance contractor service and professionally clean the grill.

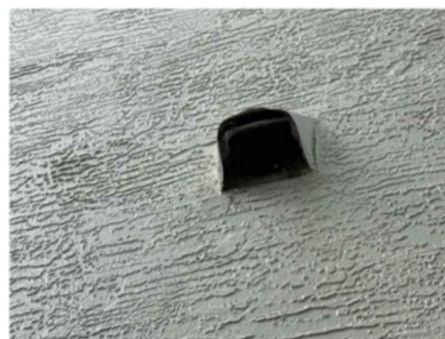
**CLEAN EXTERIOR DRYER VENT**

The exterior dryer vent flapper was observed not closing fully. This condition is often caused by lint buildup, debris, or minor warping of the vent cover, which can allow pests, moisture, or outside air to enter. Recommend cleaning the vent hood and hinge area to restore proper function. If the flapper remains stuck or does not close after cleaning, replacement of the vent cover is advised. Regular cleaning of the dryer vent line is also recommended to maintain airflow efficiency and reduce fire risk.

Contact a qualified handyman.

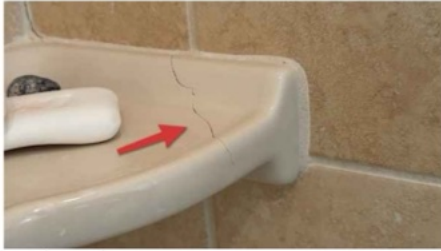
Back Bathroom

There is a cracked soap dish in an upstairs bathroom that should be replaced. There are cracks in corner grout that should be repaired to prevent water damage.

Contact a qualified tile contractor

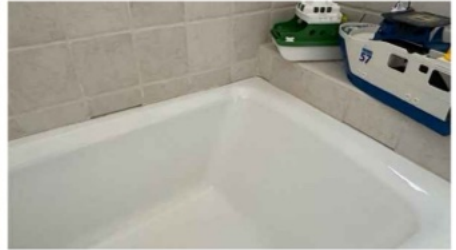
**DAMAGED GROUT**

Front bathroom

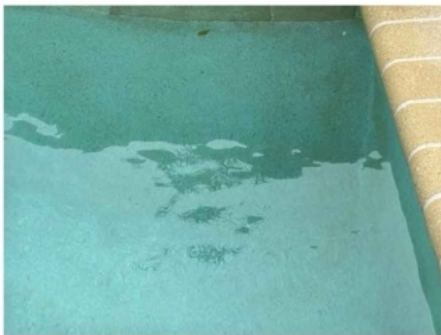
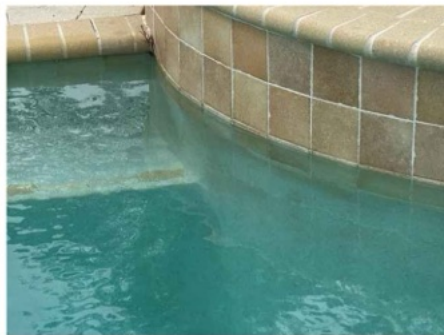
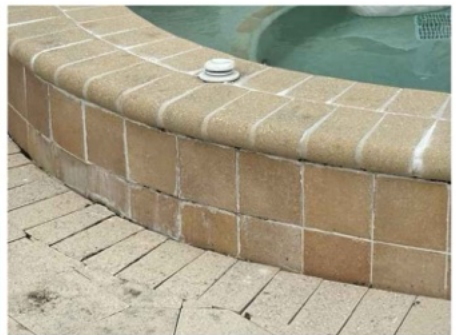
#### SURFACE STAINING & DETERIORATION

The pools aggregate surface and spa tile has some staining. Recommend speaking to a pool contractor for cleaning options.

Contact a qualified swimming pool contractor

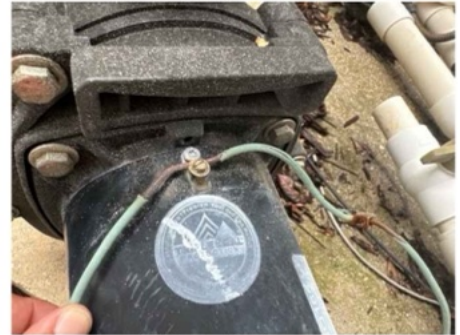
The main pump bonding wire is not secured properly to the pool pump. Recommend an electrician correct for pool safety.

Loose Bond Wore at Pump

Contact a qualified swimming pool contractor

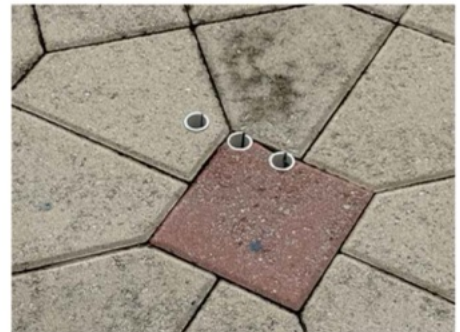
**MISSING CAPS FOR CHILD FENCE**

There are missing pool fence mount caps observed. Open sleeves can collect debris, cause corrosion, and pose a minor tripping hazard. Recommend replacement by a qualified pool or fence contractor.

Fence mounts

Contact a qualified handyman.

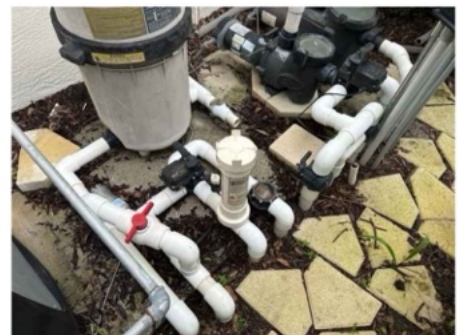
Recommend labeling all pool system valves for clear identification (e.g., "Skimmer," "Main Drain," "Spa Return," "Heater Bypass," etc.). A qualified pool technician can assist with proper identification and labeling to ensure correct operation.

Contact a qualified swimming pool contractor

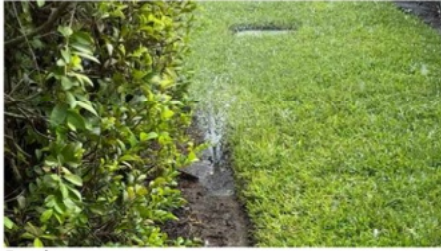
There are multiple damaged sprinkler heads that need to be replaced. Recommend full servicing of the sprinkler system for function and efficiency.

Broken

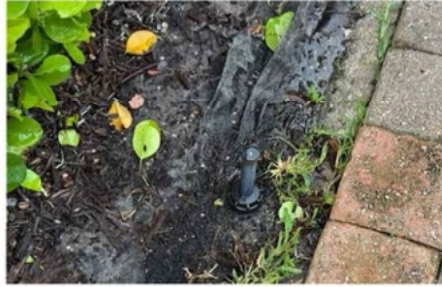
**DAMAGED SPRINKLER HEADS**

Won't recess

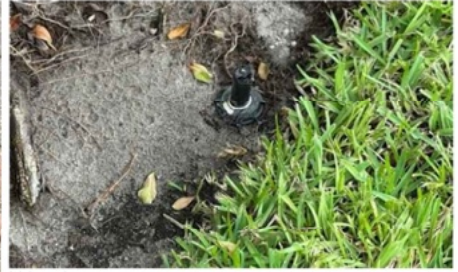
Won't recess

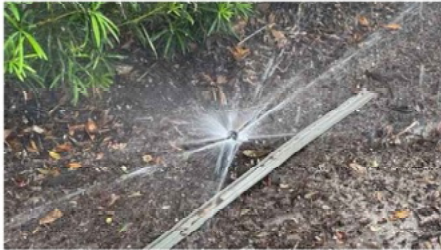
Broken

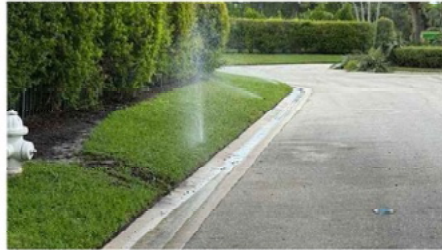
Broken

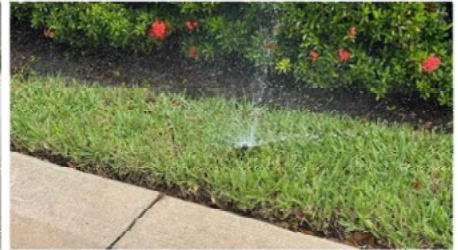
Broken

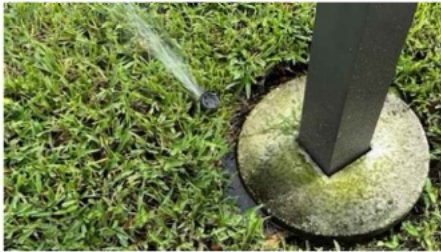
Leaking
