# Inspection Report

**Property Address:**  
123 Anywhere Lane  
Raleigh NC 27609

<b>Date:</b> 5/8/2025	<b>Time:</b> 01:00 PM	<b>Report ID:</b> Sample123
<b>Property:</b> 123 Anywhere Lane Raleigh NC 27609	<b>Customer:</b> Joe and Jane Buyer	<b>Real Estate Professional:</b>

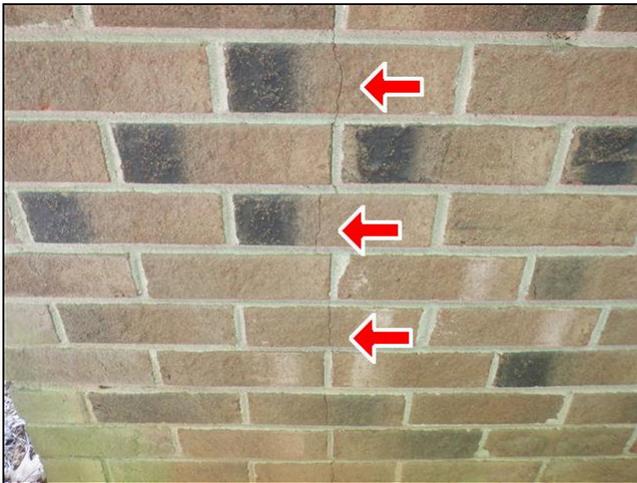
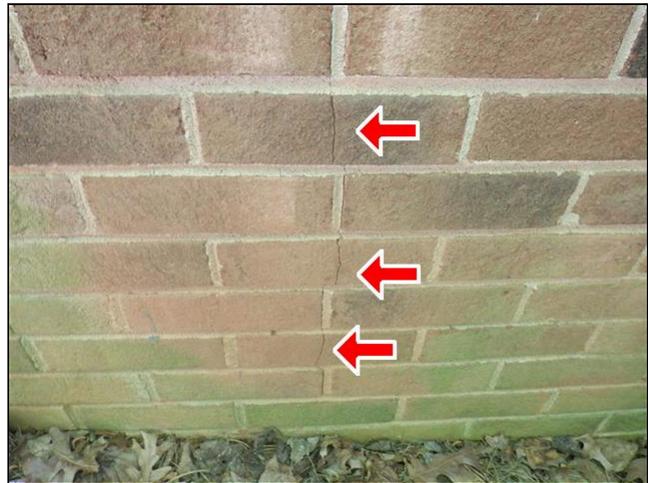
1.0 Item 1(Picture)

Noted cracks in the exterior brick cladding at the following locations: front right of the structure. The cracks are signs of possible foundation settlement. A structural engineer or foundation specialist should further investigate.

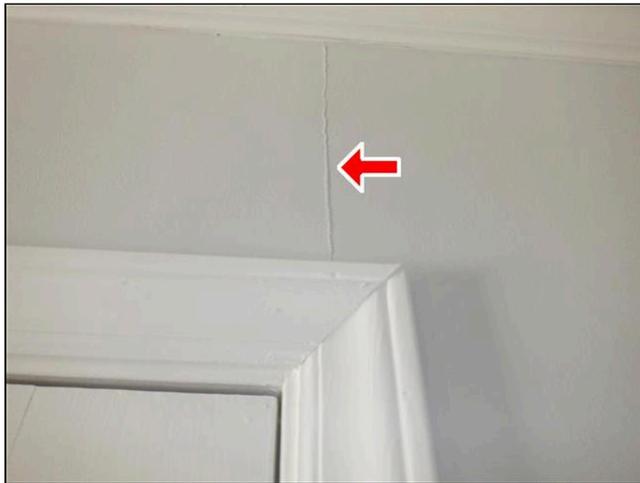
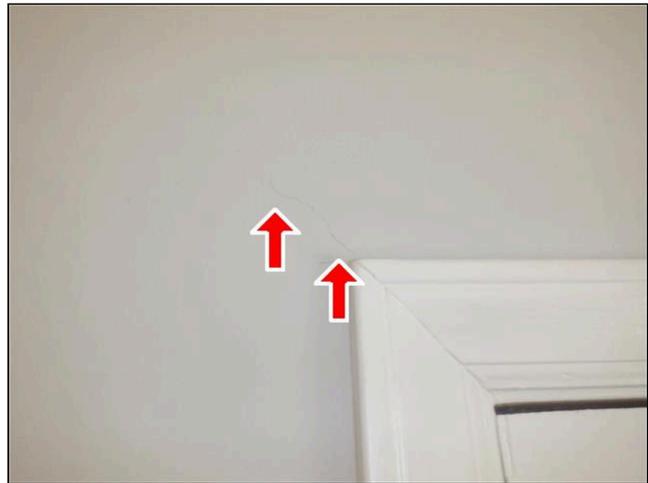
1.1 Item 1(Picture)

Cracks in the sheetrock above the doors at the following locations: left bedroom closet door and the right bedroom closet door. The cracks are signs of possible foundation settlement. A structural engineer or foundation specialist should further investigate.

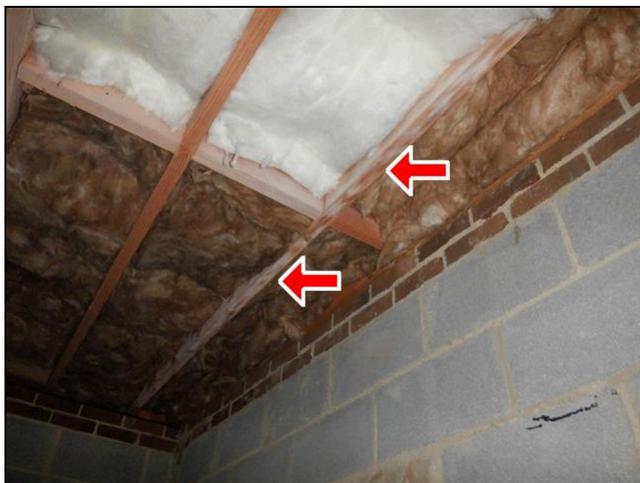
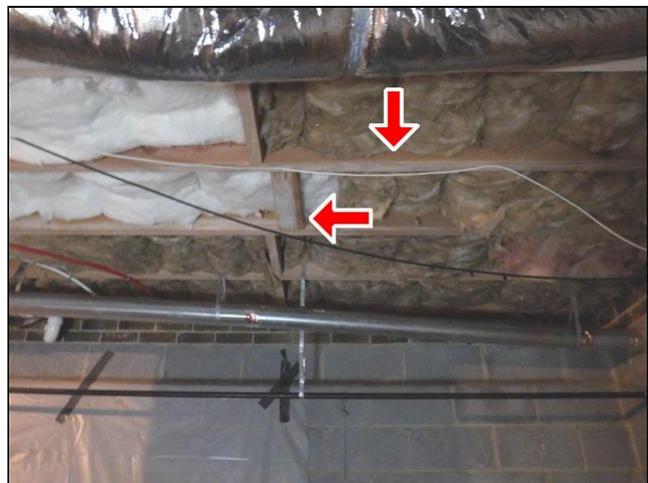
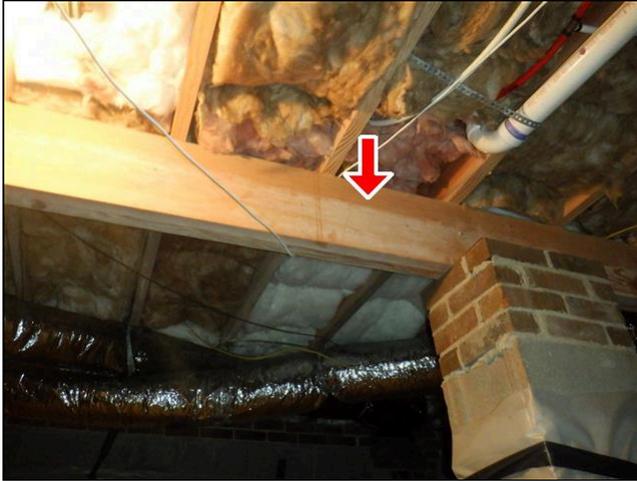
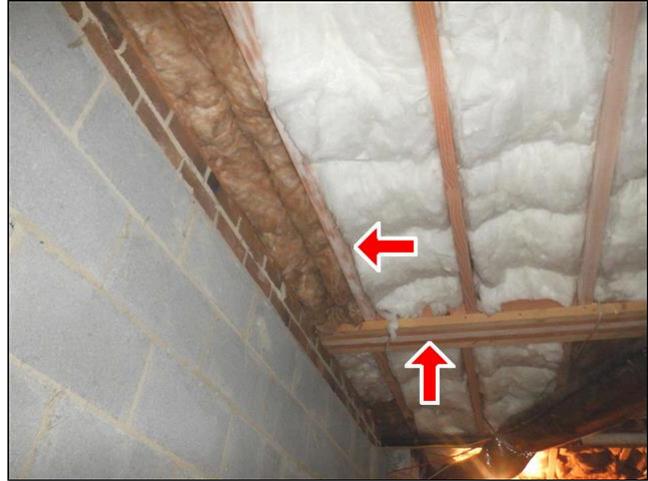
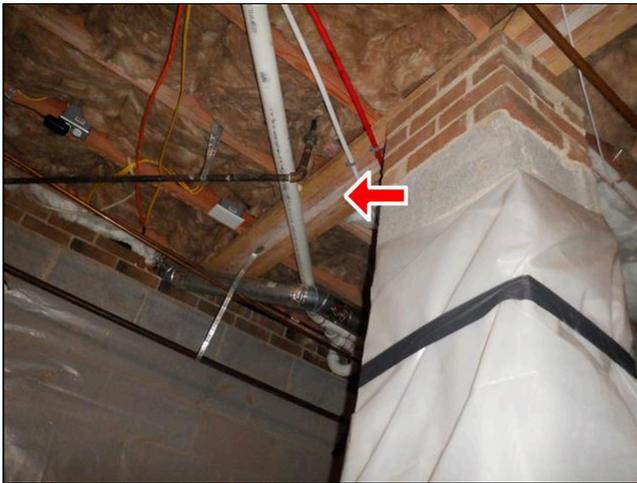
1.6 Item 1(Picture)

Evidence of an organic growth is present on the floor system in the crawl space in several areas. This evidence is possibly due to higher than typical moisture levels. We did not inspect, test or determine if this growth is or is not a health hazard. The wood framing components were not completely visible due to the organic growth and the inspector could not verify the structural integrity. Mechanically driven air may need to be added to provide functional air flow throughout the crawl space. A certified mold specialist should further investigate and determine the method of removal.

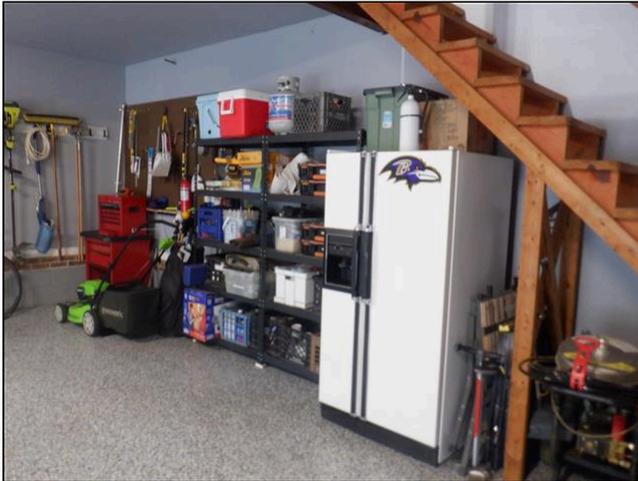
2.0 Item 1(Picture)

- (1) The garage door does not reverse when met with resistance. Safety hazard. A garage door contractor should further investigate and repair.
- (2) The garage walls and floor are blocked in some locations by personal belongings. These areas were not accessible and were not inspected. No representation of the conditions of any components.

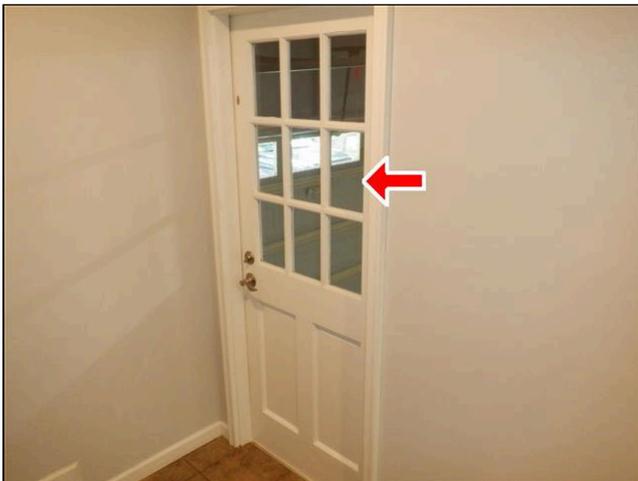
2.1 Item 1(Picture)

- (1) Noted the door entering the structure from the garage has glass light inserts. Safety hazard. A qualified contractor should further investigate and replace the door with a 20 minute fire rated door to protect the structure in case of fire.

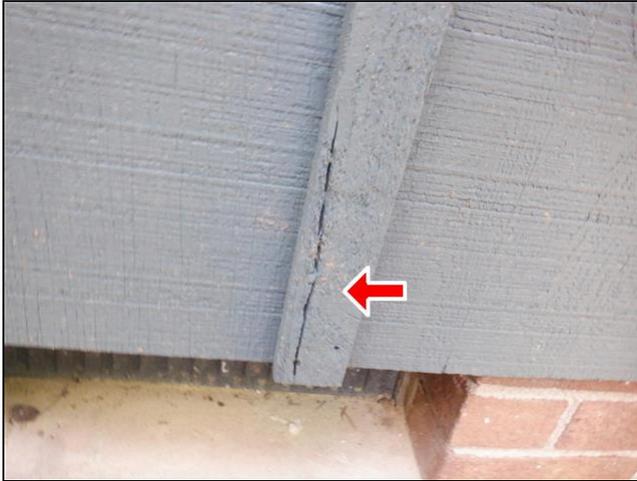
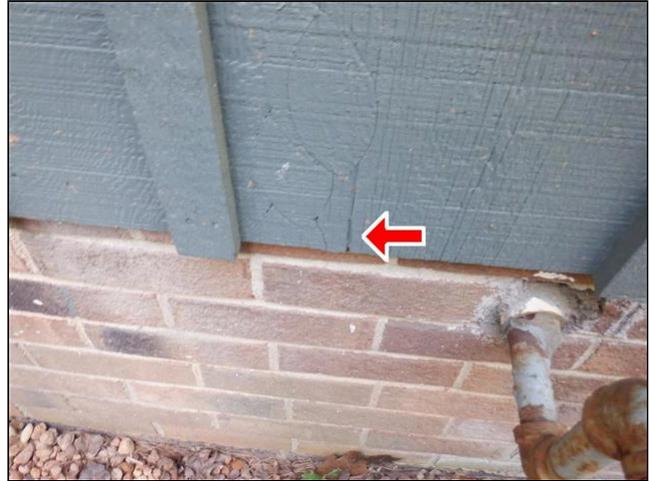
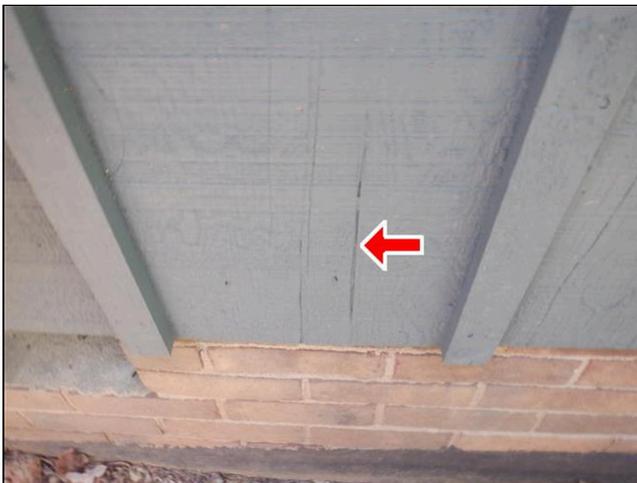
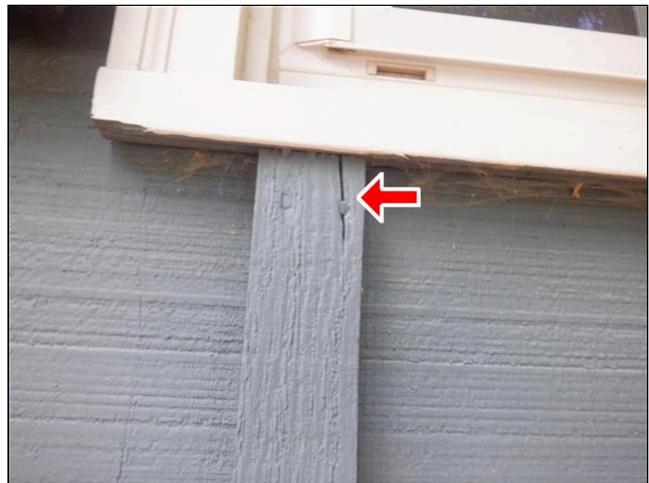
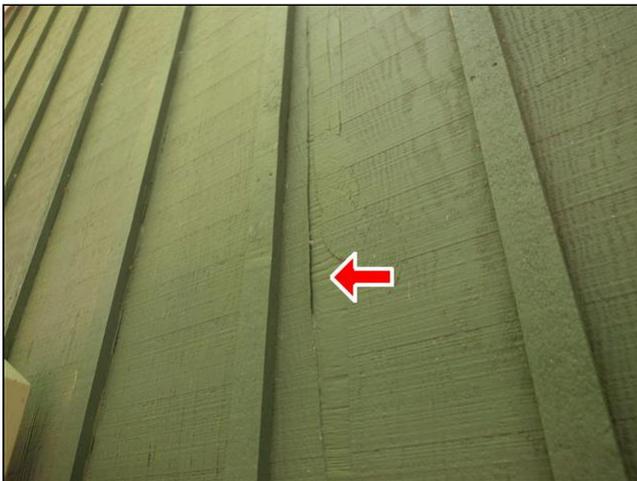
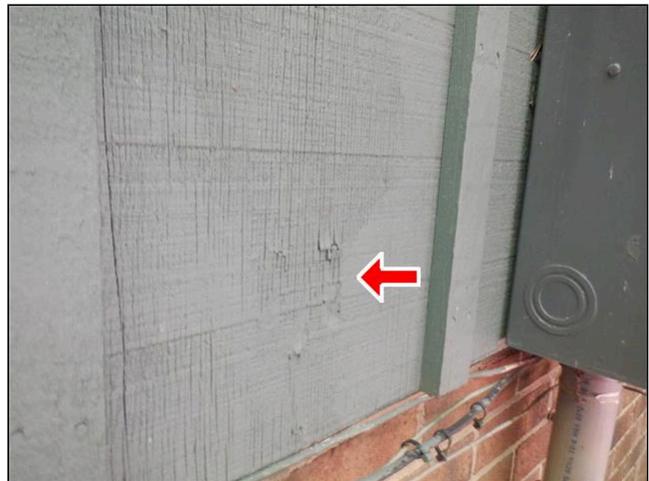
2.3 Item 1(Picture)

(1) Damaged siding at the following locations: right side and front of the structure. (the pictures may be a representative number). Water can enter through the damaged siding and cause deterioration of the adjacent framing components. A qualified contractor should repair or replace all damaged siding to prevent further deterioration and water entry.

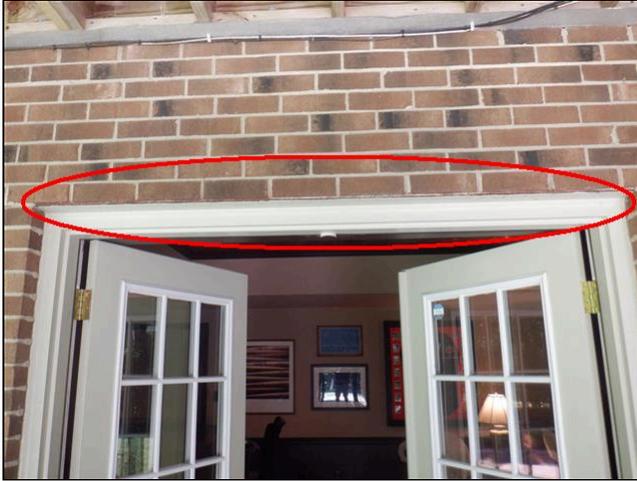
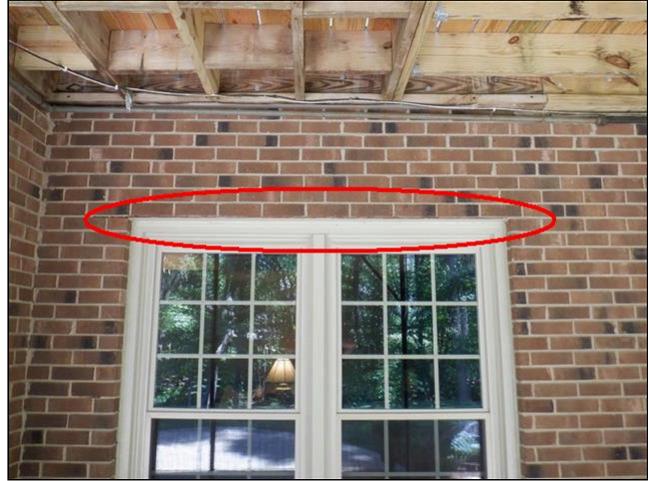
2.3 Item 7(Picture)

(2) Missing weep holes in the masonry bricks above the doors/windows at the following locations: surrounding the structure. The weep holes provide an opening to enable water to exit from behind the brick veneer. A masonry contractor should further investigate and repair.

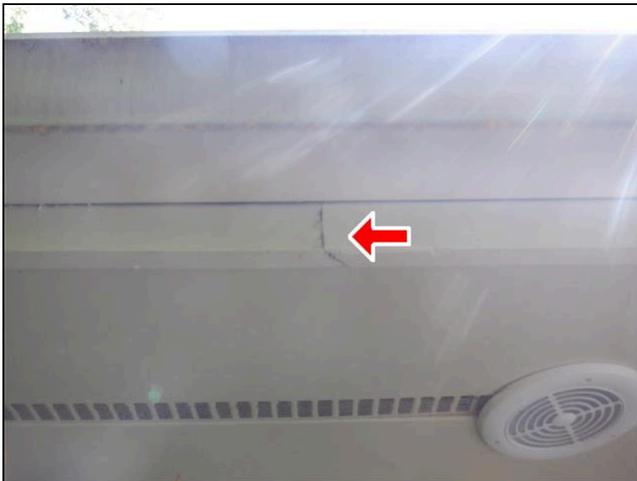
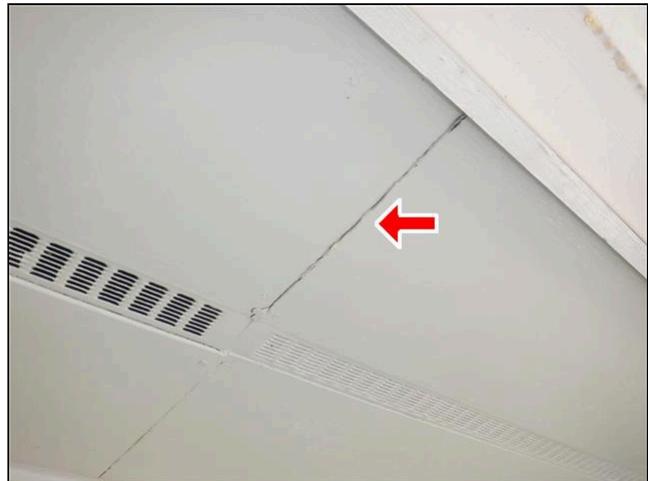
2.7 Item 1(Picture)

Openings between the exterior trim joints (the pictures may be a representative number). A qualified contractor should further investigate and repair to prevent vermin and water entry.

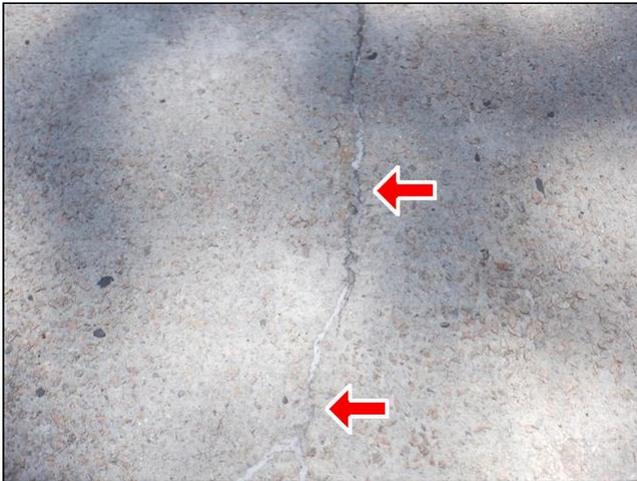
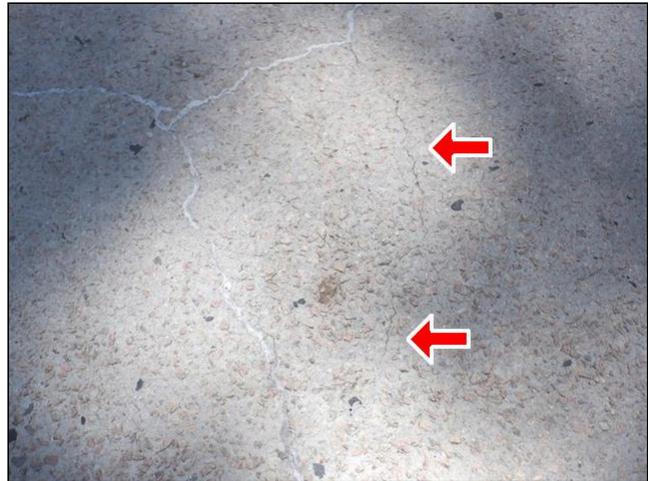
2.8 Item 1(Picture)

Cracks in the driveway concrete slabs. A qualified contractor should further investigate and repair to prevent water from entering below the slab and further deterioration.

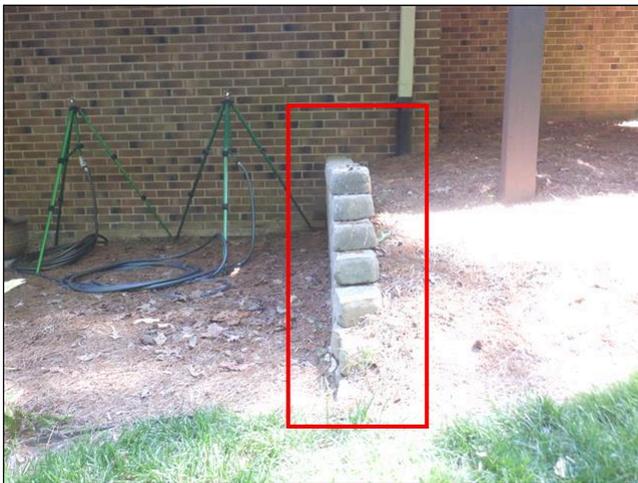
2.11 Item 1(Picture)

The retaining wall at the left rear of the structure is leaning toward the patio below the elevated deck. Structural concern. A structural engineer should further investigate.

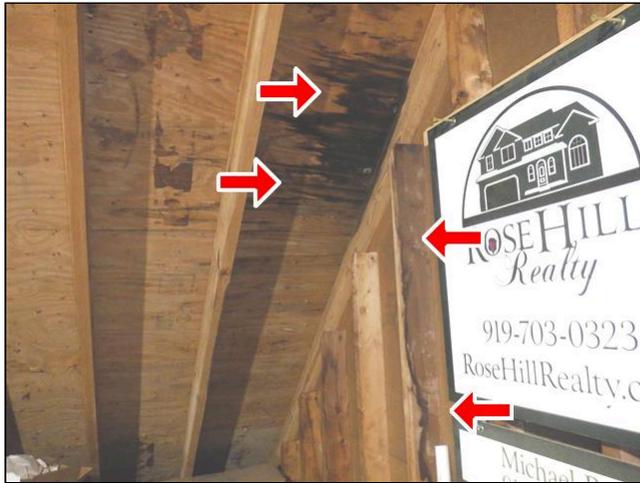
3.3 Item 1(Picture)

Noted water stained/damaged roof decking at the following locations: front of the garage attic. A roofing contractor should further investigate and repair to prevent further deterioration.

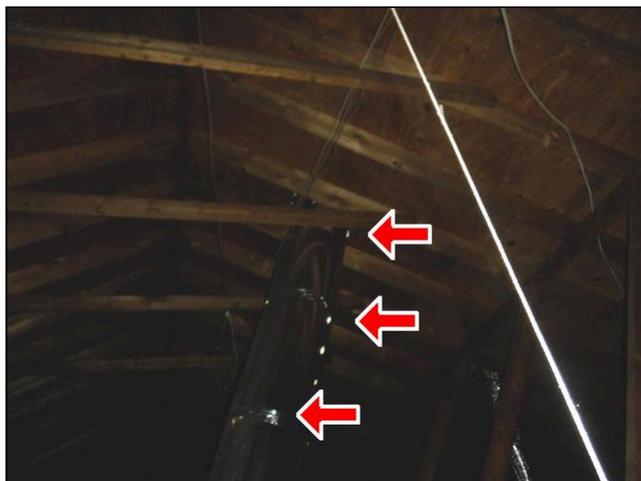
3.5 Item 1(Picture)

Visible daylight surrounding the master solar tube skylight (in attic). A roofing contractor should further investigate and repair.

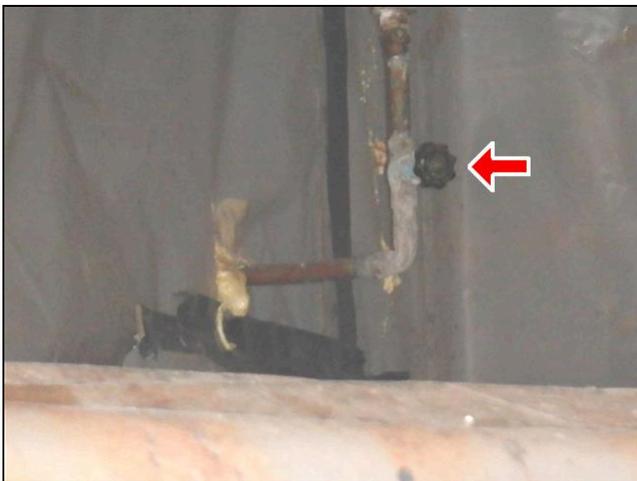
4.0 Item 1(Picture)

The picture of the main water shut off valve is provided for your information only.

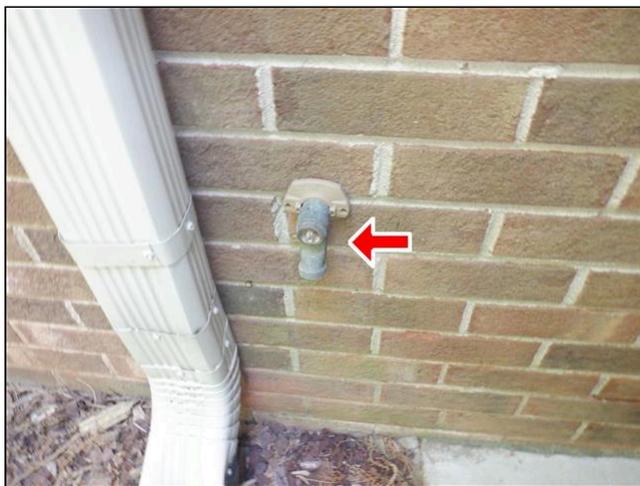
4.4 Item 1(Picture)

(1) The right rear exterior faucet has been disconnected and abandoned in place. Contact a licensed plumber for removal, if desired.

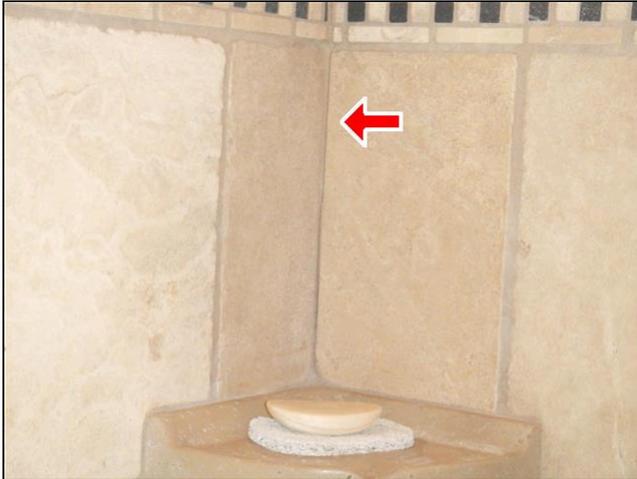
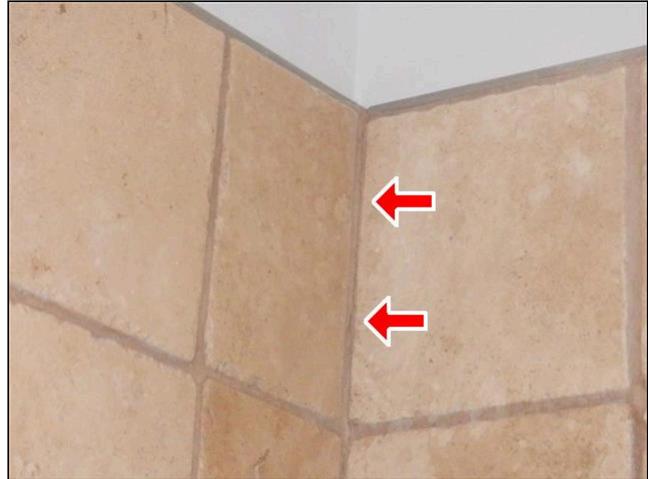
4.6 Item 1(Picture)

Openings in the caulk/grout surrounding the first floor hall shower. A qualified contractor should further investigate and seal openings to prevent water entry.

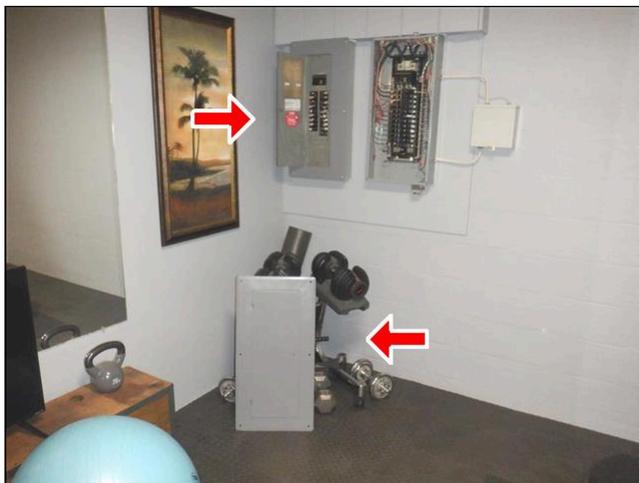
5.0 Item 1(Picture)

(1) The protective cover on the front main electrical breaker box does not latch (latch assembly missing). Electrical hazard. A licensed electrician should further investigate and repair to prevent possible bodily injury.

(2) The rear main electrical panel exterior cover could not be removed due to personal belongings and limited access. The interior of the panel was not inspected.

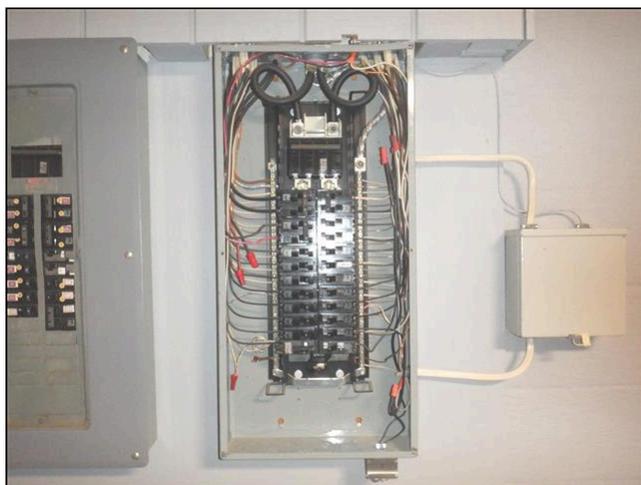
5.0 Item 2(Picture)

(3) Pictures of the interior of the electrical panels are provided for your information only.

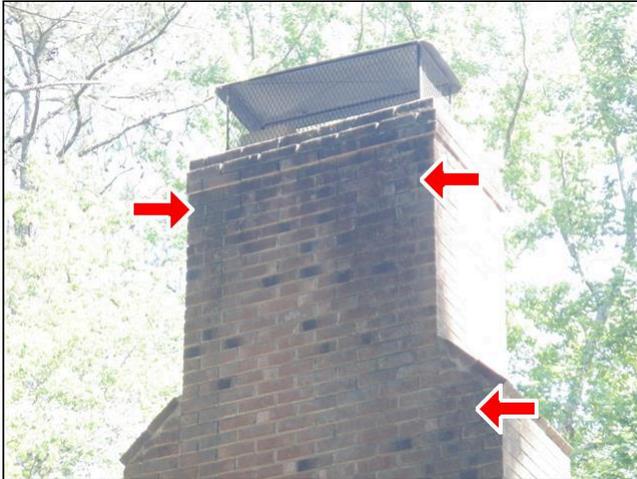
6.5 Item 1(Picture)

(1) Noted soot stains on the upper exterior edges of the fireplace chimney. A chimney sweep should further investigate.

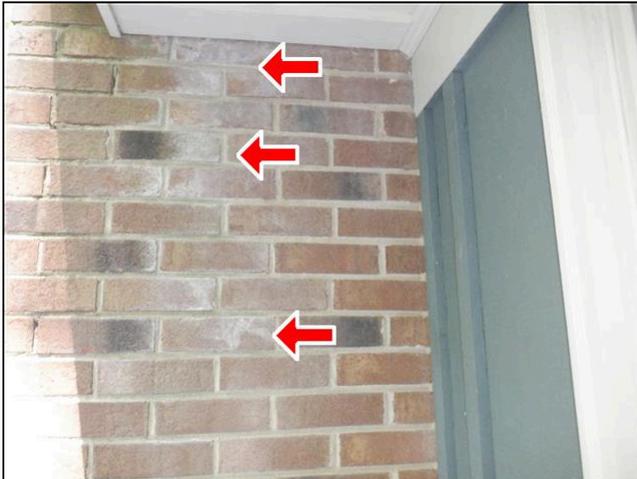
6.5 Item 2(Picture)

(2) Noted white efflorescence (powder substance) on the exterior of the fireplace chimney. Water is entering from the top of the fireplace chimney. A chimney sweep should further investigate and repair to prevent further deterioration.

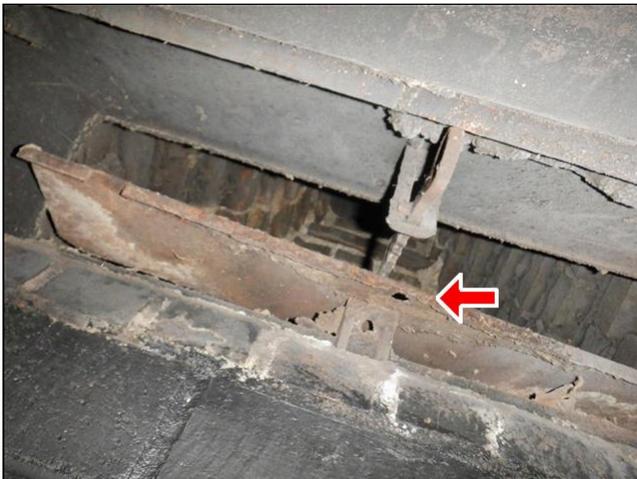
6.5 Item 3(Picture)

(3) The great room fireplace damper door is damaged and does not function. A qualified contractor should further investigate and repair to prevent vermin entry and heating/cooling loss.

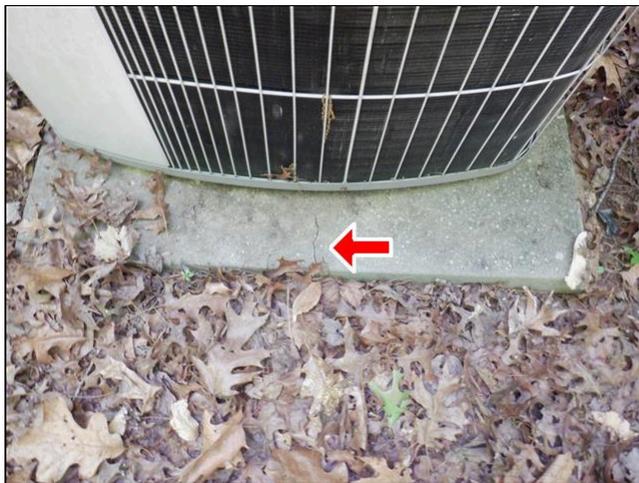
7.0 Item 1(Picture)

(1) The first floor A/C support pad is damaged. A licensed HVAC mechanical contractor should further investigate and repair.

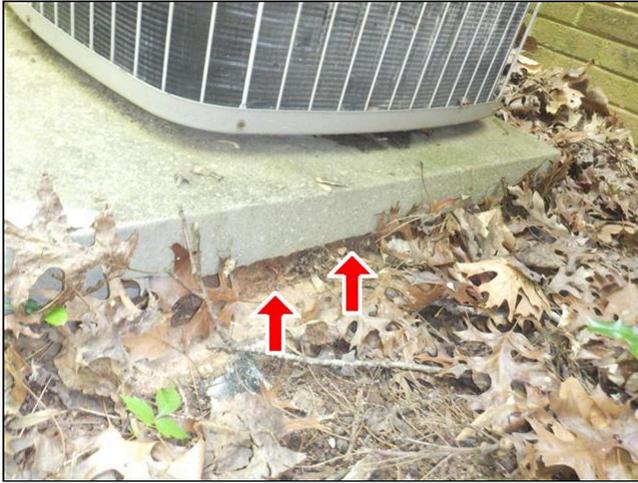
7.0 Item 2(Picture)

(2) Noted soil erosion below the first floor A/C support pad. Repair to prevent the A/C from leaning.

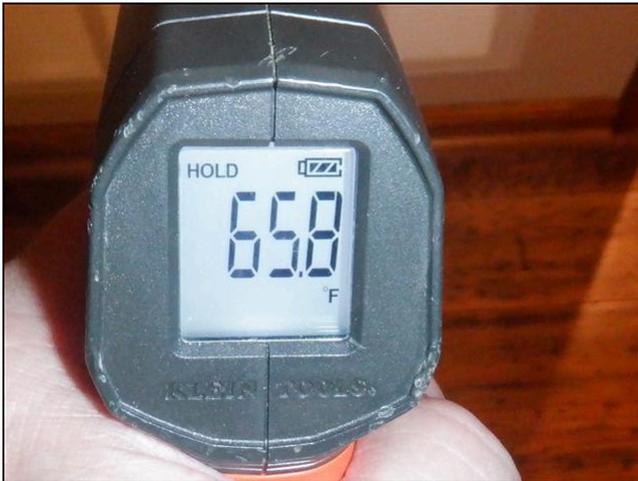
7.0 Item 3(Picture)

(4) Return in A/C mode - basement

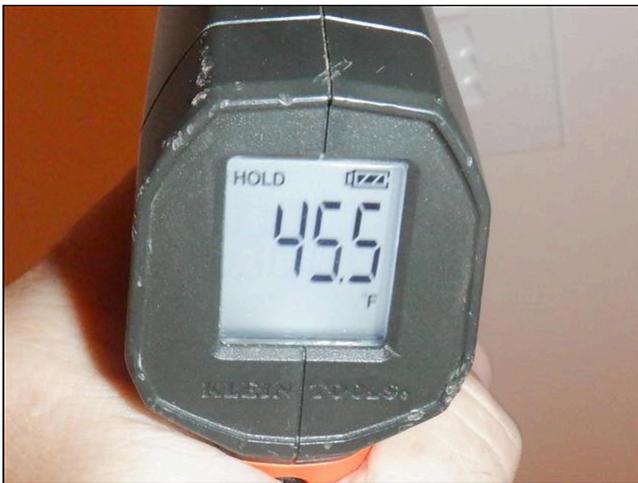
7.0 Item 4(Picture)

(5) Supply in A/C mode - basement

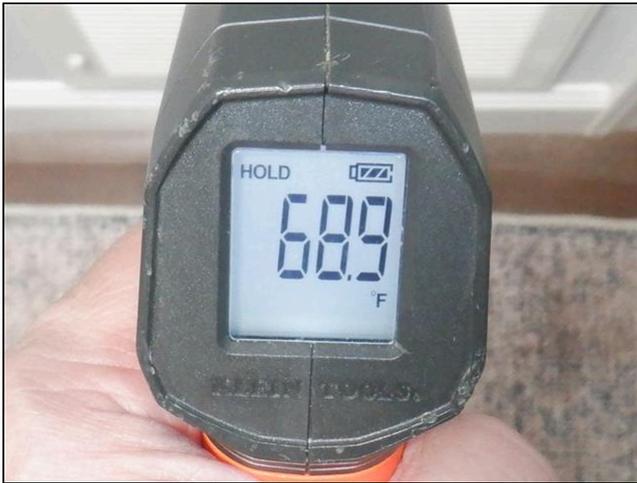
7.0 Item 5(Picture)

(6) Return in A/C mode - first floor

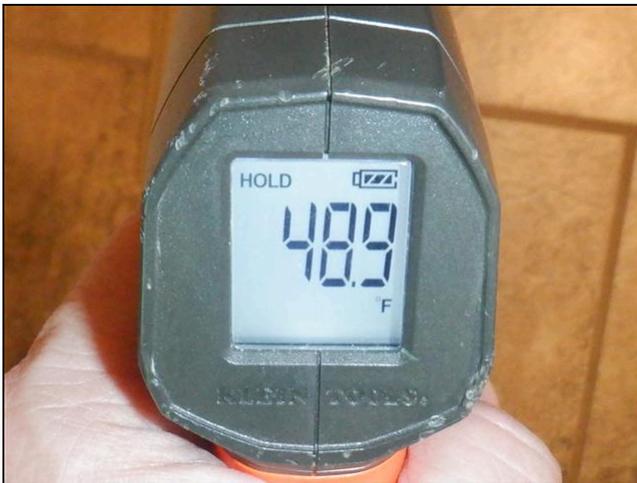
7.0 Item 6(Picture)

(7) Supply in A/C mode - first floor

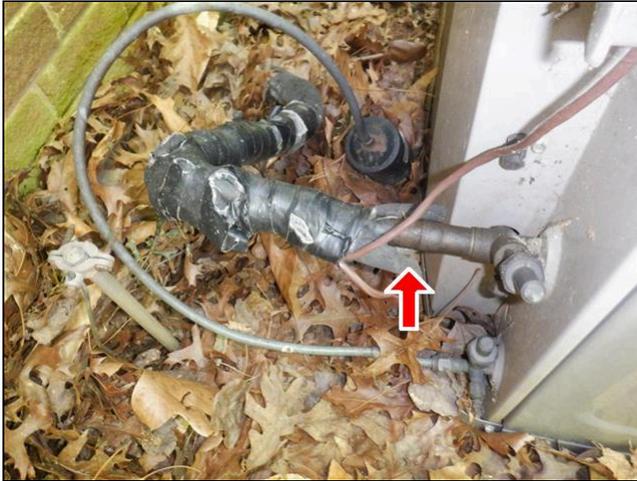
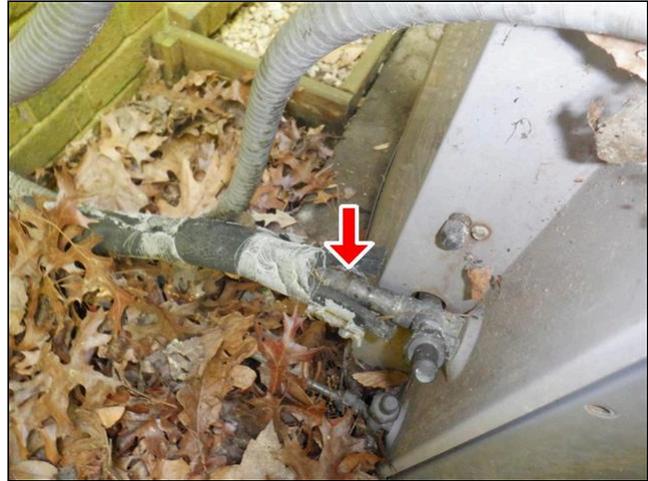
7.2 Item 1(Picture)

Missing insulation surrounding the low pressure Freon lines entering the A/C unit. A licensed HVAC contractor should further investigate and repair to prevent further deterioration.

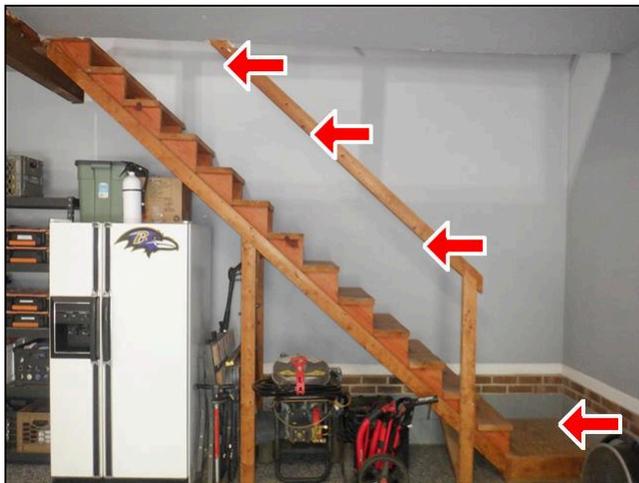
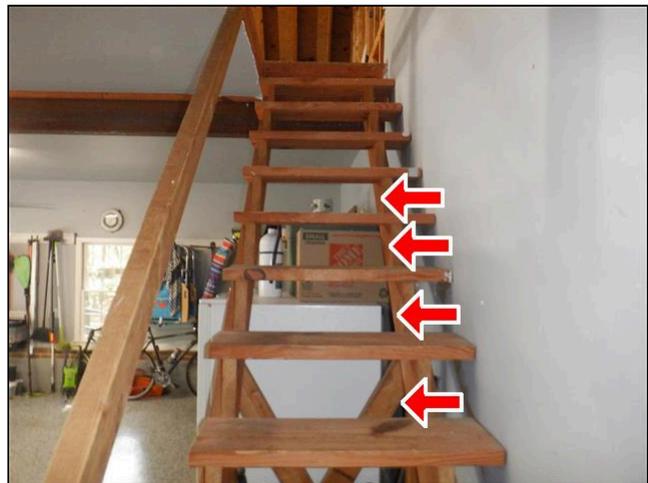
8.0 Item 1(Picture)

(1) The garage staircase is considered unsafe for usage due to the following issues: Missing balusters on the handrail system and the balcony handrail, handrails are loose, missing risers, and the staircase moves when walked on. A qualified contractor should further investigate and repair to prevent possible bodily injury.

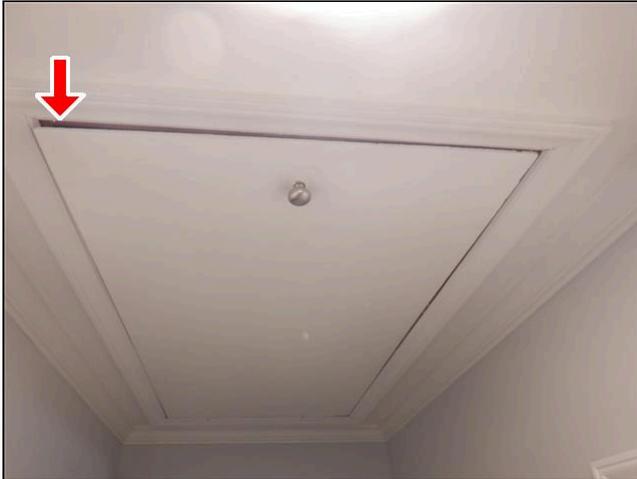
8.0 Item 3(Picture)

(2) The attic pull down staircase does not seal against the frame. A qualified contractor should further investigate and repair to prevent heating/cooling loss and vermin entry.

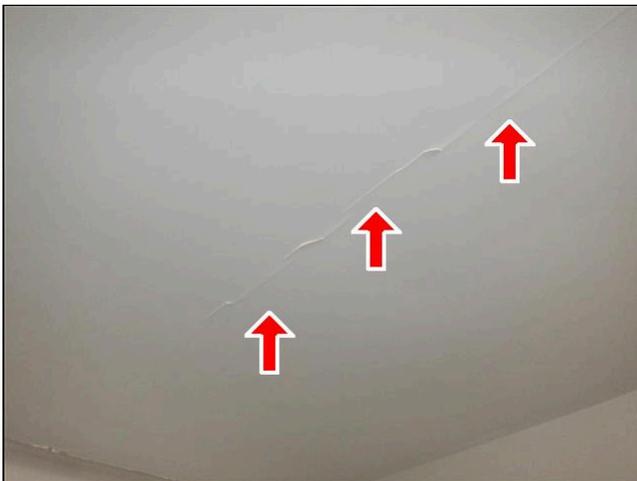
8.1 Item 1(Picture)

Damaged sheetrock in the ceilings at the following locations: garage ceiling. A qualified contractor should further investigate and repair to prevent further deterioration.

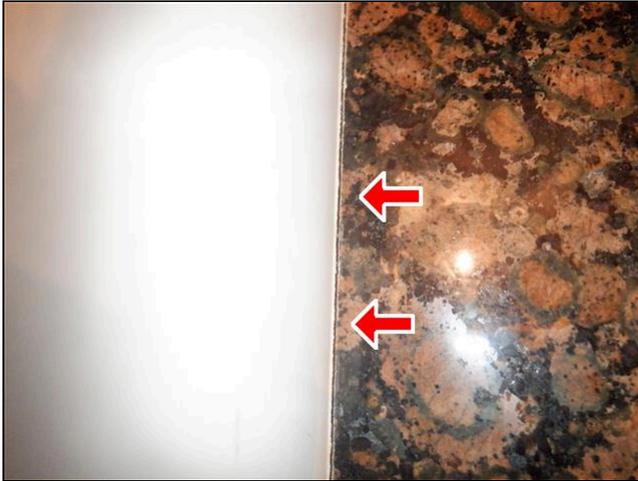
8.4 Item 1(Picture)

Noted openings between the basement bathroom vanity sink top and the wall. A qualified contractor should further investigate and repair to prevent water entry.
