### QC Report Sample:

**Product Manufacturer :**ADI/ **Manufacturer Part No :**LT8631EFE#TRPBF

# Test Report

Part Number: LT8631EFE#TRPBF

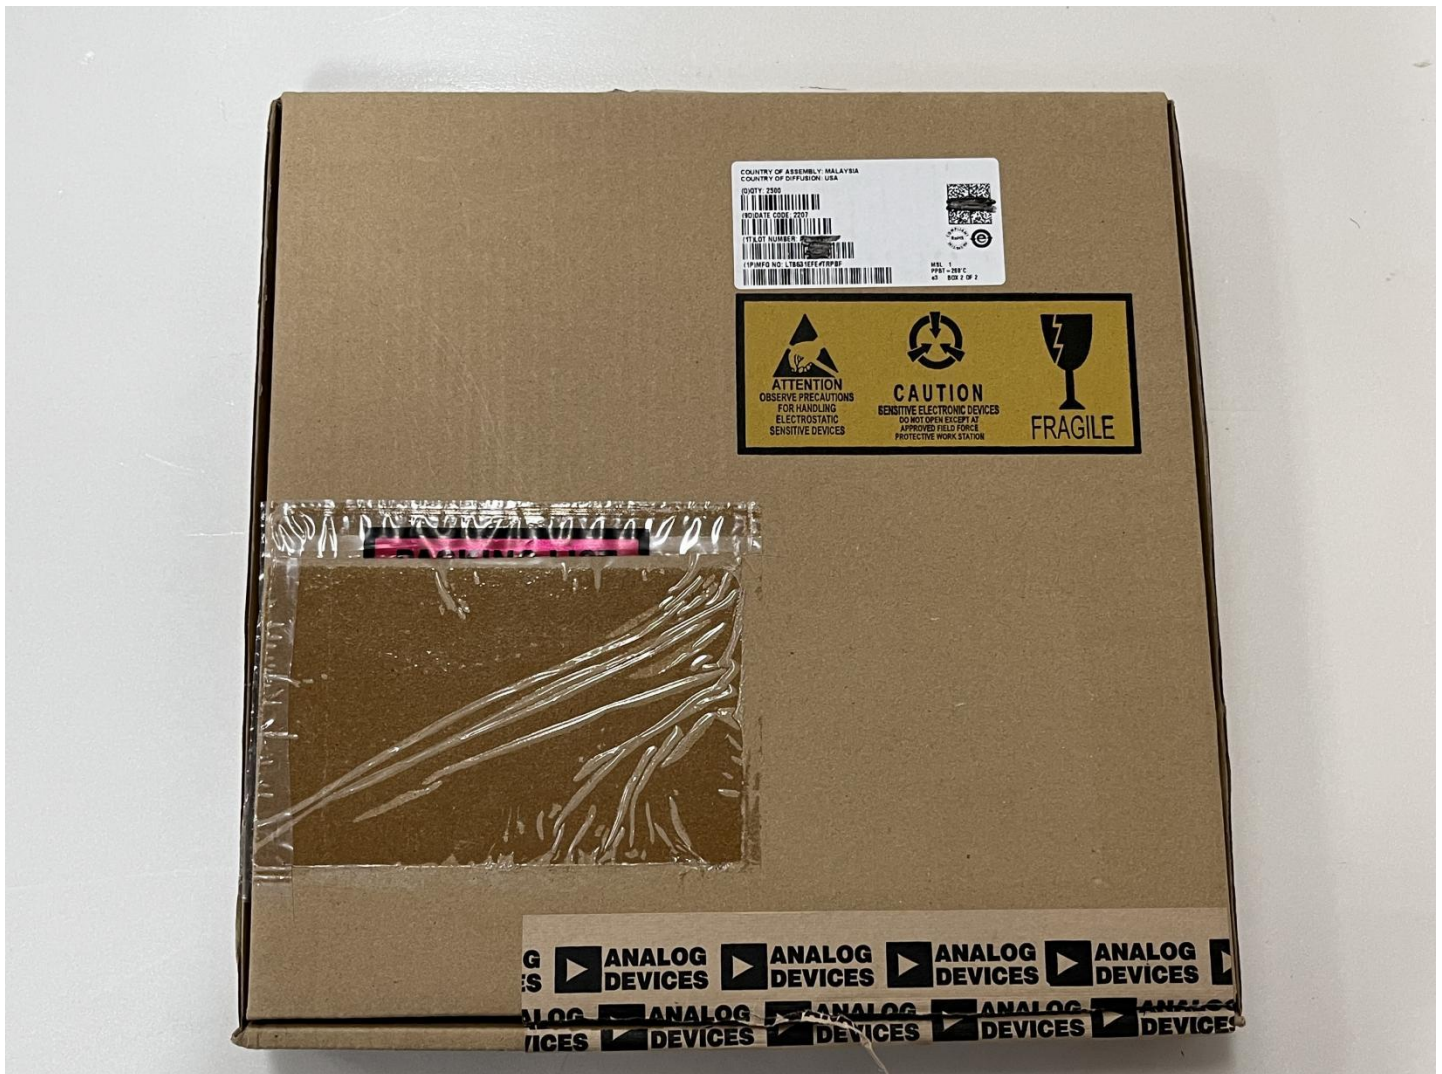
Outer Packaging

#	Packaging Inspection	Sample Size	Result
1	Verify product condition – any damage on product or packaging	2504	Pass
2	Verify package structural integrity	2500	Pass
3	Verify labels – any signs of tampering	/	Pass
4	Verify packaging ESD compliance	2504	Pass
5	Verify if humidity control package (dry pack) is in good condition	/	Pass

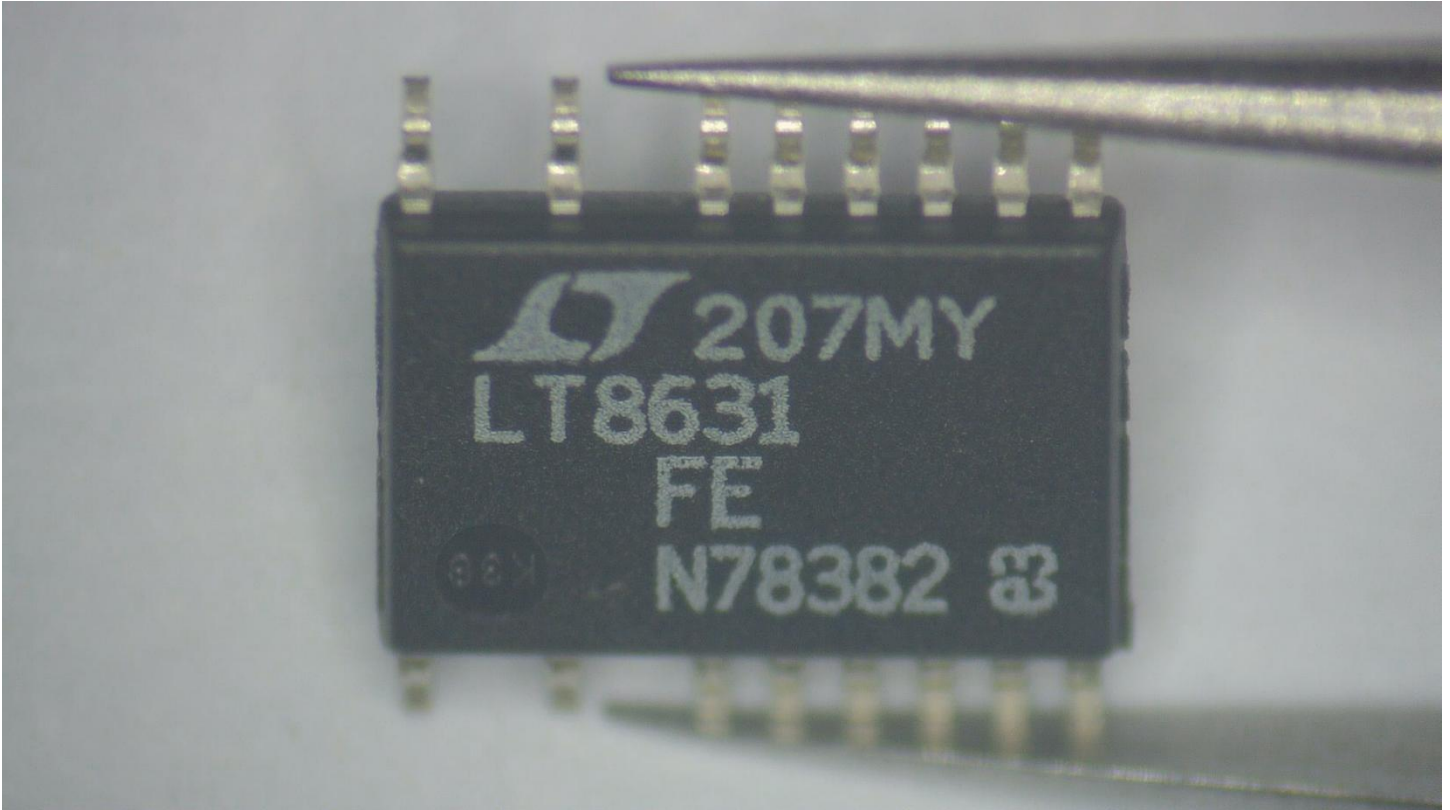
Top Marking(N78382)

#	Marking Inspection	Sample Size	Result
1	All markings are clear	100	Pass
2	Verify if markings on top and bottom of parts are consistent throughout the entire lot–font color and size orientation	100	Pass
3	Verify if marking of part number,datecode,country of origin or lot number are consistent	100	Pass
4	Check for evidence of test dots or engineering sample	100	Pass

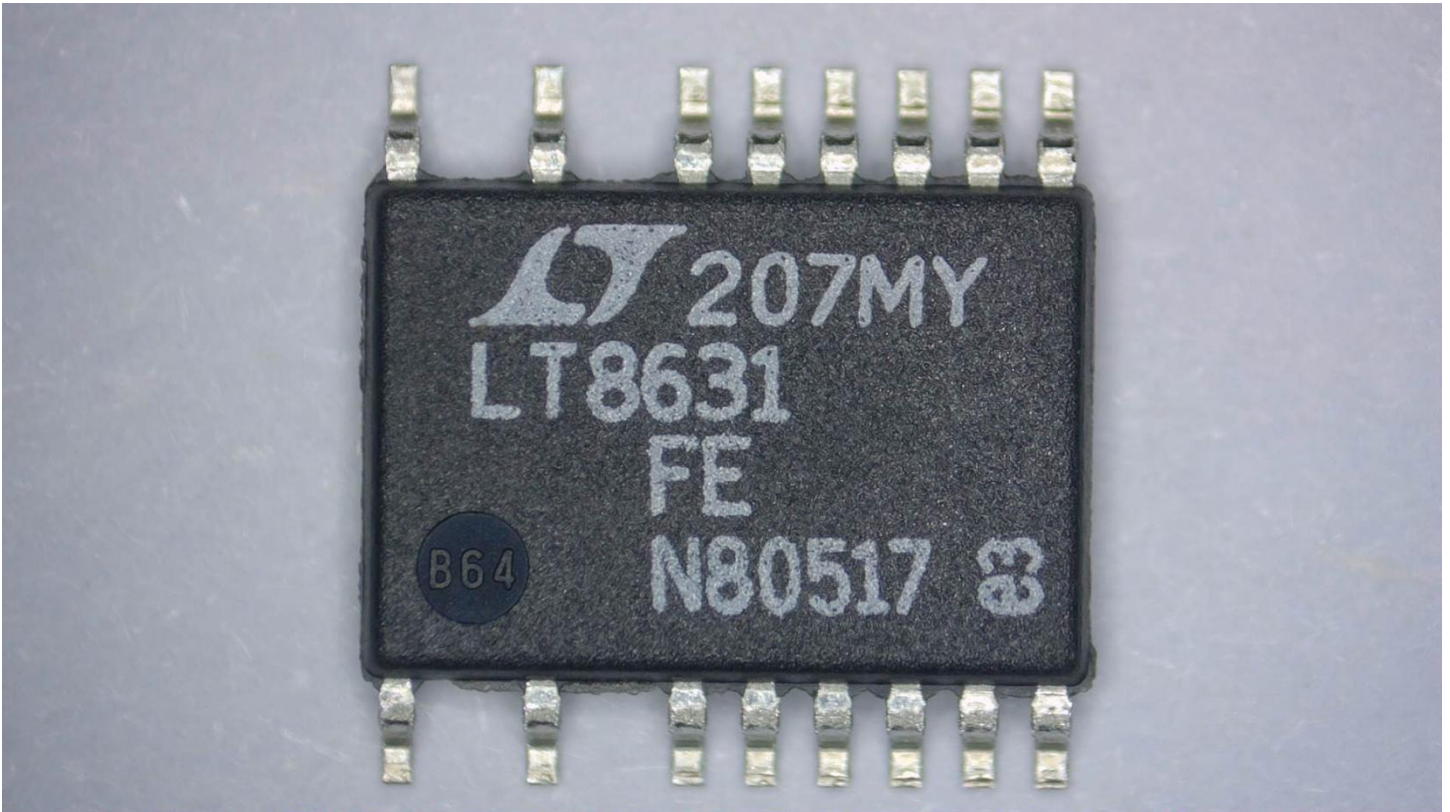
Top View

External Visual Inspection on 100PCS sample marked with D/C 2207. No secondary coating, sanding marks, crack or chips were observed on all inspected.

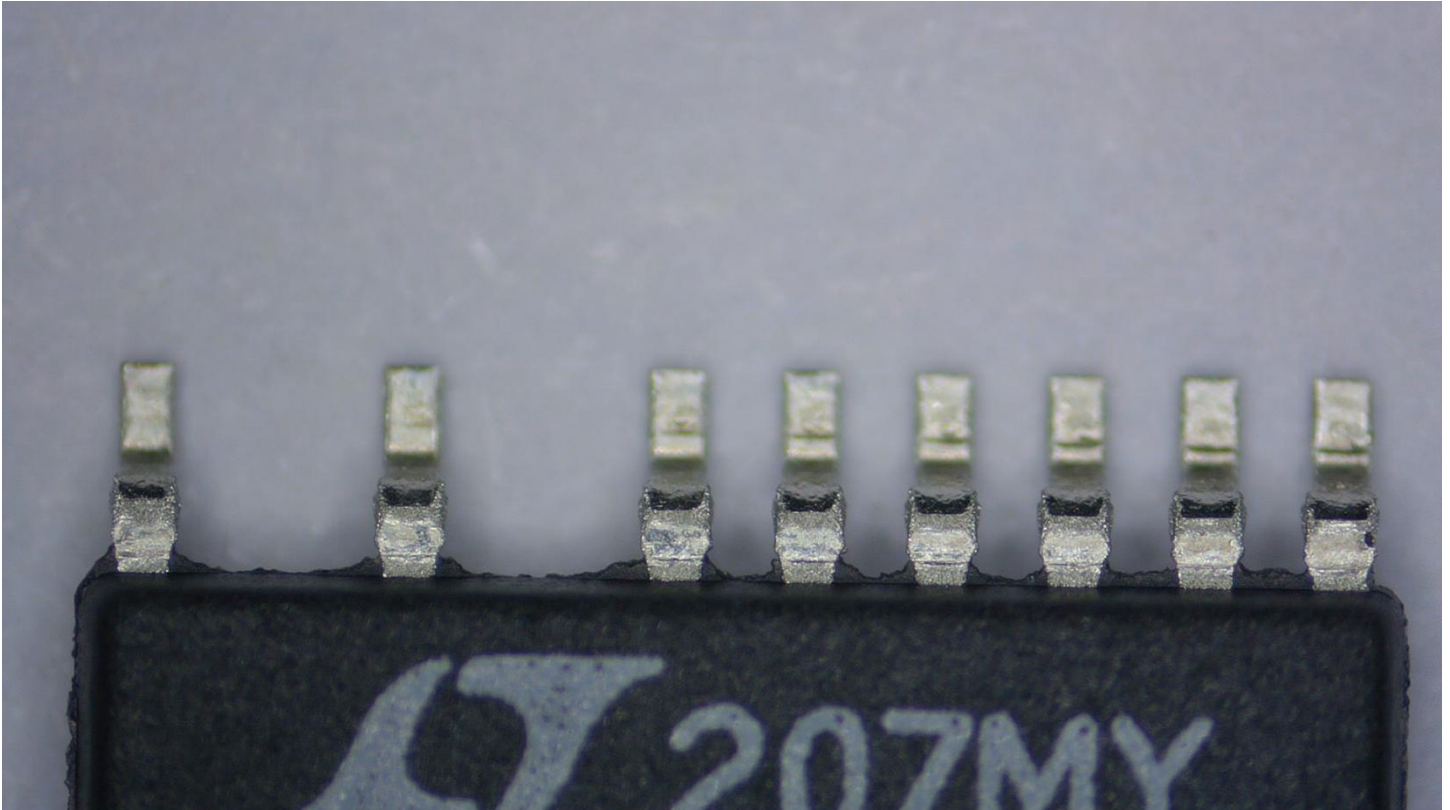
Top Leads 1

#	Lead Inspection	Sample Size	Result
1	Verify any bent, damaged, or missing lead	100	Pass
2	Check lead alignment	100	Pass
3	Verify leads for scratches on outer in inner lead surfaces.	100	Pass
4	Inspect consistency of lead with respect to color, gloss/dull and texture	100	Pass
5	Inspect if leads exhibit any corrosion, discoloration, or oxidation	100	Pass
6	Inspect if leads have been used or trimmed	100	Pass

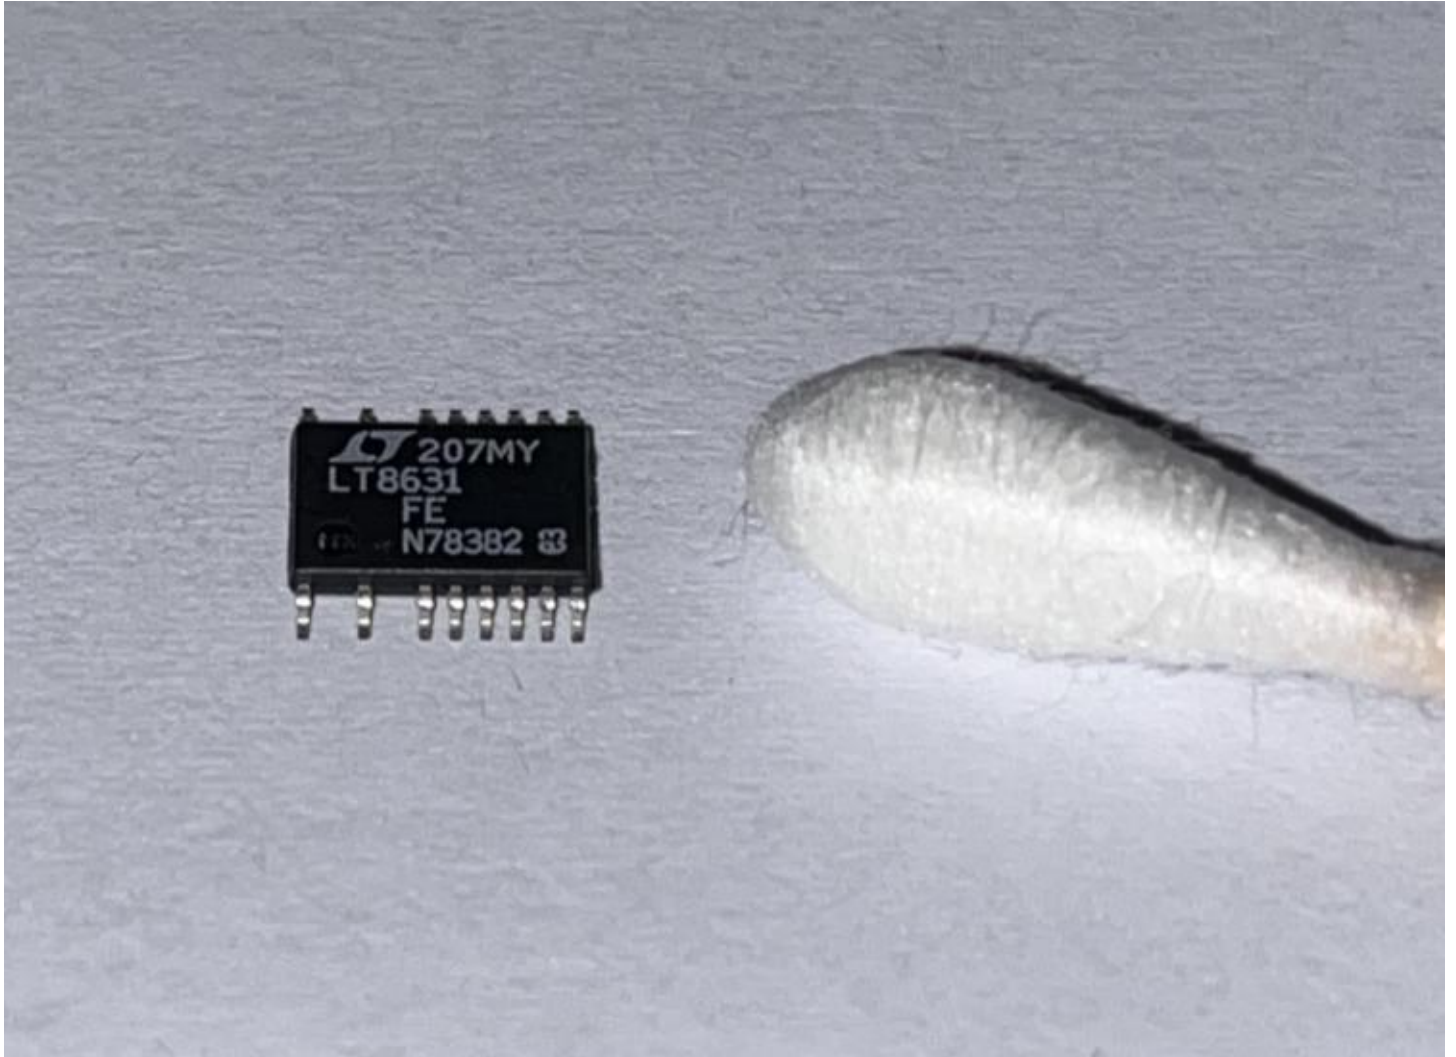
#	Acetone Test	Test Result
1	Rub part surface with cotton bud dipped in acetone solvent. Check for transfer of Black coating on cotton bud.	3 - PASS

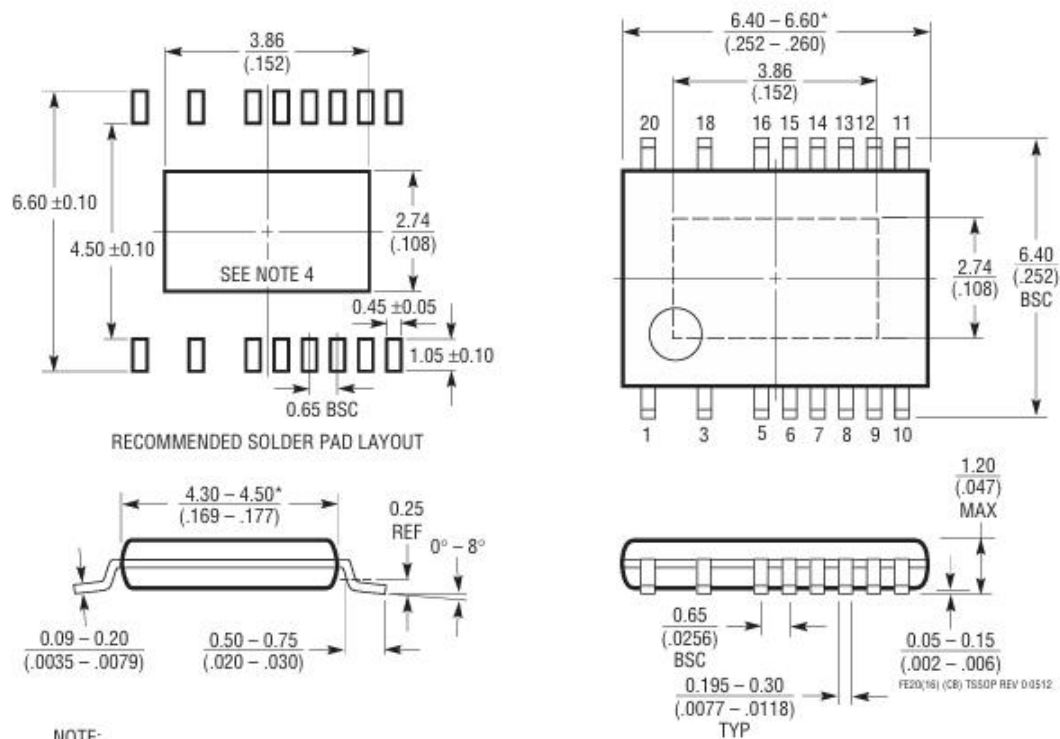
**FE Package**  
**Variation: FE20(16)**  
**20-Lead Plastic TSSOP (4.4mm)**  
 (Reference LTC DWG # 05-08-1924 Rev 0)  
**Exposed Pad Variation CB**

\*DIMENSIONS DO NOT INCLUDE MOLD FLASH. MOLD FLASH SHALL NOT EXCEED  $0.150$  mm ( $.006$  in) PER SIDE

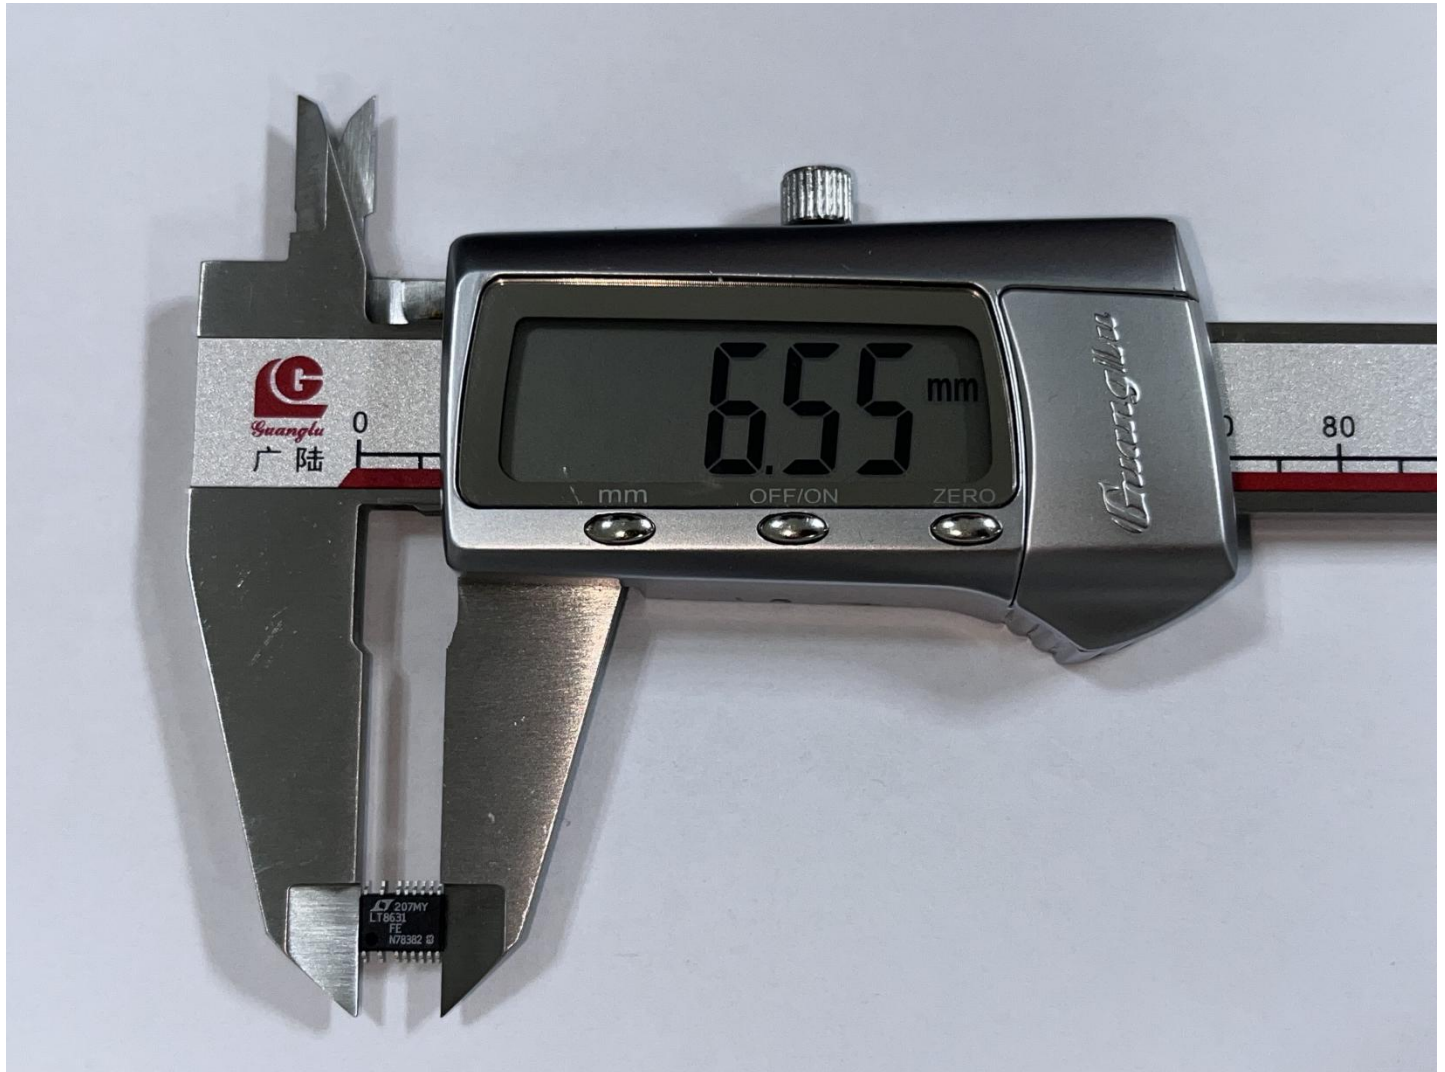
#	Measurements and Pin Count	Test Result	
1	Counting number of pins per part - Verify if number of pins on component matches manufacturer's specifications	TSSOP20	
Sample	Length	Width	Height
1	6.55mm	6.40mm	1.04mm
2	6.55mm	6.40mm	1.04mm
3	6.55mm	6.40mm	1.04mm

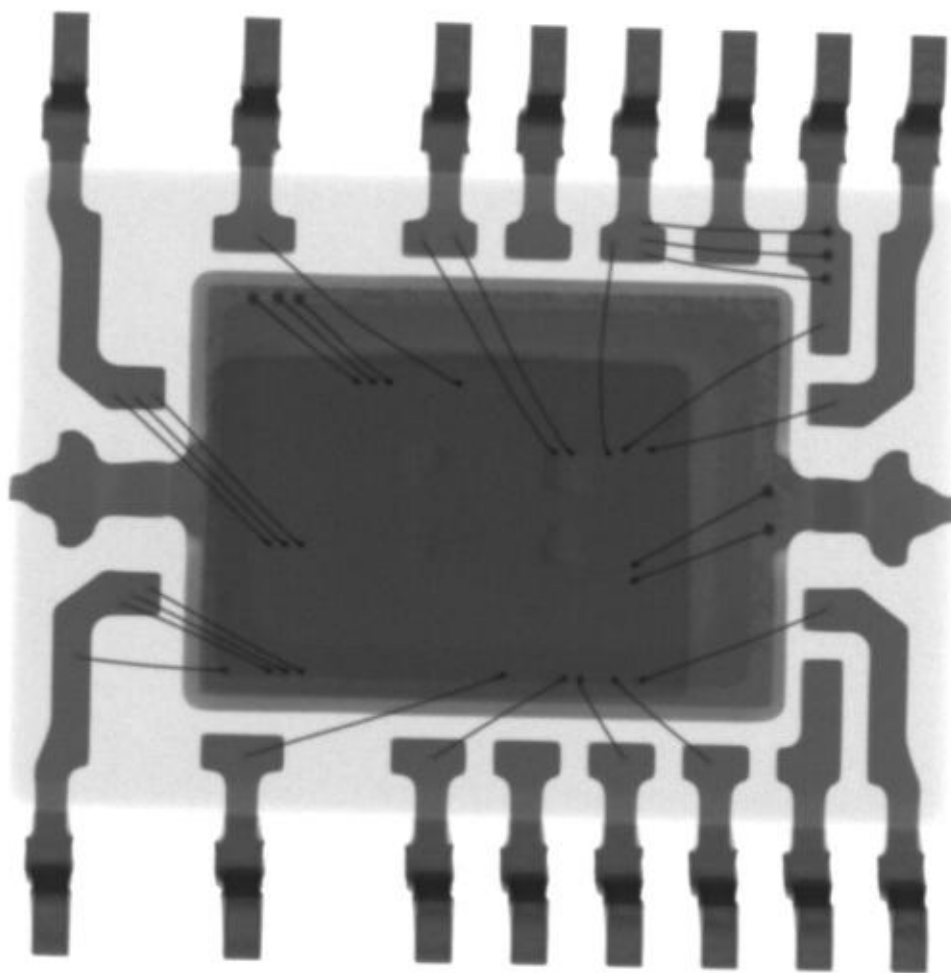
X-RayTopView-Sample1

10PCS sample X-ray analysis reveals consistent internal structure within the tested samples. The samples do not exhibit internal connection defects, voids or other apparent anomalies.

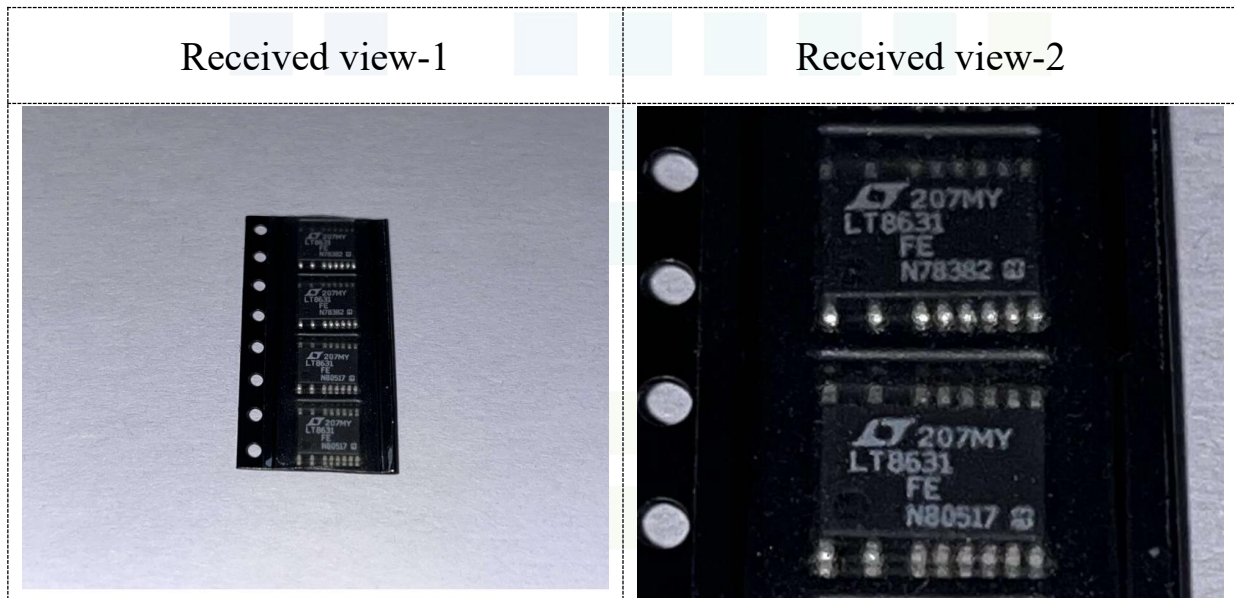
Gross Weight	3.2 g	Quantity Received	4 PCS
Number of Boxes	N/A	Full Label	N/A
Package Type	Reel	Moisture Protection	N/A
MSL	N/A	ESD Protection	N/A

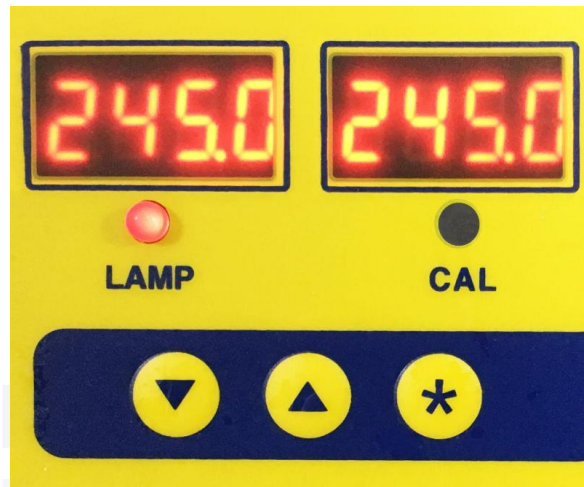
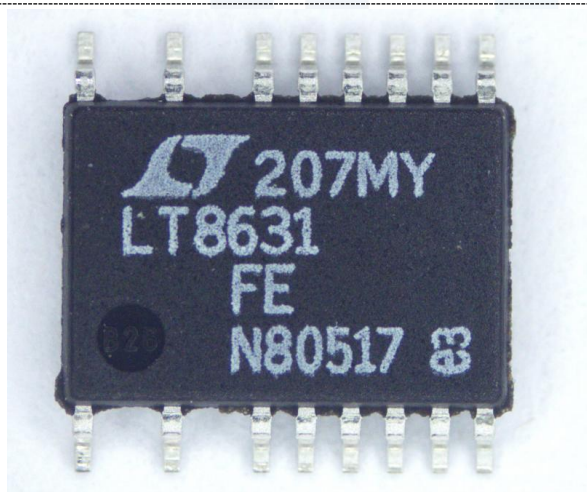
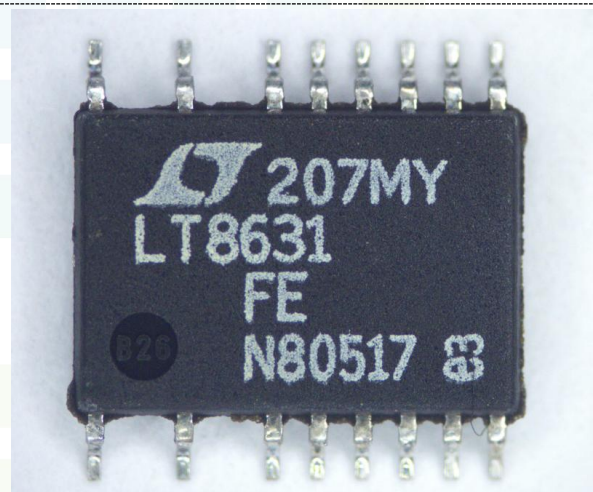
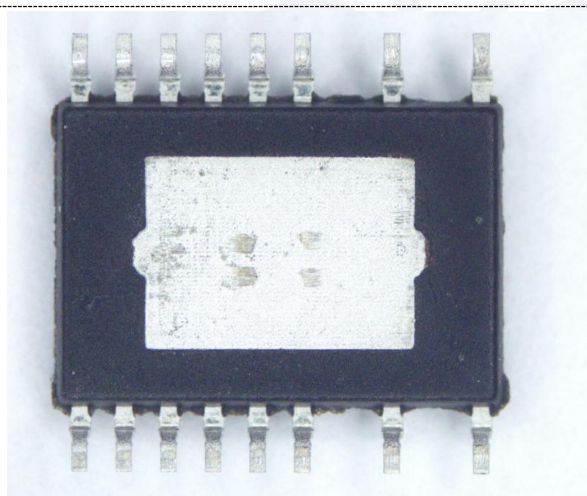
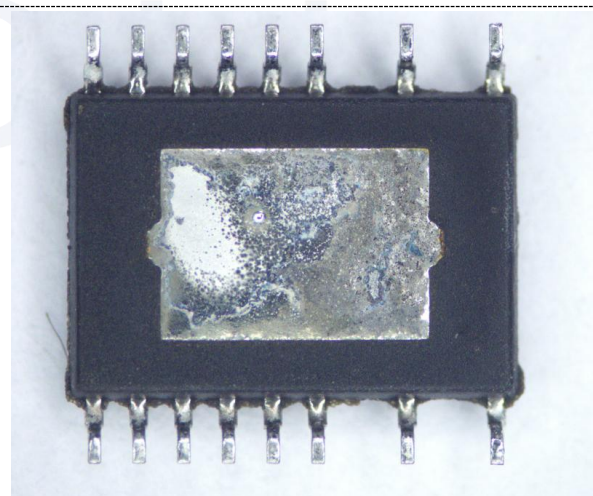
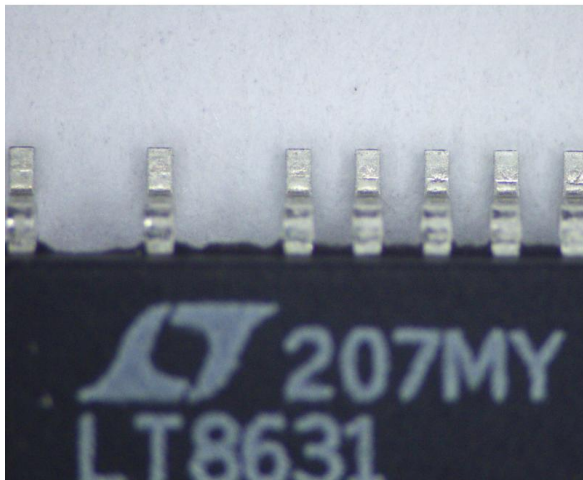
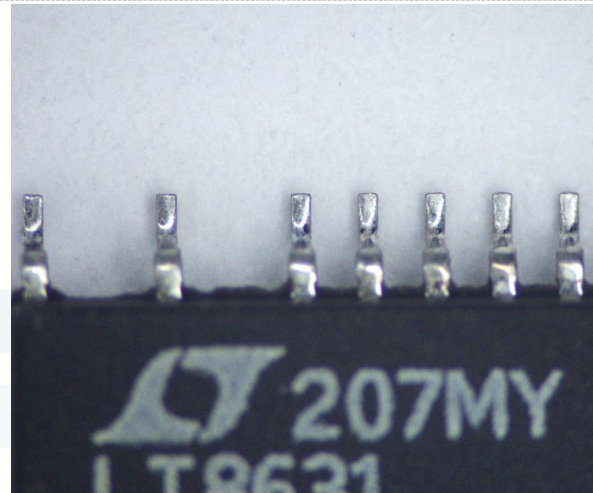
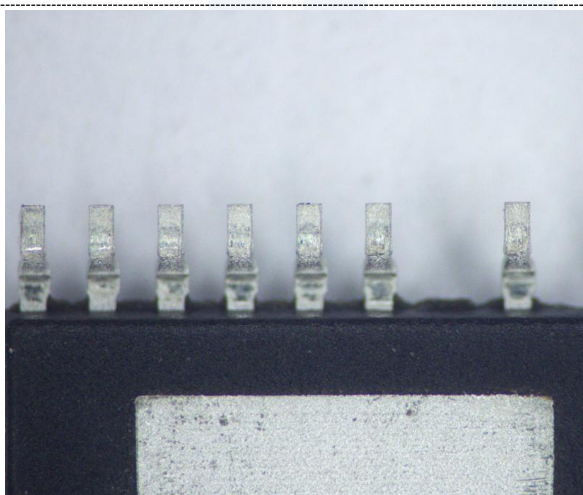
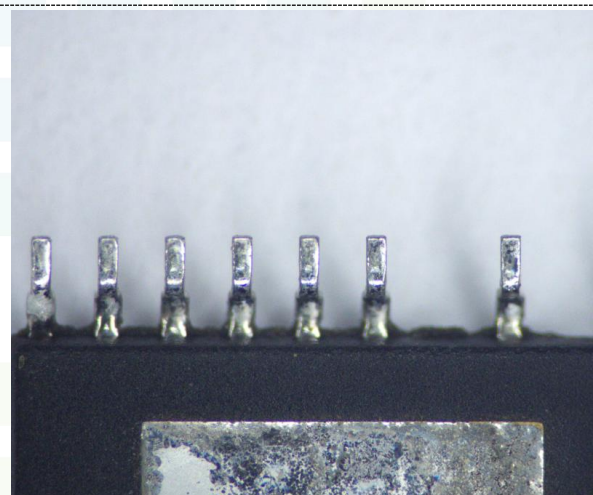
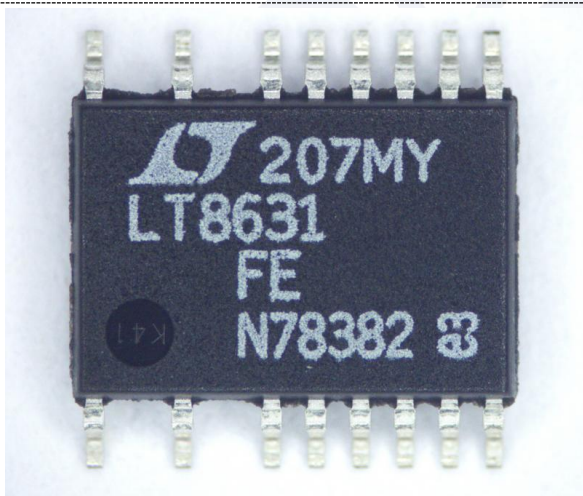
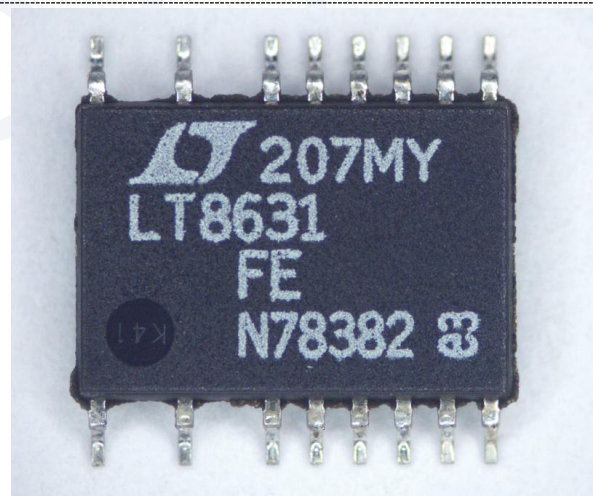
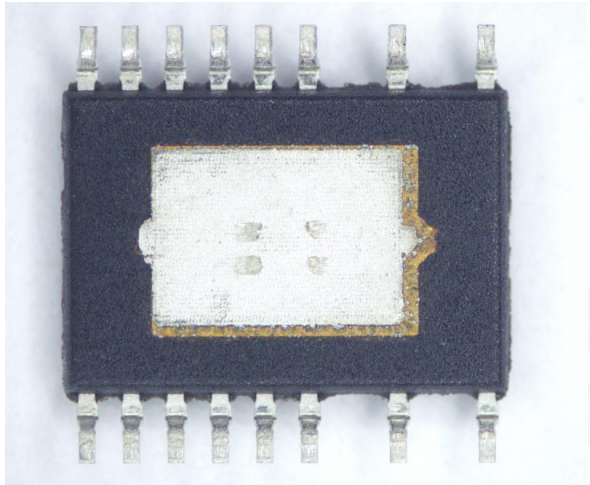
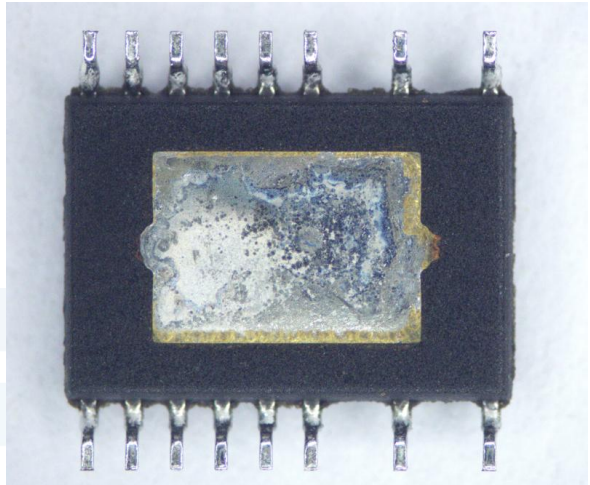
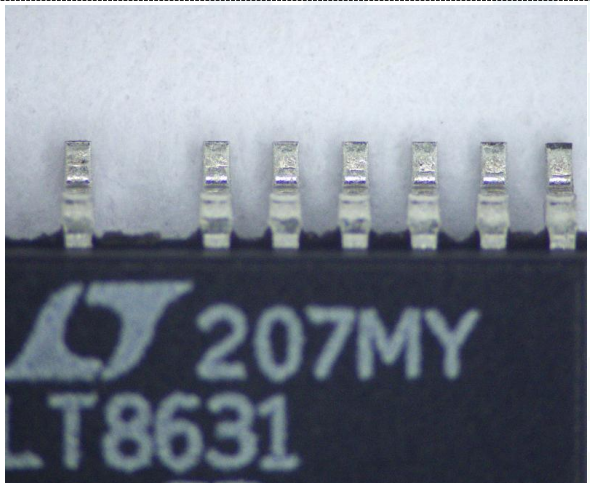
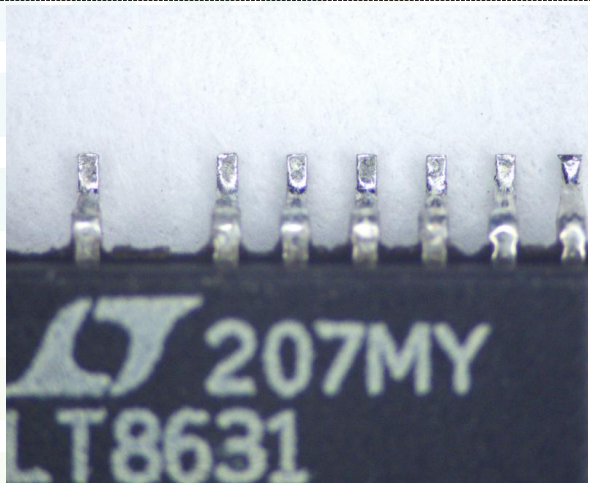
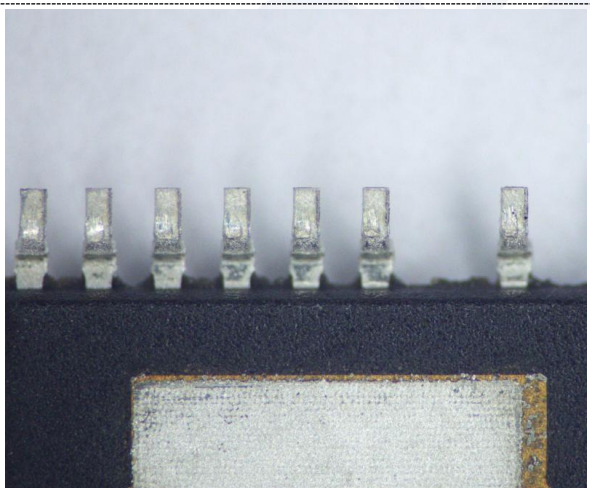
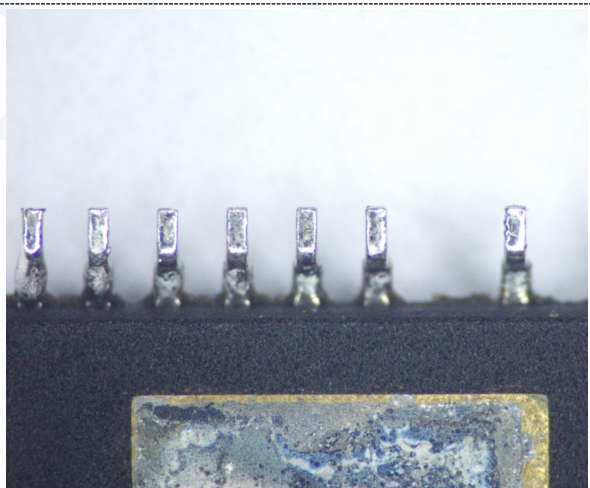
Solderability tested were performed on 2 PCS samples(1 PCS of #N80517 and 1 PCS of #N78382) using the dip and look methods. 2 PCS pass solderability test. The dipped portion of the terminations is more than 95% covered by a continuous new solder coating.

The dipped portion of the bonding pad is more than 80% covered by a continuous new solder coating.

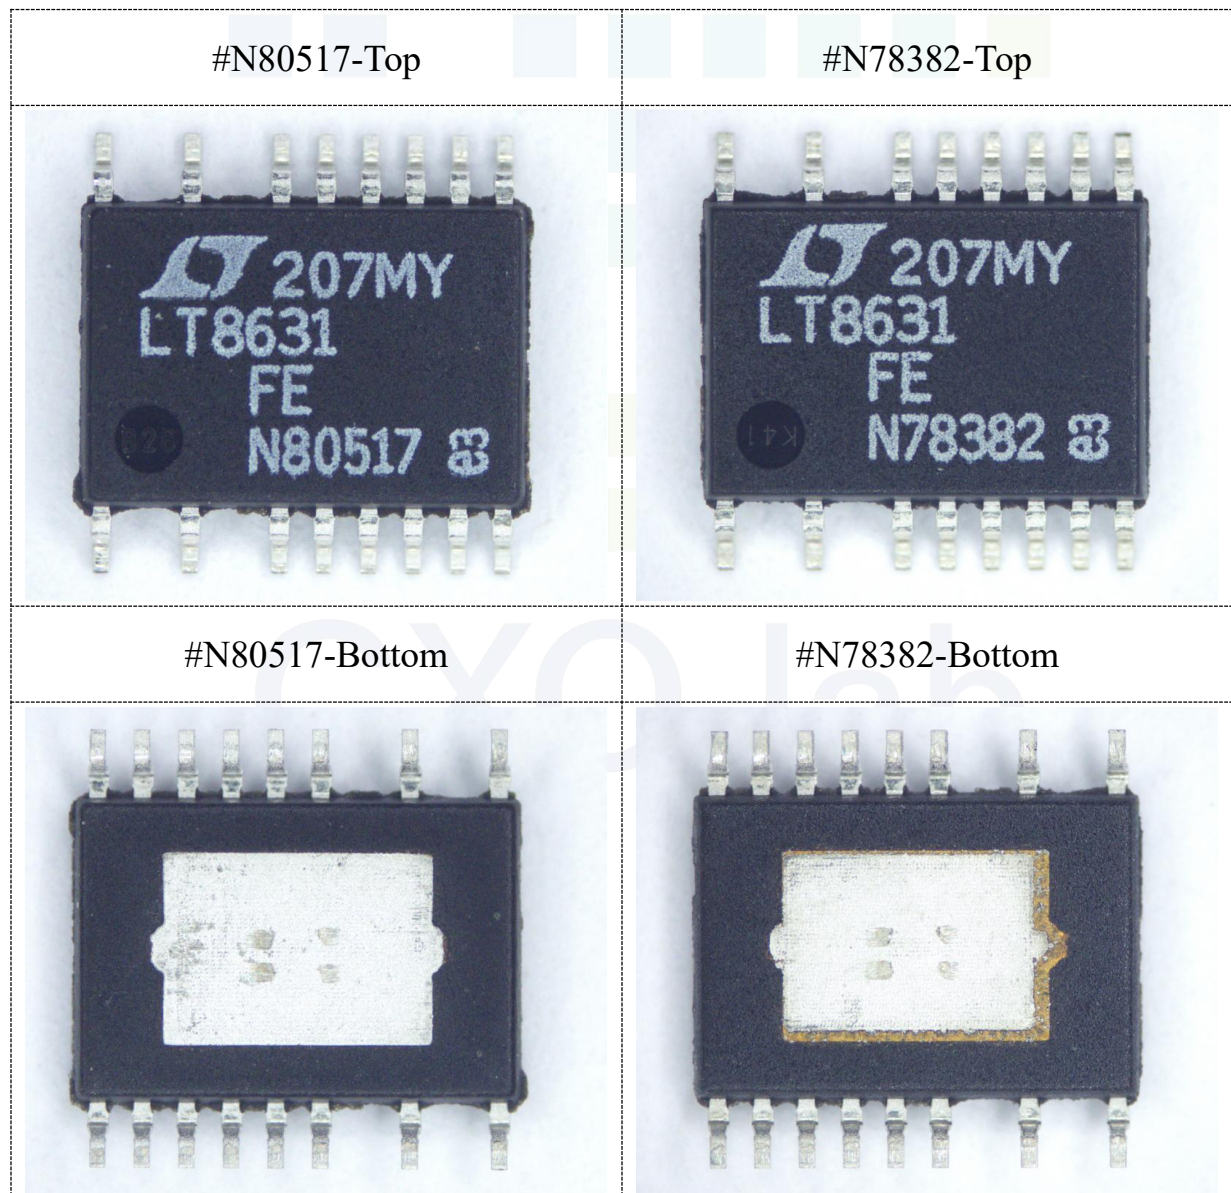
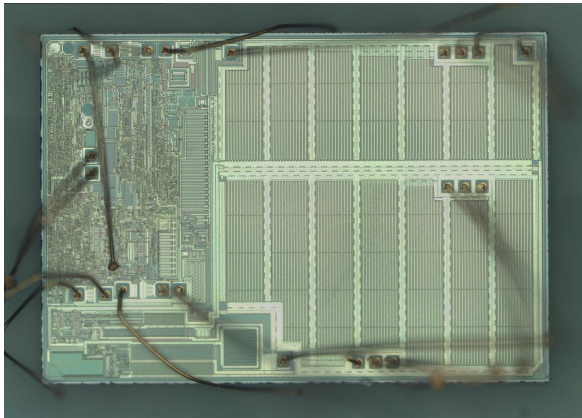
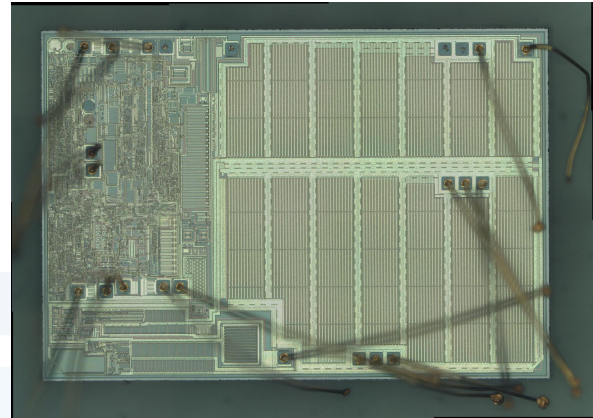
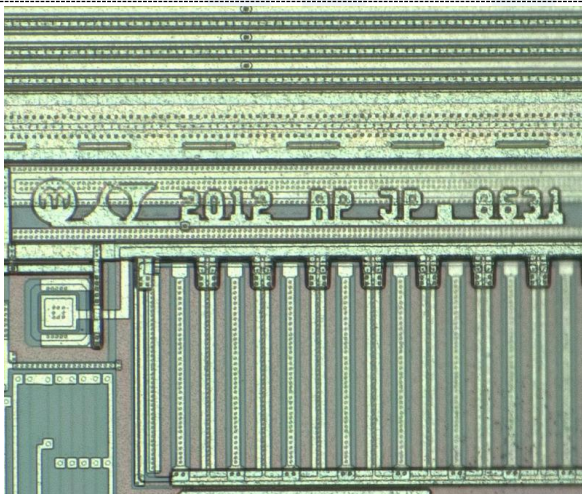
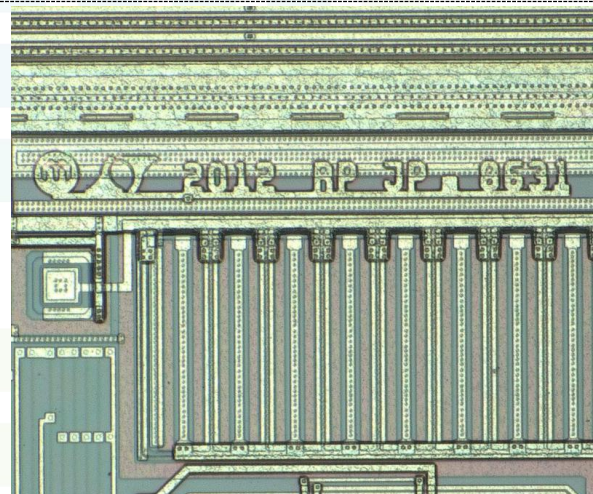
Internal visual inspection was verified on 2 PCS samples(1 PCS of #N80517 and 1 PCS of #N78382). The 2 PCS samples have the same structure. Manufacturer LINEAR marking with 2012 copyright year and die marking RP JP 8631 were found on the die surface. Devices confirmed to be the LINEAR device.
