### QC Report Sample:

**Work Order No :** QC01190/ **Sales Order No :**FCPI202503250028

**Product Manufacturer :**ST/ **Manufacturer Part No :**ISM330DLCTR

# Test Report

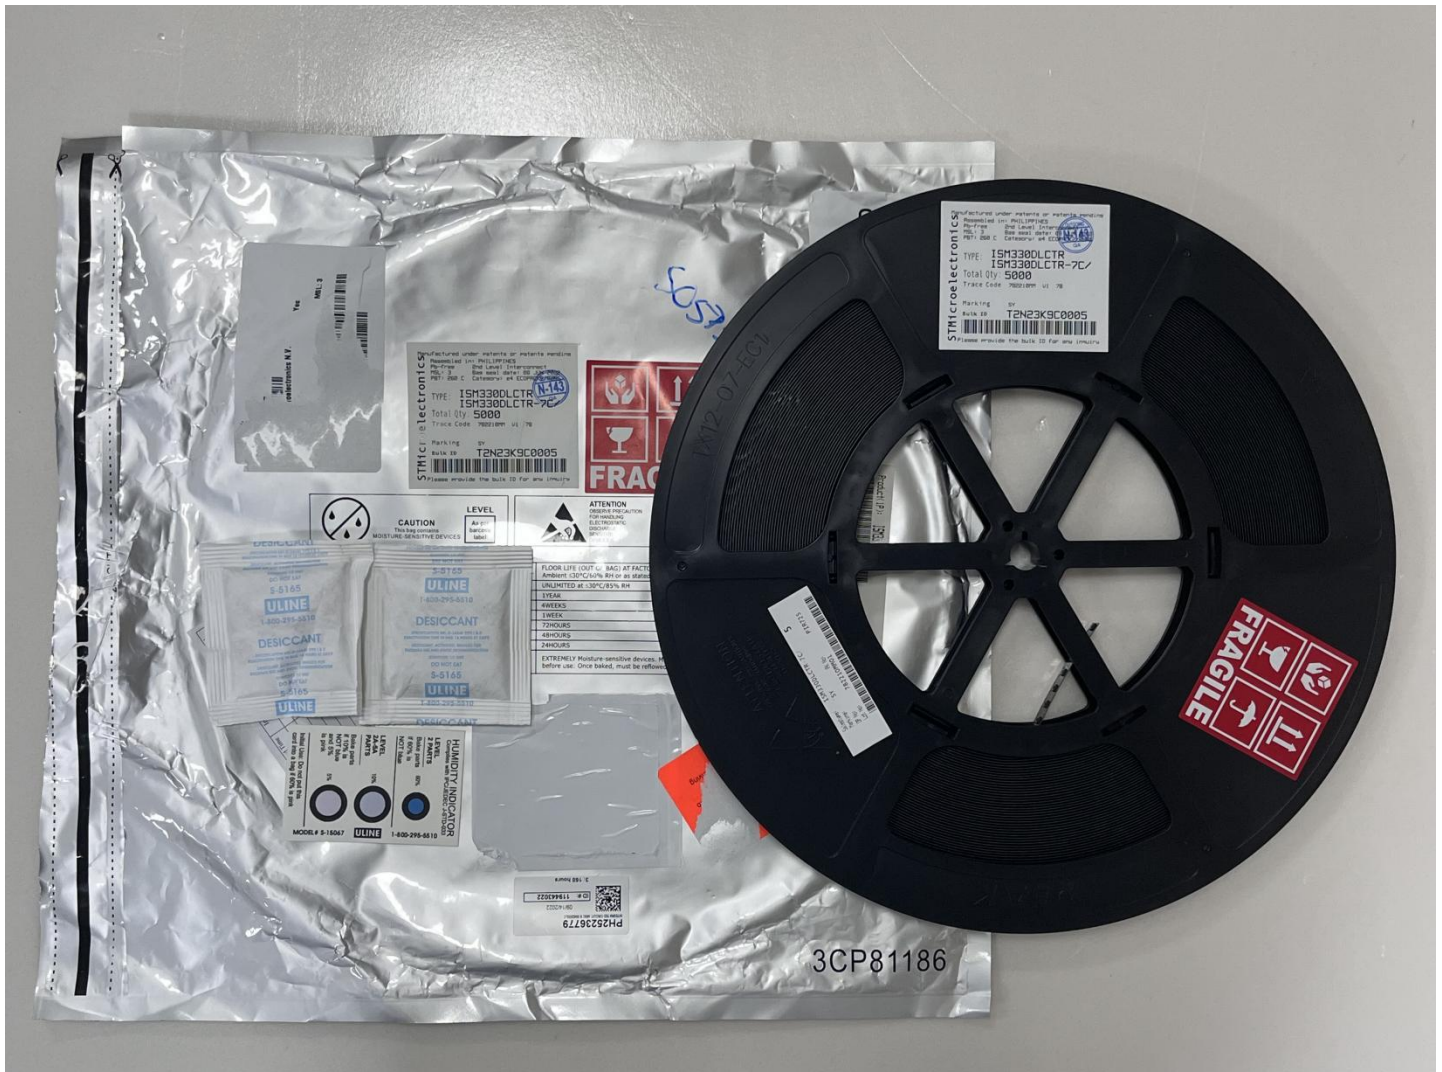
Top Marking

Samples pass chemical MPT for remarking, indicating that the samples are not remarked.

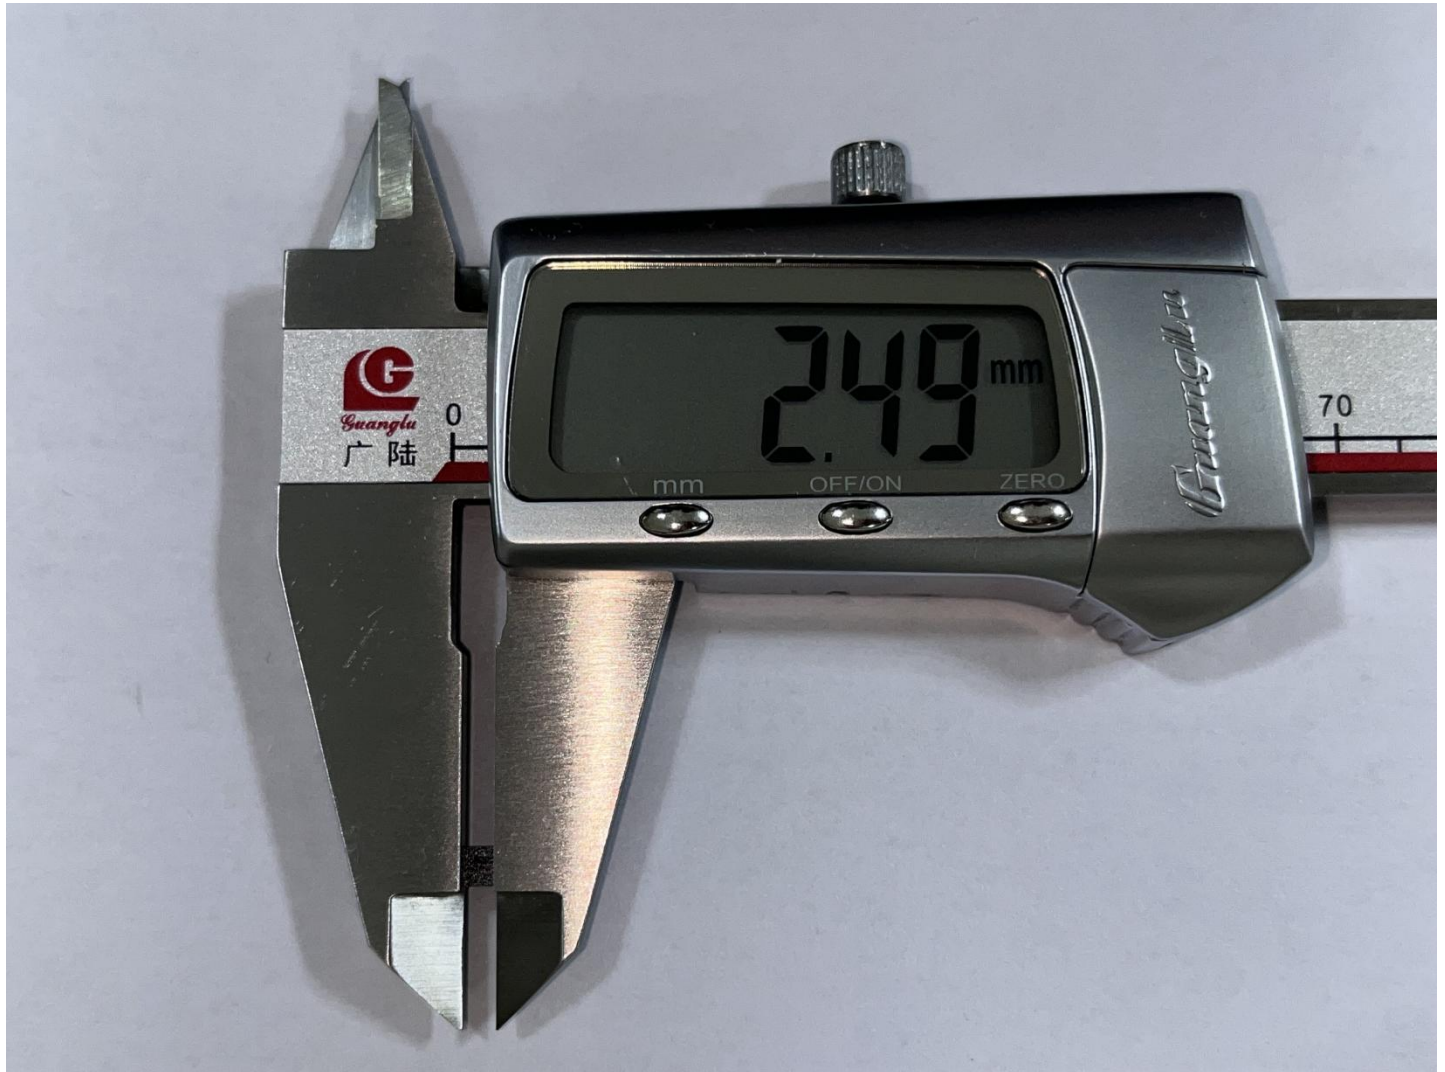
Length

| # | Measurements and Pin Count | Test Result | |
|---|---|---|---|
| 1 | 2.49mm | 3.00mm | 0.83mm |

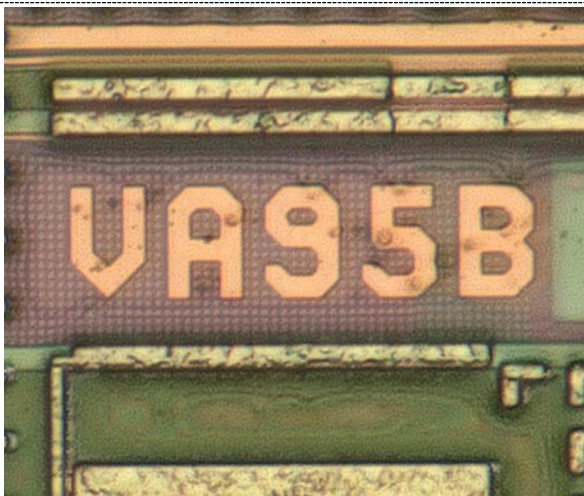
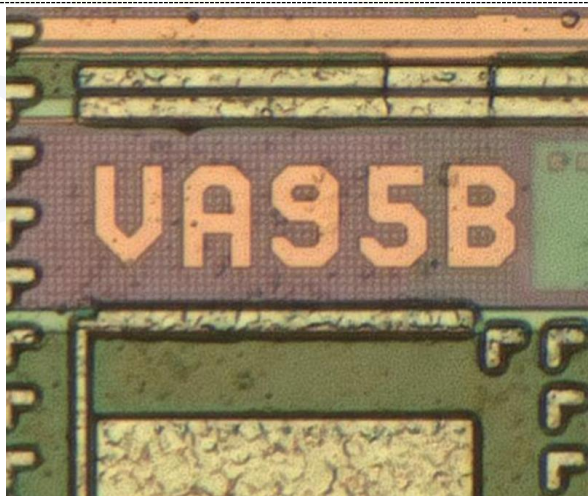
Internal visual inspection was verified on 2 PCS samples(1 PCS of D/C2221 and 1 PCS of D/C2233). The 2 PCS samples have the same structure and both have 2 PCS dies. Die1 manufacturer ST marking with 2015 copyright year and die marking VA95B were found on the die surface. Die2 size was 2.73mm\*1.93mm, samples do not exhibit cracks or damage on die surface. Devices confirmed to be the ST device.
