Tire Photo Examples – pg. 1 of 3 – Submit photos through the Online Claim Portal

One photograph of the damaged area clearly marked. Additional photographs may be requested for bubbles in the sidewall to show damage to the inner liner damage (see below). A photo showing an object in the puncture or break such as a pen or screwdriver to confirm the damage may also be requested.

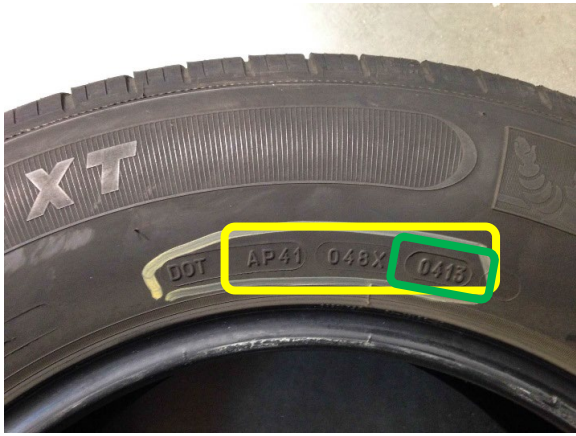
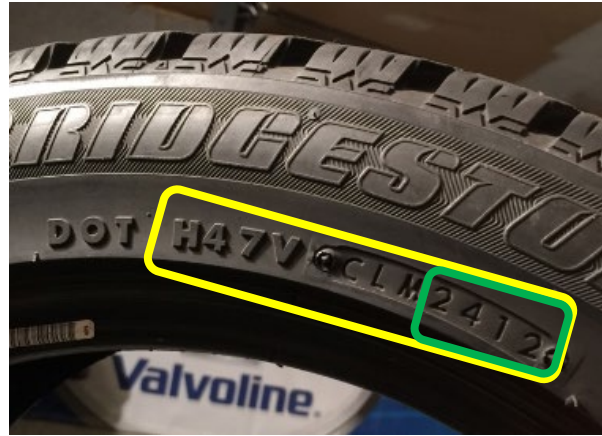
- One photograph of the **complete DOT**. Please note that the complete DOT (yellow) is often found on only one sidewall and will always end in four numbers (green) that represent the week and year that the tire was manufactured.

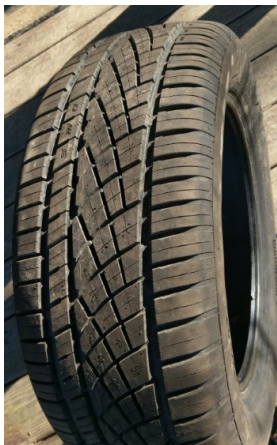
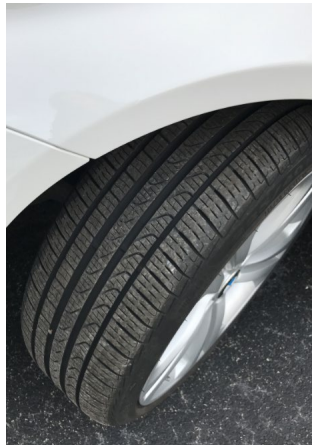
- One photograph showing the section width of the tread area from one side to the tire to the other.

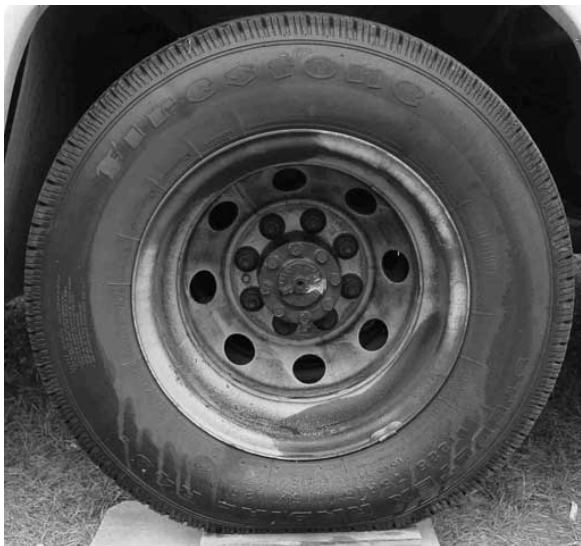
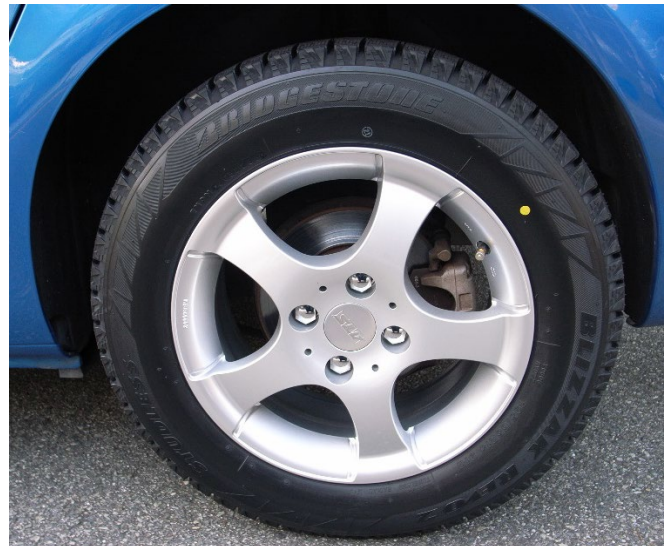
- One photograph that clearly displays the full sidewall. Ensure the brand, model and tire size are clearly visible in the photograph.

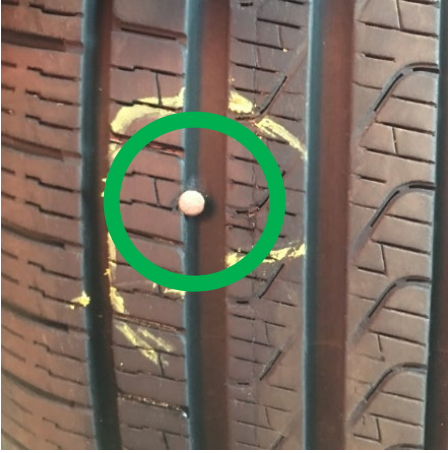
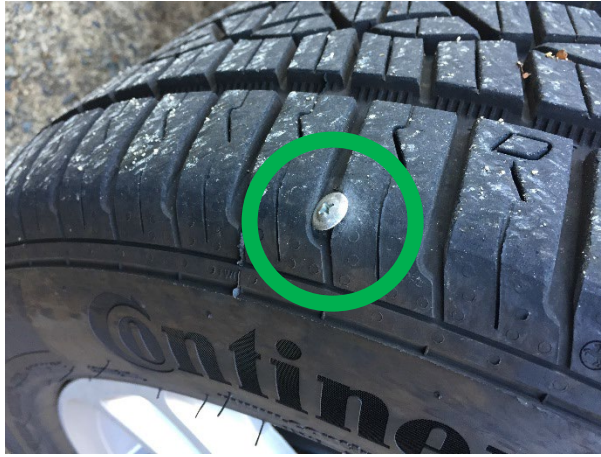
- Nail and screw punctures

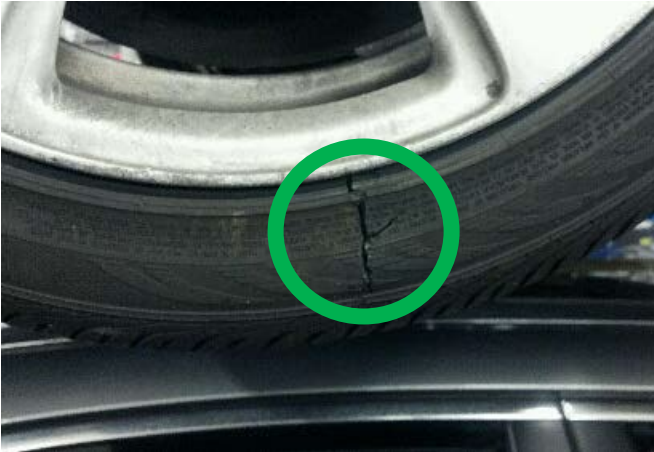
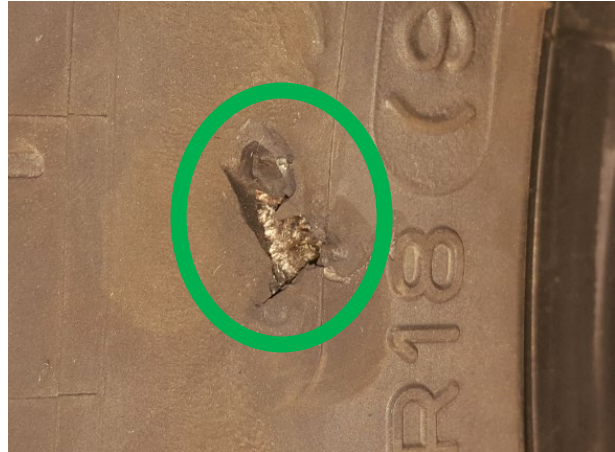
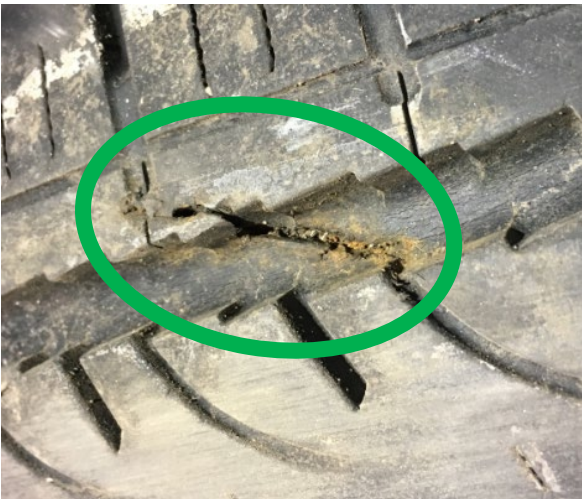
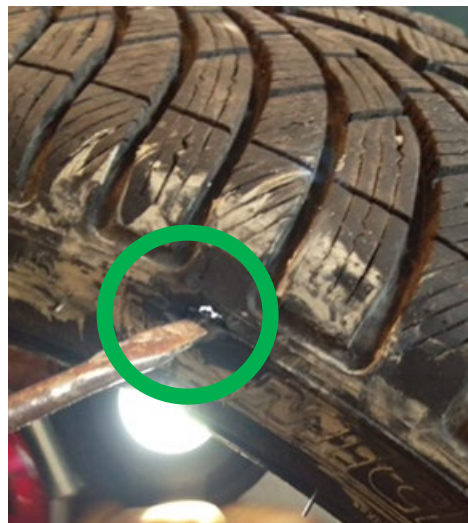
- Cuts and breaks

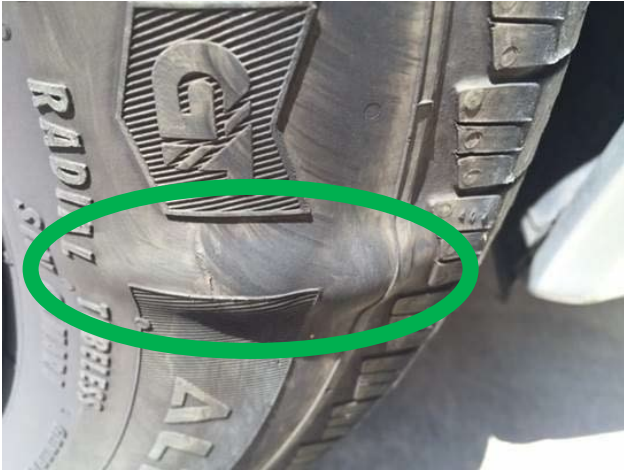
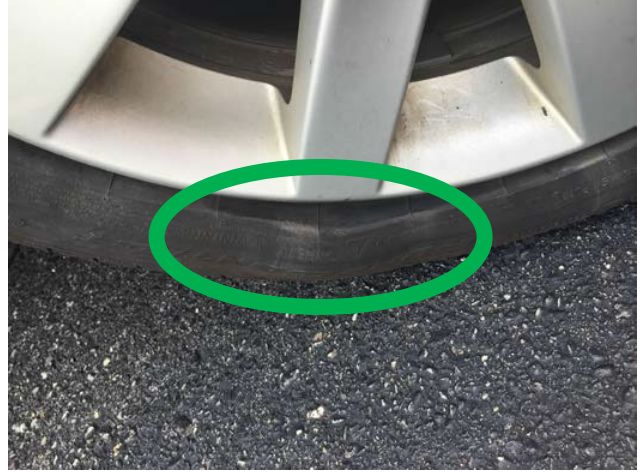
- Bubbles formed on the sidewall due to impact with a pothole, curb, or road debris.

The following photographs show bubbles that have been caused by a road hazard. Photographs will need to be provided to show the damage to the inner liner.

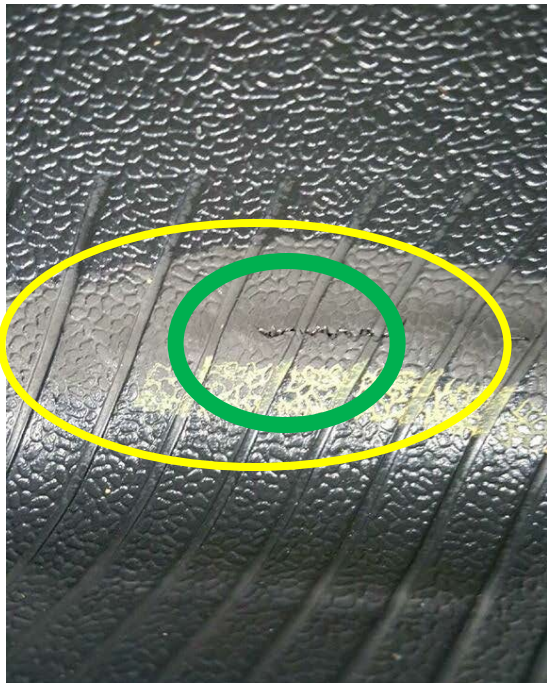
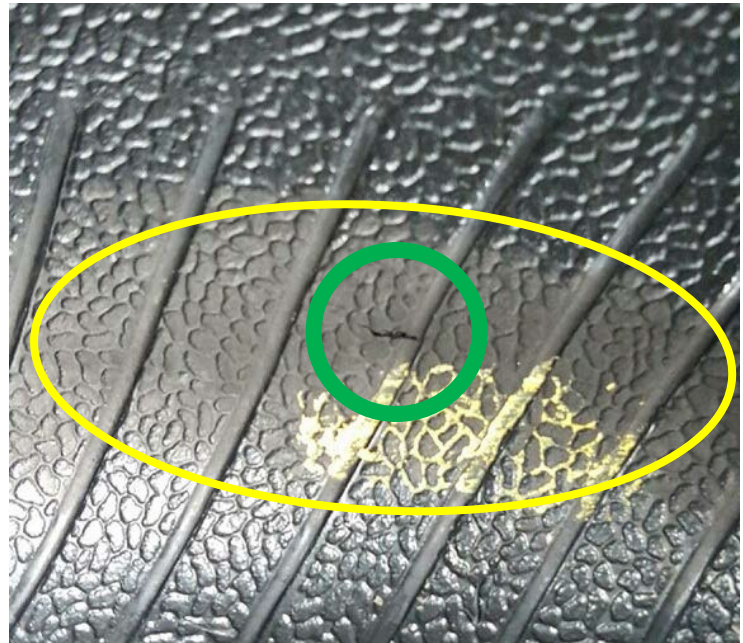
- Inner liner damage showing that the bubbles were caused by an impact to the tire. The discoloration (yellow) and breaks (green) are common identifiers for bubbles caused by a road hazard. Obtaining these photos requires that the tire be dismantled from the wheel.
