Tire Photo Examples – pg. 1 of 4 – Please submit photos to claimphoto@sonsio.com include in the subject line either the claim number, last 9 of the VIN or Customers Name

This document is a tool to give you examples of the type of damage we need to see to review and determine coverage for your claim.

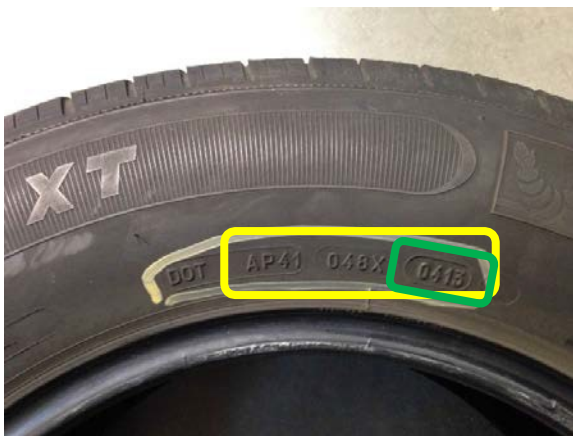
- One photograph of the **full DOT**. Please note that the full DOT (yellow) is often found on only one sidewall and will always end in four numbers (green) that represent the week and year that the tire was manufactured.

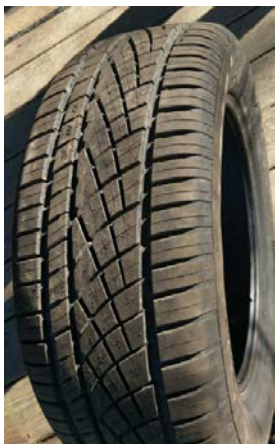
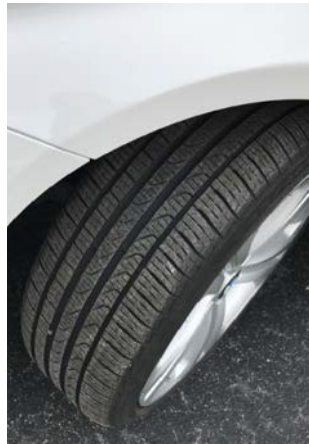
- One photograph showing the full tread area from one side to the other.

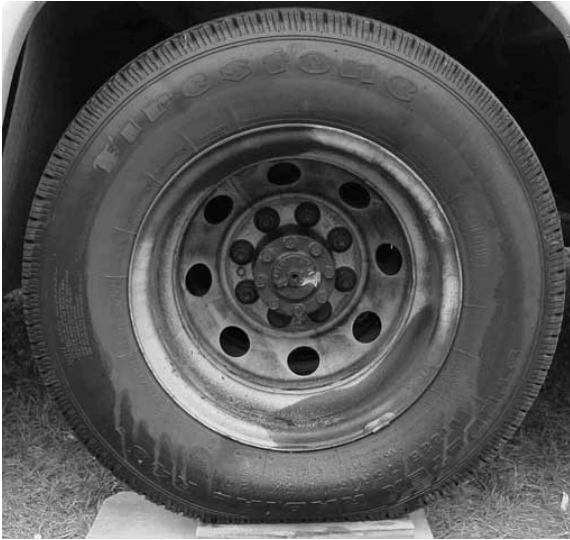
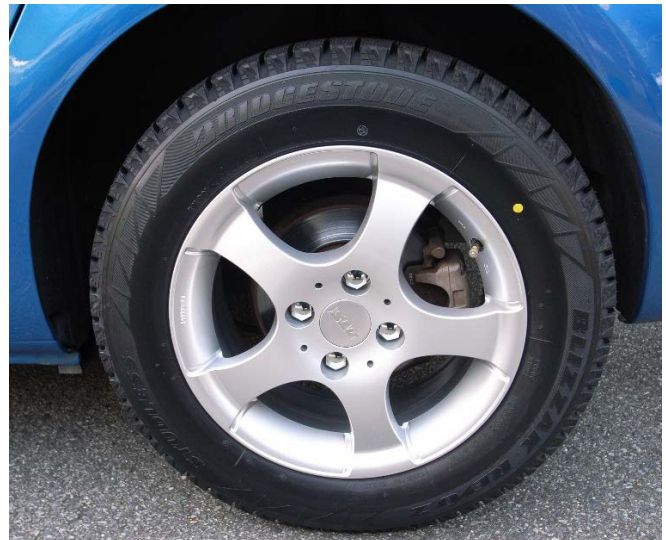
- One photograph showing the full sidewall, this is used to verify the brand, type, and size of the tire so please make sure they are visible and legible in the photo.

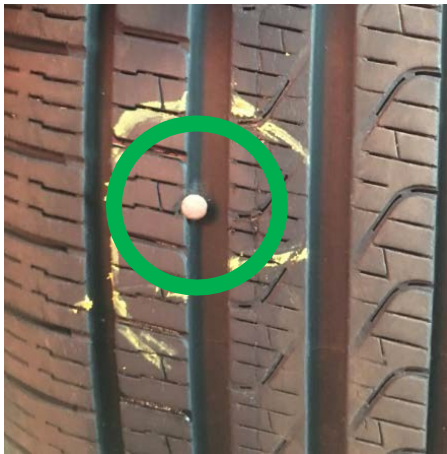
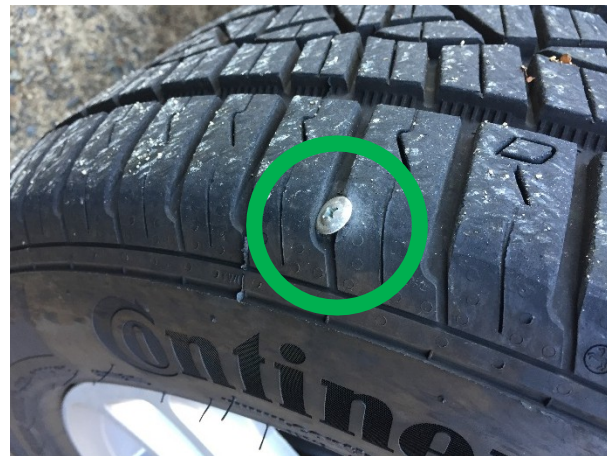
- Nail and screw punctures.

At least one photograph of the damaged area should be sent to us for review, the following photos show common punctures, cuts, and breaks in different areas, please see page 3 for examples of less common types of damage. Sonsio may request a photo showing an object in the puncture or break such as a pen or screwdriver to confirm it is through.

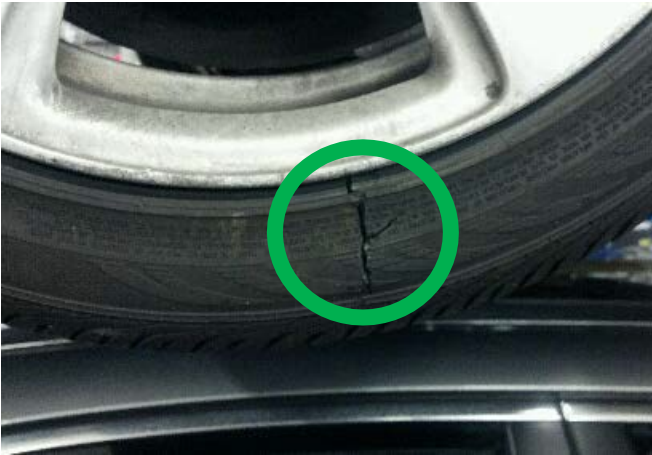
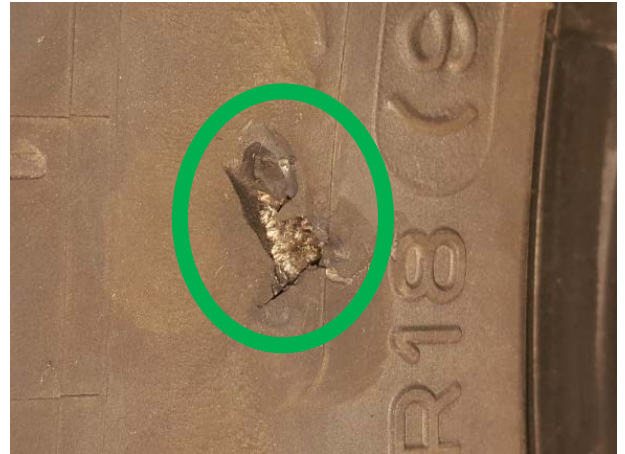
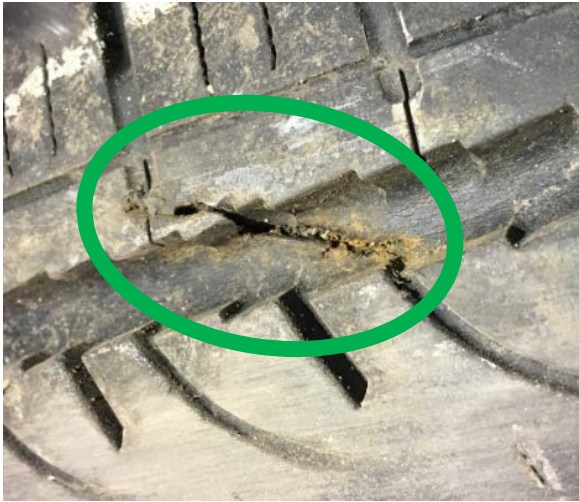
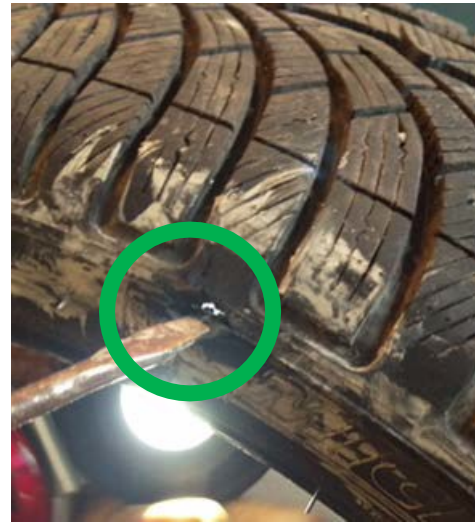
- Cuts and breaks found in different areas of various tires.

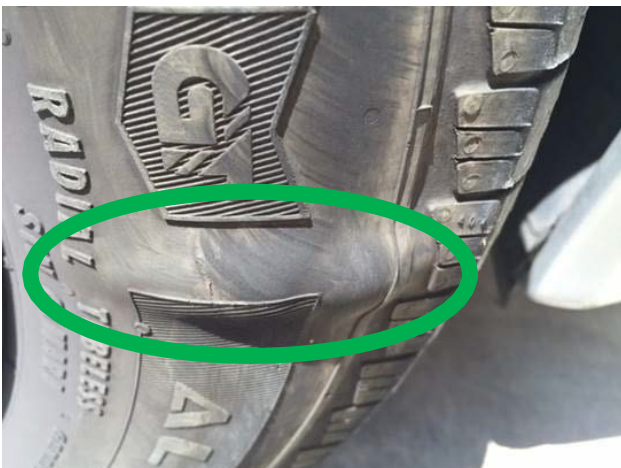
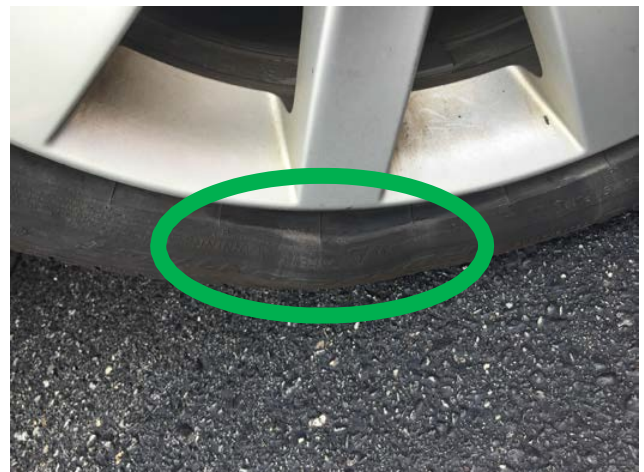
- Bubbles formed on the sidewall due to impact with a pothole, curb, or road debris.

The following photographs show bubbles that have been caused by road hazard damage. Facilities are required to dismount the tire from the wheel when photos are requested and will need to submit photos of the damage on the inner liner. **Photos of the inner liner must be sent each time photos are requested if the damage is a bubble and reminder that the tire must be dismounted from the wheel.**

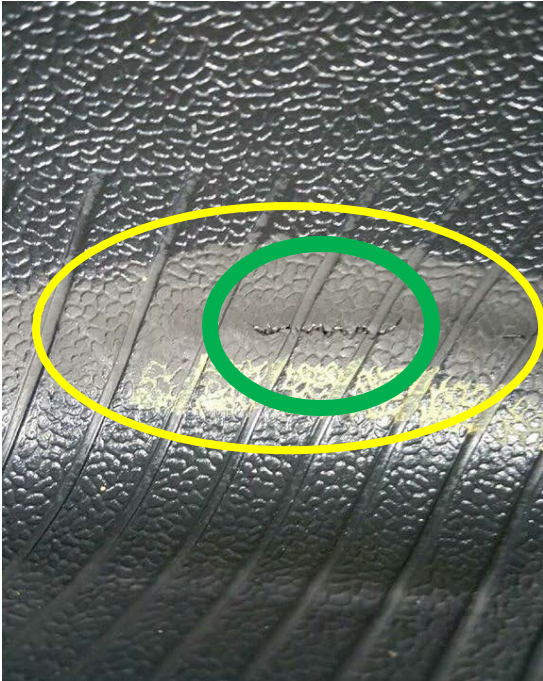
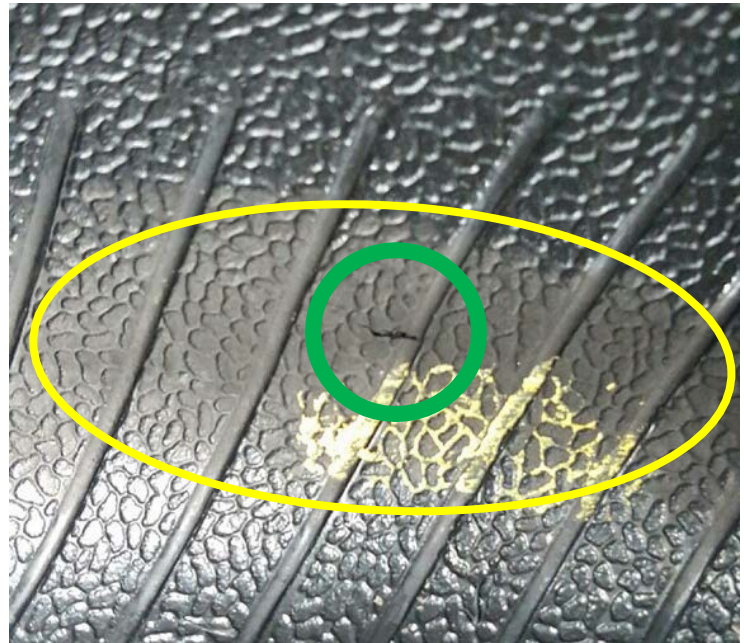
- These show that the bubbles were caused by impact, notice the discoloration (yellow) and breaks (green). Obtaining these photos requires that the tire be dismounted from the rim/wheel.

Pictures of the Inner liner damage are required on all bubbles *as well as any damage called in that does not clearly show the damage goes all the way thru the tire.*
