Baseline Assessment - Stream Attributes

Reach S-MN21 (Pipeline ROW)

Spread G

Montgomery County, Virginia

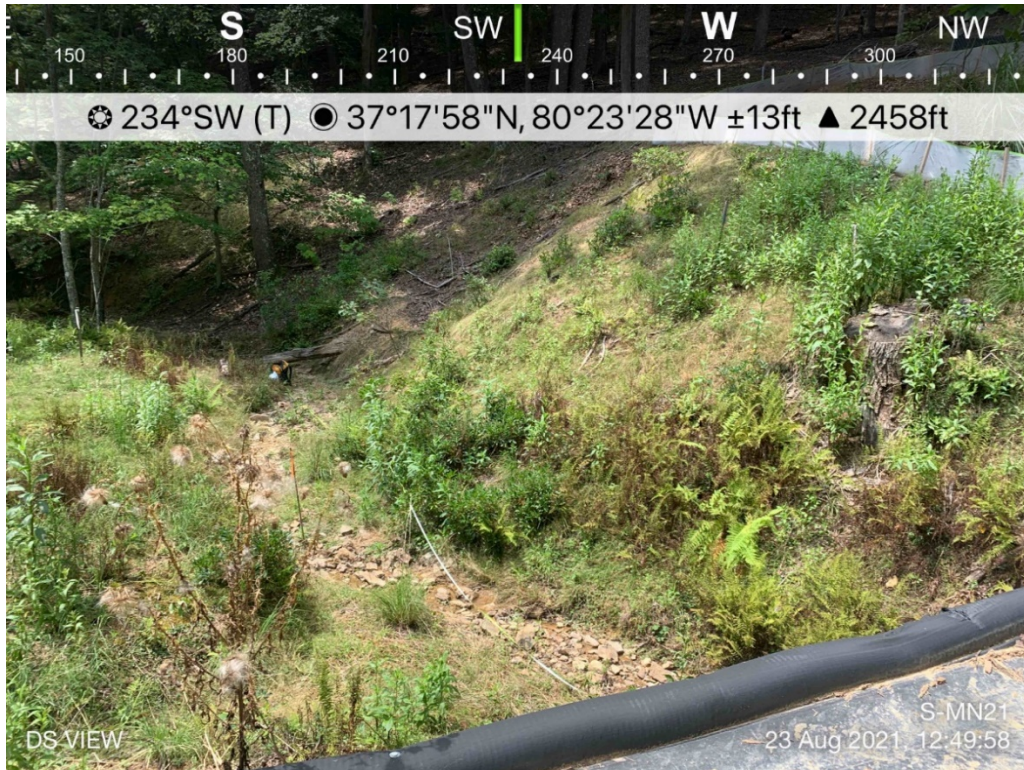
Photo Type: DS VIEW

Location, Orientation, Photographer Initials: Downstream view of ROW looking SW, TC

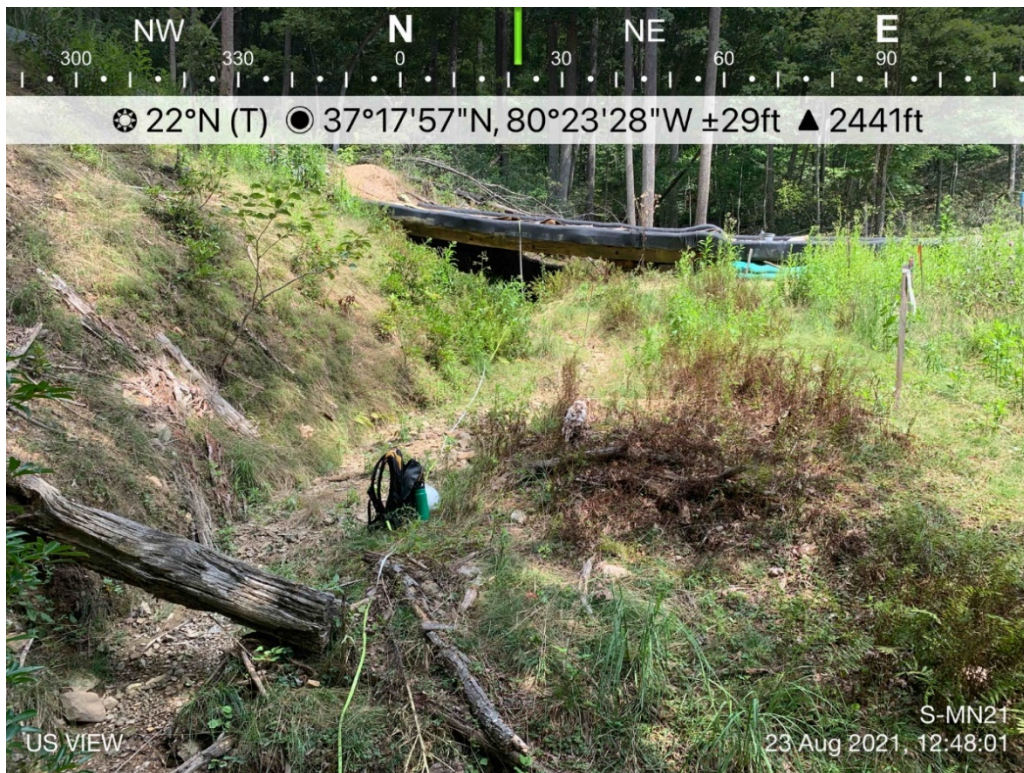
Photo Type: US VIEW

Location, Orientation, Photographer Initials: Upstream view of ROW looking NNE, TC

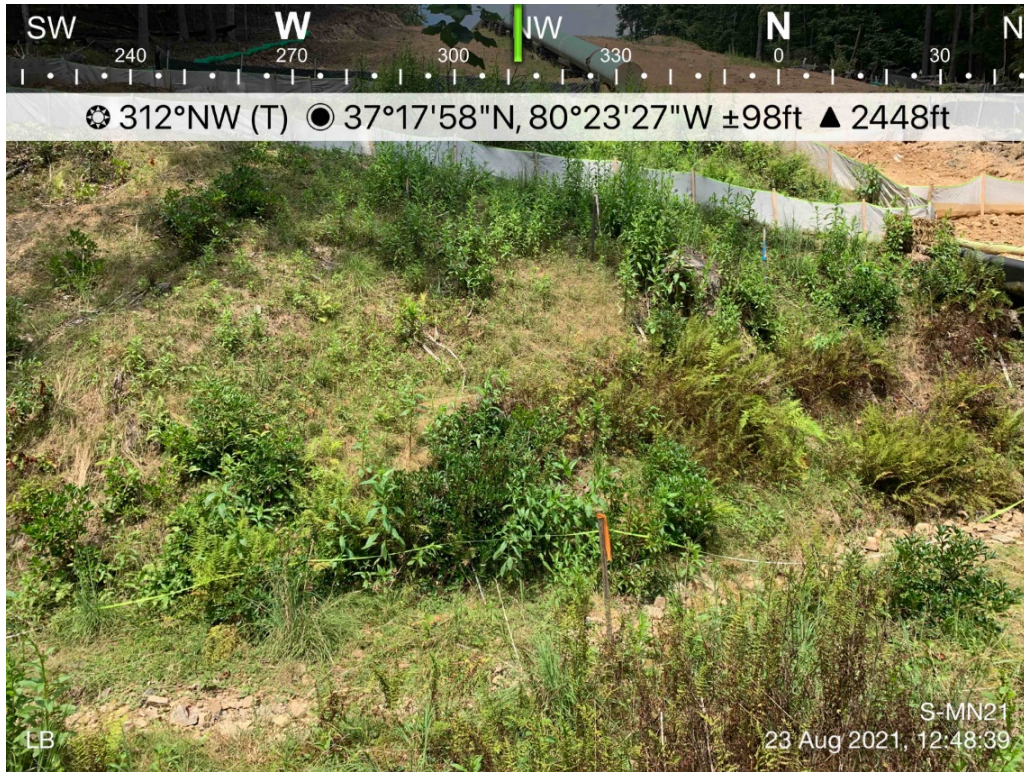
Photo Type: LB CL

Location, Orientation, Photographer Initials: Standing on LB looking at RB along pipe centerline looking NW, TC

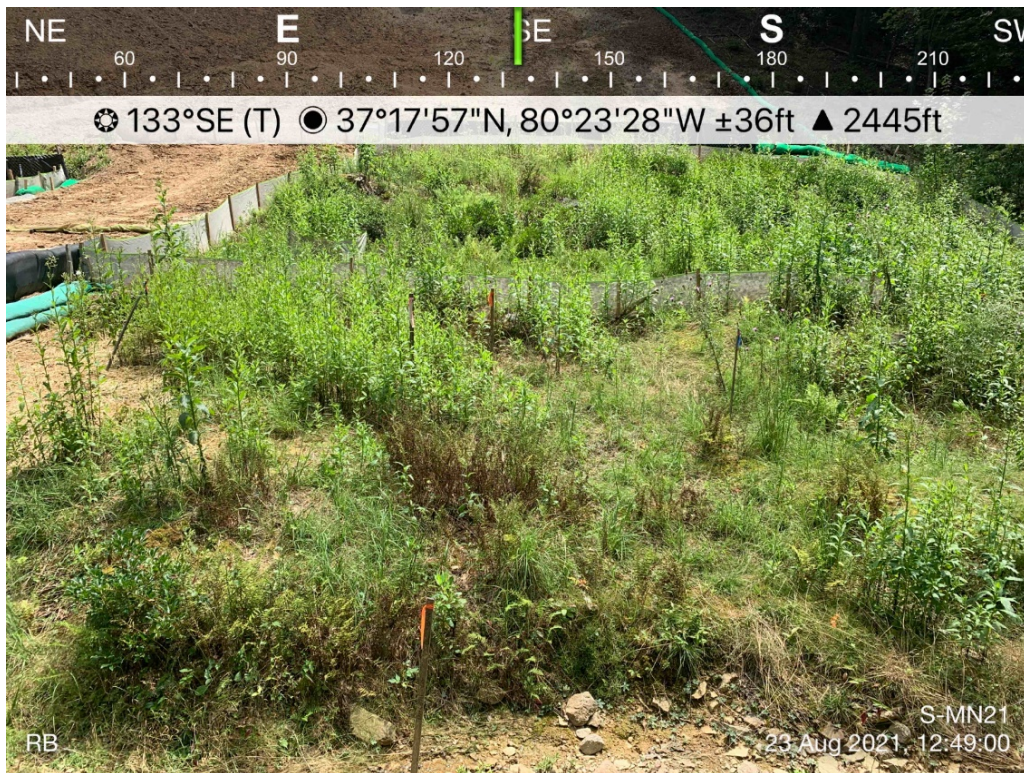
Photo Type: RB CL

Location, Orientation, Photographer Initials: Standing on RB looking at LB along pipe centerline looking SE, TC

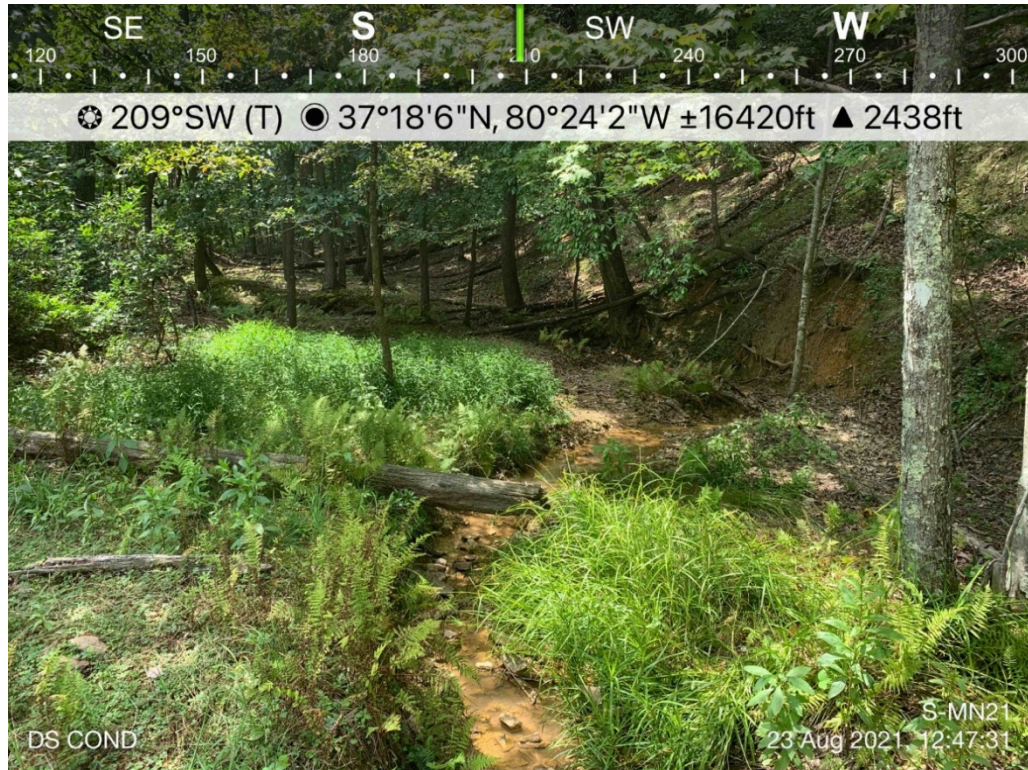
Photo Type: DS COND

Location, Orientation, Photographer Initials: Downstream conditions outside of ROW looking SSW, TC

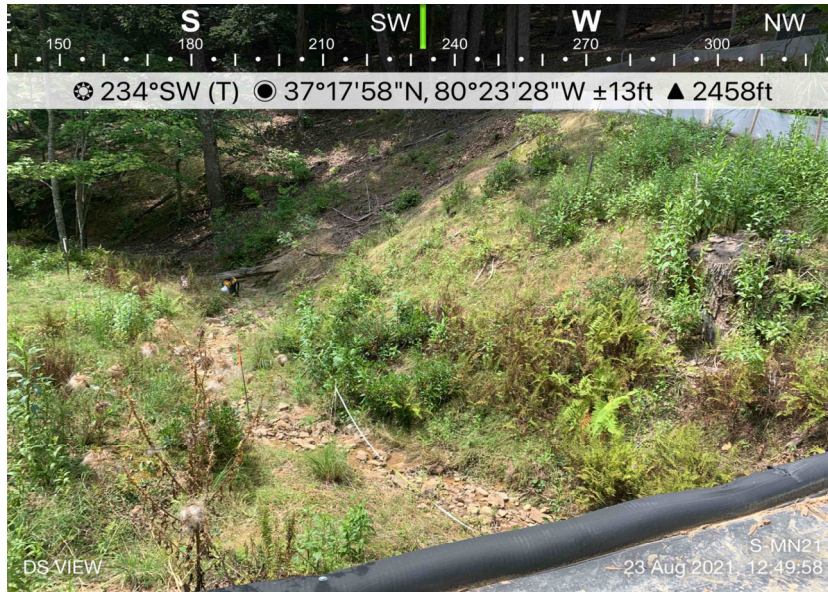
(WSSI Photo Location L:\22000s\22800\22865.06\Admin\05-ENVR\Field Data\Spread G\Field Forms\S-MN21\Photos\IMG_0542.JPG)

View downstream looking SW. Assessment is limited to areas within the temporary ROW.

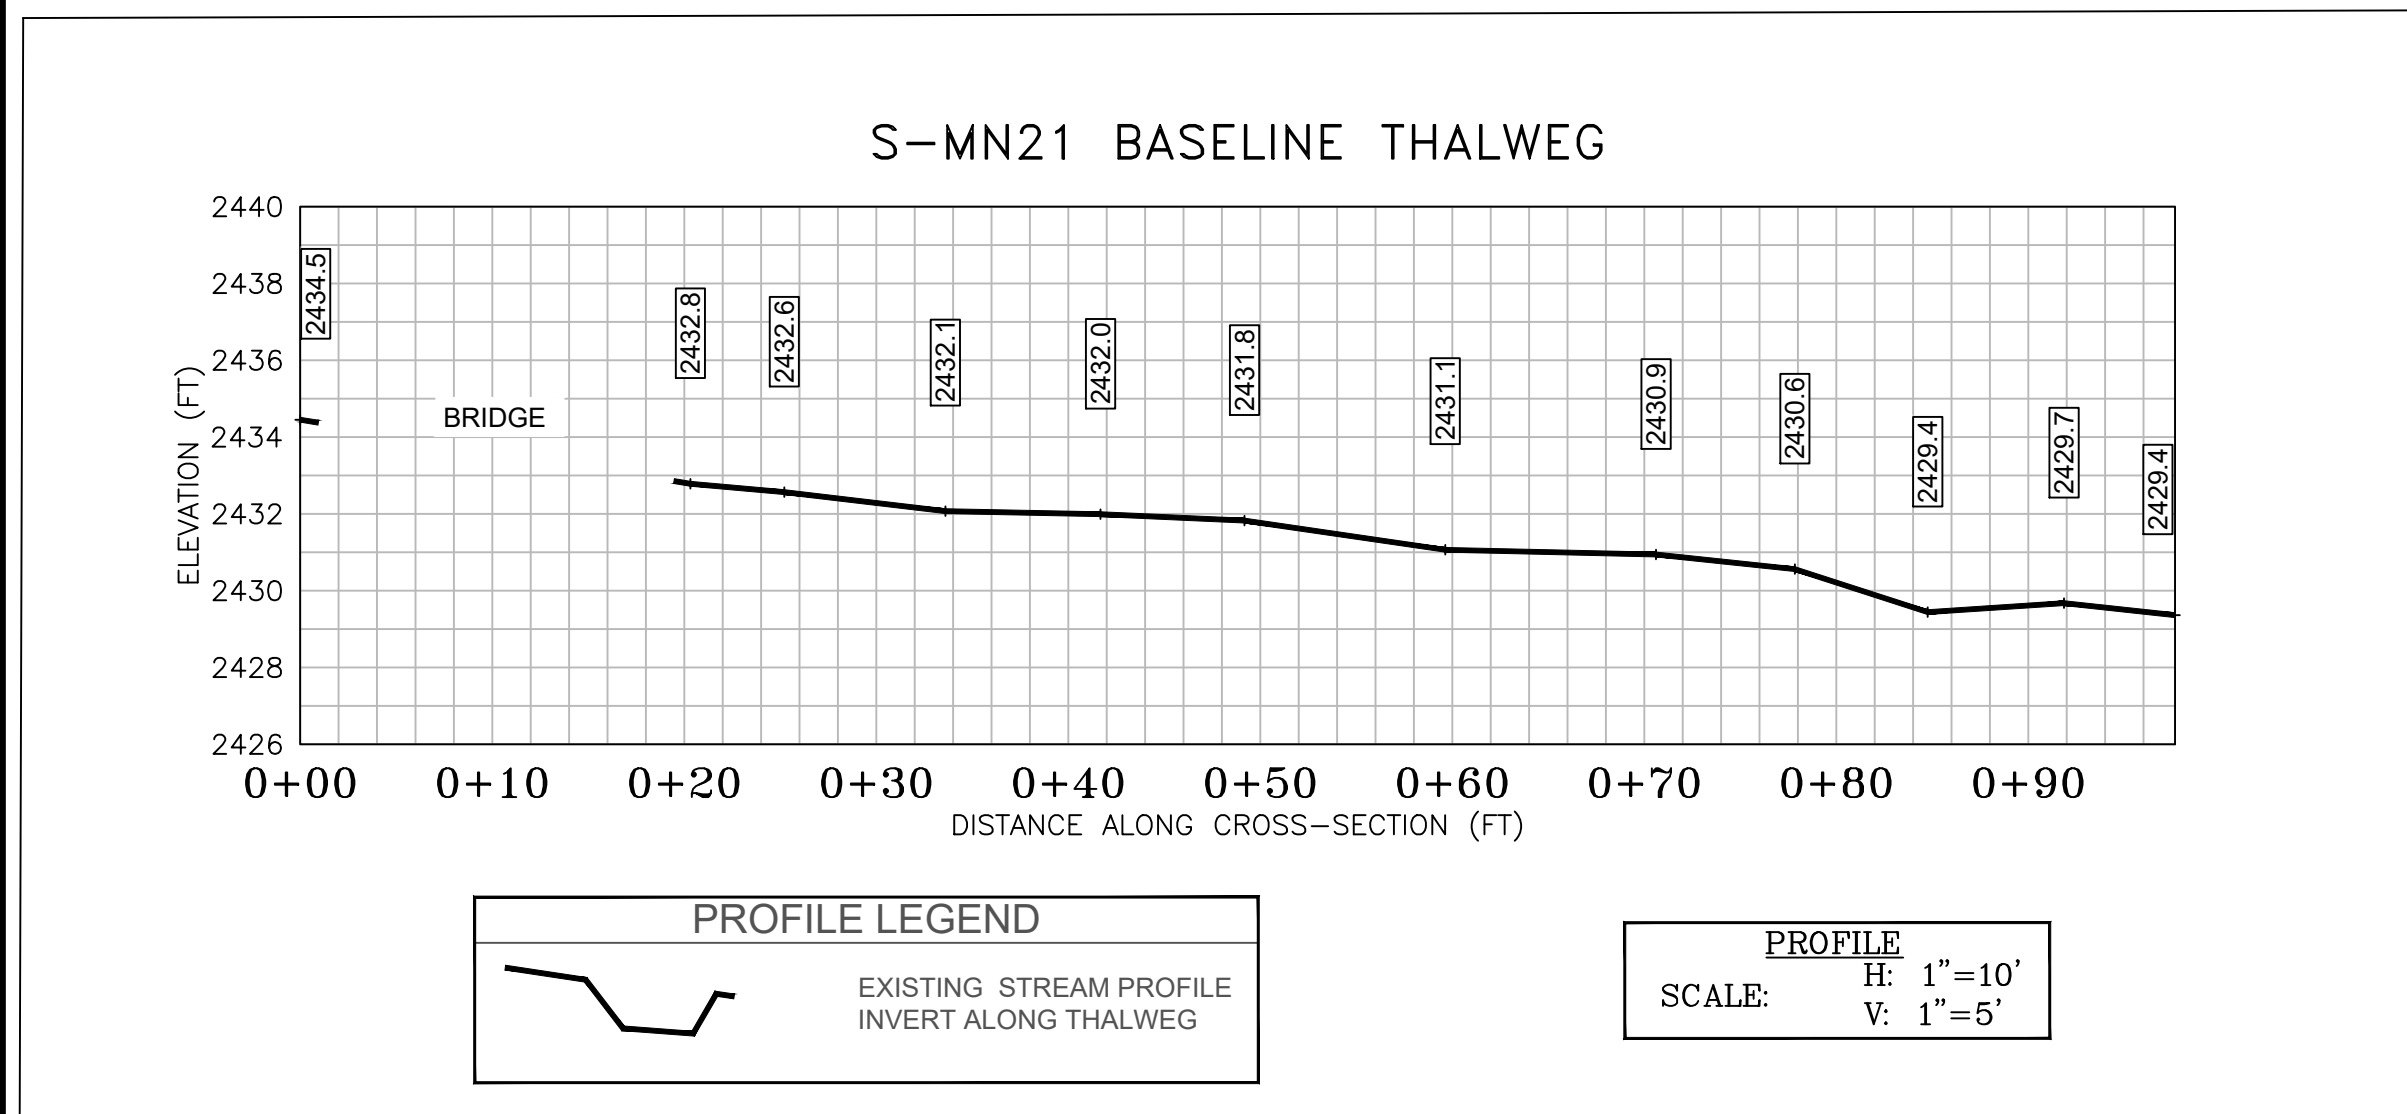
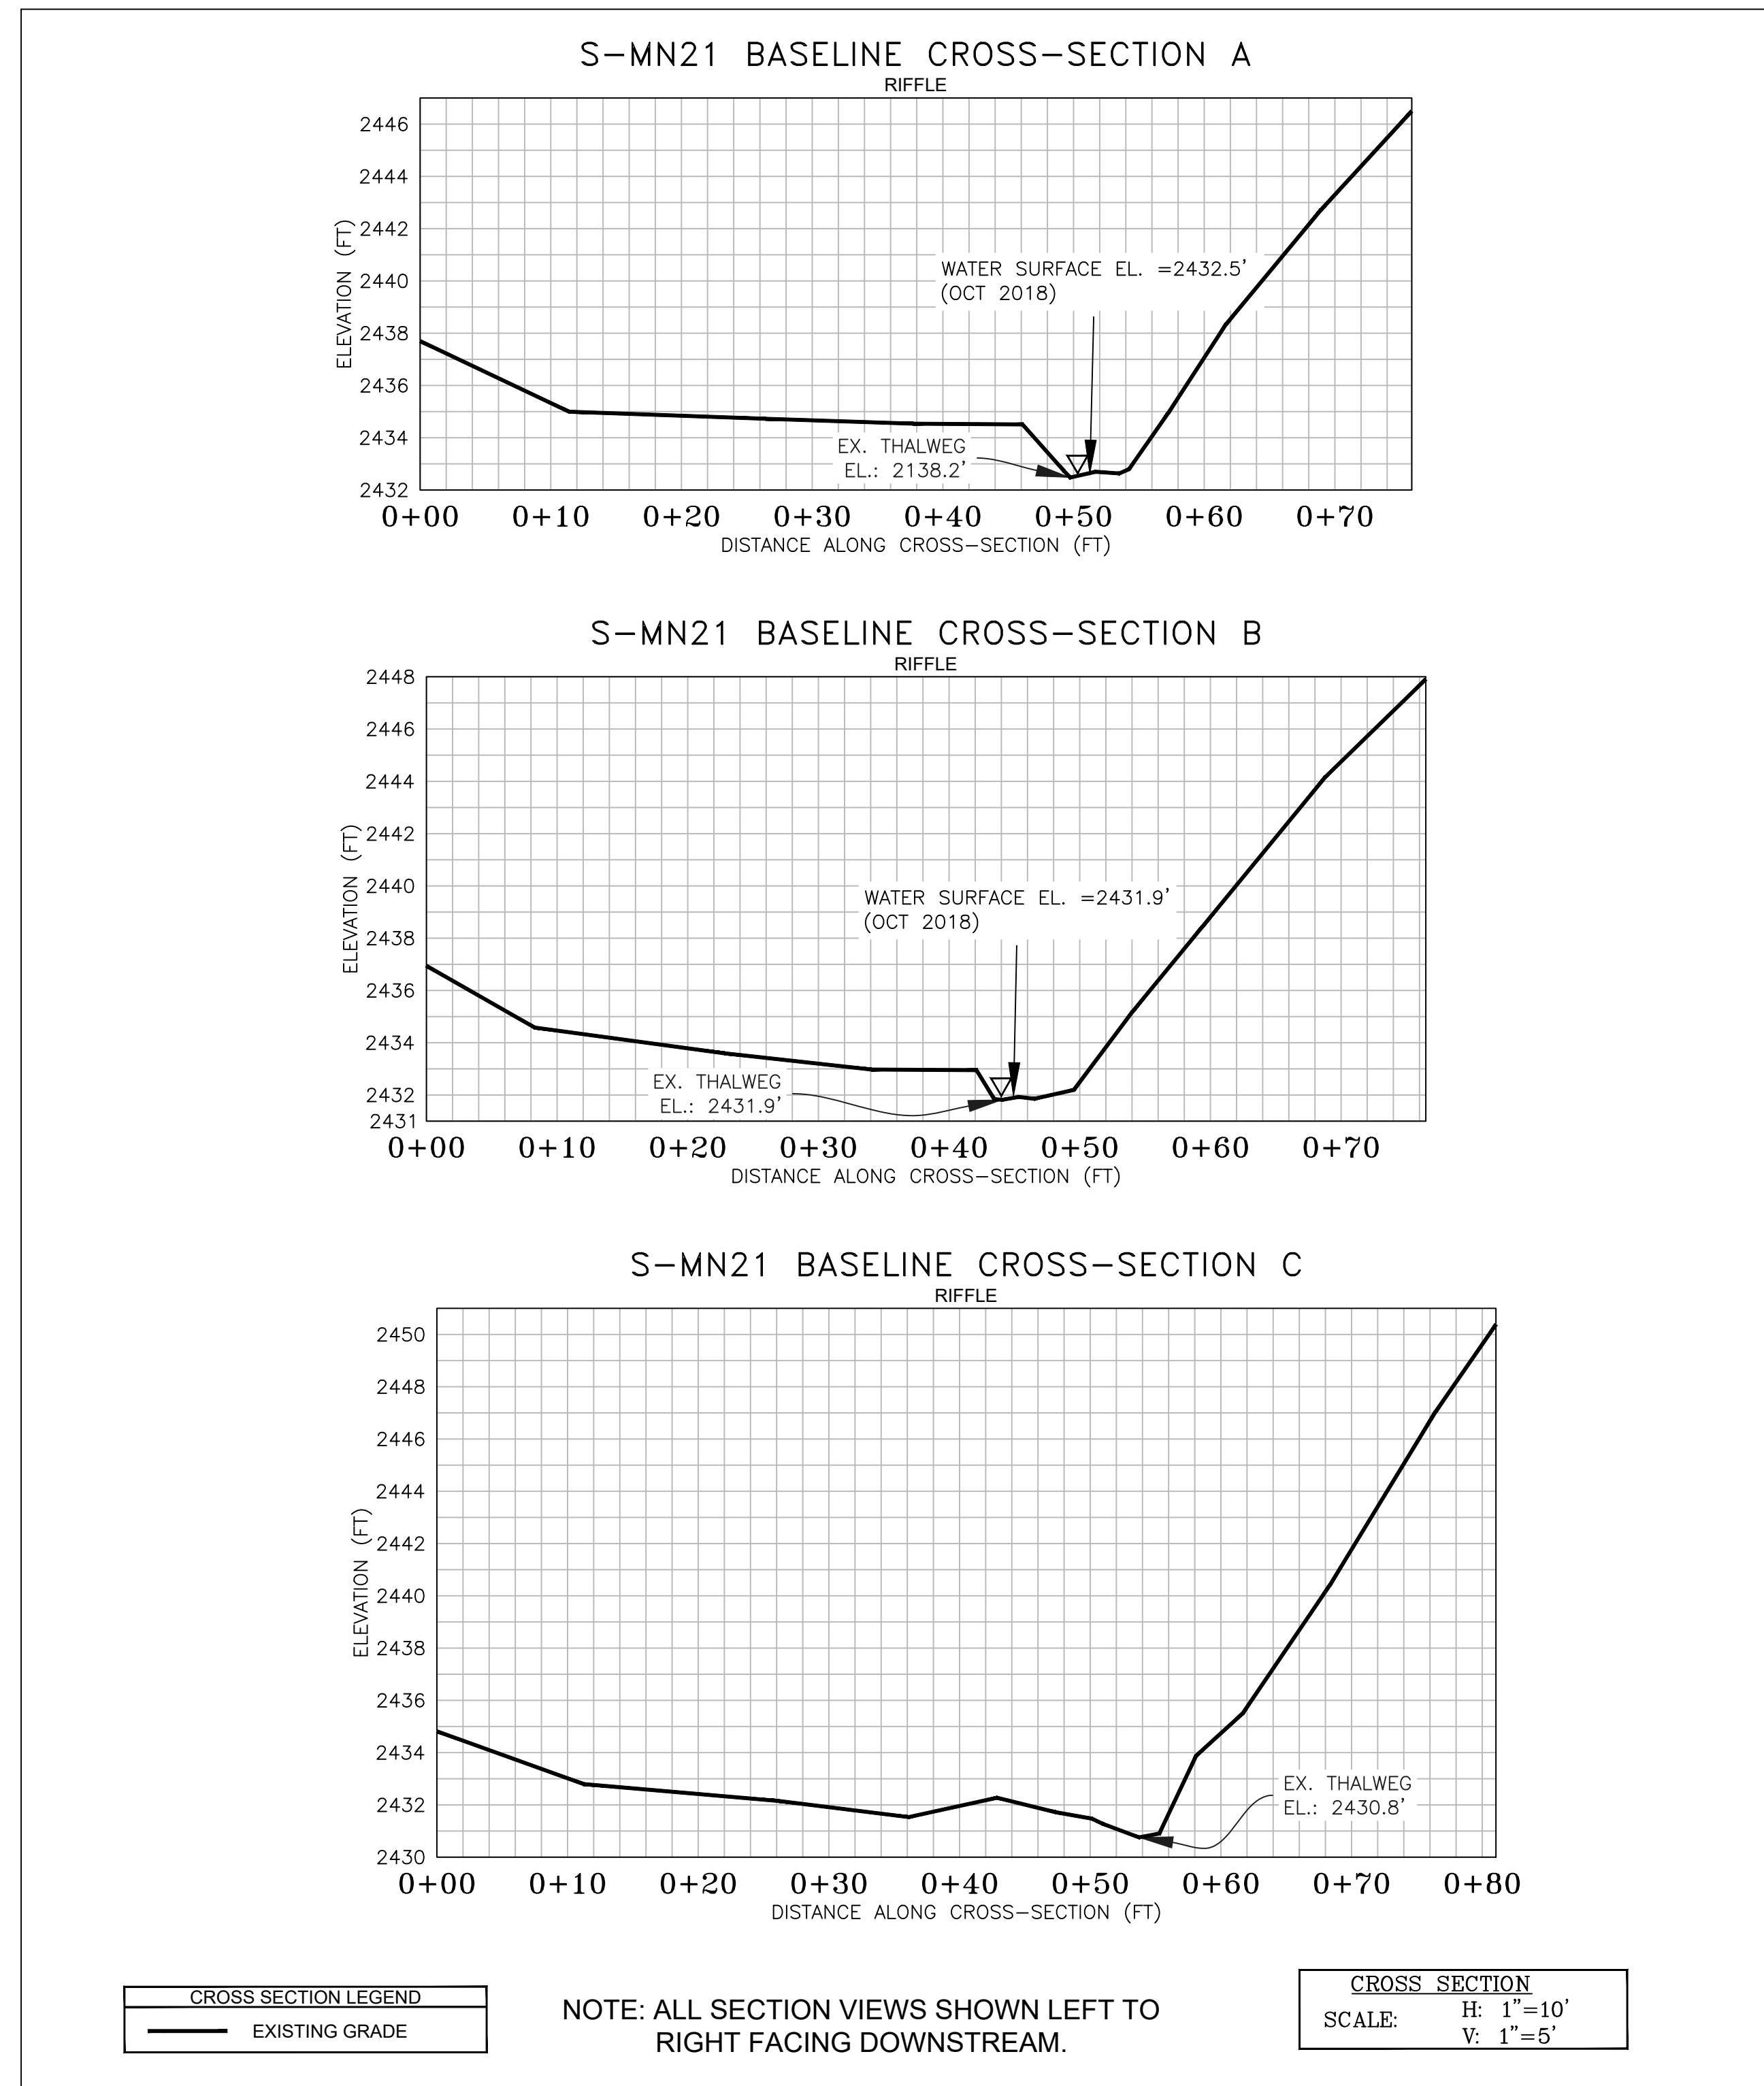
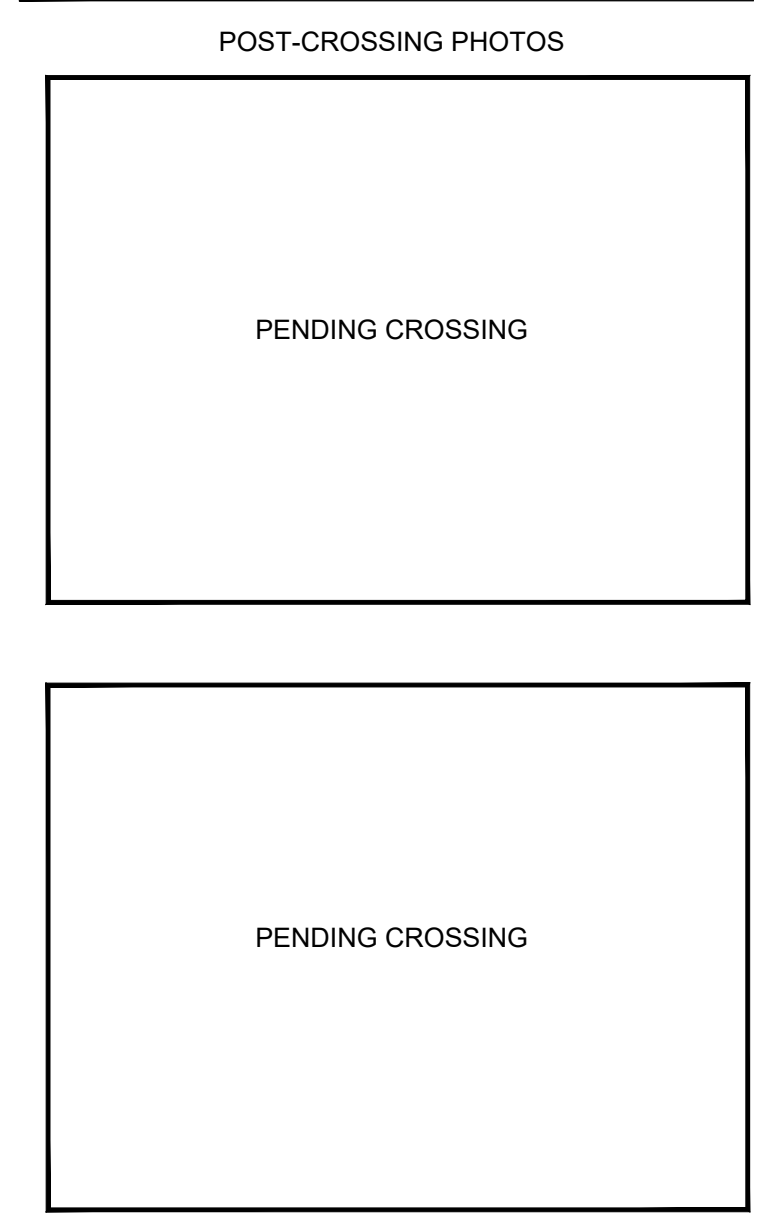
Profile and Cross-Sections Baseline Survey

- This map has been oriented to NAD 1983 UTM ZONE 17N, and vertically to The North American Vertical Datum of 1988 (NAVD 88), using a Real Time Network (RTN) GPS. Field locations were completed on October 22, 2018.
- Monumentation, including traverse stations and fly points, shown on this drawing should be used to orient any future boundary, topographic, or location survey.
- Easement lines shown on plan view were provided by Mountain Valley Pipeline (MVP).
- WSSI Contour Interval = 2.0'. Contours within the channel were interpolated using stream channel breaklines (i.e. top of slopes, toe of slopes, thalweg) and cross-sectional points. Contours outside the channel were interpolated using cross-sectional spot shots.
- All section views shown are left to right facing downstream.
- Cross-section B shot at location of pipe centerline (based on best professional judgement).

CL STAKEOUT POINTS: S-MN21 CROSS SECTION B (PIPE CL)					
PT. LOC.	PRE-CROSSING			POST-CROSSING	
	NORTHING	EASTING	ELEV.	VERT. DIFF.	HORZ. DIFF.
TS-L	13544136.72	1817414.62	2435.19	----	----
BS-L	13544134.22	1817418.36	2432.19	----	----
THW	13544131.60	1817421.66	2431.92	----	----
BS-R	13544130.94	1817422.75	2431.82	----	----
TS-R	13544129.55	1817424.16	2432.95	----	----
