## Baseline Assessment – Stream Attributes

### Reach S-D7 (Pipeline ROW) Intermittent Spread I Franklin County, Virginia

## Spread I Stream S-D7 (Pipeline ROW) Franklin County

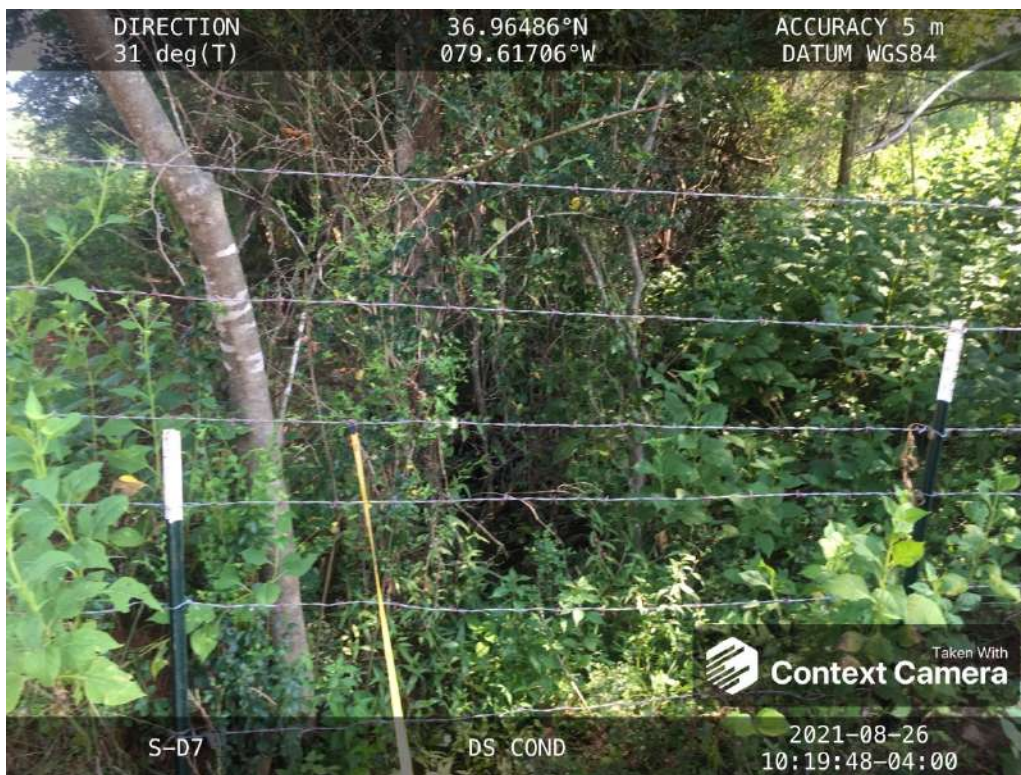
Photo Type: DS COND

Location, Orientation, Photographer Initials: Downstream at ROW/LOD looking NE downstream, CB

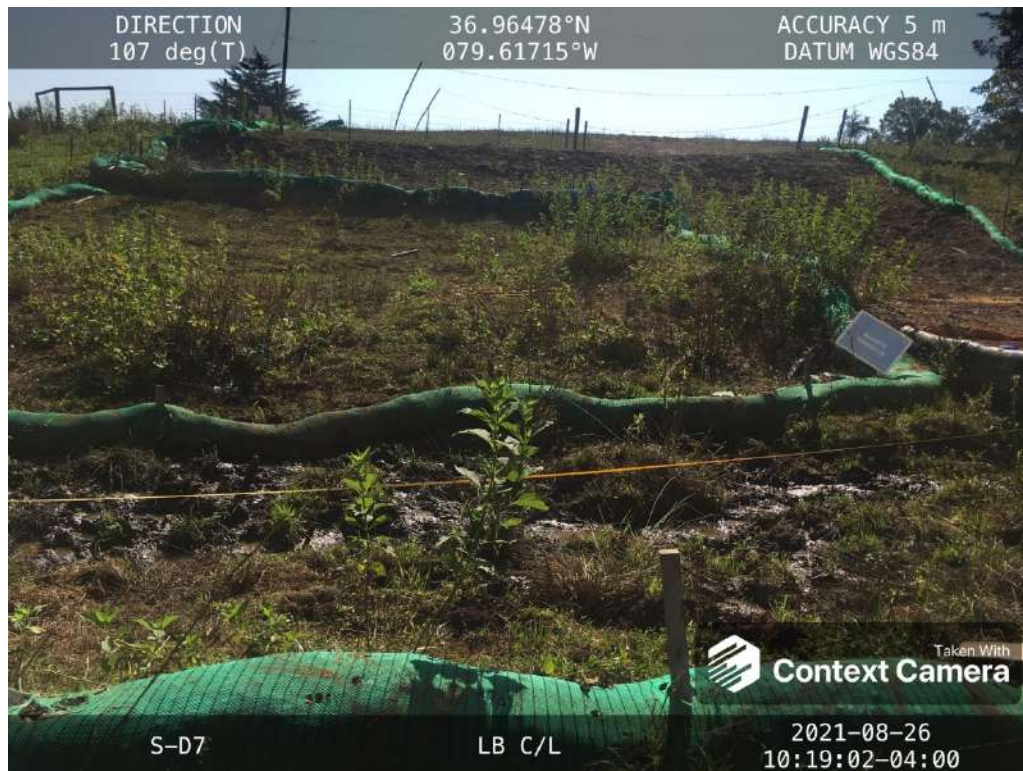
Photo Type: LB CL

Location, Orientation, Photographer Initials: On left bank at pipe centerline looking SE at right streambank, CB

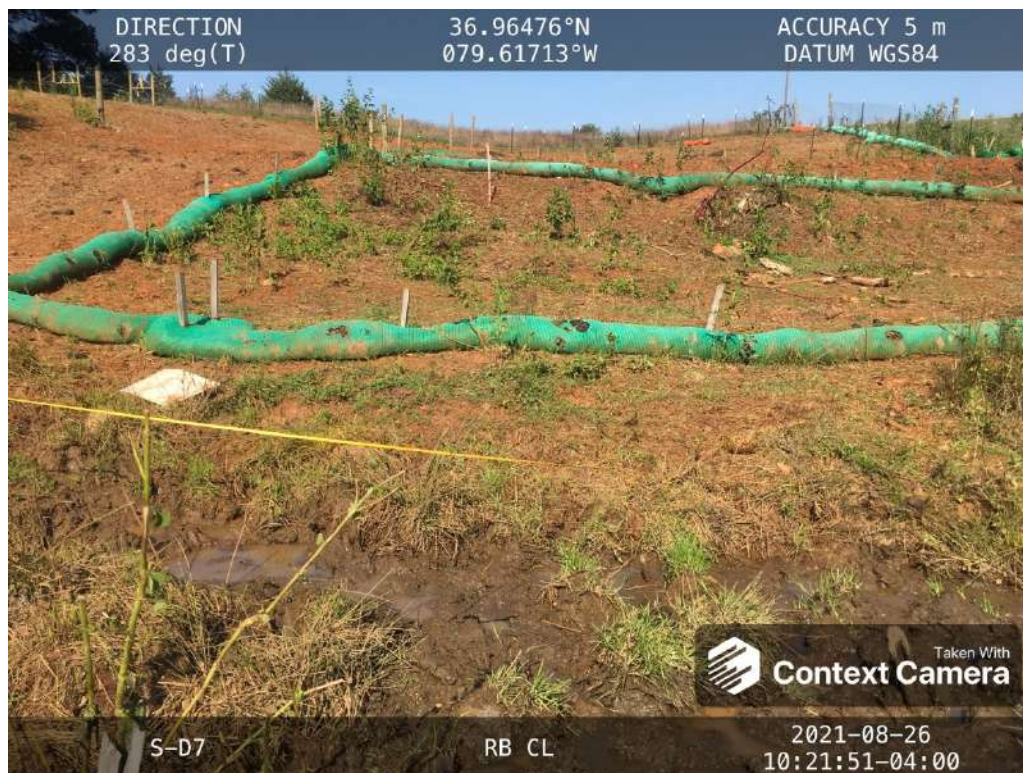
Photo Type: RB CL

Location, Orientation, Photographer Initials: On right bank at pipe centerline looking NW at left streambank, CB

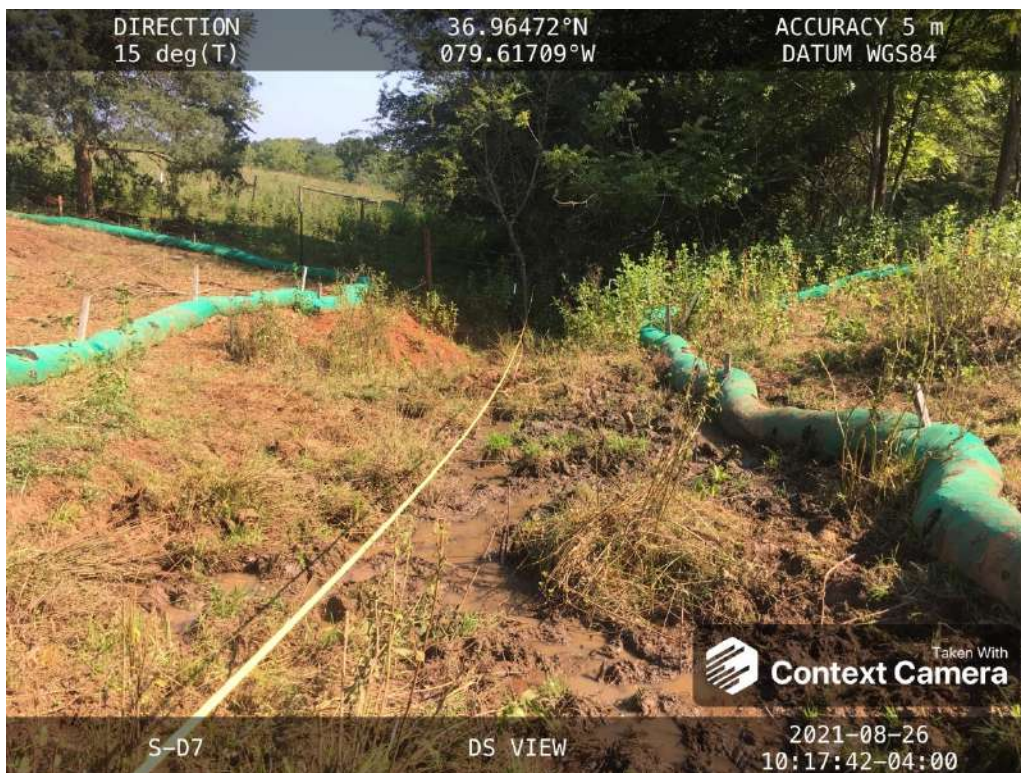
Photo Type: DS VIEW

Location, Orientation, Photographer Initials: Upstream at ROW/LOD looking NE downstream, CB

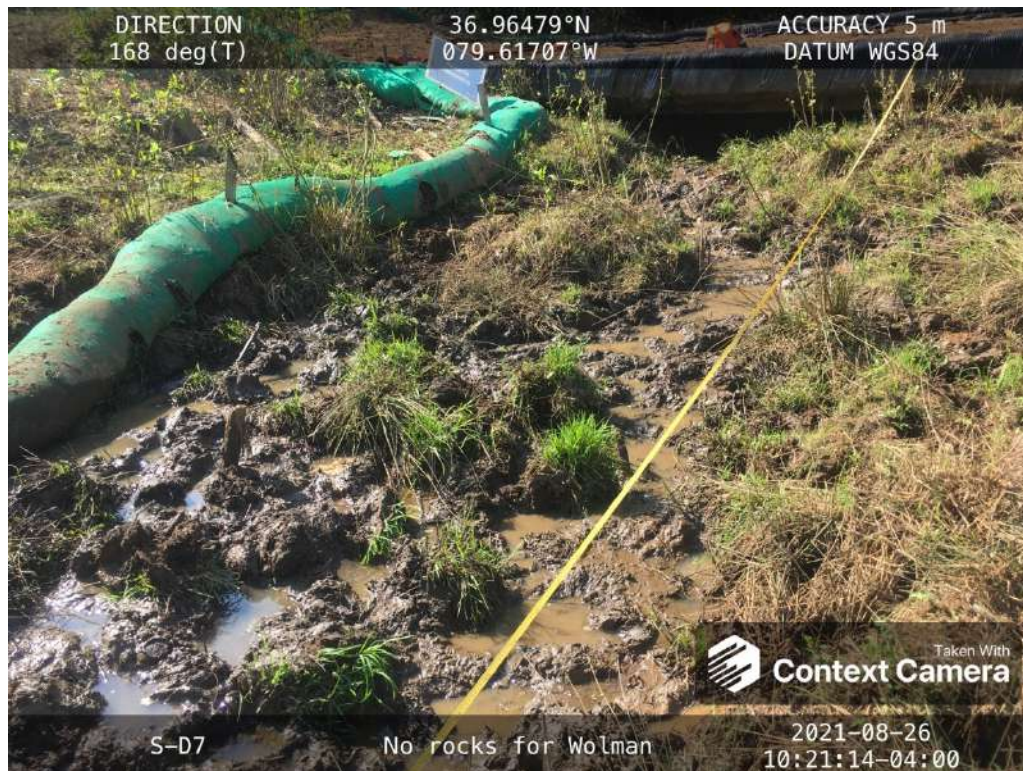
Photo Type: No Wolman pebble count due to no rocks in channel  
Location, Orientation, Photographer Initials: Mid-channel looking SE upstream, CB

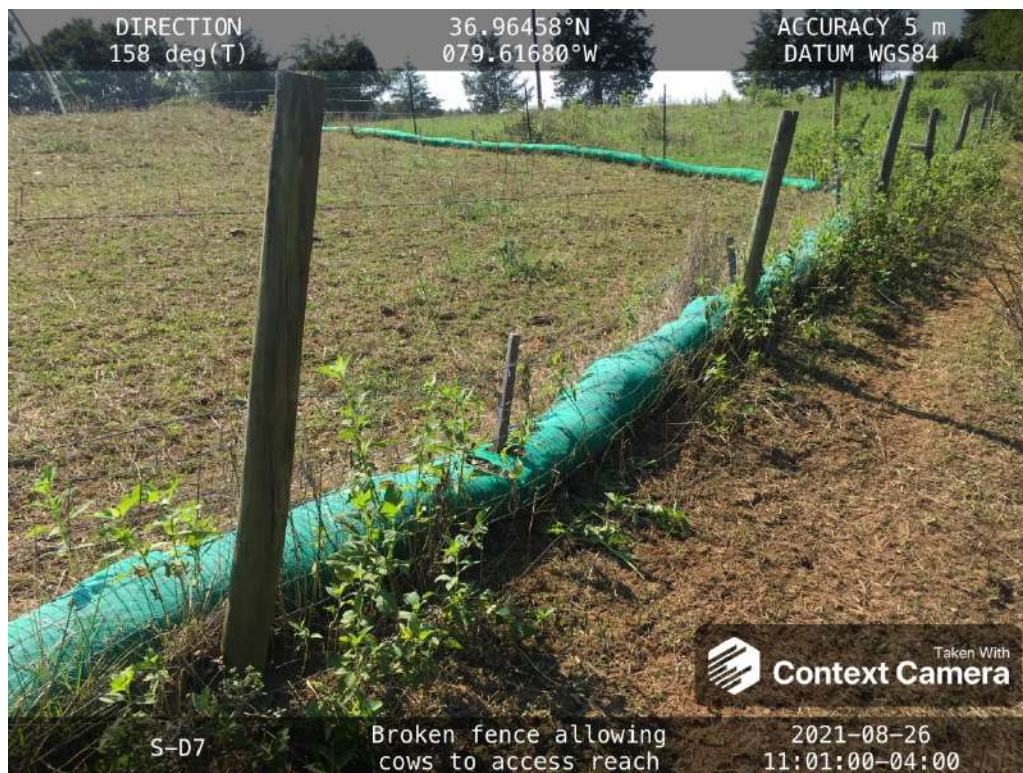
Photo Type: Fence section allowing cows access  
Location, Orientation, Photographer Initials: SE of reach looking SE, CB

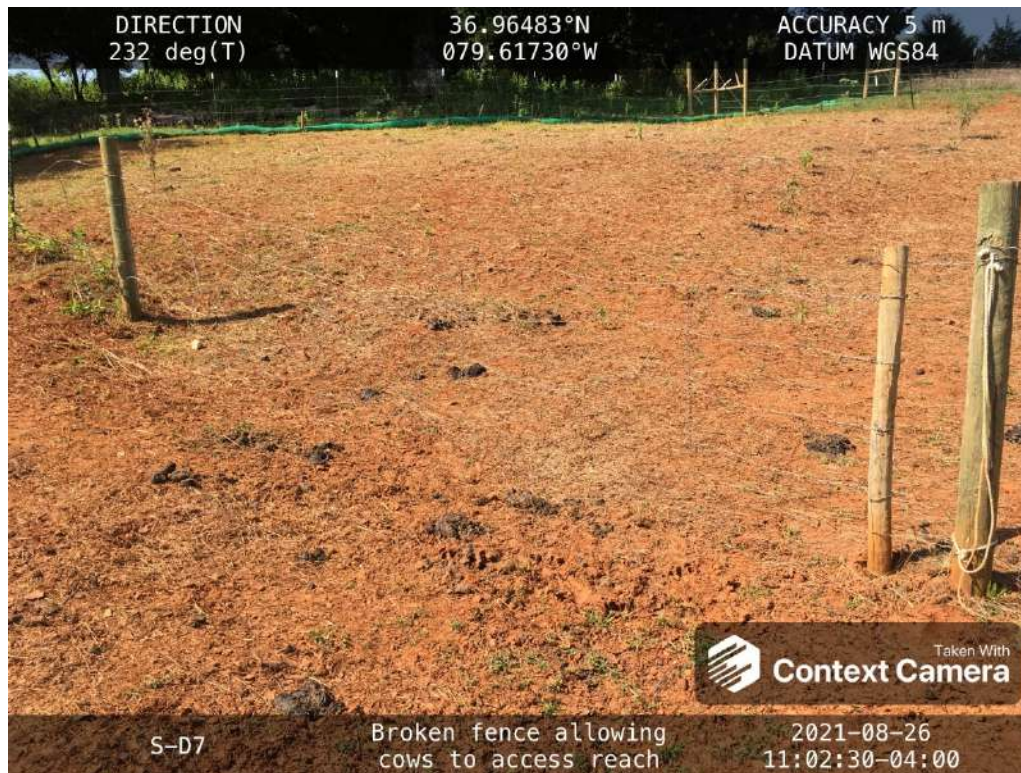
Photo Type: Fence gate section allowing cows access  
Location, Orientation, Photographer Initials: W of reach looking SW, CB
