VIVELAB ERGO CASE STUDY

REDESIGN OF A PRE-ASSEMBLY LINE TO REDUCE WORK CYCLE TIME AND INCREASE THE LEVEL OF OCCUPATIONAL SAFETY

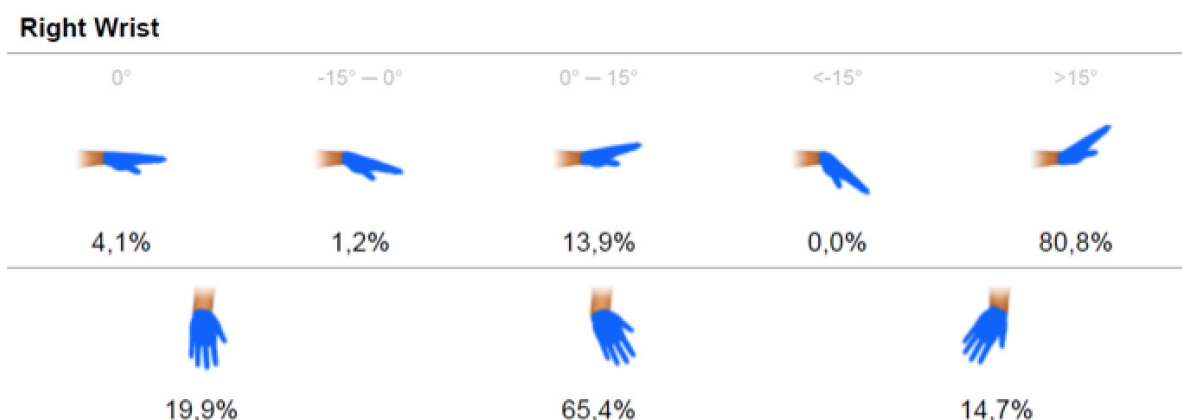
High frequency movements and sustained uncomfortable static postures occurred in many cases. As shown in the figure below, the wrist joint was heavily stressed because the hand was raised or tilted sideways during a high percentage of the cycle time.

Extract from ViveLab Report - RULA Detailed Statistics

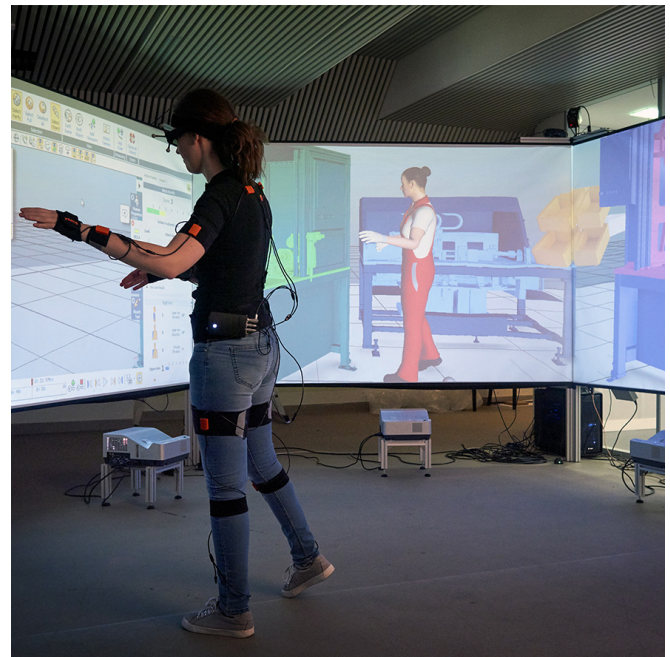
Virtual validation without a prototype before the implementation

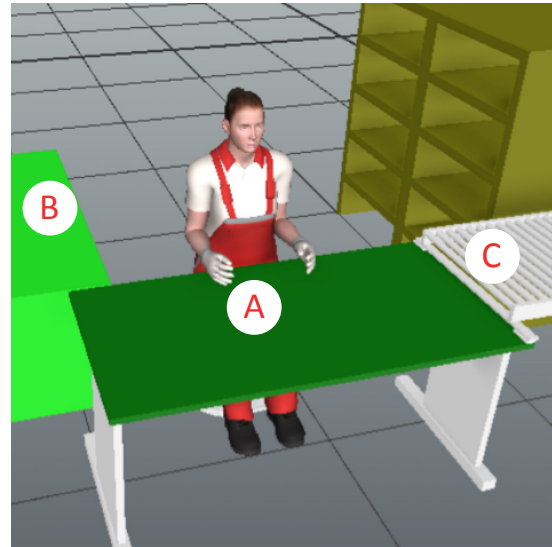
Cable box assembly station

At this workstation we recommended the use of the aforementioned height-adjustable table (A) and ergonomic chair. In this way we have achieved that the worker does not have to work in the same body position all day. The storage of the parts to be assembled (B) was placed near the workplace, saving the fatigue of walking to the supply container and back. We also split the workflow and passed the second phase to the next employee. At this workstation only the assembly of the cable box is carried out, and the next worker has to fix the cables with an insulating tape. The workpieces are passed to the next employee on the roller bar conveyor (C) that is placed between the tables. In this way the workpiece can be transferred to the next workstation much faster and without superfluous movements.

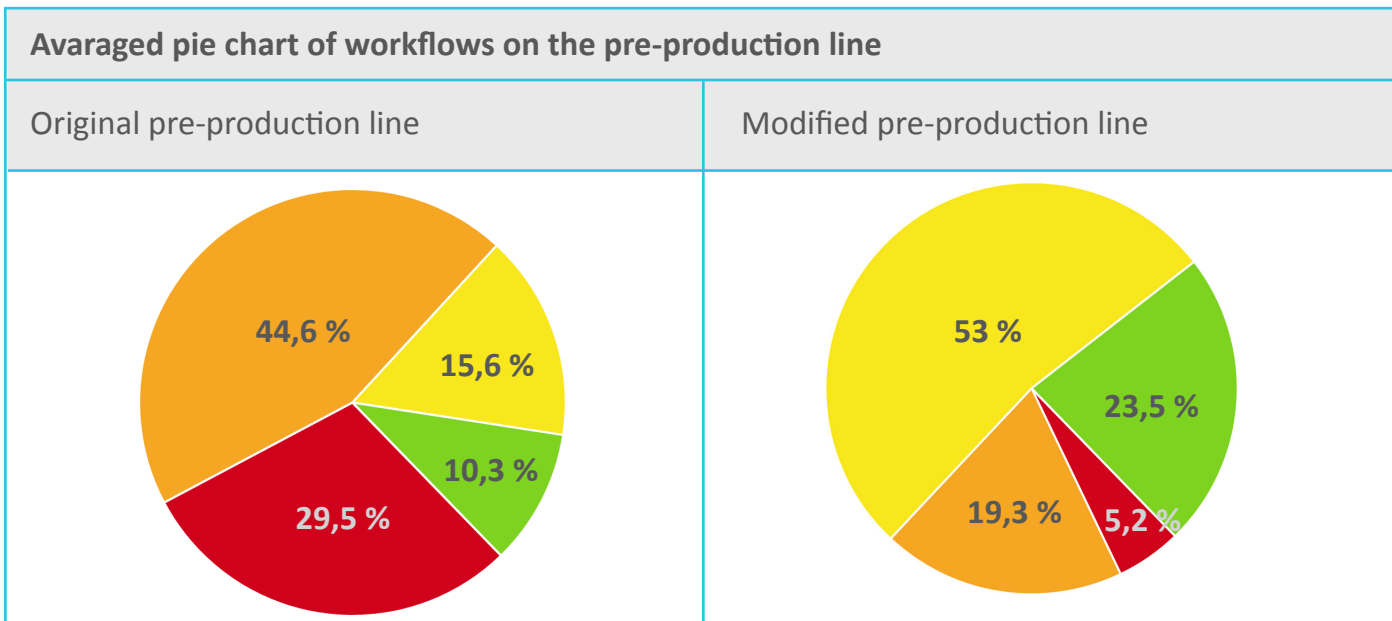
At the redesigned workstation, according to the above pie chart, in 23.5% of the cycle time the body position of the worker was ergonomically completely correct. Moreover, in 53% of the cycle time the movement requires later further attention. In 19.3% of the time the movement requires examination and corrective measures on the long run and only in 5.2% of the time are immediate corrective measures needed. **As one can see from the charts, the proportion of postures that pose long-term health risks has been significantly reduced. In parallel, the proportion of healthy postures has increased. This example illustrates that significant results can be achieved with a few simple modifications when we want to reduce the workload for the employees.**

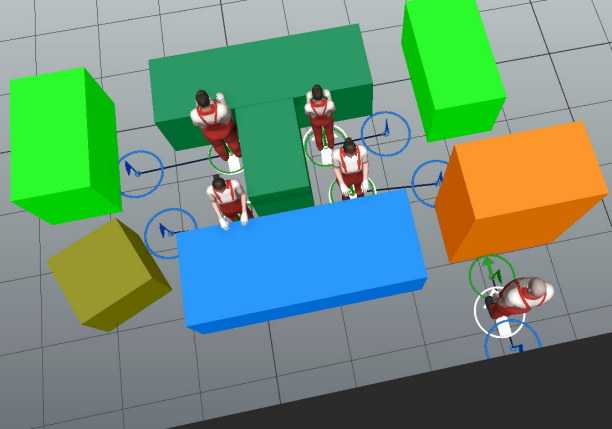
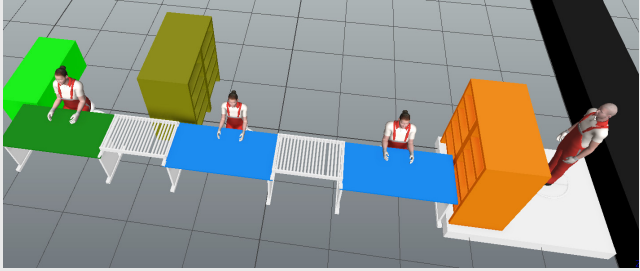
Original pre-assembly line	Modified pre-assembly line

41 m ²	24 m ²

As can be seen in the table above, the space requirements of the workstations have been reduced from 41 m² to 24 m², which means that the space requirement has been reduced to 58%.
