## LOAD & DURABILITY CERTIFICATION

## TEST REPORT

**Lucideon Reference:** UK234413 (QT-72325/1/MM)/Ref. 2

**Project Title:** Load and Durability Testing of Raaft Ltd's Preventa System Incorporating Atria and Farrino Porcelain Tiles

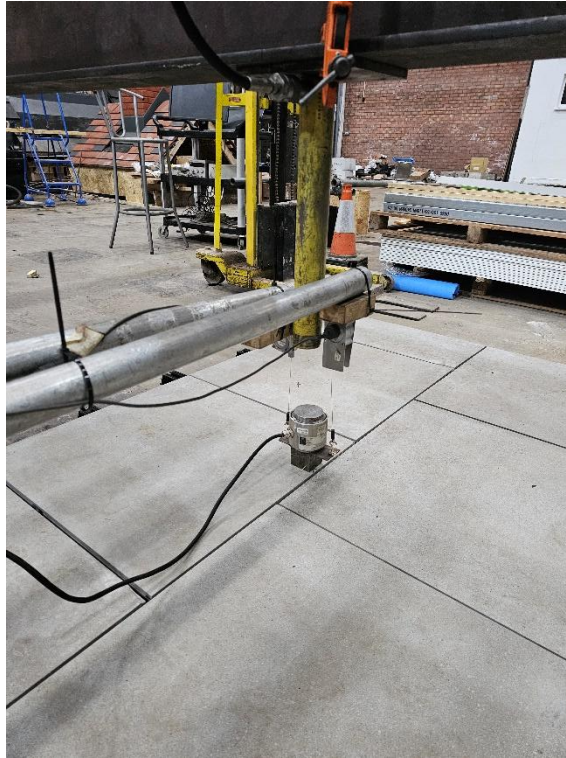
**Plate 1** – Point Load Test Set-Up Atria Tiles

For each set of point load tests, two portal frames were spanned over the floor system and bolted down to the Structures Laboratory Strong Floor to ensure rigidity.

A crossbeam was clamped to span in between the portal frames. A hydraulic ram was fixed to the crossbeam, with the ability to be moved along the beam, to suit the relevant loading position.

The ram had a calibrated load cell connected in a series within a cage, to measure the load applied to the board, and a hand pumping unit was used to apply said load.

A 50 mm square loading plate was placed onto the relevant loading position, to enable application of the load.

On top of this loading plate was an additional, wider steel plate to allow for two deflection readings to be taken, either side of the hydraulic ram.

Two calibrated Linear Voltage Displacement Transducers (LVDT's) were positioned via scaffolding and connected to the steel plate described.

Refer to Plate 1 for the general test arrangement.

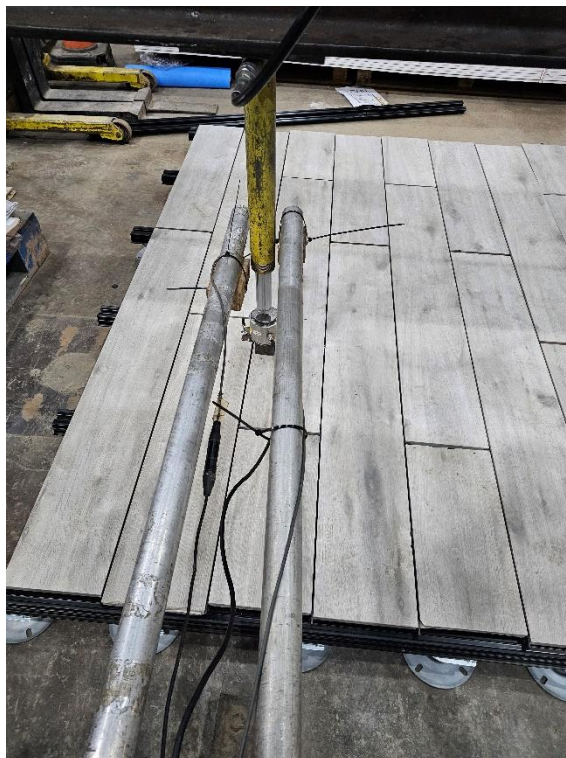
**Plate 2** – Point Load Test Set-Up Farrino Tiles

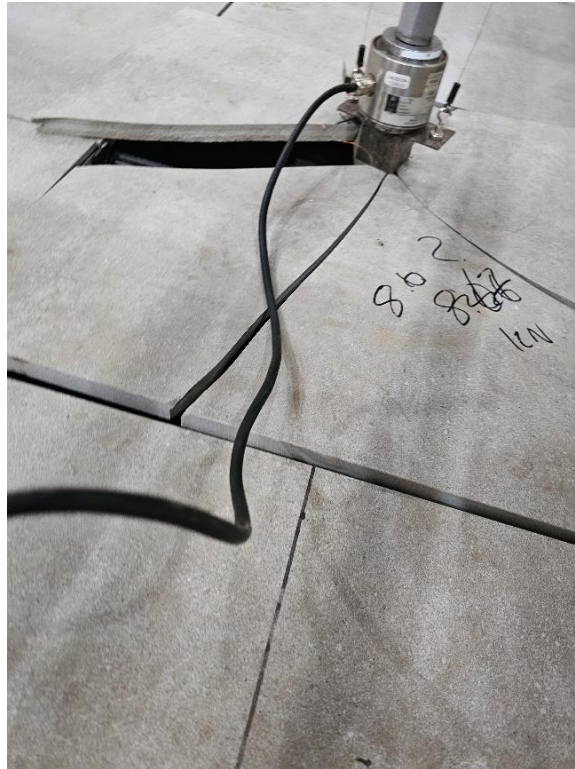
**Plate 3** – Typical Failure for Atria Tile Point Load

Raaft Preventa System incorporating Atria Porcelain Tiles achieved a mean load value of 7.02 kN prior to failure by way of the tile cracking.

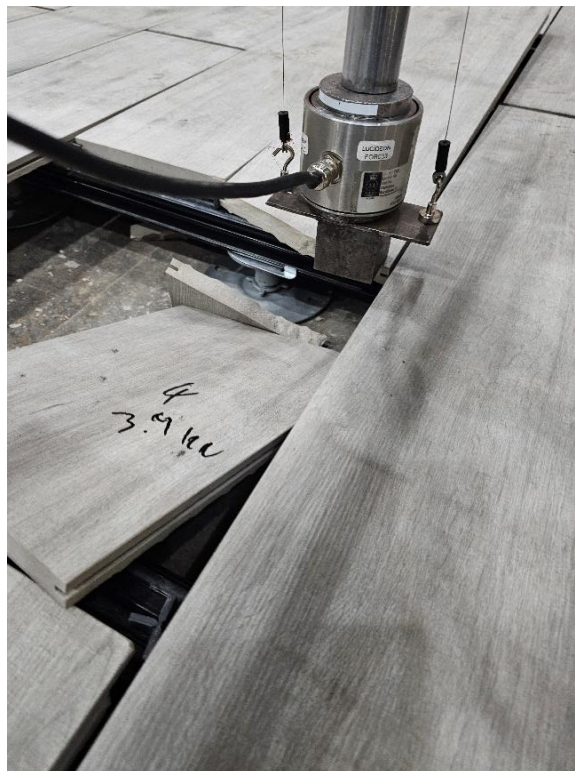
**Plate 4** – Typical Failure for Farrino Tile Point Load

Raaft Preventa System incorporating Farrino Porcelain Tiles achieved a mean load value of 6.32 kN prior to failure by way of the tile cracking.

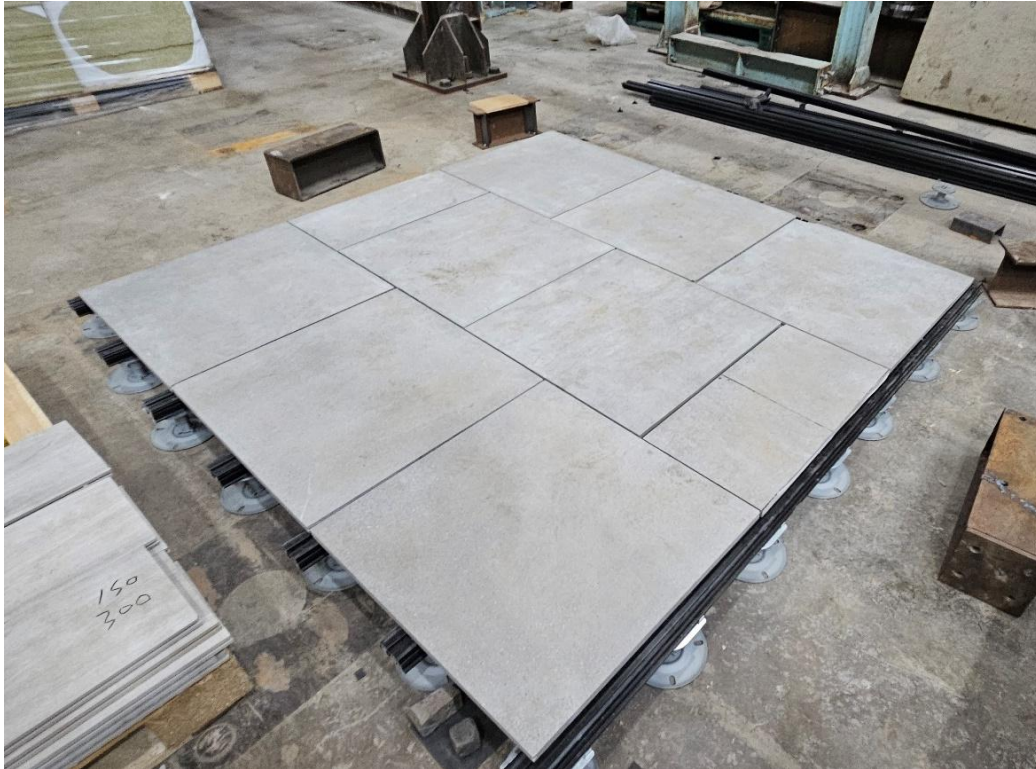
**Plate 5** – Atria UDL Test Sample

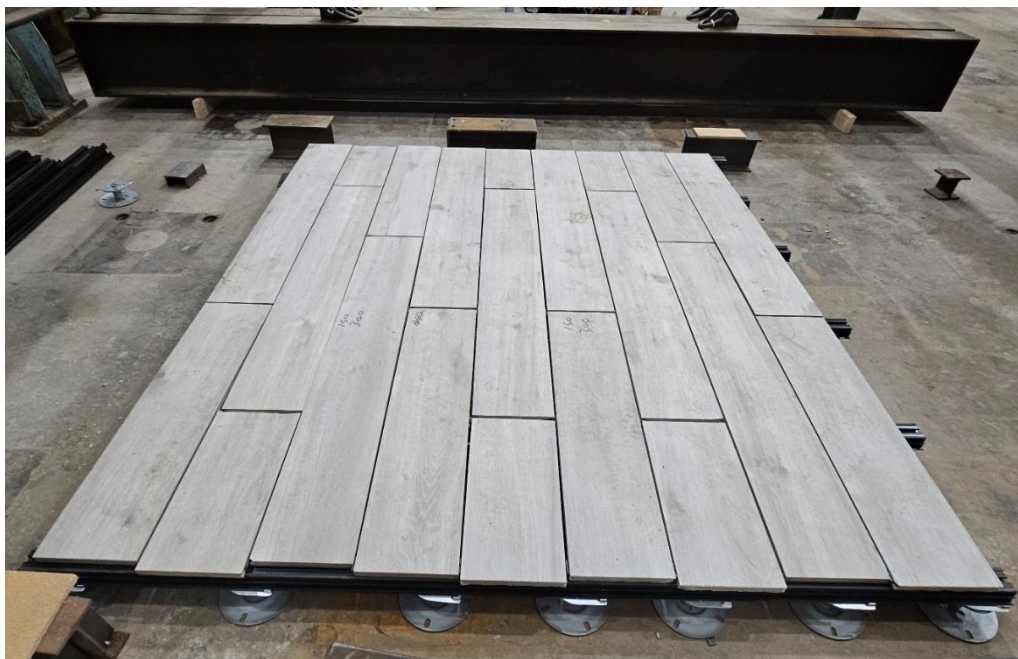
**Plate 6** – Farrino UDL Test Sample

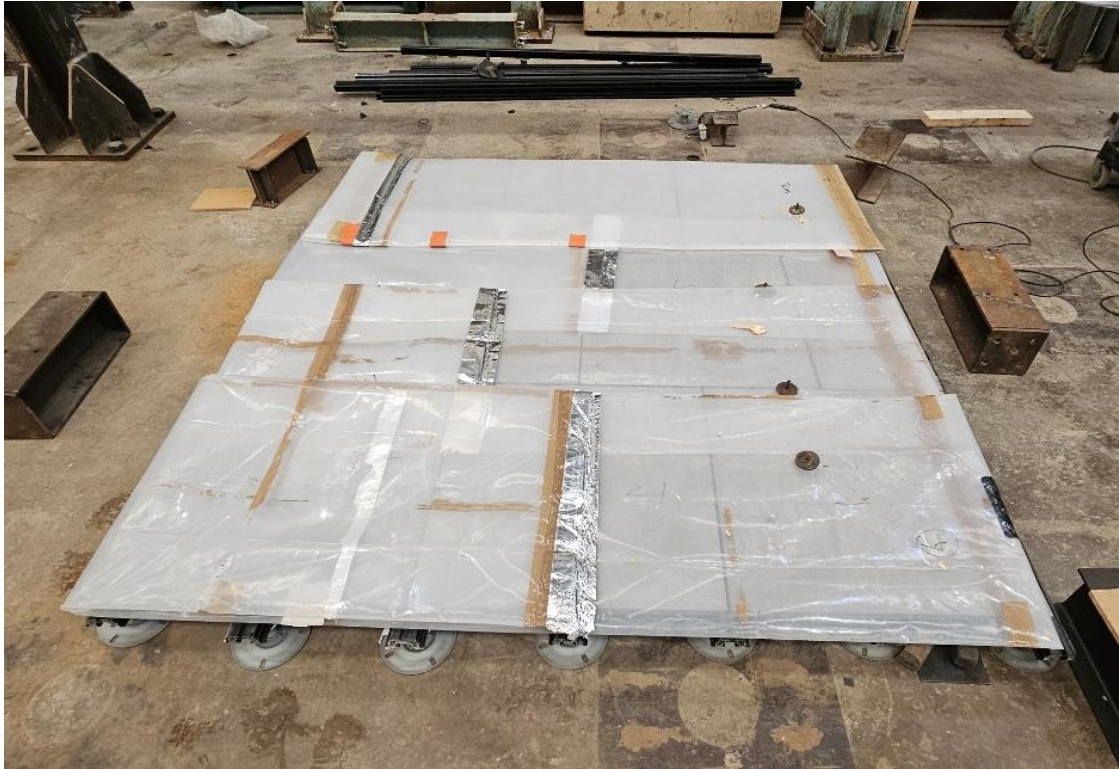
**Plate 7 – Sample with Airbags Installed**

Air bags were laid across the entirety of the sample face ensuring a 100 mm overlap of each airbag to ensure the whole area was loaded.

The air bags were connected to a common supply manifold which was connected to an air regulator and an air compressor.

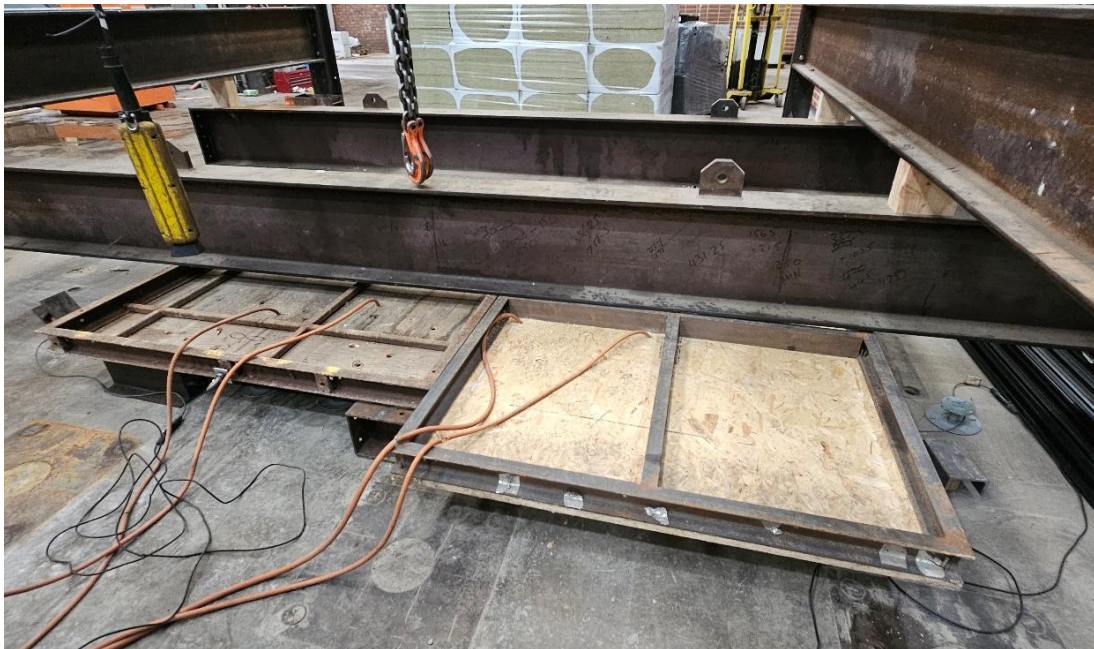
**Plate 8 – Reaction Frames Installed**

A large reaction frame, constructed from 18 mm plywood sheets, 50 mm x 50 mm x 5 mm internal strengthening bars within a 35 mm x 50 mm x 5 mm Parallel Flange Channel (PFC) perimeter frame was placed approximately 50 mm above the uppermost surface of the air bags and clamped to the underside of the UB's described previously.

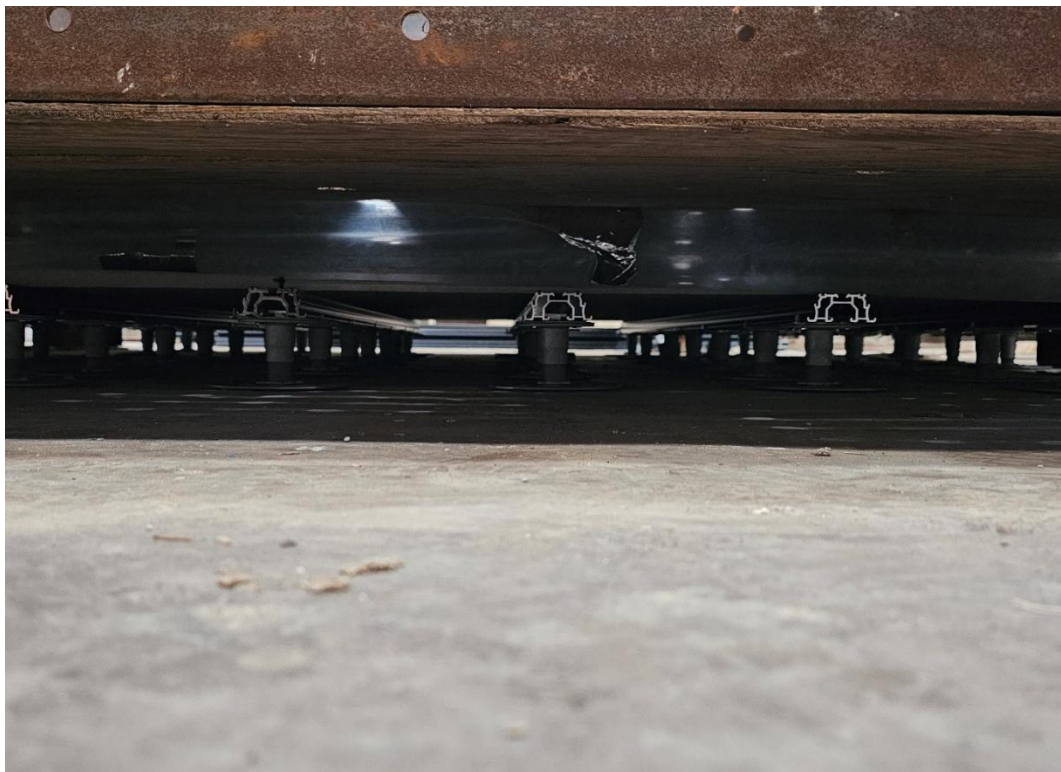
**Plate 9** – Sample Under Test
