**Ballinacurra Mill LRD at Ballynacorra,  
Midleton, Co. Cork**

**Stage 1 Road Safety Audit**

**February 2025**

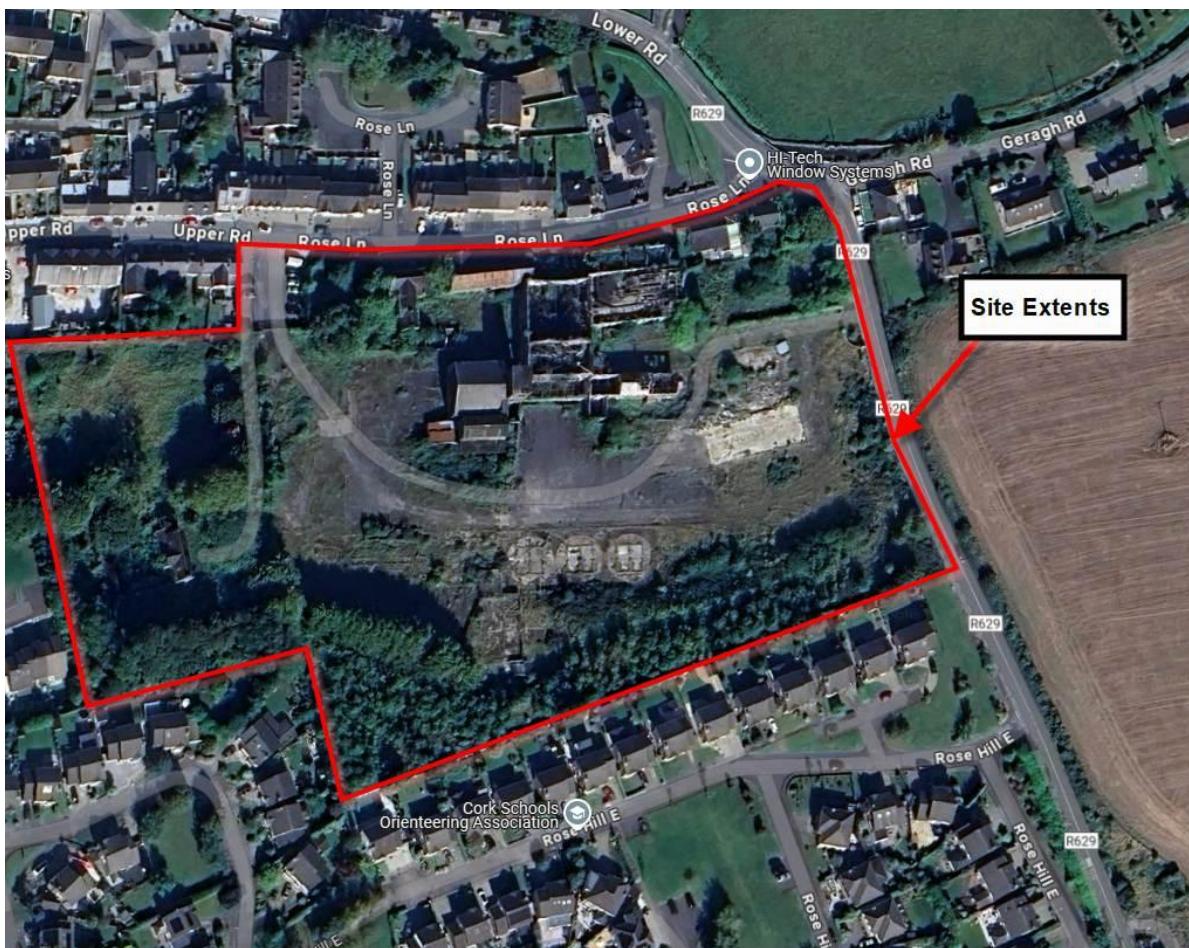
**Figure 1.2 – Site Extents**

The development access points will be located within the 50kph Urban speed limit. See Figure 1.1 Site Location Map. Figure 1.2 shows the site extents on aerial photography and Figure 1.3 shows the site layout for the proposed works.

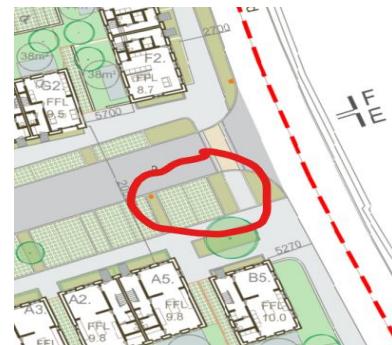
### 2.1. Problem: Perpendicular parking in proximity to raised pedestrian crossing.

The following image shows the location of perpendicular parking associated with a private detached dwelling that may result in a reversing car encroaching onto the proposed raised pedestrian table at the main access to the site. There is a potential that this could result in an accident with pedestrians using this crossing.

#### Recommendation 1

If possible the crossing should be moved towards the main road and away from this parking to avoid this potential safety issue. Alternatively the parking serving this dwelling could be revised.

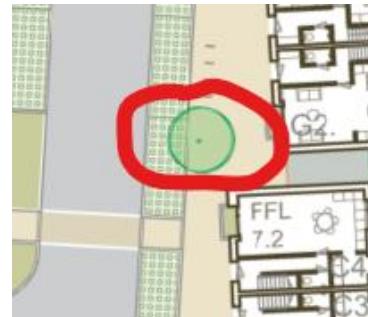
### 2.2. Problem: Proposed landscape features within the walking carriageway.

At a few locations within the scheme there are trees located within the designated footpath. In some instances these are located adjoining the kerbline which visually impaired persons use to navigate. The detail around these features was not evident in the drawing submitted for audit. These landscape features could be a trip hazard for the visually impaired.

#### Recommendation 2

The landscape features as outlined above should be moved to more appropriate locations.

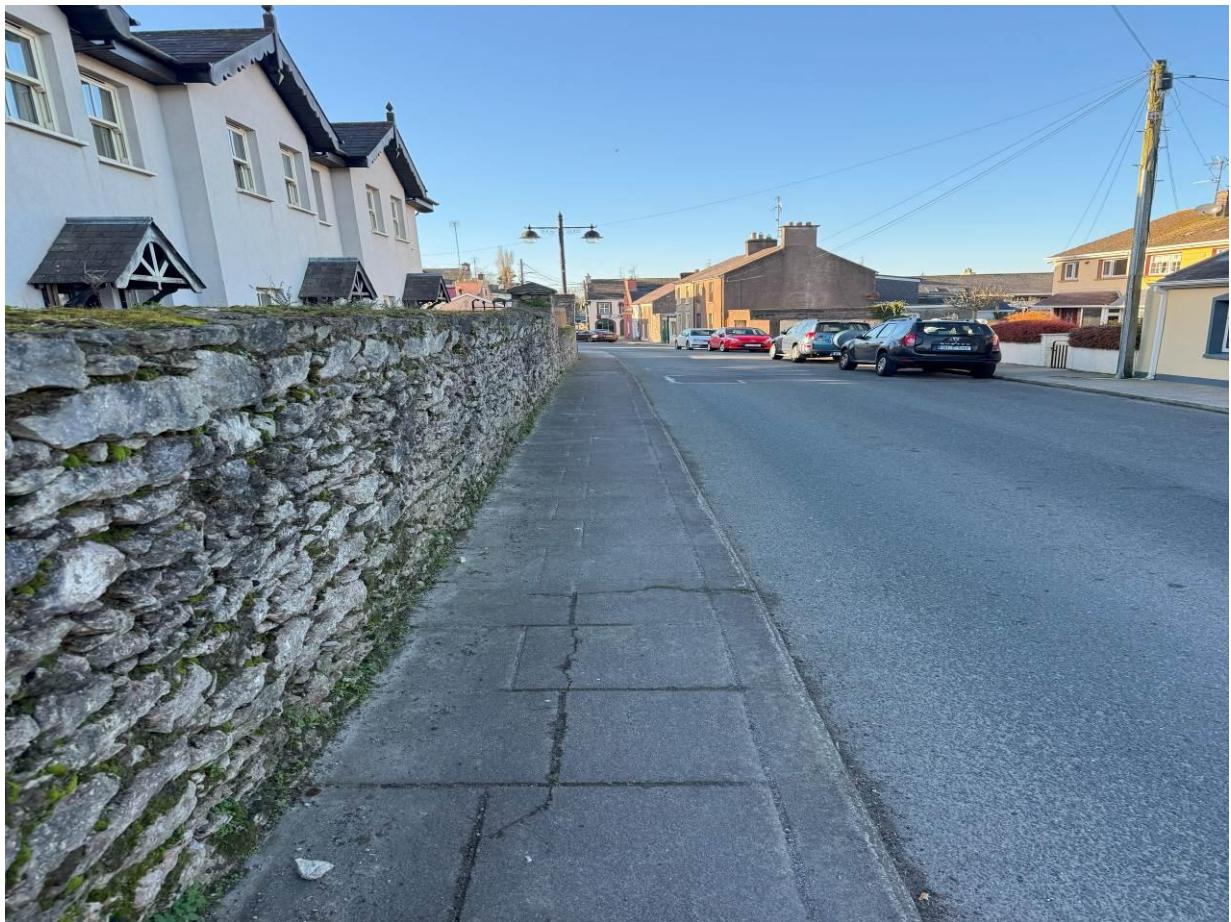
***Photo A1 –Existing Footpath from the proposed development to Main Street***

The proposed layout shows pedestrian facilities to the access junction on Rose Lane and it is expected that these pedestrians will continue onwards towards Main Street. This development will increase the pedestrian activity in the locality including along Rose Lane and Upper Rd. Whilst outside of the red line boundary, the existing footpath facilities around this location appear to vary in width and are poor quality at locations. Failure to provide adequate footpath facilities and width will discourage users and force them onto the roadway. Refer to Photos A1 & A2.

Adequate pedestrian connections should be provided between the town centre and the site.
