SERIES: 5000—TH THERMALLY BROKEN  
ALUMINUM IMPACT WINDOW WALL

SERIES: 5000-TH THERMALLY BROKEN  
ALUMINUM IMPACT WINDOW WALL WITH SERIES 3000-TH  
THERMALLY BROKEN CASEMENT WINDOW

SERIES: 5000—TH THERMALLY BROKEN  
ALUMINUM IMPACT WINDOW WALL  
WITH SERIES 3000—TH THERMALLY BROKEN  
PROJECT—OUT WINDOW

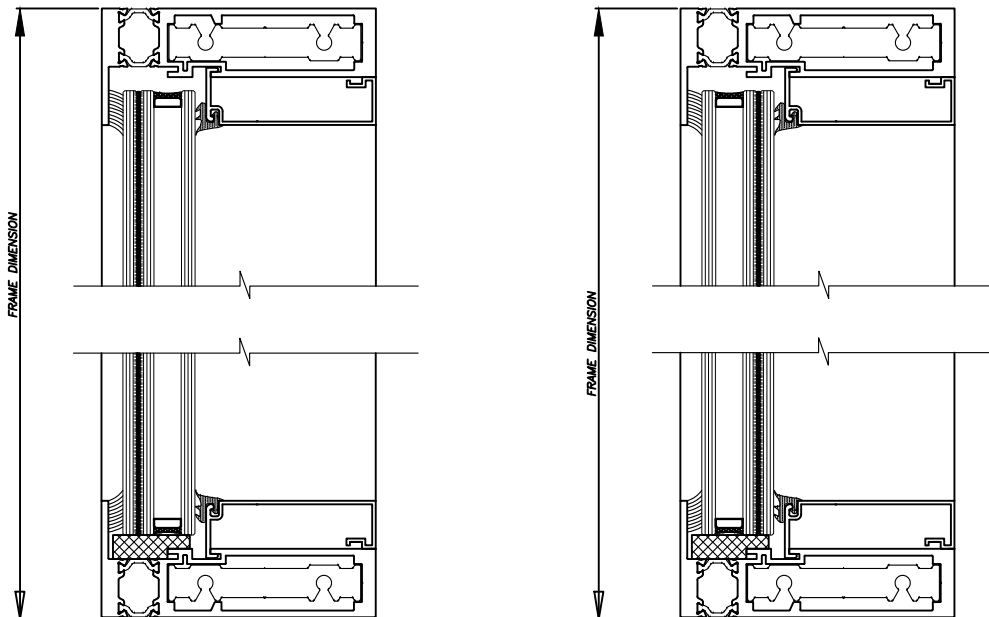
GLAZING:  
1 $\frac{5}{16}$ " LAMINATED  
INSULATED IMPACT  
GLASS

LAMINATED GLASS AT INTERIOR AND EXTERIOR  
OPTION SHOWN

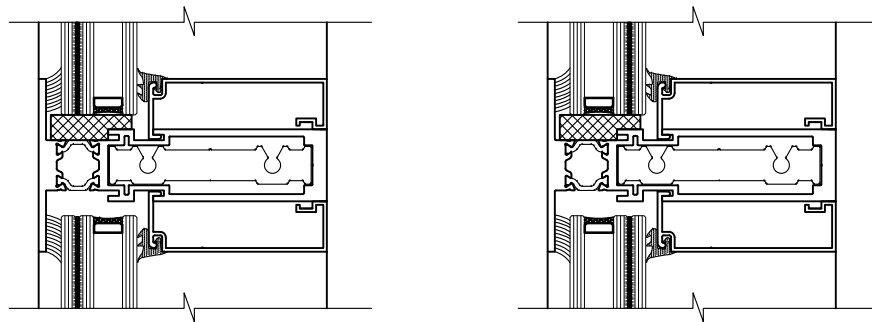
3

GLAZING:  
1 $\frac{5}{16}$ " LAMINATED  
INSULATED IMPACT  
GLASS

LAMINATED GLASS AT INTERIOR AND EXTERIOR  
OPTION SHOWN

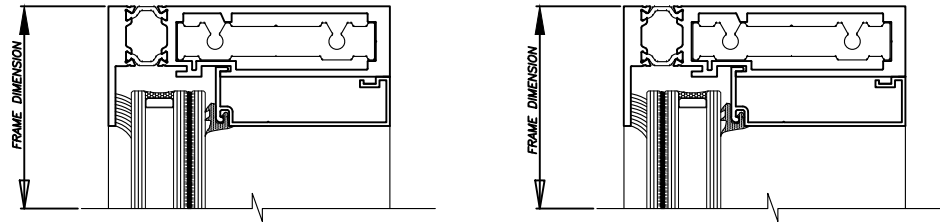
GLAZING: 1 $\frac{5}{16}$ " LAMINATED  
INSULATED IMPACT GLASS

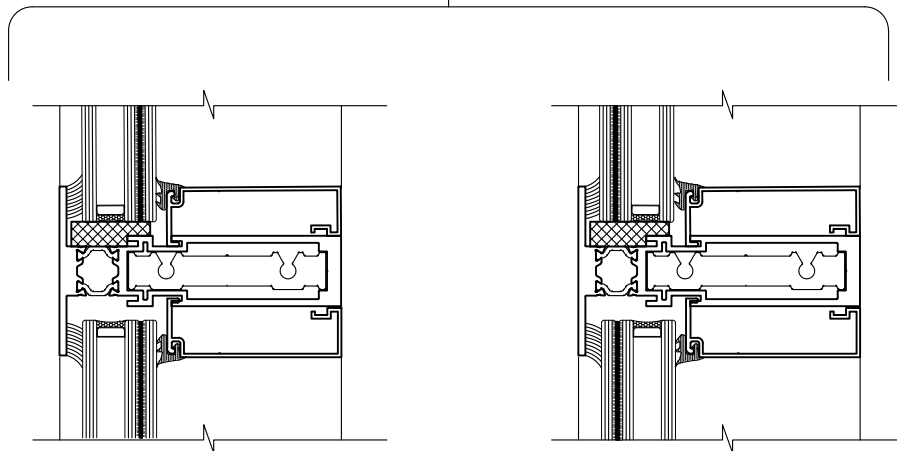
2

LAMINATED GLASS INTERIOR AND EXTERIOR  
OPTION SHOWN

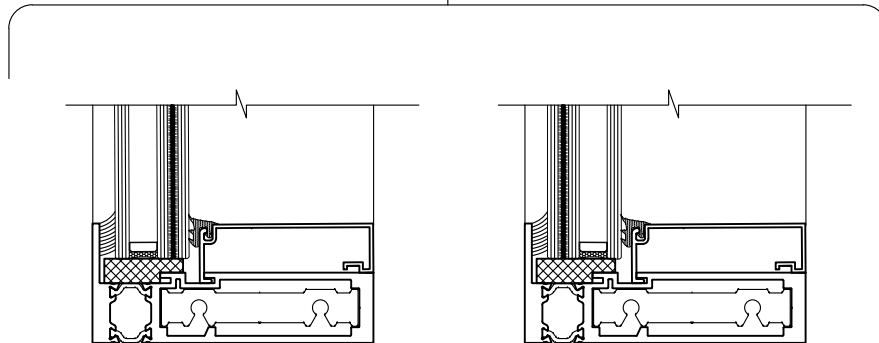
3

GLAZING: 1 $\frac{5}{16}$ " LAMINATED  
INSULATED IMPACT GLASS

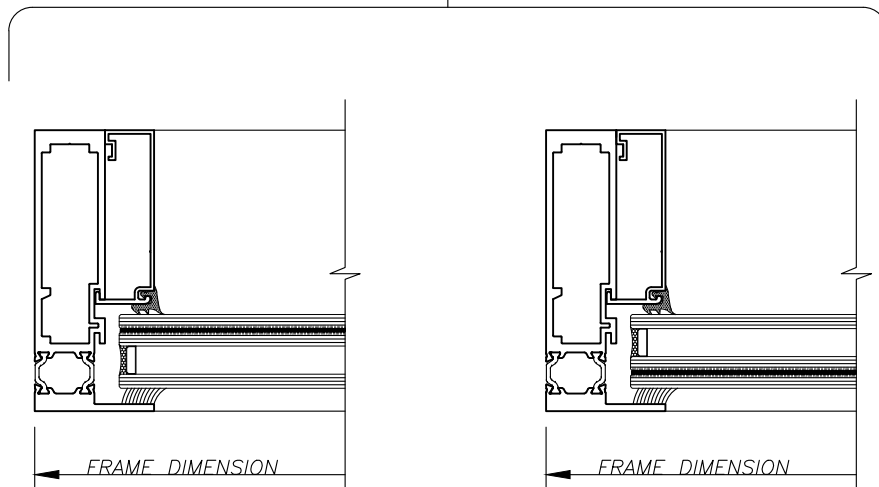
4

LAMINATED GLASS INTERIOR AND EXTERIOR  
OPTION SHOWN

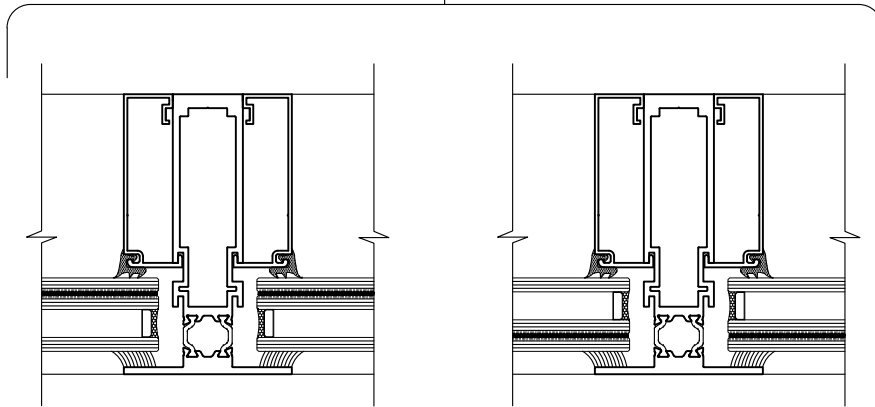
5

GLAZING: 1 $\frac{5}{16}$ " LAMINATED  
INSULATED IMPACT GLASS

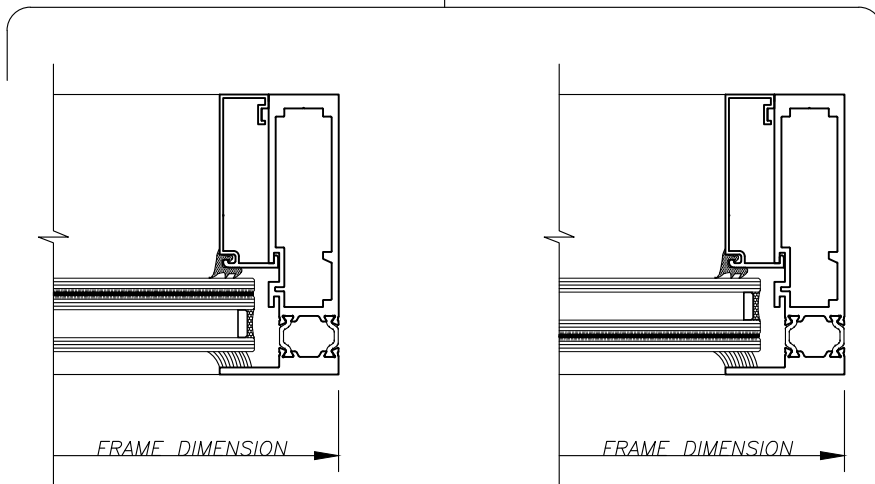
6

LAMINATED GLASS INTERIOR AND EXTERIOR  
OPTION SHOWN

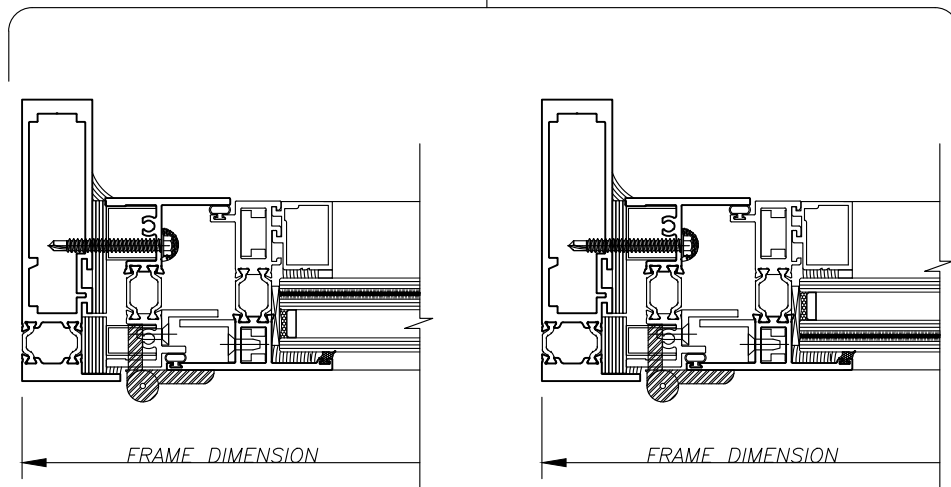
7

GLAZING: 1 $\frac{5}{16}$ " LAMINATED  
INSULATED IMPACT GLASS

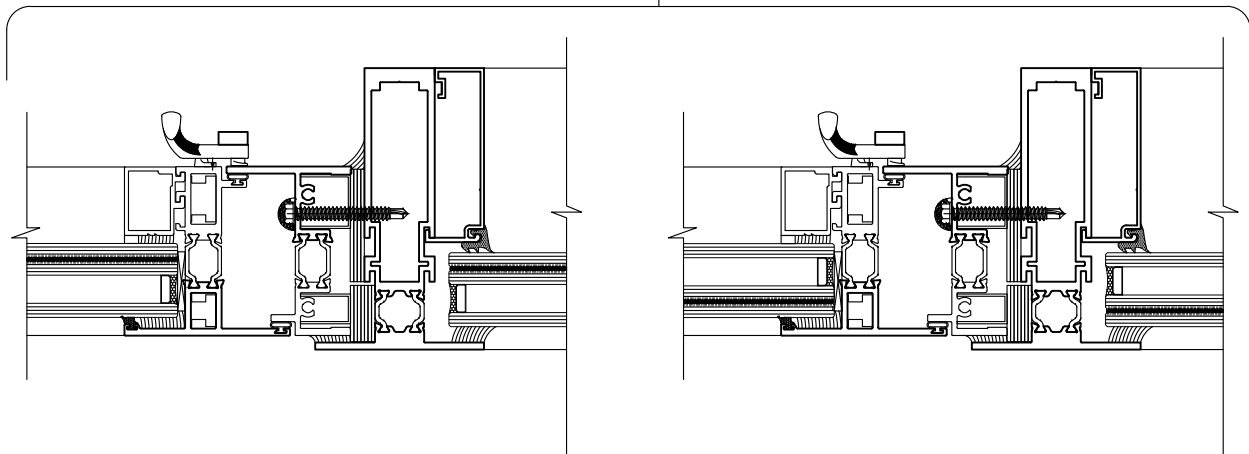
8

LAMINATED GLASS INTERIOR AND EXTERIOR  
OPTION SHOWN

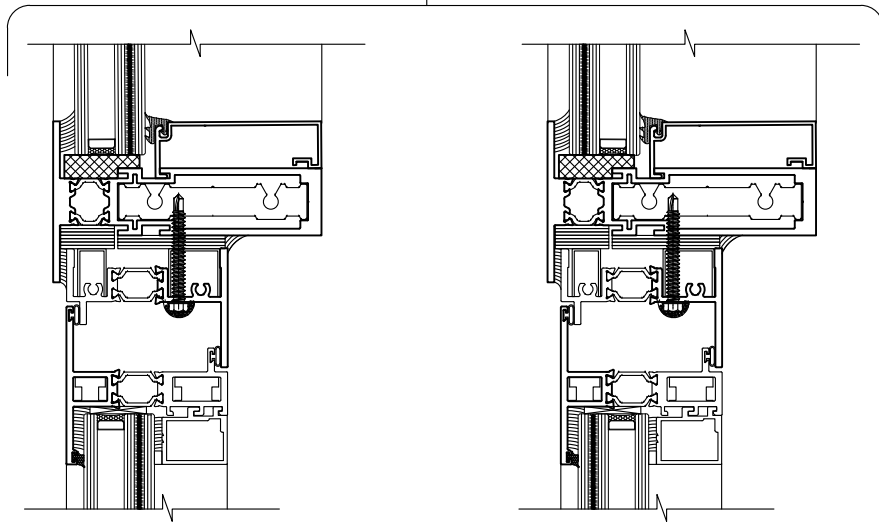
9

GLAZING: 1 $\frac{5}{16}$ " LAMINATED  
INSULATED IMPACT GLASS

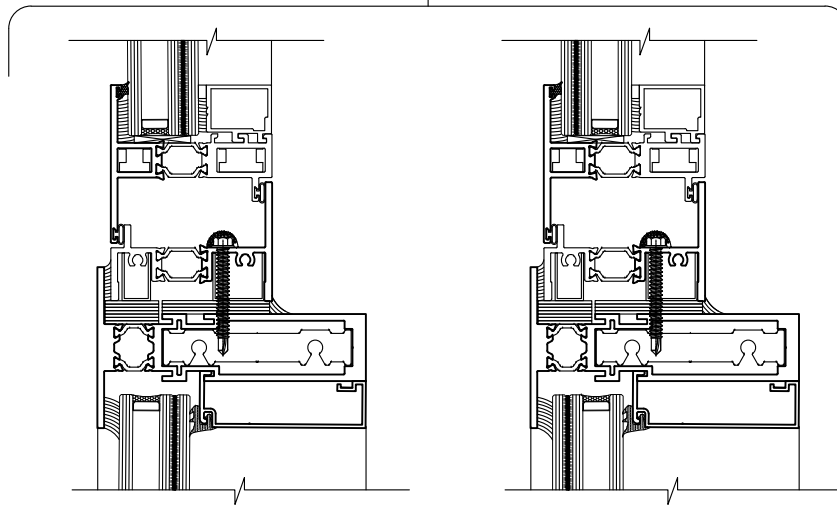
10

LAMINATED GLASS INTERIOR AND EXTERIOR  
OPTION SHOWN

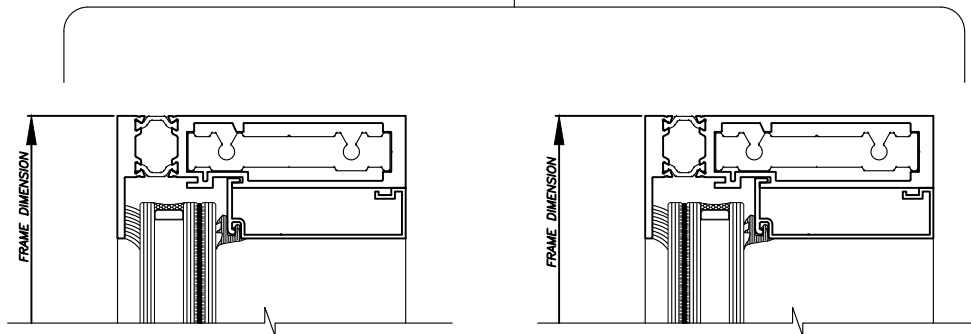
GLAZING: 1 $\frac{5}{16}$ " LAMINATED  
INSULATED IMPACT GLASS

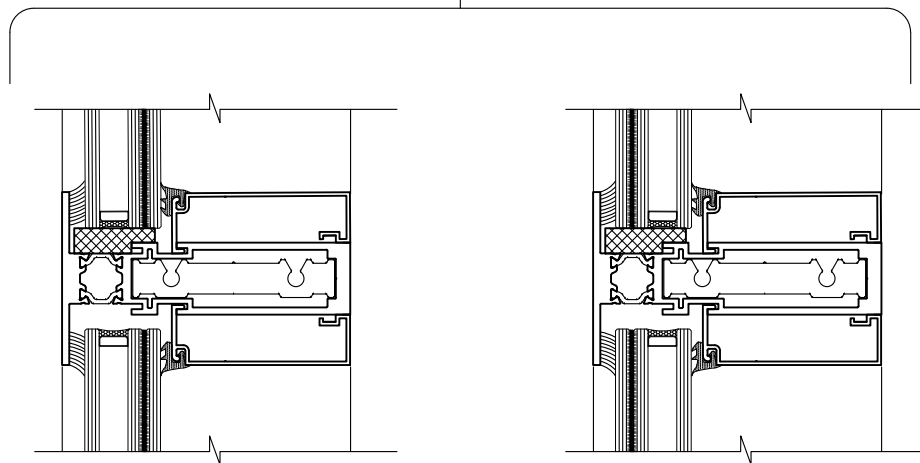
2

LAMINATED GLASS AT INTERIOR AND EXTERIOR  
OPTION SHOWN

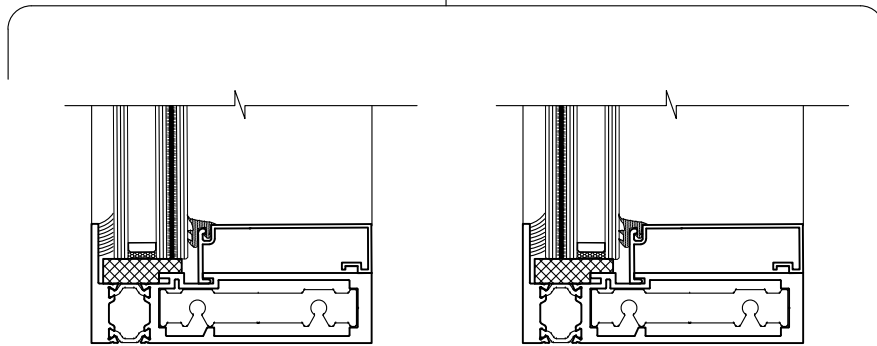
3

GLAZING: 1 $\frac{5}{16}$ " LAMINATED  
INSULATED IMPACT GLASS

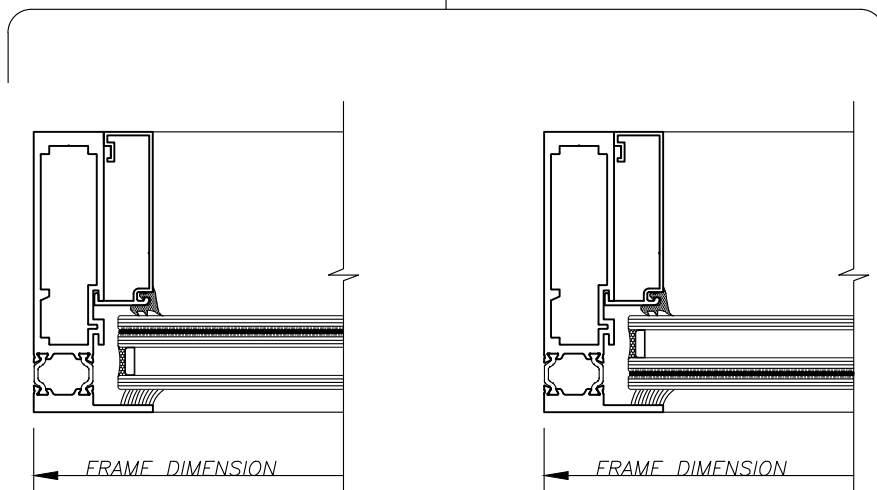
4

LAMINATED GLASS AT INTERIOR AND EXTERIOR  
OPTION SHOWN

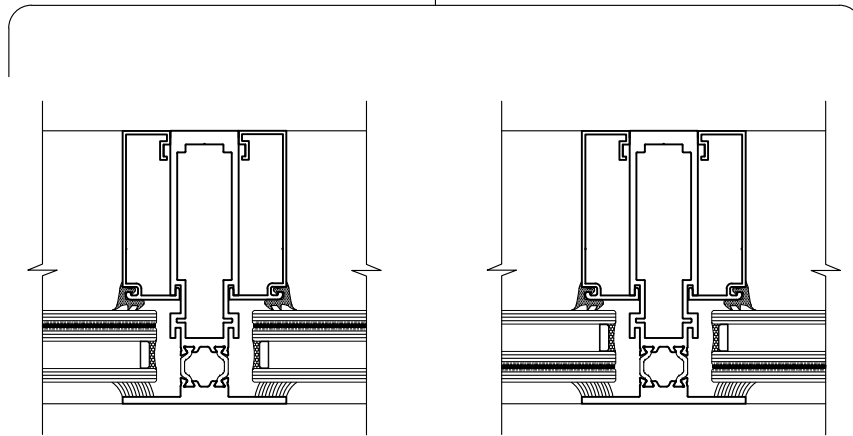
5

GLAZING: 1 $\frac{5}{16}$ " LAMINATED  
INSULATED IMPACT GLASS

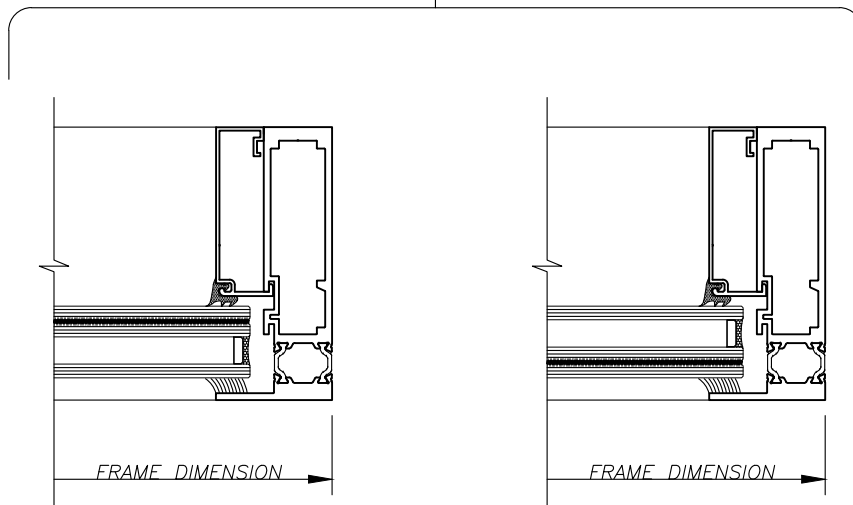
6

LAMINATED GLASS AT INTERIOR AND EXTERIOR  
OPTION SHOWN

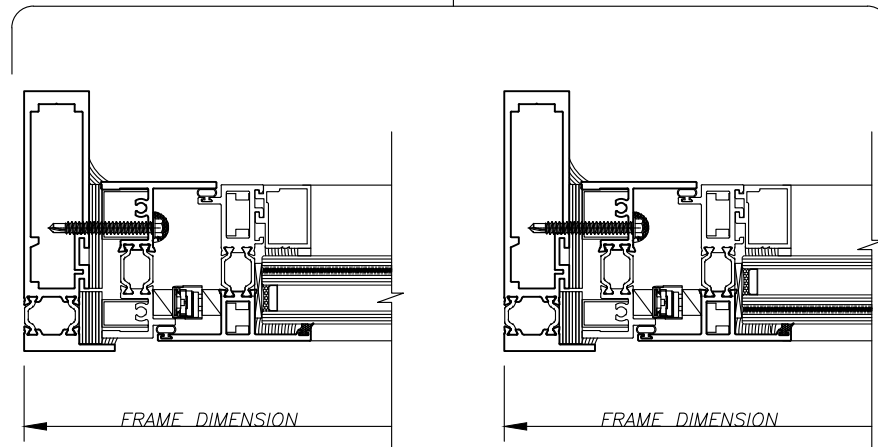
7

GLAZING: 1 $\frac{5}{16}$ " LAMINATED  
INSULATED IMPACT GLASS

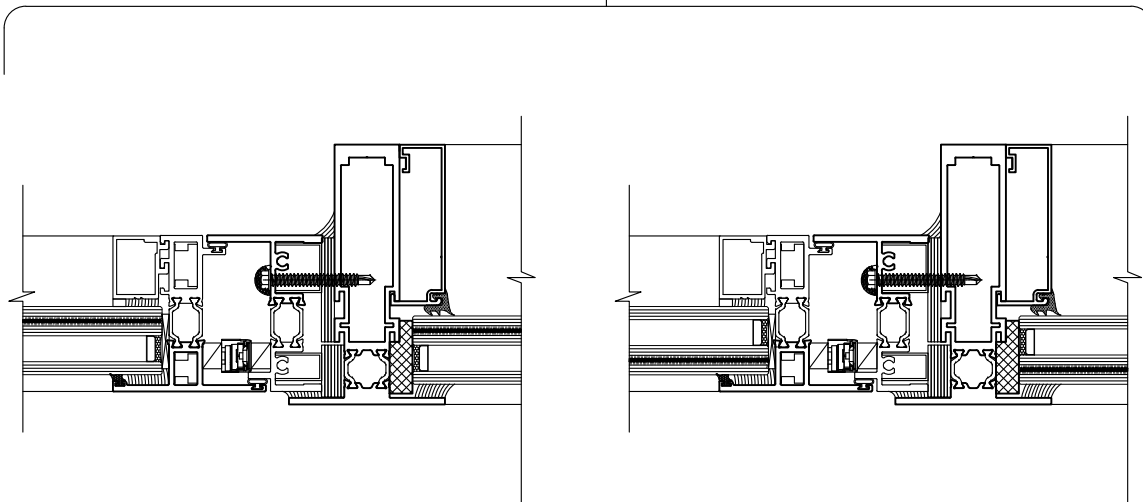
8

LAMINATED GLASS AT INTERIOR AND EXTERIOR  
OPTION SHOWN

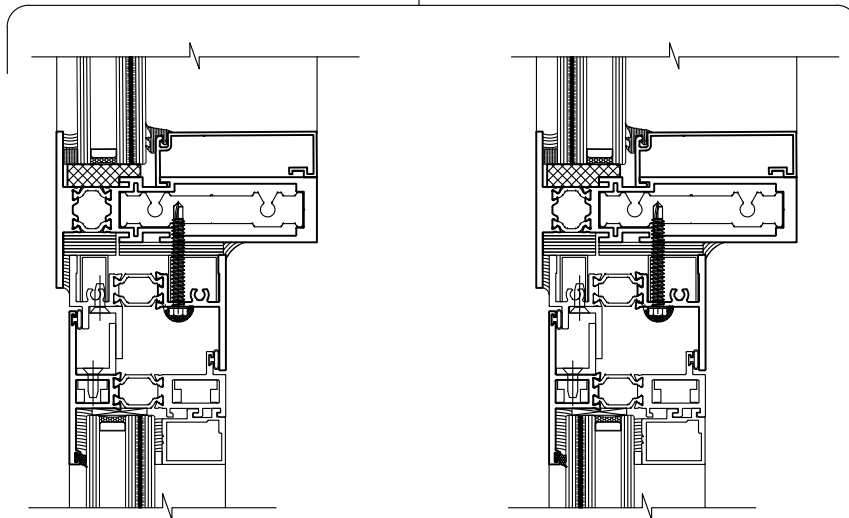
9

GLAZING: 1 $\frac{5}{16}$ " LAMINATED  
INSULATED IMPACT GLASS

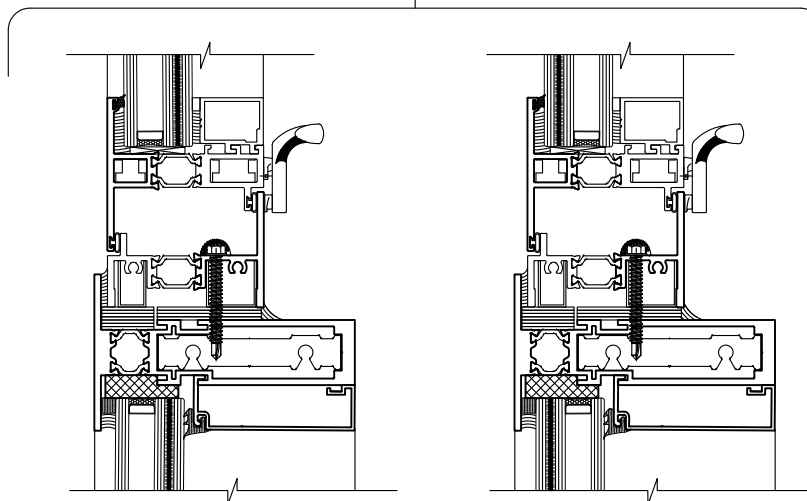
10

LAMINATED GLASS AT INTERIOR AND EXTERIOR  
OPTION SHOWN
