## Good Practice Guide No. 120

### Avoidance of Corrosion in Plumbing Systems

#### **Lifetime Management of Materials**

September 2011

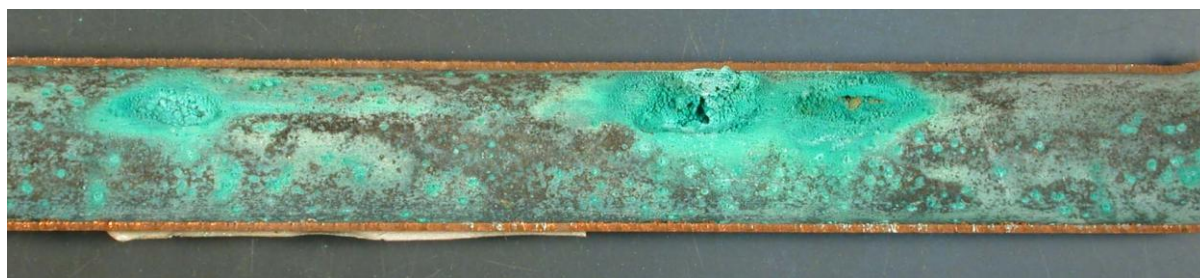
Type 1 pits appear as hemispherical pits overlaid with a mound of blue-green malachite or basic copper carbonate ( $\text{Cu}_2(\text{OH})_2\text{CO}_3$ ). They are usually distributed randomly along a length of pipe, although the deeper pits are nearly always found close to the bottom of horizontal pipe runs. A typical example is shown in Figure 1.

*Figure 1 Type 1 Pitting.*

Although it is not usually practical to change the water composition, the risk of Type 1 pitting occurring can be substantially reduced by always using pipes certified to BS EN 1057 and by avoiding long periods of stagnation between installation and bringing the system into operation. If there is a long period between filling the system and eventual hand-over, then the system should be flushed regularly (at least once a week) in order to introduce fresh aerated water into the system and build-up a stable protective film.

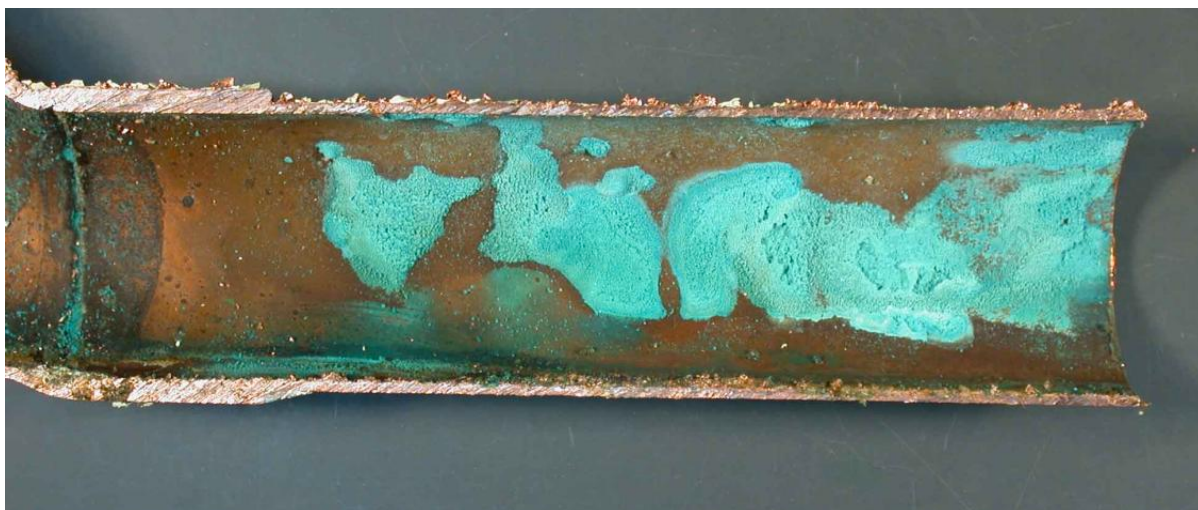
Blue water can occur either due to a high concentration of  $\text{Cu}^{2+}$  ions in the water or, more commonly, through the discharge of particles of copper carbonate patina, which have spalled off the bore of copper pipes. In the first case, this is induced in cuprosolvent water. In the second, it occurs due to a combination of adverse water quality and water stagnation, esp. in the early stages after installation. In either case, it can lead to copper levels in the water exceeding the 2 mg/L limit under drinking water regulations and staining of wash hand basins and baths. Figures 5a and 5b shows an example of an irregular bluish patina which has formed on a length of copper pipe and staining of a wash hand basin.

*Figure 5a Irregular carbonate patina giving rise to blue water.*

In the last few years, there have been several cases of blue water in the north of England, where high levels of phosphate have been found in the copper carbonate patina. The patina itself was irregular and only loosely adherent, so that it was often removed from the top half of the bore. The phosphate derives from the supply water, which has been added by water companies in order to inhibit the corrosion of old lead pipes.

As with pitting corrosion, the likelihood of blue water can be significantly reduced by avoiding water stagnation in the pipes in the period between installation and when the system is brought into use. Chlorination to kill any microbial activity may help as could the fitting of a dolomitic limestone filter on the incoming mains in cases of very soft water. In the few cases where blue water has occurred due to excessive softening, blending the water to give a total hardness of around 60 mg/L, seems to be effective. However, if a substantial irregular patina has been formed then this must be removed by a citric acid flush in order to get back to bare copper. A uniform, stable patina can then only be reformed if regular flushing with fresh water is carried out in the weeks following the citric acid flush. Even then, this treatment may not be effective in the long term, so that complete replacement of pipework may be necessary.

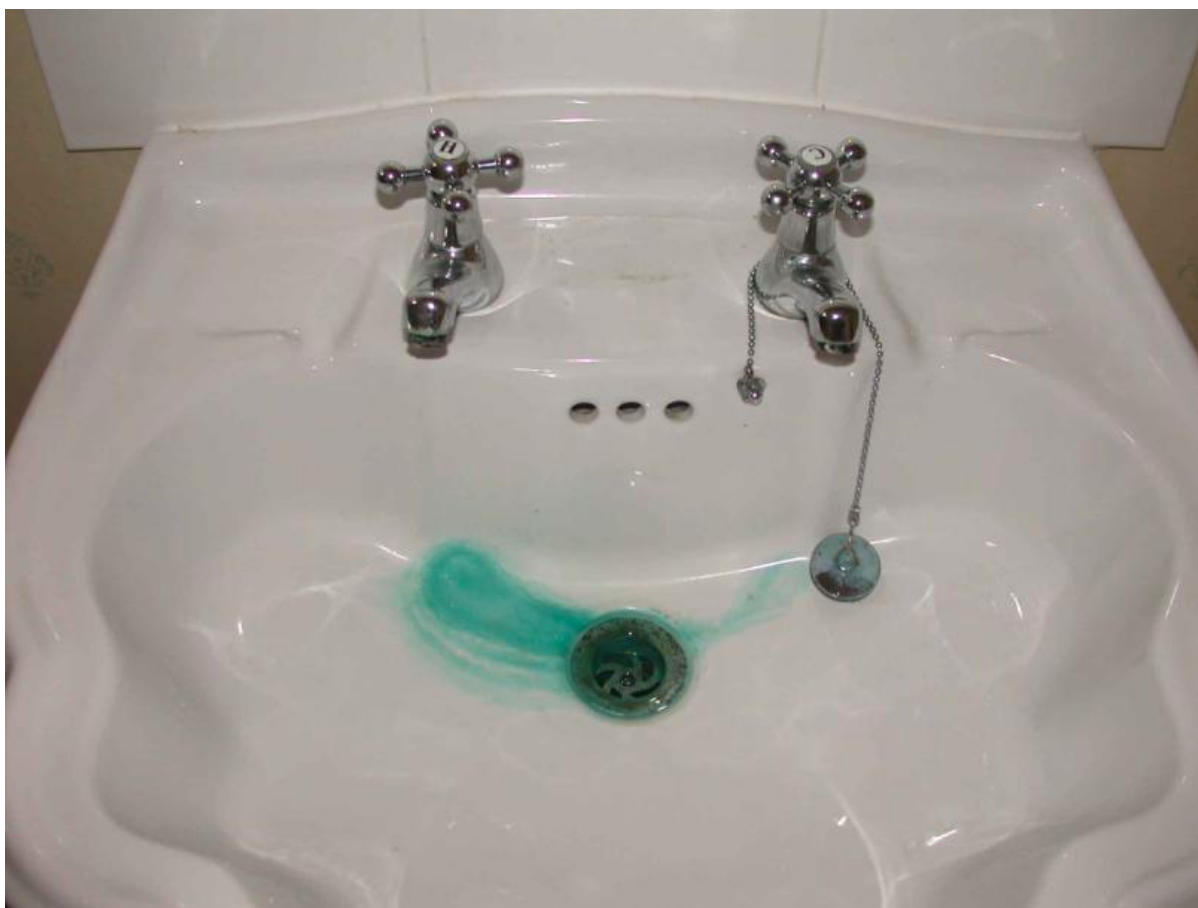
*Figure 5b Staining in hand basin caused by blue water.*
