Title: Product wind and impact resistance testing of a sample of Ultralite rainscreen cladding for TI Tiles International Ltd

Report No: N950-17-17478

Customer: TI Tiles International Ltd
Westview House, Devro Campus
Gartferry Road, Moodiesburn G69 0JE

Issue date: 10 October 2017

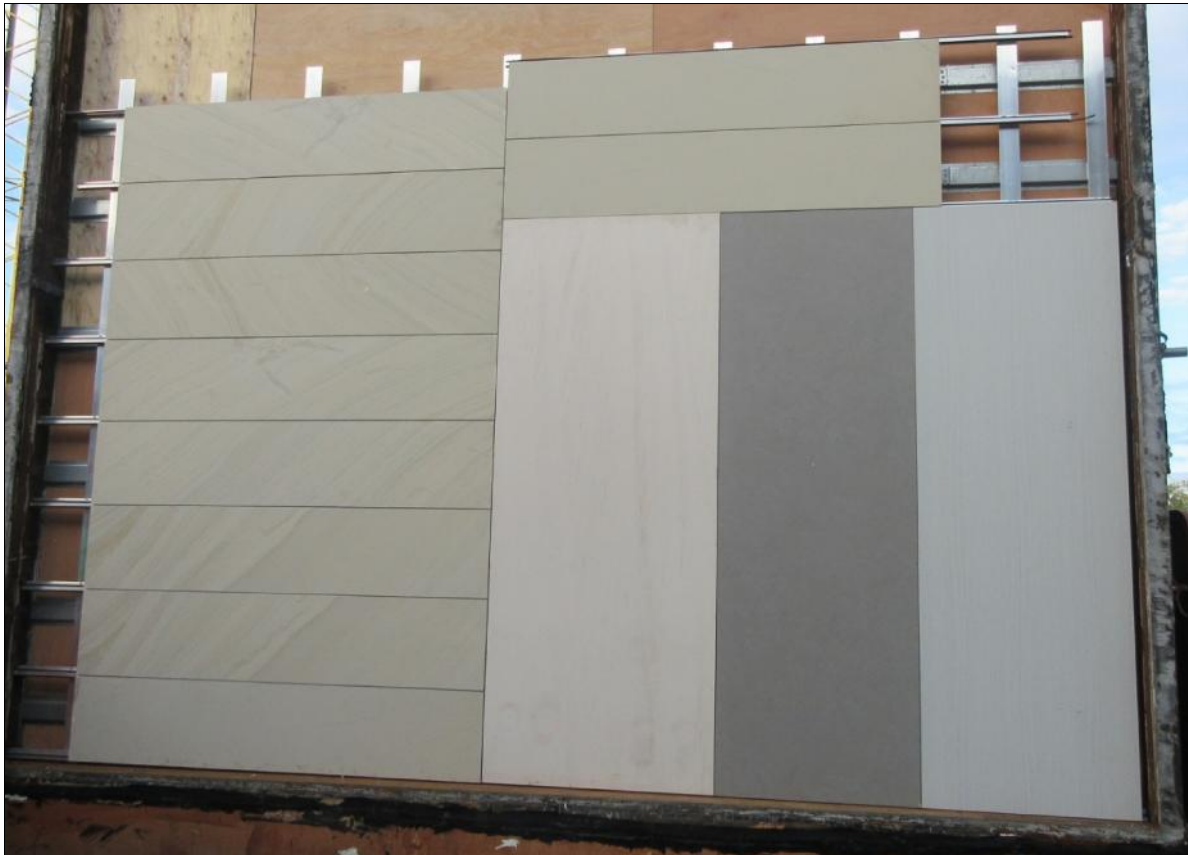
PHOTO 1654

The sample was as shown in the photo below and the drawings included as an appendix to this report.

TEST SAMPLE

During the dismantling of the sample no discrepancies from the drawings were found.

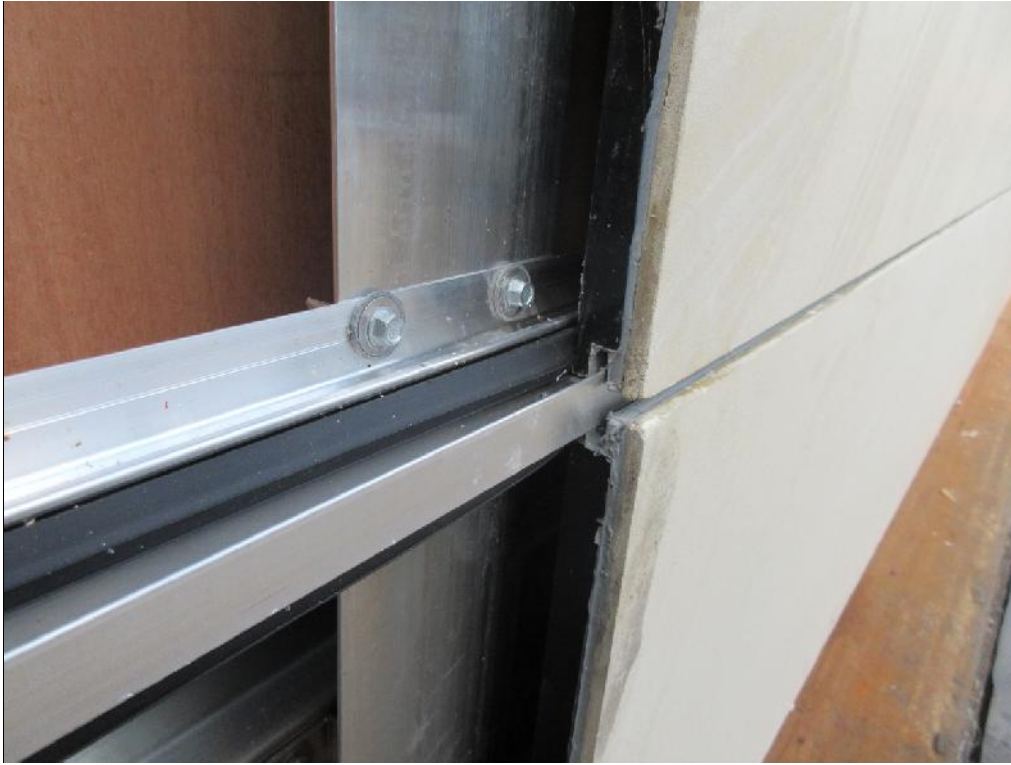
PHOTO 1655

SUPPORT FRAME AND EDGE OF PANELS

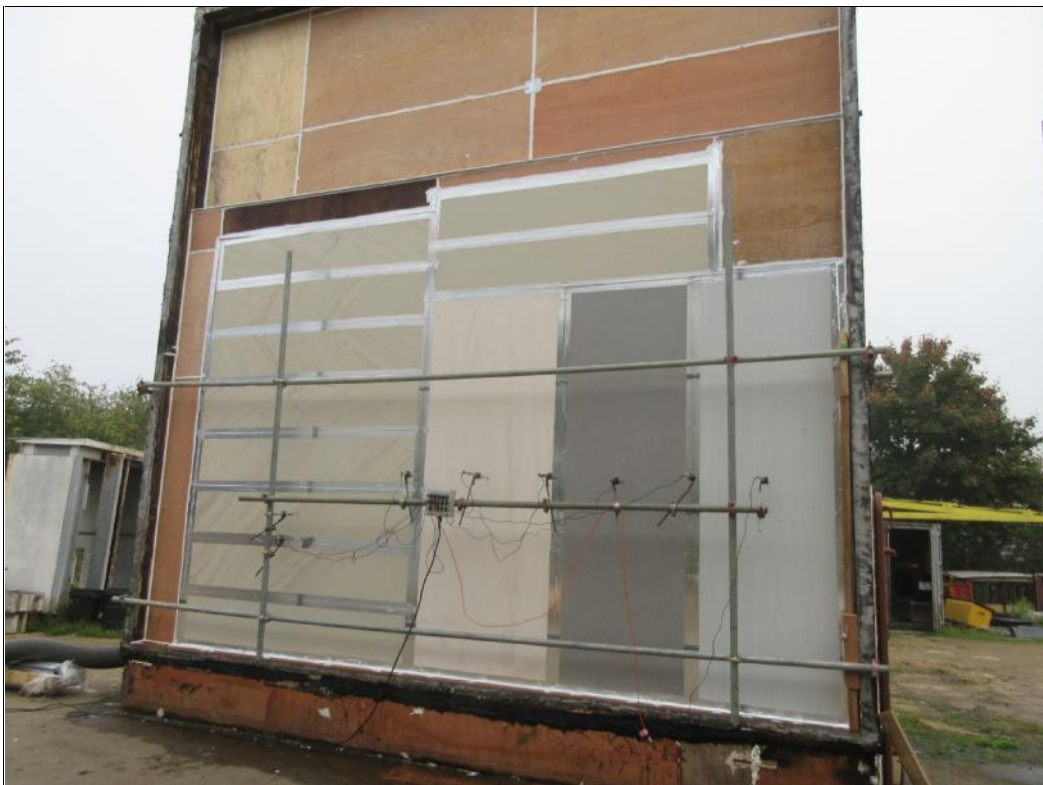
PHOTO 1658

TEST SAMPLE DURING WIND LOADING

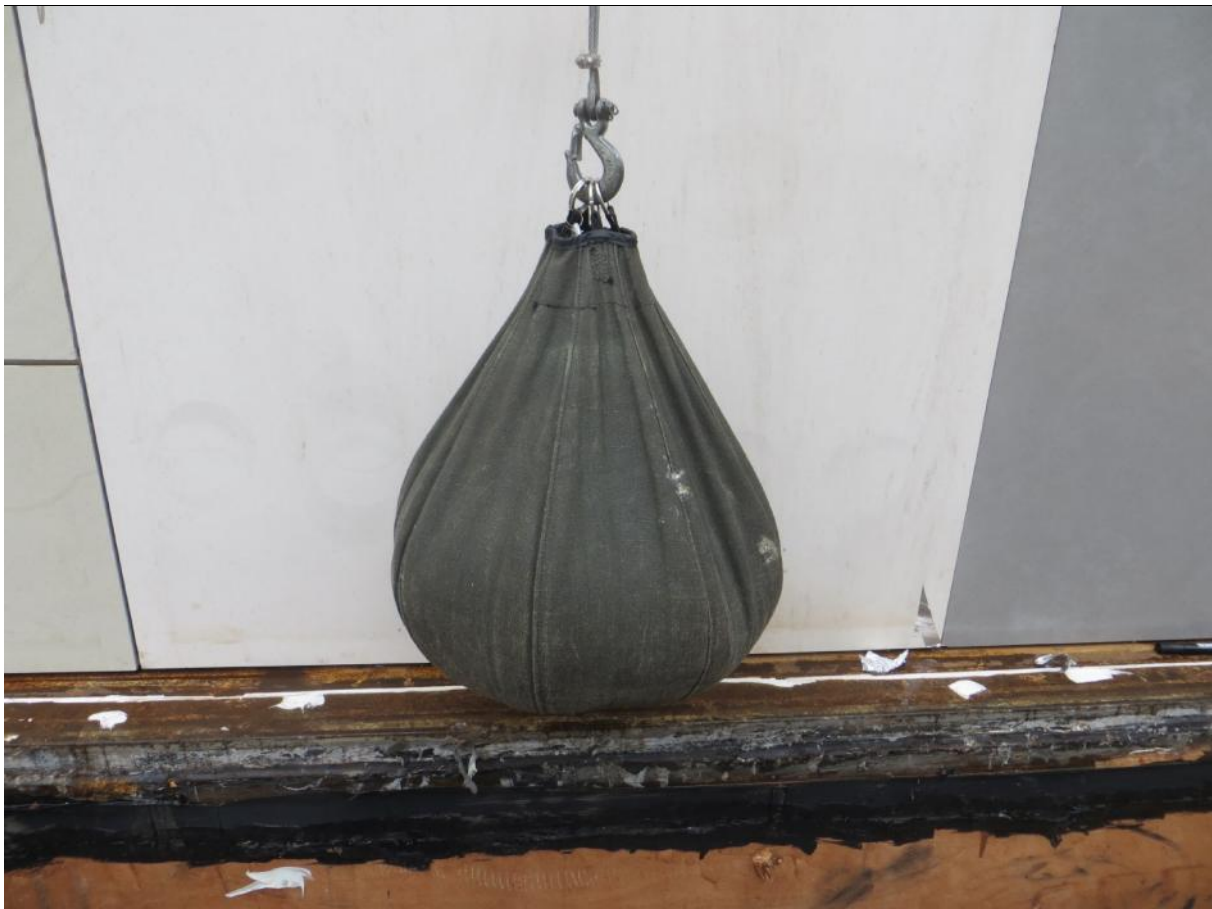
PHOTO 6024

The soft body impactor comprised a canvas spherical/conical bag 400 mm in diameter filled with 3 mm diameter glass spheres with a total mass of 50 kg suspended from a cord at least 3 m long.

SOFT BODY IMPACTOR

The impactor almost touched the face of the sample when at rest. It was swung in a pendular movement to hit the sample normal to its face. The test was performed at the locations shown in Figure 3. The impact energies were 120 Nm for serviceability and 350 Nm and 500 Nm for safety.

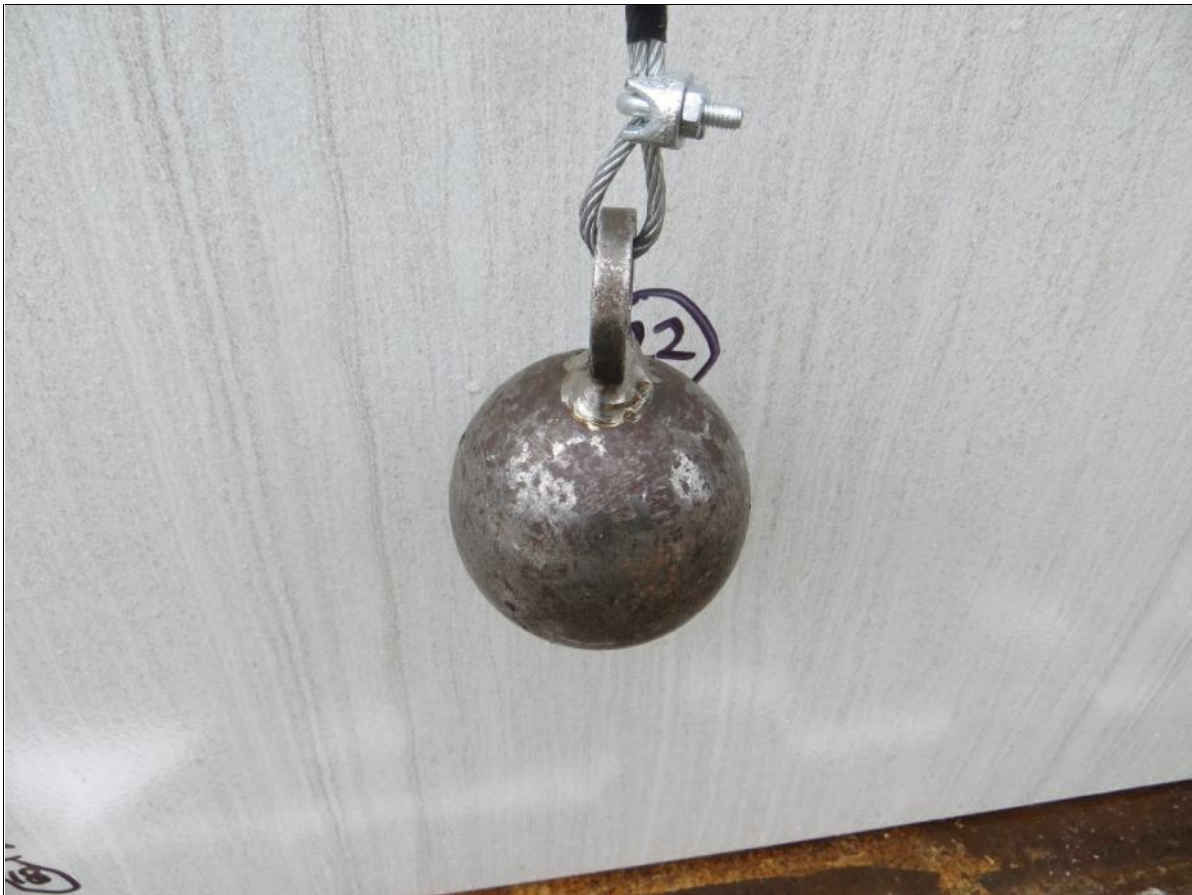
PHOTO 6038

The hard body impactor was a solid steel ball of 50 mm or 62.5 mm diameter and approximate mass of 0.5 kg or 1.0 kg.

HARD BODY IMPACTOR

The impactor almost touched the face of the sample when at rest. It was swung in a pendular movement to hit the sample normal to its face. The test was performed at the locations shown in Figure 4. The impact energies were 3 Nm, 6 Nm and 10 Nm.

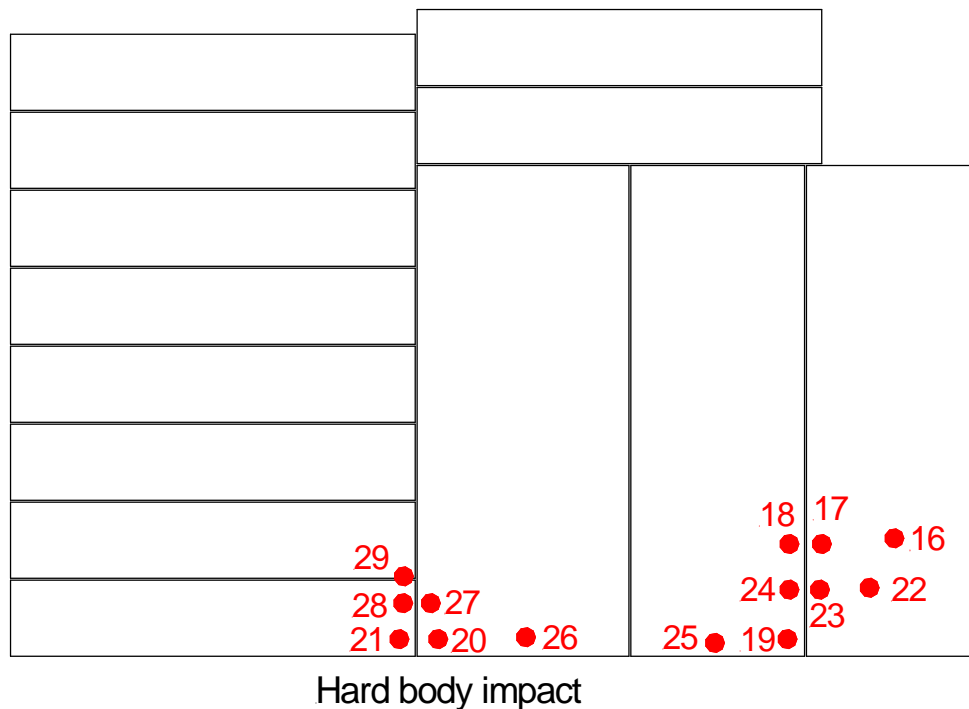
FIGURE 4

HARD BODY IMPACT TEST LOCATIONS

Impact location	Impact energy (Nm)	Observations
16	3 6	No damage observed. Minor indent.
17	3 6	No damage observed. Minor indent.
18	3 6	No damage observed. “
18A	3 6	No damage observed. Small crack.
19	3 6	No damage observed. Minor indent.
20	3 6	No damage observed. Minor indent.
21	3 6	No damage observed. Minor indent.
22	10	Minor indent.
23	10	No damage observed.
24	10	Minor indent.
25	10	Minor indent.
26	10	Minor indent.
27	10	No damage observed.
28	10	Minor indent.
29	10	No damage observed.

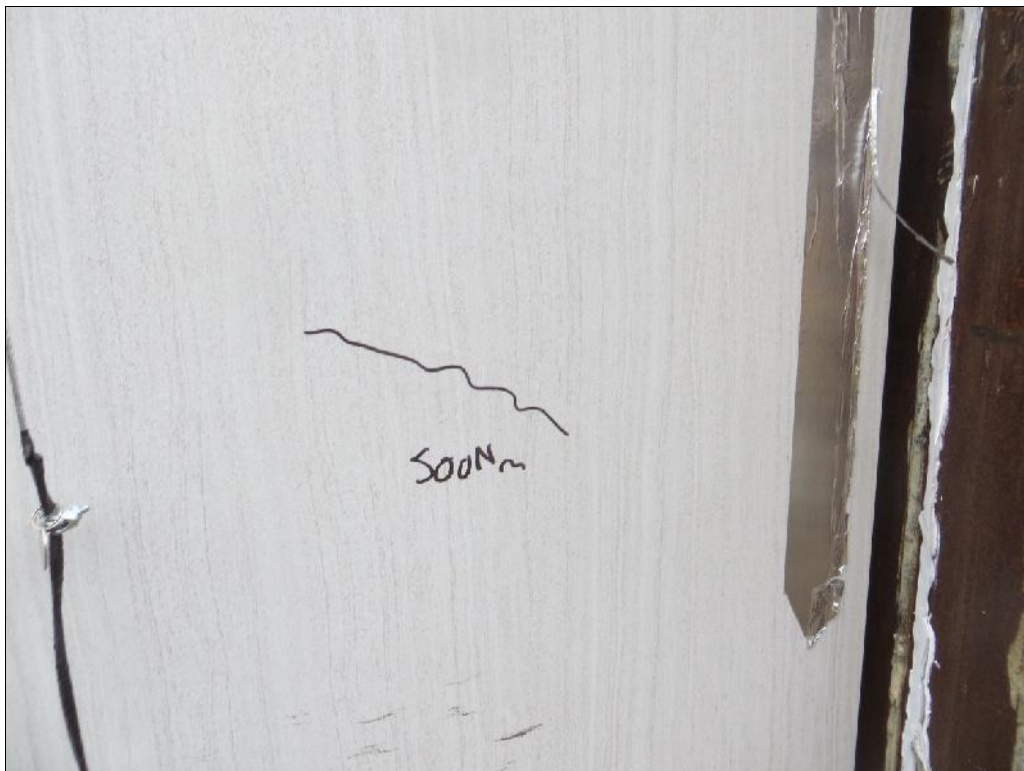
PHOTO 6026

SOFT BODY IMPACT AT LOCATION 14 (marker pen line along hairline crack)

Impact location	Impact energy (Nm)	Observations
1	120 x 3 350 500	No damage observed. “ “
2	120 x 3 350 500	No damage observed. “ “
3	120 x 3 350 500	No damage observed. “ “
4	120 x 3 350 500	No damage observed. “ “
5	120 x 3 350 500	No damage observed. “ “
6	120 x 3 350 500	No damage observed. “ “
7	120 x 3 350 500	No damage observed. “ “
8	120 x 3 350 500	No damage observed. “ “
9	120 x 3 350 500	No damage observed. “ Hairline crack. No fallout.
10	120 x 3 350 500	No damage observed. “ “
11	120 x 3 350 500	No damage observed. “ “
12	120 x 3 350 500	No damage observed. “ “
13	120 x 3 350 500	No damage observed. “ “
14	120 x 3 350 500	No damage observed. “ Hairline crack. No fallout.
15	120 x 3 350 500	No damage observed. “ Hairline crack. No fallout.

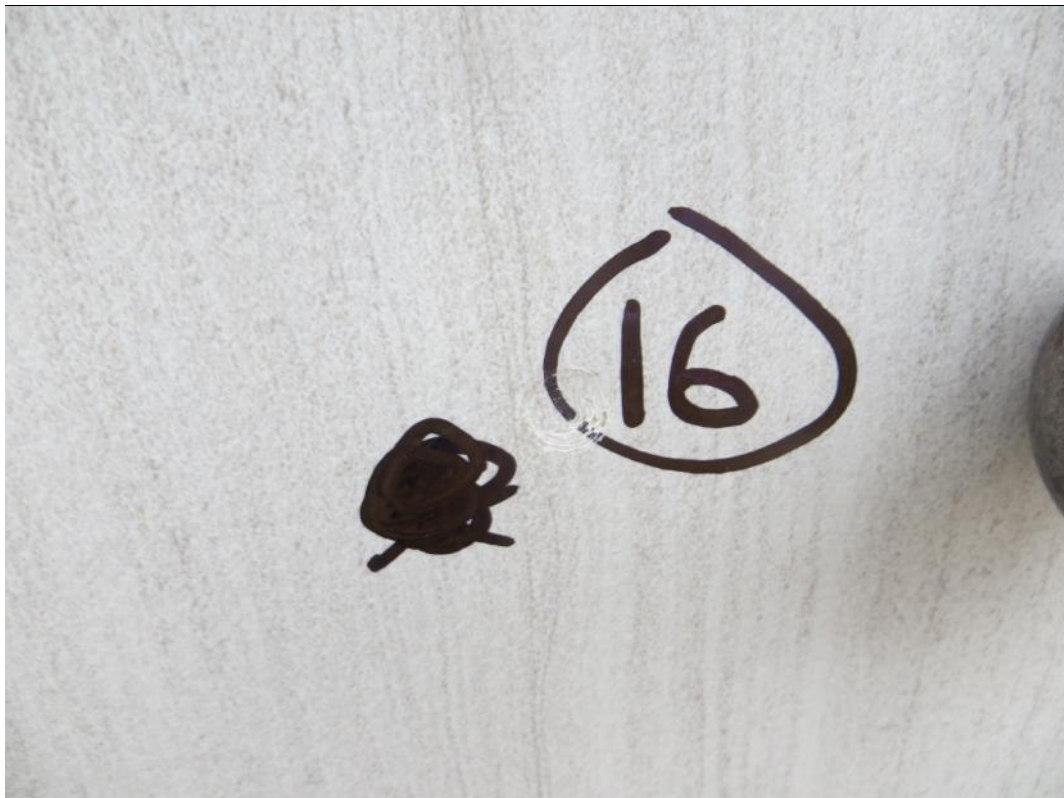
PHOTO 6030

HARD BODY IMPACT AT LOCATION 16

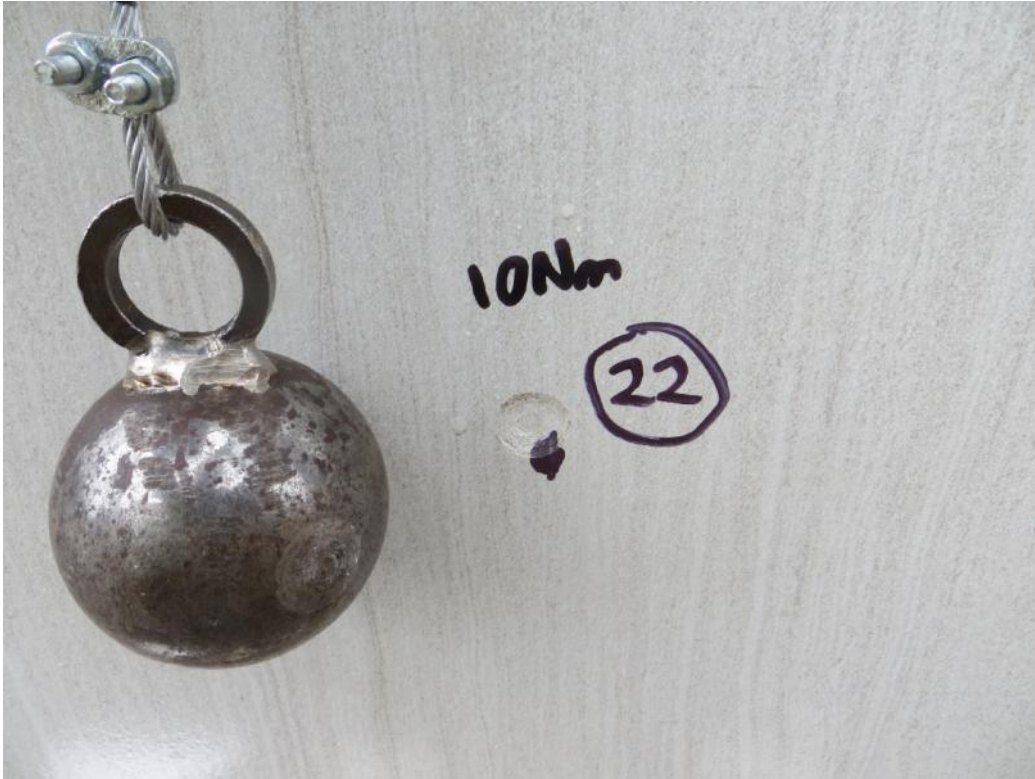
PHOTO 6039

HARD BODY IMPACT AT LOCATION 22

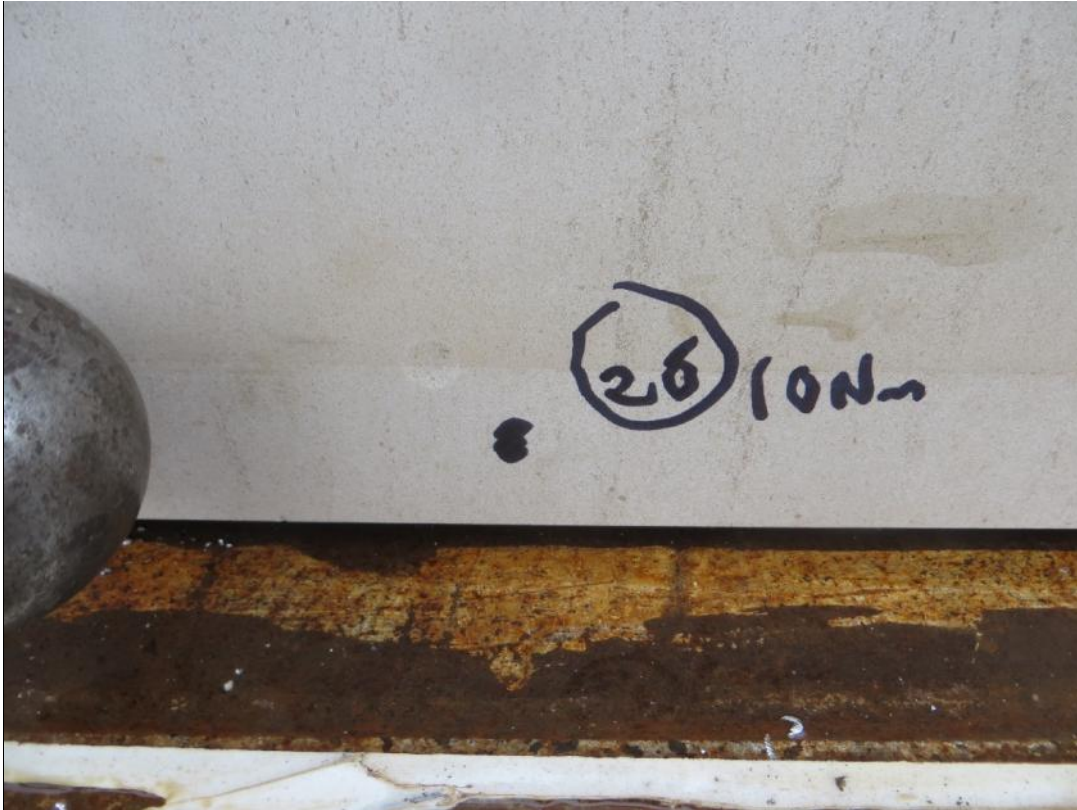
PHOTO 6042

HARD BODY IMPACT AT LOCATION 26
