# Wind load and impact testing of a sample of Rainscreen Cladding using a TI-Tracking Carrier Frame

Report No. N950/10/16184

September 2010

N950/10/16184  
26 OCTOBER, 2010

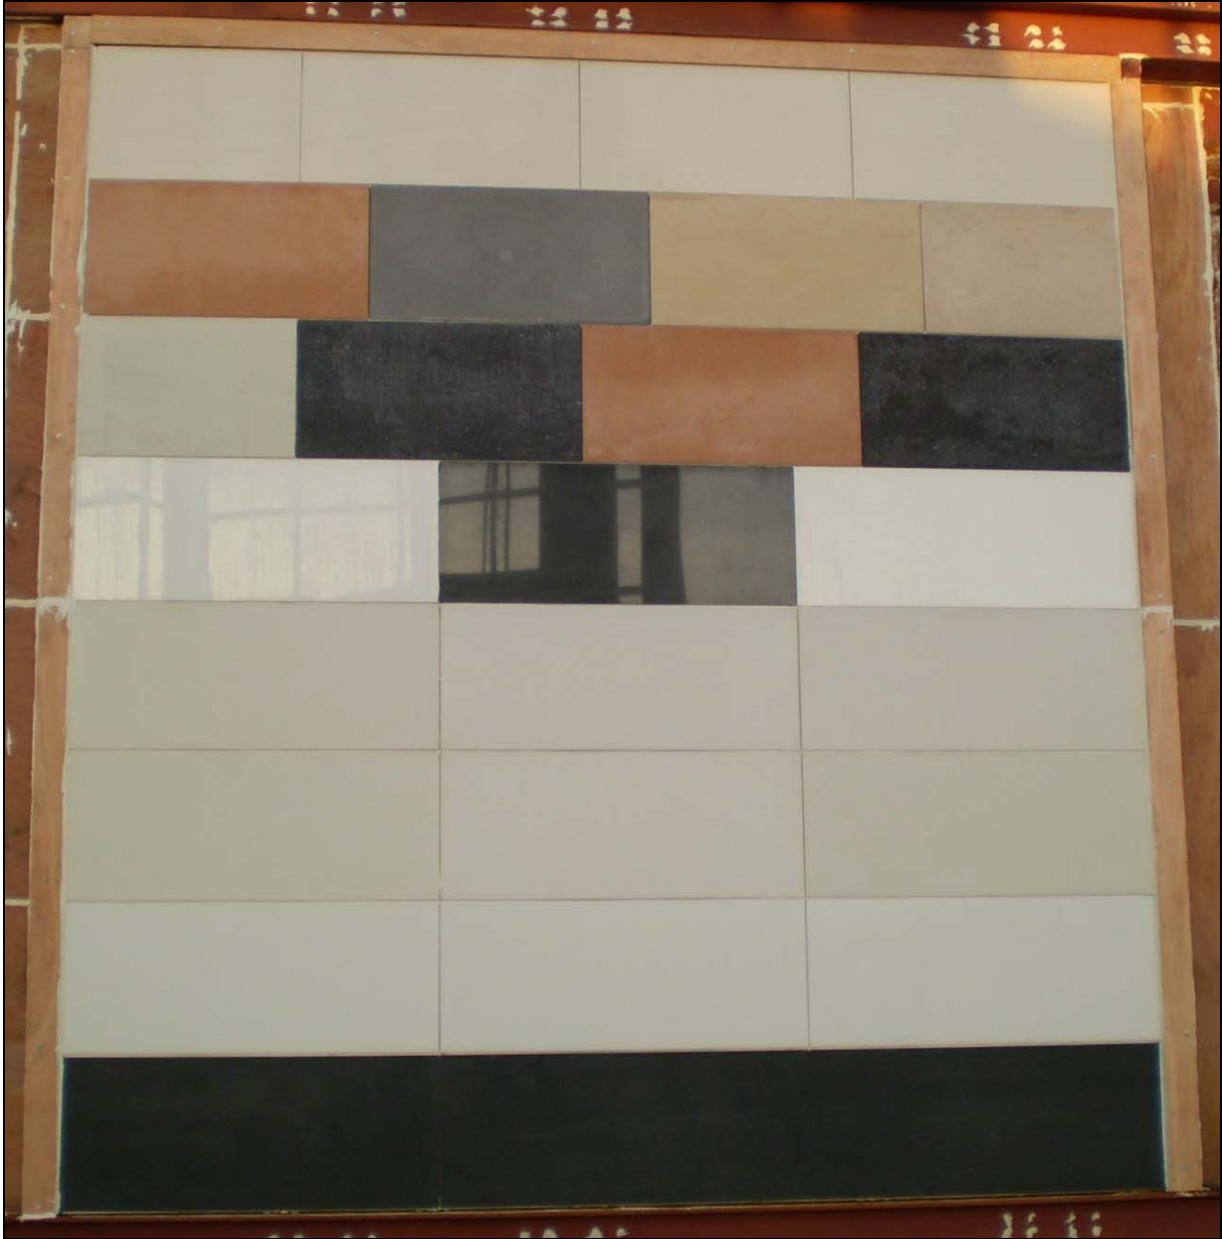
PHOTO 3160041

The test sample comprised of an array of rainscreen panels 1500mm wide by 600mm high and 1200mm wide by 600mm high set in a landscape style.

The panels from bottom to top were three number black polished Aerolite Granite panels 15mm thick c/w fiberglass reinforced backing 1500mm wide by 600mm high; followed by three number white Urban Glass panels 15mm thick c/w fiberglass reinforced backing 1500mm wide by 600mm high.

TEST SAMPLE ELEVATION

The sample was as shown in the photo below and the drawing included as an appendix to this report.

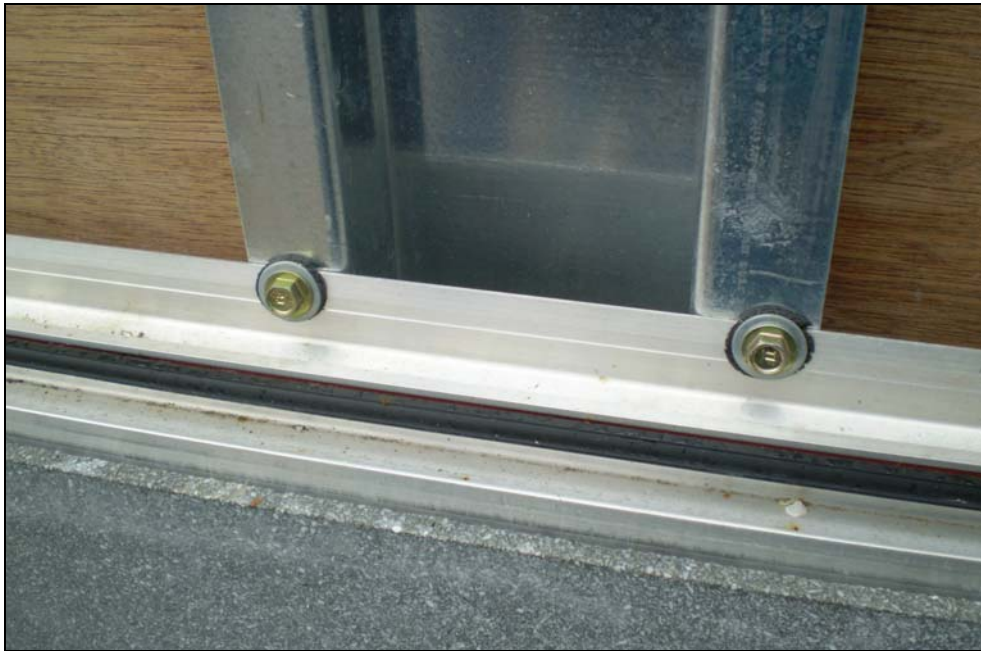
PHOTO 7010014

The horizontal Ti-Tracking carrier rails were tek screw fixed to vertical spanning 1.6mm galvanized steel inverted top-hats 30mmx30mmx80mmx30mmx30mm at 600mm centres which were tek fixed through to an appropriately designed backing structure. This comprised vertical spanning channel sections faced with 20mm thick plywood externally.

CARRIER FRAME FIXINGS INTO VERTICAL TOP-HAT SUPPORT

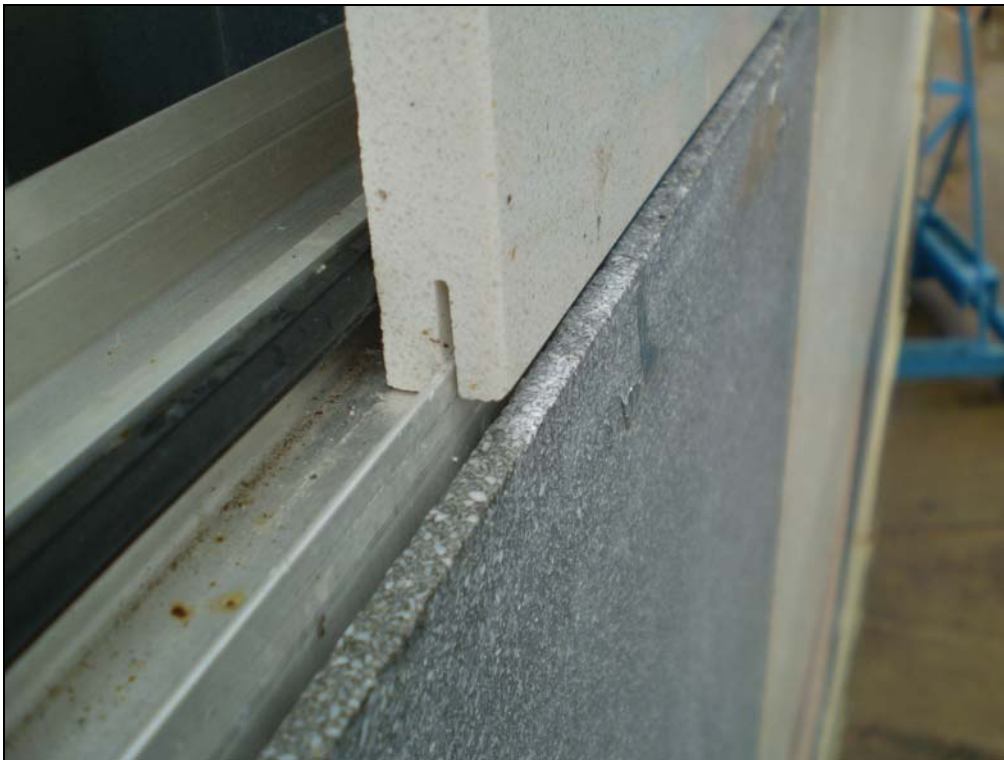
PHOTO 7010015

The panels had special rebated longitudinal edges that enabled them to engage into the horizontal TI-Tracking carrier rail which were spaced at 600mm module (see dwg in appendix).

GROOVE IN EDGE OF TILE RESTING ON CARRIER FRAME

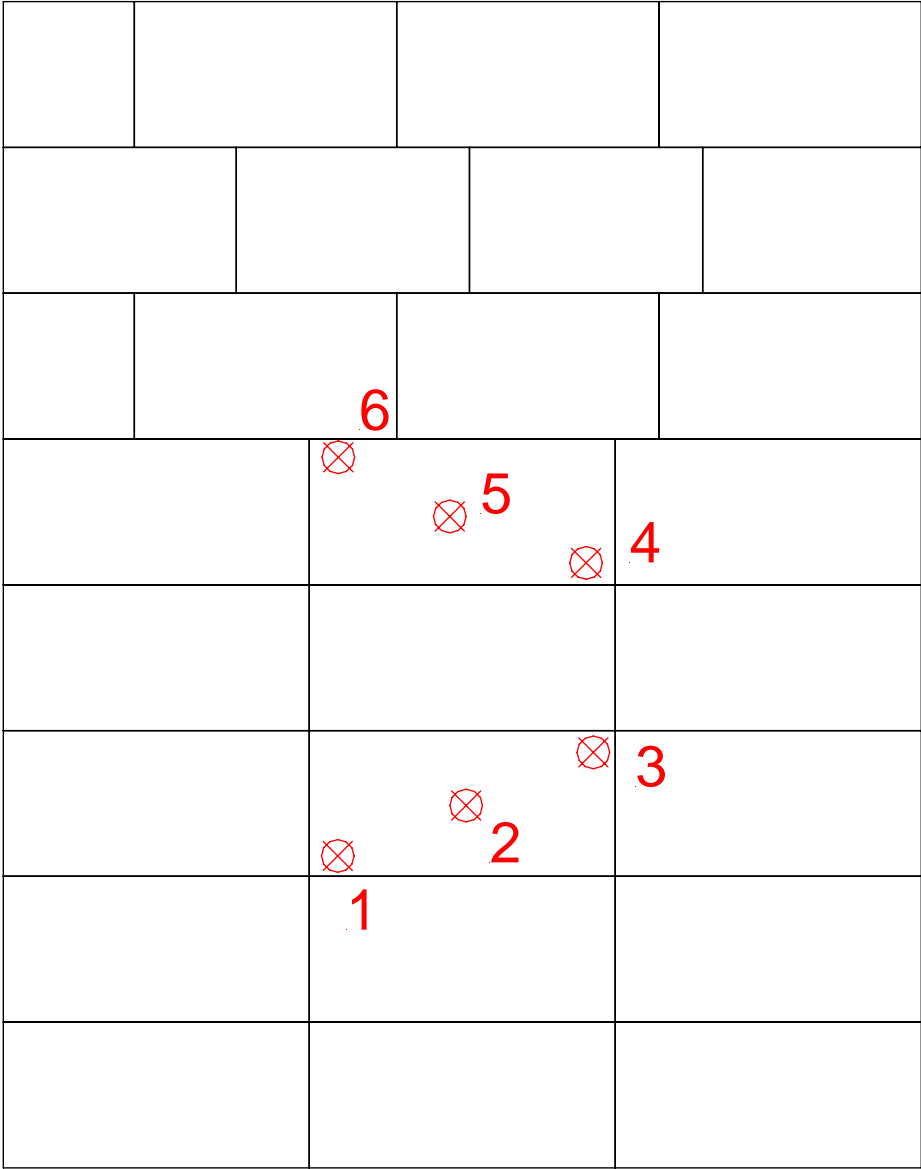
FIGURE 2

Displacement transducers were used to measure the deflection of principle framing members to an accuracy of 0.1 mm. The gauges were set normal to the sample framework at mid-span and as near to the supports of the members as possible and installed in such a way that the measurements were not influenced by the application of pressure or other loading to the sample. The gauges were located at the positions shown in Figure 2.

DEFLECTION GAUGE LOCATIONS

deflection gauge

The deflections measured during the wind resistance test, at the positions shown in Figure 2, are shown in Tables 3 and 4.

Position	Pressure (pascals) / Deflection (mm)				
	600	1201	1821	2399	Residual
1	0.5	0.9	1.2	1.5	0.0
2	0.5	1.0	1.4	1.8	0.0
3	0.6	1.1	1.6	2.2	0.1
4	0.5	1.1	1.7	2.4	0.1
5	0.6	1.2	1.9	2.5	0.1
6	0.3	0.7	1.0	1.4	0.1
2 *	0.0	-0.1	0.0	0.0	0.0
5*	0.2	0.3	0.5	0.6	0.0

Position	Pressure (pascals) / Deflection (mm)				
	-593	-1204	-1820	-2411	Residual
1	-0.6	-1.2	-2.1	-3.0	-0.2
2	-0.8	-1.8	-2.9	-4.0	-0.1
3	-0.8	-1.7	-2.7	-3.8	-0.3
4	-0.6	-1.4	-2.3	-3.3	-0.3
5	-0.8	-1.8	-3.1	-4.3	-0.1
6	-0.6	-1.4	-2.3	-3.3	-0.3
2 *	-0.1	-0.4	-0.5	-0.6	0.1
5 *	-0.2	-0.5	-0.7	-1.0	0.2

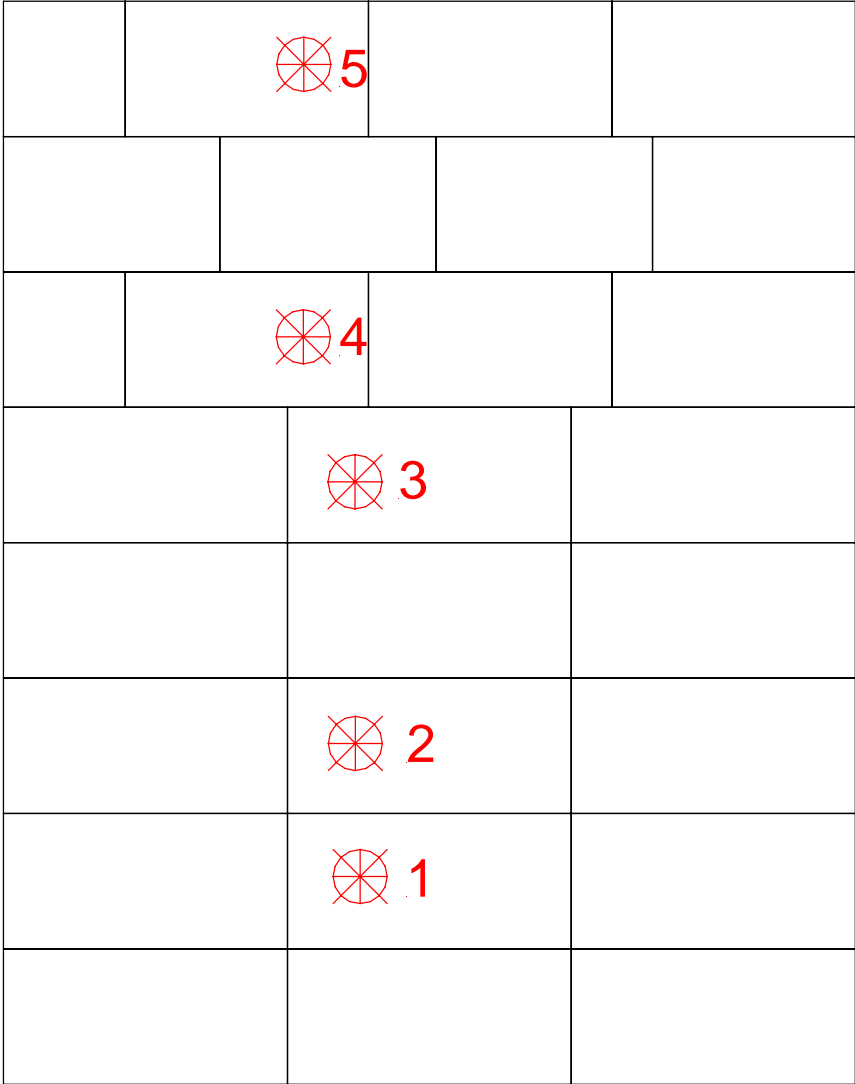
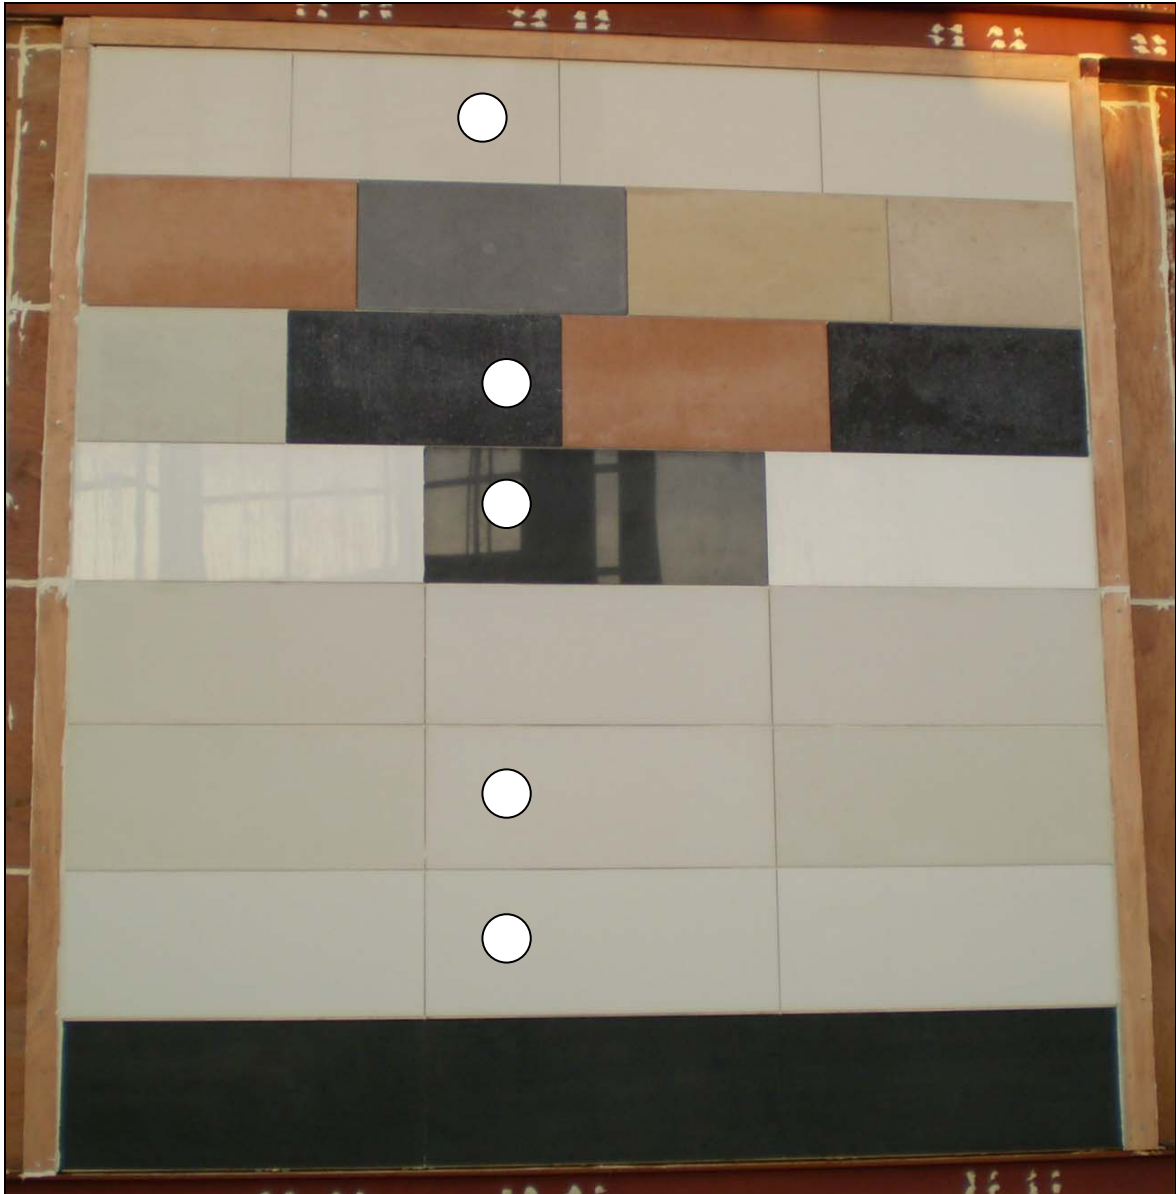
FIGURE 3

The impactor almost touched the face of the sample when at rest. It was swung in a pendular movement to hit the sample normal to its face. The test was performed at the locations shown in Figure 3. The impact energies were 120, 350 and 500 Nm.

SOFT BODY IMPACT TEST LOCATIONS

○ Soft body impact location

500 Nm – A small chip in the top left-hand corner was observed.

500 Nm – The panel broke.

Impact location	Impact energies (Nm)	Result
1	120, 350, 500	Pass
2	120, 350, 500	Pass
3	120, 350, 500	Pass
4	120, 350, 500	Pass
5	120, 350, 500	Fail at 500 Nm

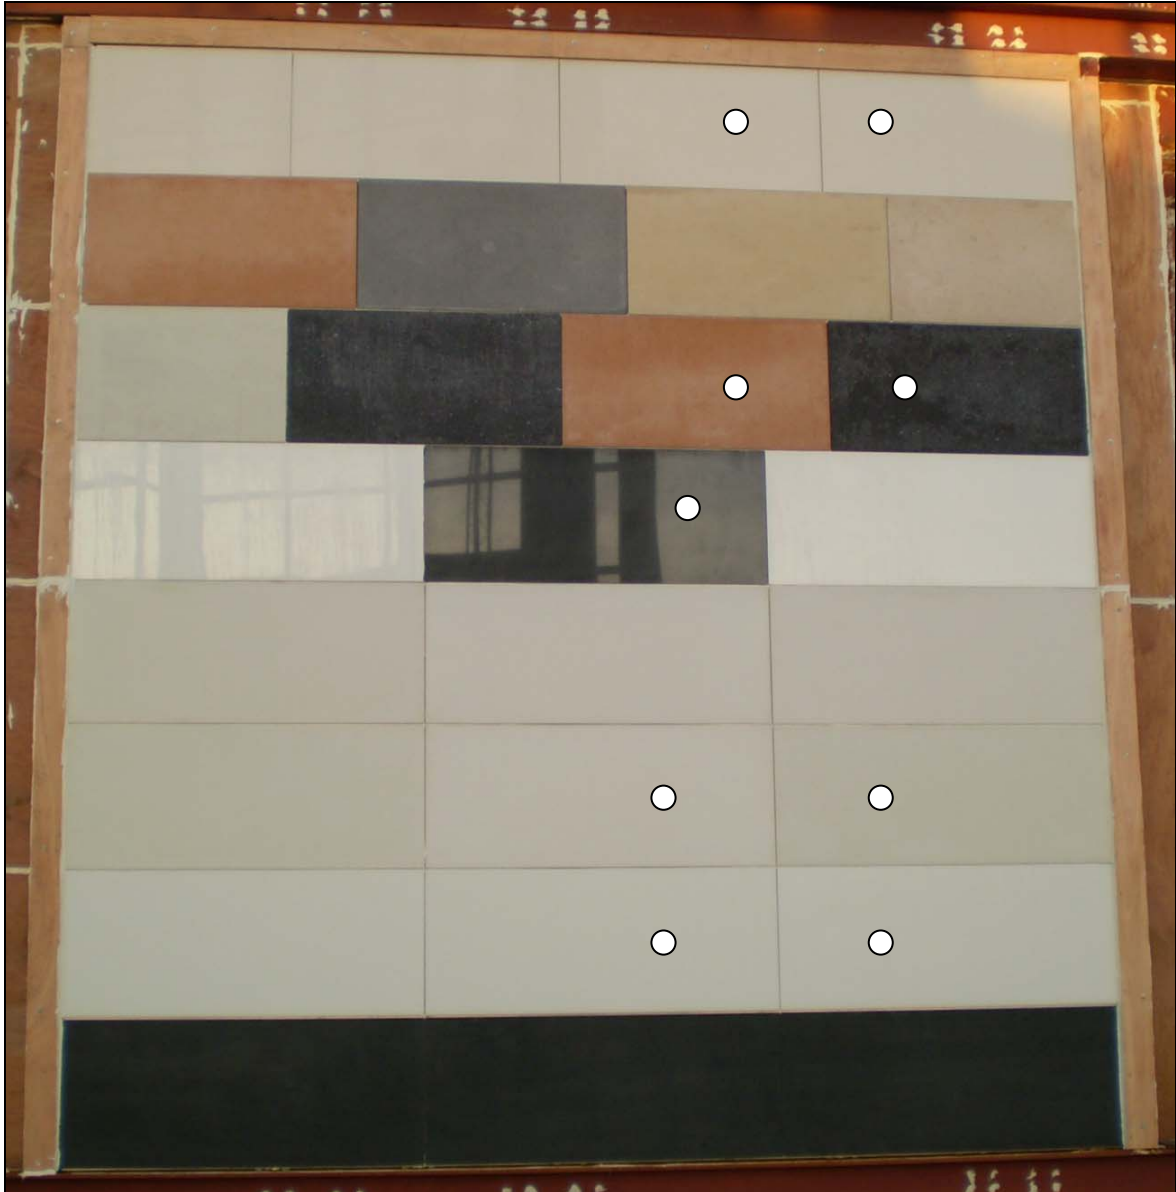
FIGURE 4

The impactor almost touched the face of the sample when at rest. It was swung in a pendular movement to hit the sample normal to its face. The test was performed at the locations shown in Figure 4. The impact energies were 3, 6 and 10 Nm.

HARD BODY IMPACT TEST LOCATIONS

○ Hard body impact location

Impact location	Impact energies (Nm)	Result
1	3, 6	Pass
2	3, 6	Pass
3	3, 6	Pass
4	3, 6	Pass
5	3, 6, 10	Pass
6	10	Pass
7	10	Pass
8	10	Pass
9	10	Pass

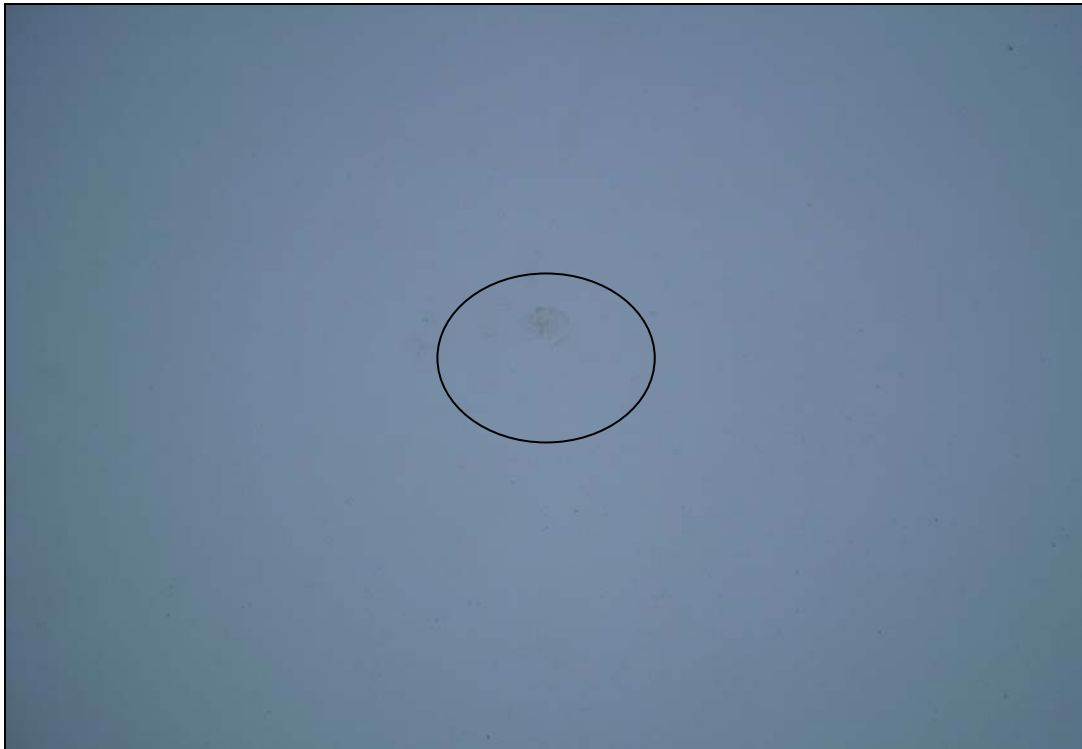
PHOTO 3260016

10 Nm – A small indent was observed in the panel.

TILE AFTER 10 Nm HARD BODY IMPACT AT LOCATION 6
