Title: Weathertightness testing of a sample of T.I.DF-2 rainscreen cladding

Report No: N950-25-18986

Customer: TI Tiles International

Issue date: 05 September 2025

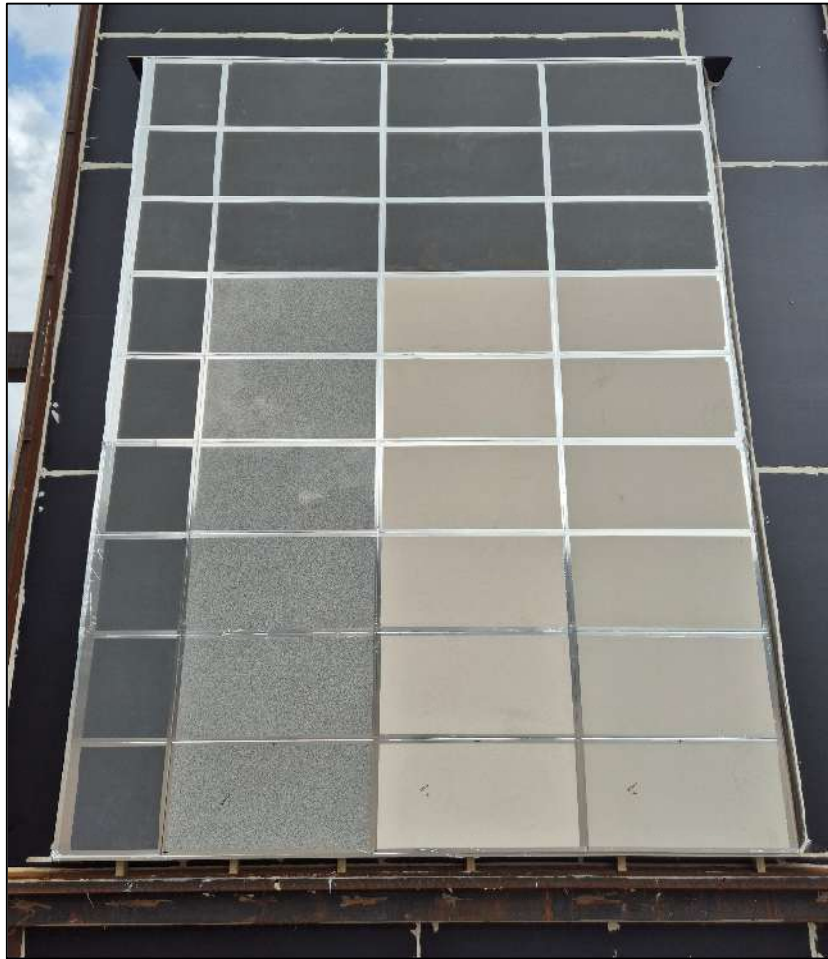
TEST SAMPLE ELEVATION

The sample was as shown in the photo below and the drawings included as an appendix to this report.

The test sample comprised of an array of rainscreen panels of varying sizes set in a landscape style, sizes were as follows:

The 1200 x 600mm panels from right to left were 6nr Engineered Stone panels 20mm thick c/w fibreglass reinforcement imbedment.

Following this was 6nr Aerolite Stonework 20mm thick comprising of a 5mm thick natural stone veneer, 15mm thick granite backer and fibreglass reinforced backing.

The last column of 1200 x 600mm panels was 6nrAerolite Granite panels 20mm thick c/w fibreglass reinforced backing.

All other panels on the rig of varying sizes are Aerolite Stonework 20mm thick comprising of 5mm thick natural stone veneer, 15mm thick granite backer and fibreglass reinforced backing.

The panels had kerfs cut along horizontal edges to allow engagement with the TI-DF2 carrier rail which were spaces at required module heights as per layout drawing included in appendix.

The TI-DFI subframe comprised of Helping hand brackets fixed to appropriately designed backing structure which comprised of 10mm vertical steel profiles and a plywood facing fixed externally. These were installed as per layout drawing included in appendix.

T/L metal extrusions were affixed to the helping hands using tek screws.

The TI-DF2 rail was fixed to T/L profiles at required module setting out with 2nr tek screws per vertical profile.

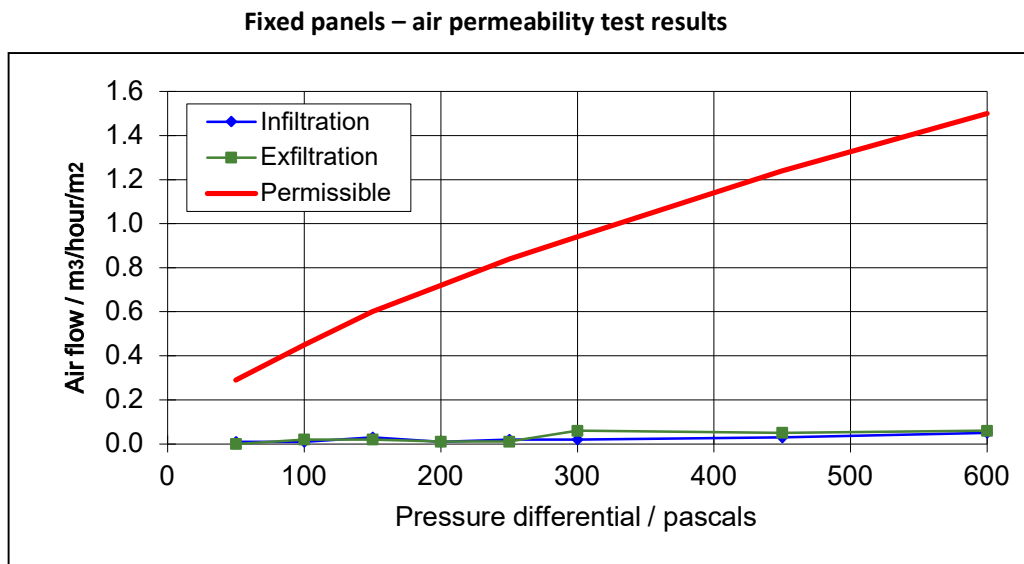
FIGURE 2

Pressure differential (pascals)	Measured air flow through sample (m ³ /hour/m ²)	
	Infiltration	Exfiltration
50	0.01	0.00
100	0.01	-0.02
150	0.03	-0.02
200	0.01	-0.01
250	0.02	-0.01
300	0.02	-0.06
450	0.03	-0.05
600	0.05	-0.06
Temperatures	Ambient = 15°C Chamber = 16°C	Ambient = 16°C Chamber = 17°C

The results are shown graphically in Figure 2.

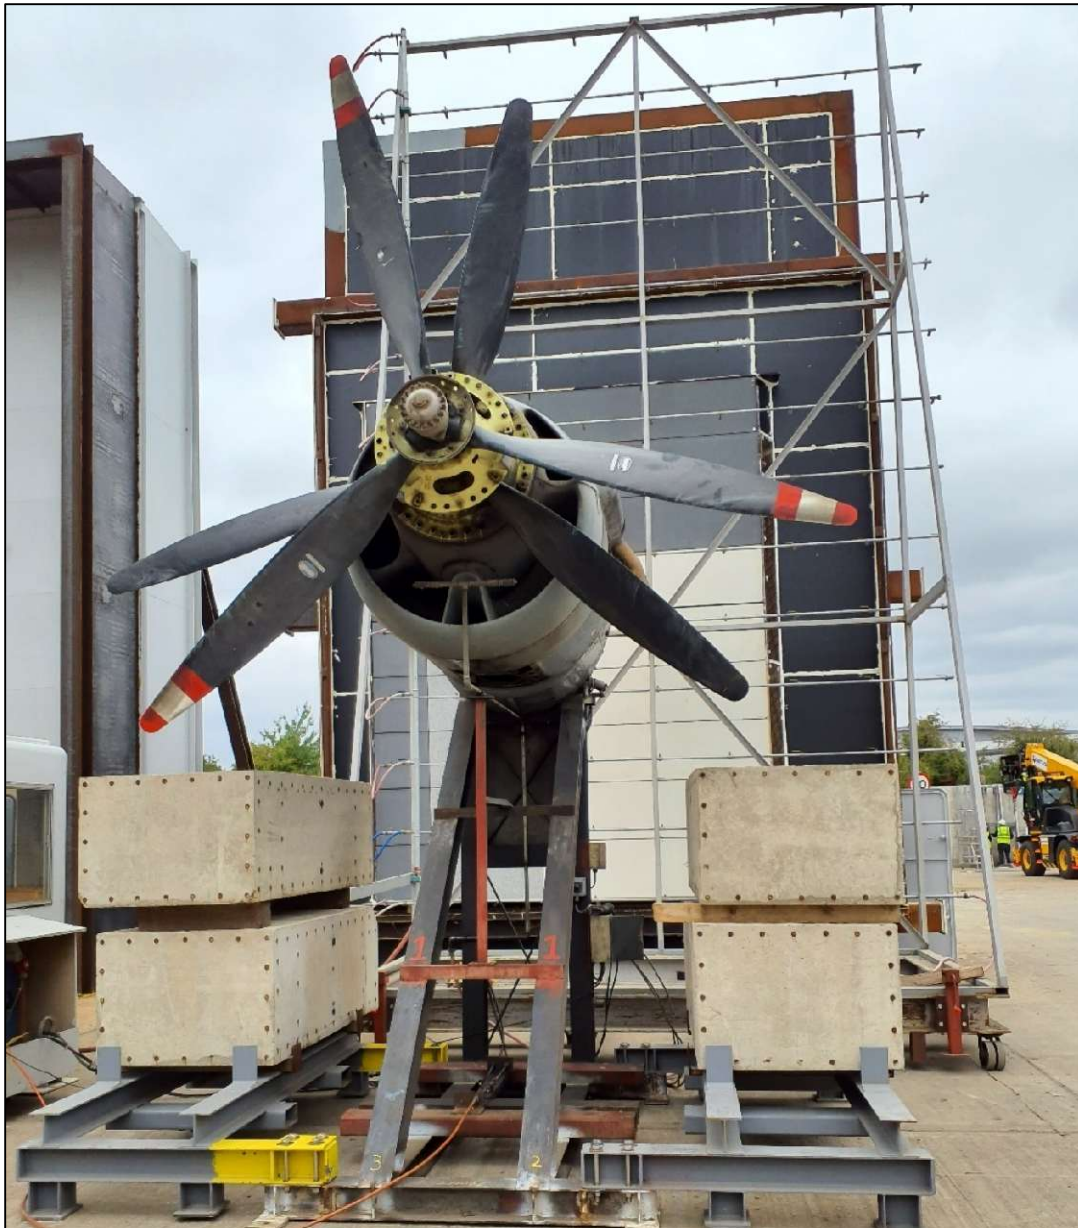
DYNAMIC AERO ENGINE

A wind generator was mounted adjacent to the external face of the sample and used to create positive pressure differentials during dynamic testing. The wind generator comprised a piston type aero-engine fitted with 4 m diameter contra-rotating propellers.

The aero-engine was used to subject the sample to wind of sufficient velocity to produce average deflections in the principle framing members equal to those produced by a static pressure differential of 600 pascals. These conditions were maintained for 15 minutes. Throughout the test the inside of the sample was examined for water penetration.

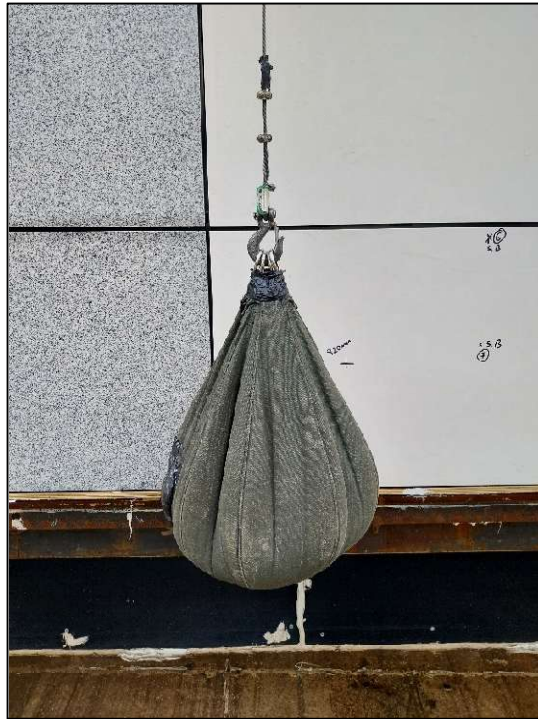
PHOTO 152614

SOFT BODY IMPACT LOCATION 5

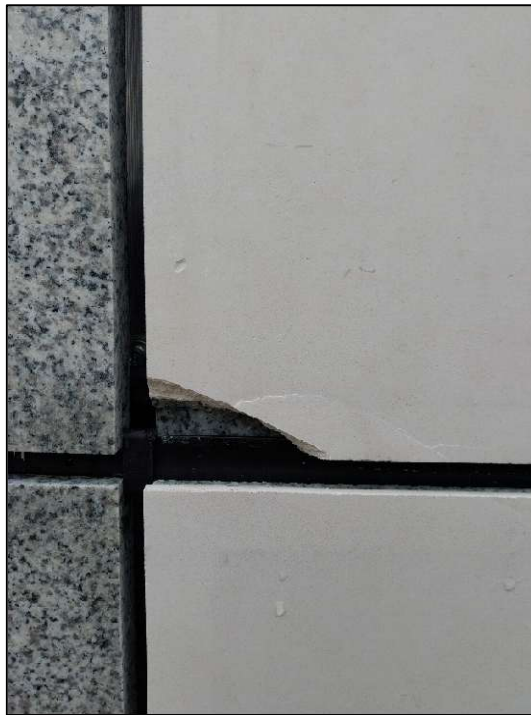
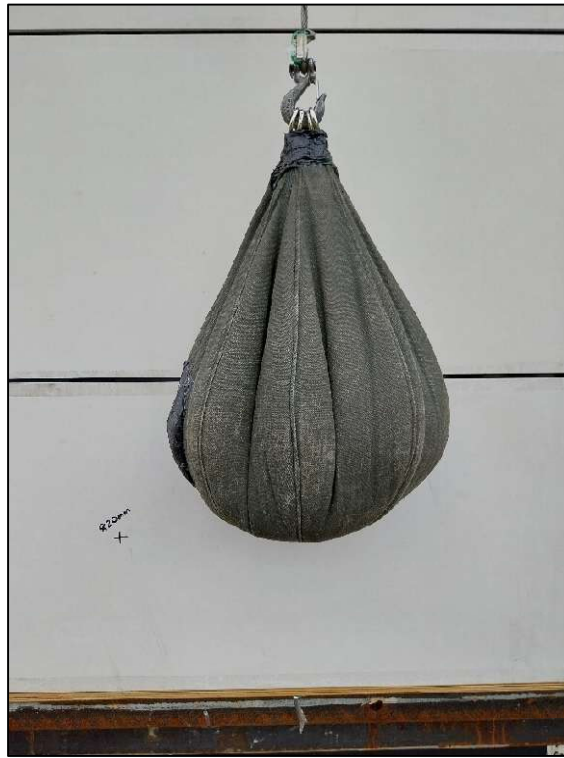
PHOTO 152211

SOFT BODY IMPACT LOCATION 6
