Title: Weathertightness product testing of a sample of Tiles
International Rainscreen Cladding on a Eurobond backing wall

Report No: N950-11-16479a

Issue date: 27 January 2012

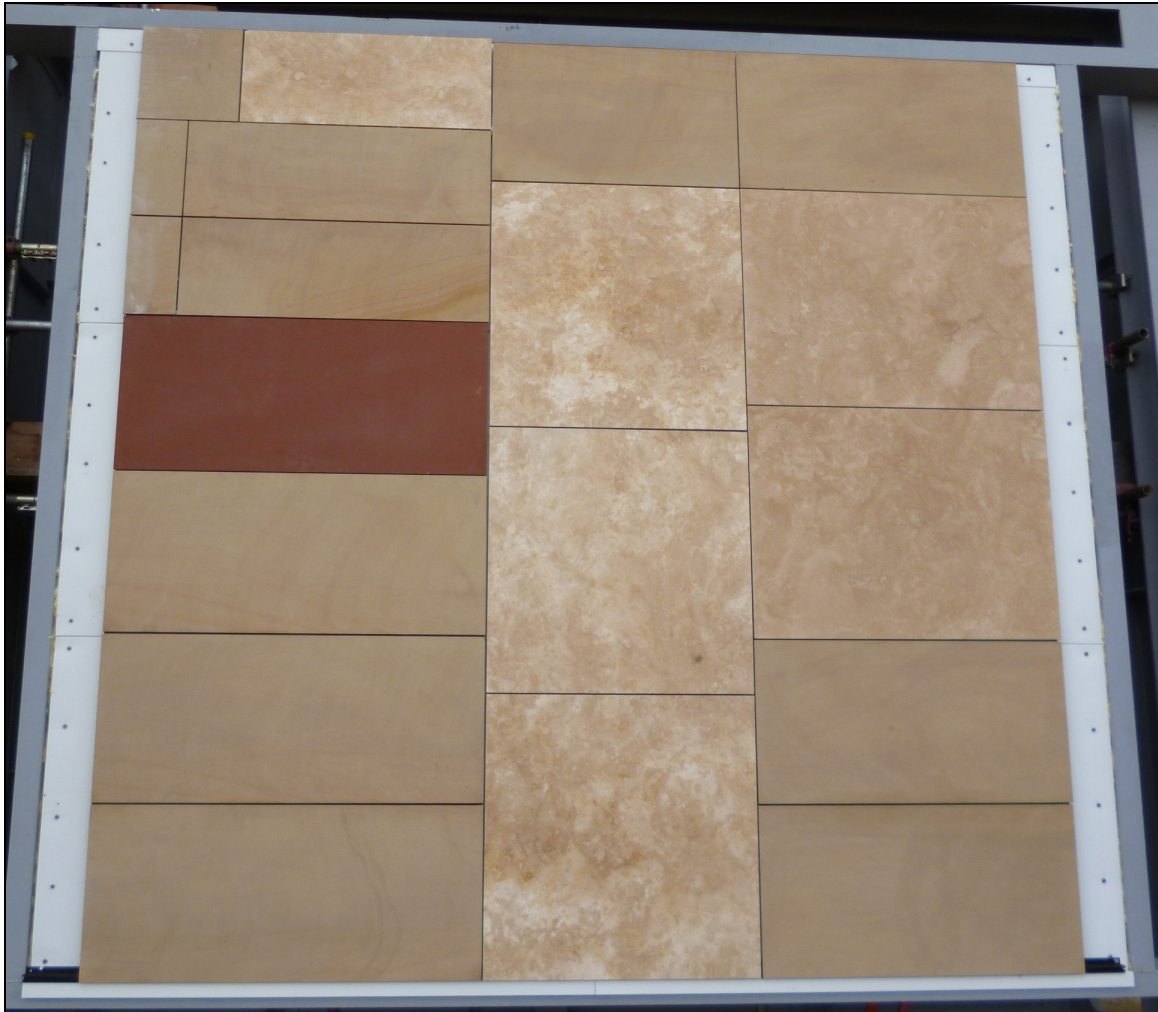
TEST SAMPLE ELEVATION

The sample was as shown in the photo below and the drawings included in the appendix to this report.

The test sample comprised of 3 number 150 mm thick Rainspan support panels with 0.70 mm thick steel facings spanning 4000 mm horizontally between vertical steel supports by others. The panels were 1200 mm module and have a male/female joint along the top and bottom edges. The panels were stacked on top of each other to create the 3600 mm high sample. The panels were through fixed into the vertical supports at panel ends with 5.5 mm diameter self drilling self tapping fixings and into horizontal steel supports at the head and base of the sample with 5.5 mm diameter self drilling self tapping fixings at 450 mm centres. The panels were air sealed around the perimeter of the sample with a continuous 12 x 6 mm self adhesive foam tape.

An array of Aerolite Stonework panels was then fixed to the Rainspan composite backing wall supported by the Ti-tracking “Generic” horizontal carrier system fixed through the front skin of the composite panel by means of the SFS SL3 self drilling fixing.

The Aerolite Stonework panels were 17 mm thick comprising of a 12 mm natural granite backing and a 5 mm natural stone veneer c/w a reinforced fibreglass backing and have a system weight of 42 kg/m².

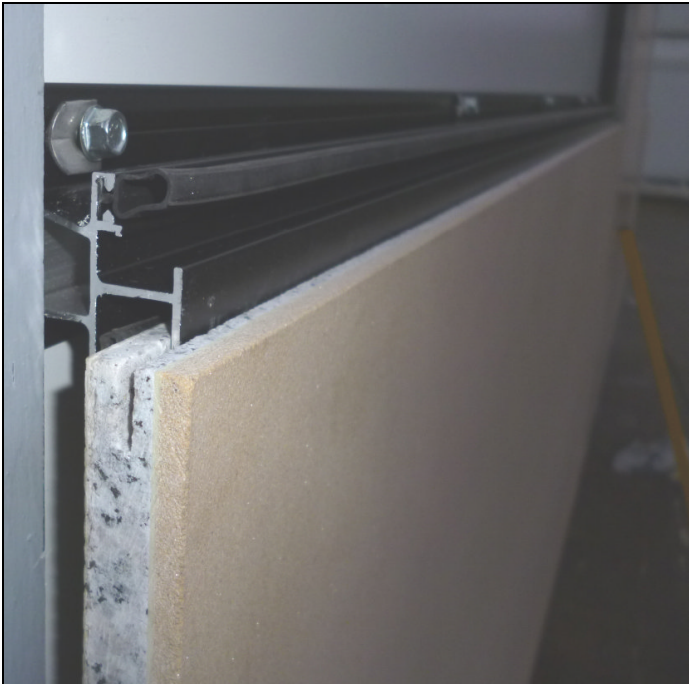
PHOTO 1000471

The Ti-Tracking horizontal carriers were tek screw fixed through the front skin only of the Eurobond Rainspan composite panel by the SFS SL3 light section self drilling fixing.

SUPPORT RAIL ALONG TOP OF PANEL

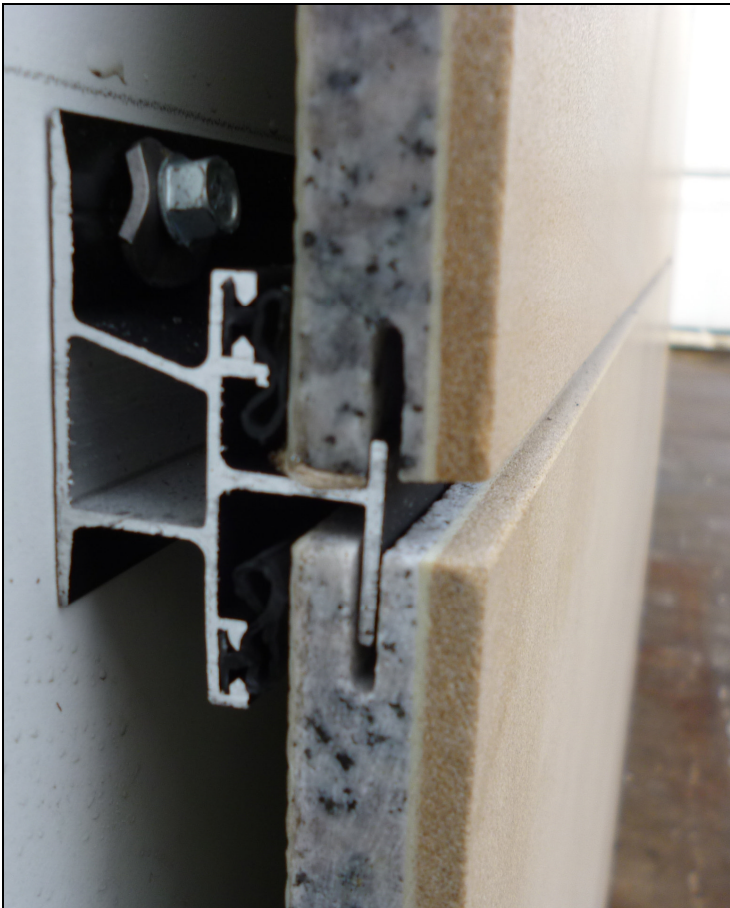
PHOTO 1000528

The panels had special grooved longitudinal edges called a Kerf that enabled them to engage into the horizontal Ti-tracking “Generic” carrier which was spaced at the panel module height centres.

SIDE VIEW BETWEEN PANELS

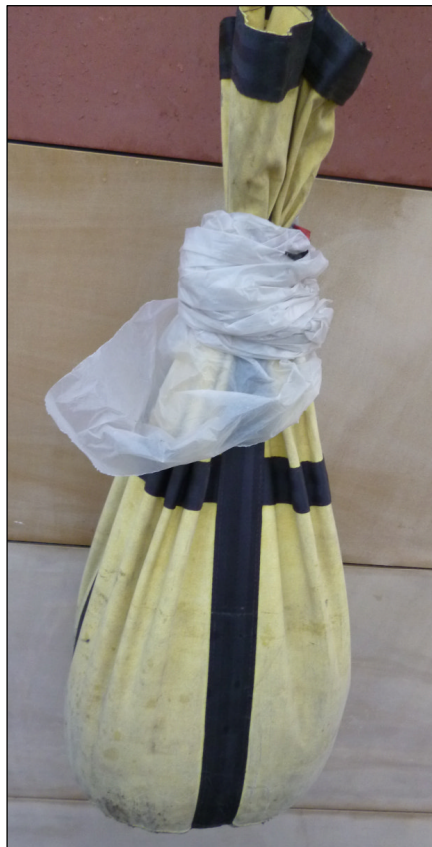
PHOTO 1000614

The soft body impactor comprised a canvas spherical/conical bag 400 mm in diameter filled with 3 mm diameter glass spheres with a total mass of approximately 50 kg suspended from a cord at least 3 m long.

The impactor almost touched the face of the sample when at rest. It was swung in a pendular movement to hit the sample normal to its face. The test was performed at the locations shown in Figure 3. The impact energies were 120 Nm and 500 Nm.

SOFT BODY IMPACTOR

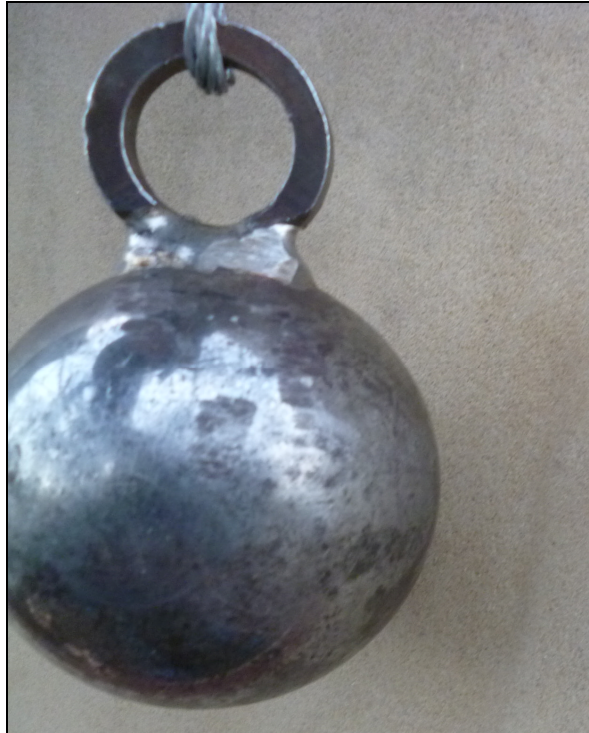
PHOTO 1000617

The hard body impactor was a solid steel ball of 62.5 mm diameter and approximate mass of 1.0 kg.

The impactor almost touched the face of the sample when at rest. It was swung in a pendular movement to hit the sample normal to its face. The test was performed at the locations shown in Figure 4. The impact energy was 10 Nm.

HARD BODY IMPACTOR

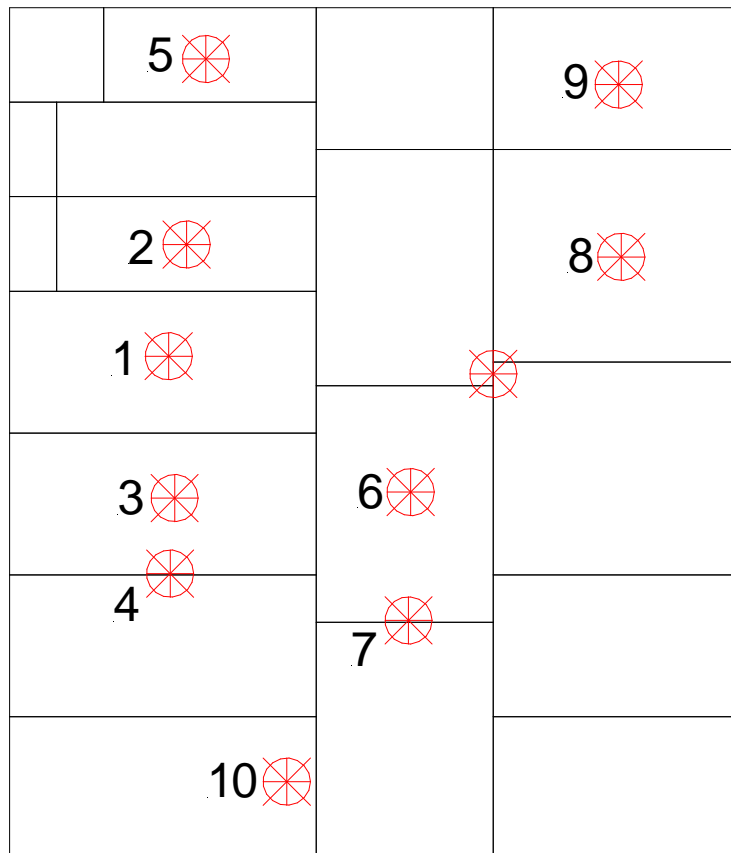
FIGURE 3

No damage to the sample was observed during the soft body impact tests.

SOFT BODY IMPACT TEST LOCATIONS

Soft body impact location

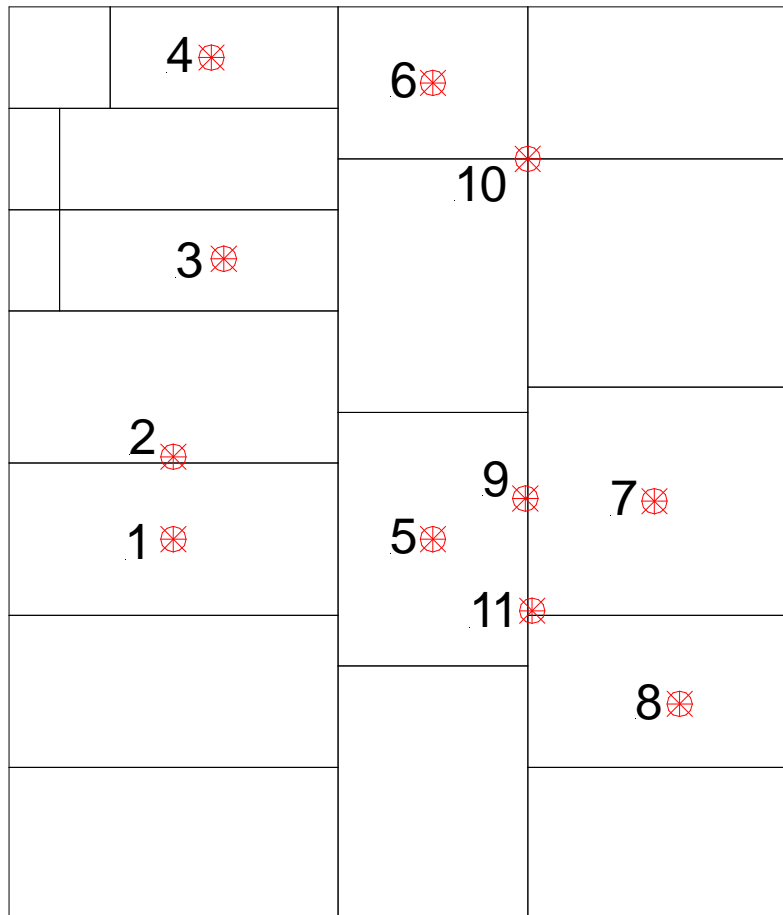
FIGURE 4

During the hard body impact test a small mark was visible on the panels, from close distance, at locations 1, 3 and 5.

No damage was observed at locations 2, 4, 6, 7, 8 and 9.

HARD BODY IMPACT TEST LOCATIONS

Hard body impact location

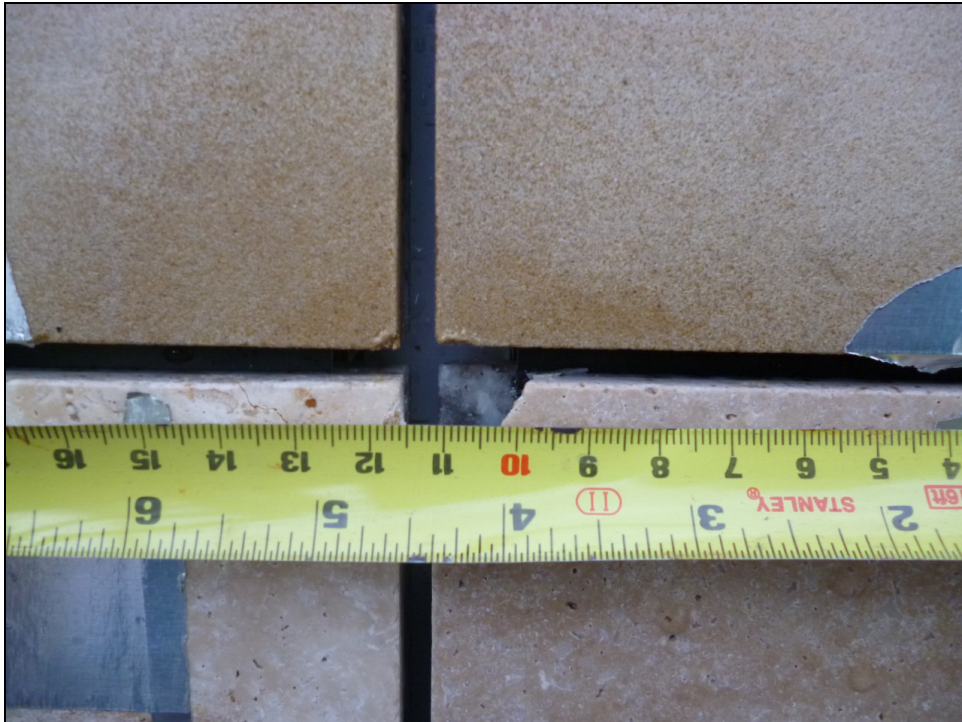
PHOTO 1000619

At location 10, a small 11 mm long corner piece came away from the front of the panel. The panel remained secure on the wall.

HARD BODY IMPACT AT LOCATION 10
