TEST REPORT

Lucideon Reference: UK222081 (QT-67623/2/KNA)/Ref. 2

Project Title: 60-Year Study for TI Tiles International Ltd's Aerolite Monolith Stone and Ceramic Cladding Panels

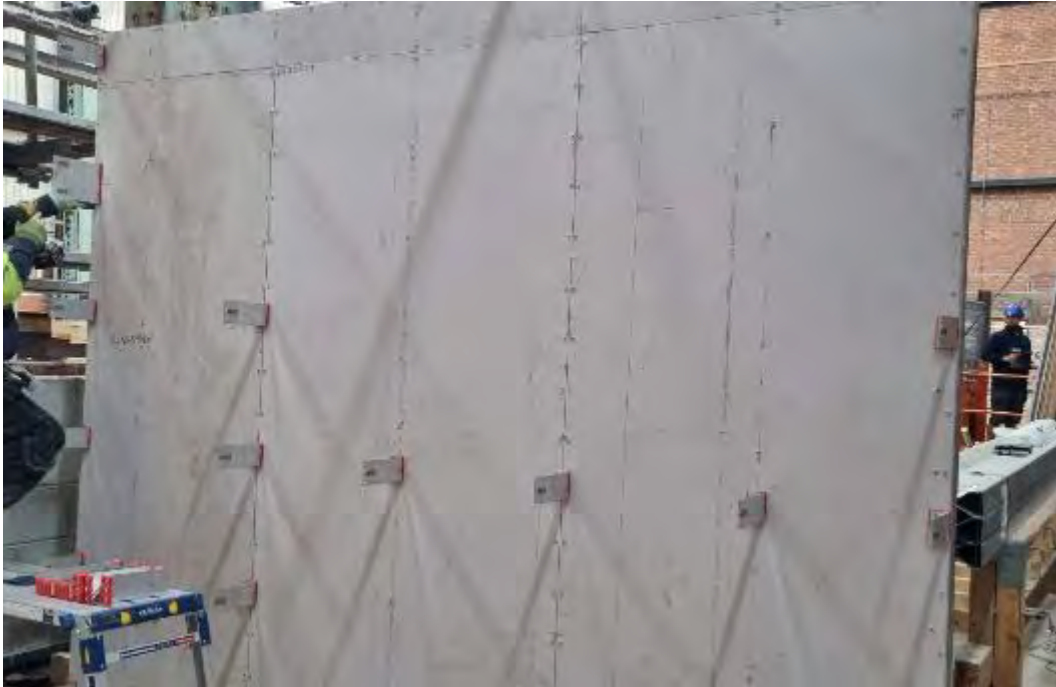
Plate 1 - Installation of Cement Particle Board and Helping Hand Brackets

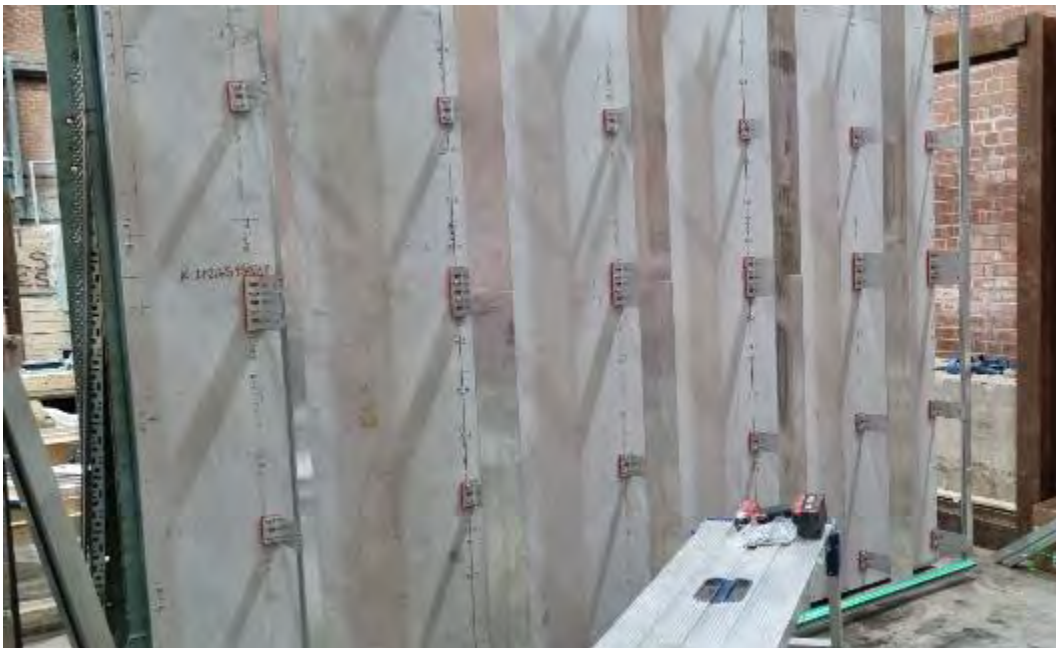
Plate 2 - Installation of 3 mm L-Shaped and T-Shaped Vertical Rails

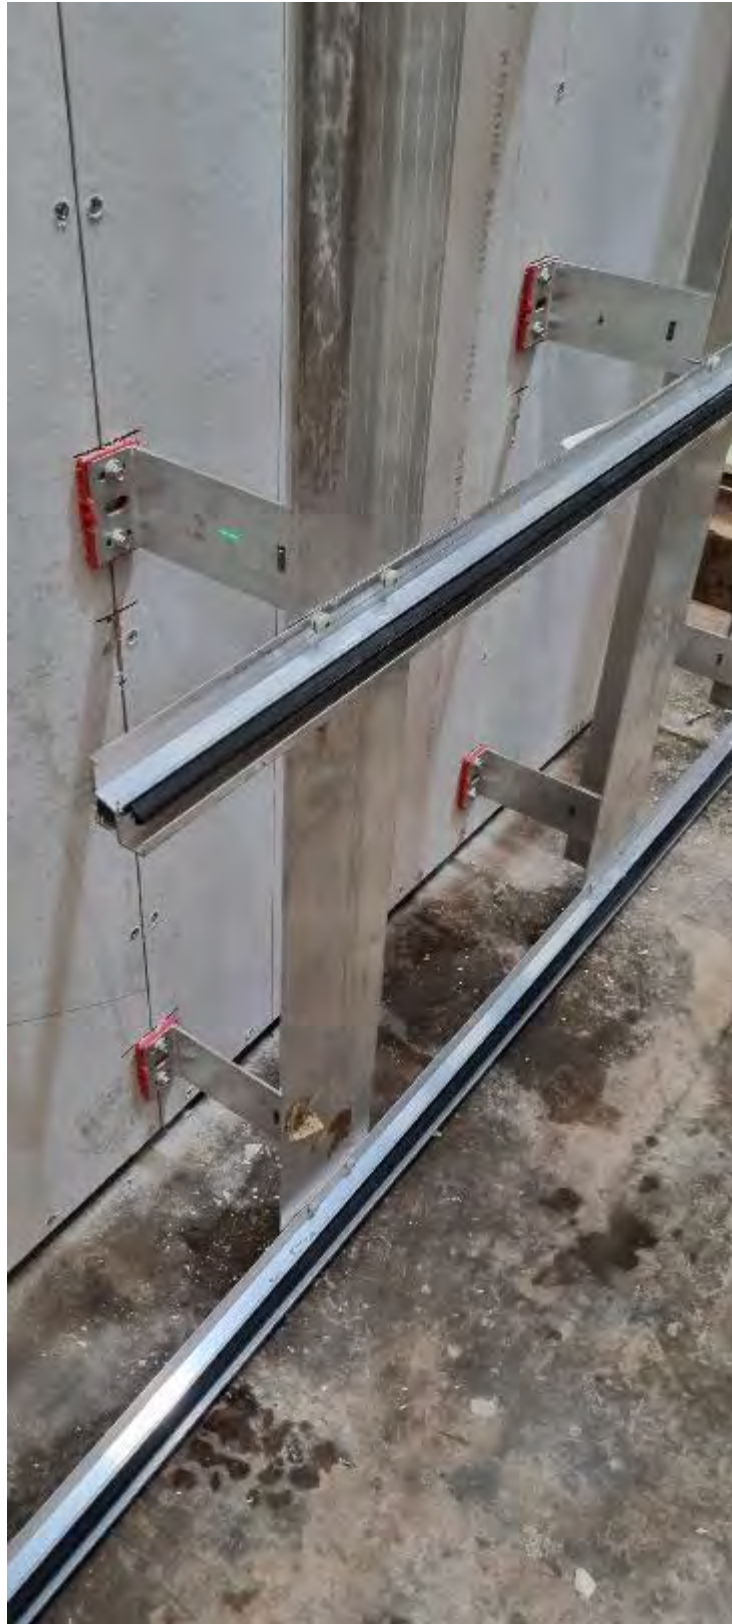
Plate 3 - Application of TI Generic Horizontal Starter Rails for the Bottom Row of Ceramic Panels

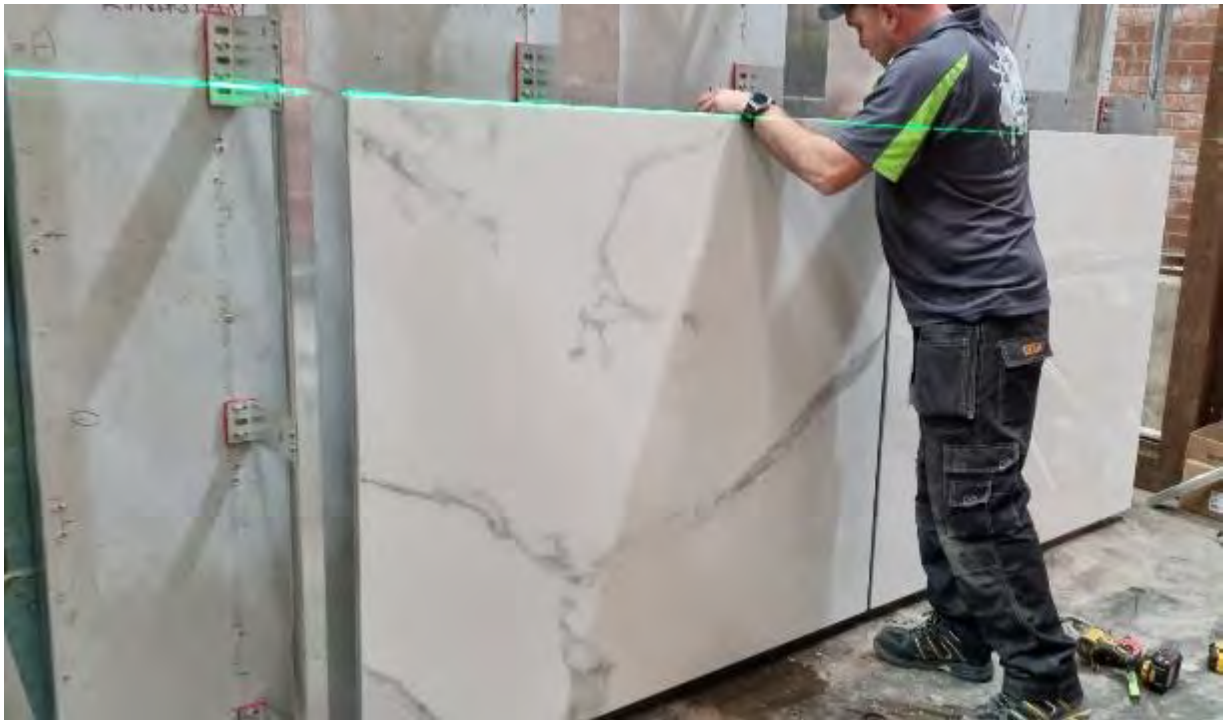
Plate 4 - Installation of the Bottom Row of Ceramic Panels on the Rail System

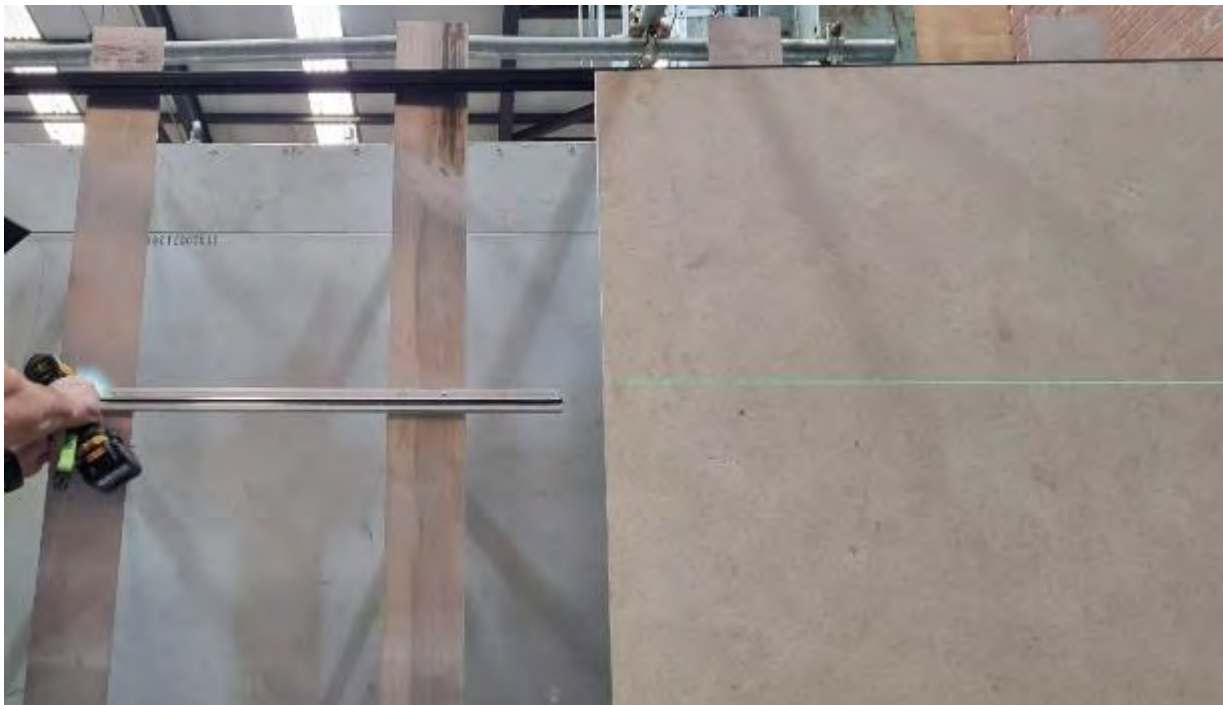
Plate 5 - Installation of the Top Row of Ceramic and Stone Panels on the Rail System

The wall was completed using a TI generic horizontal top rail, which was installed using generic self-drill stainless 5.5 x 28 mm steel fixings at 600 mm horizontal centres over the top edges of the ceramic panels.

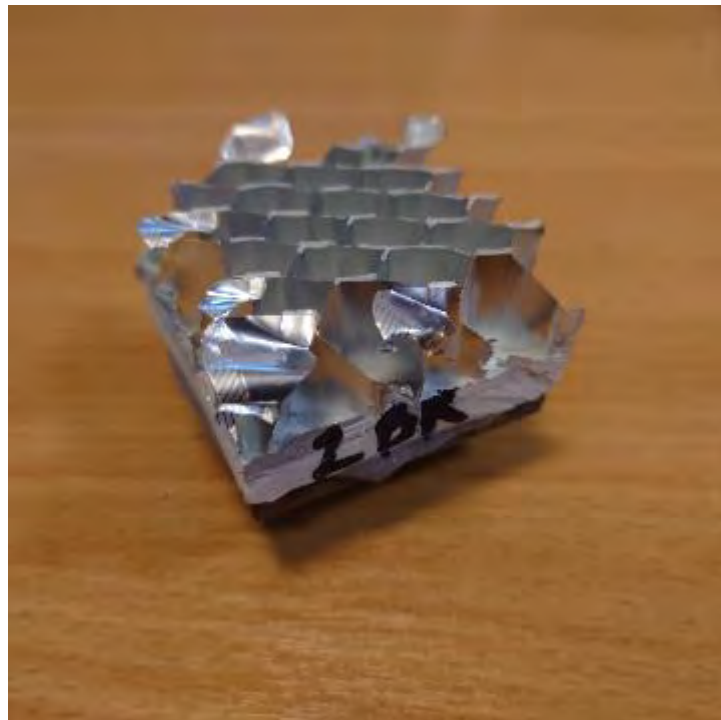
Plate 7 - Typical Sample where Failure Mode is in the Honeycomb Layer

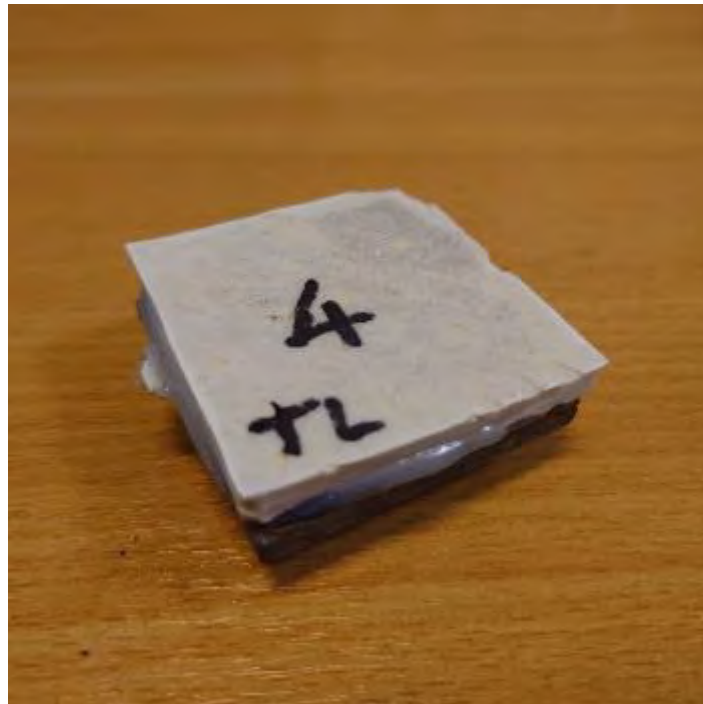
Plate 8 - Typical Sample where Failure Mode is Between the Veneer and Honeycomb Layers

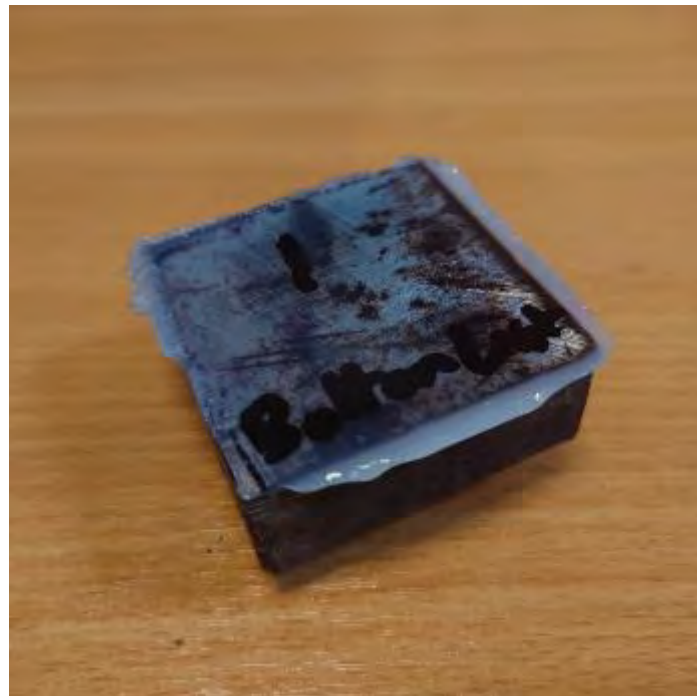
Plate 9 - Typical Sample where Failure Mode is Between the Plate and Veneer Layer

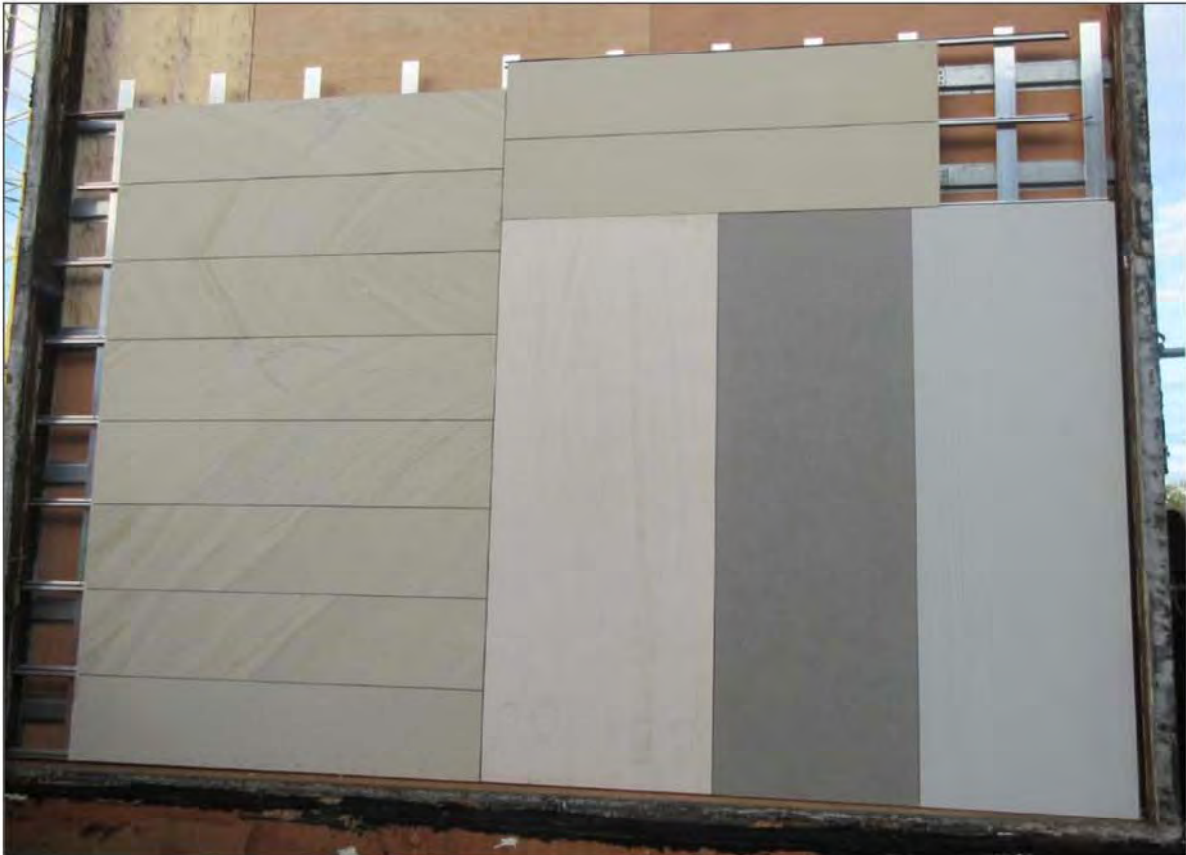
PHOTO 1654

TEST SAMPLE

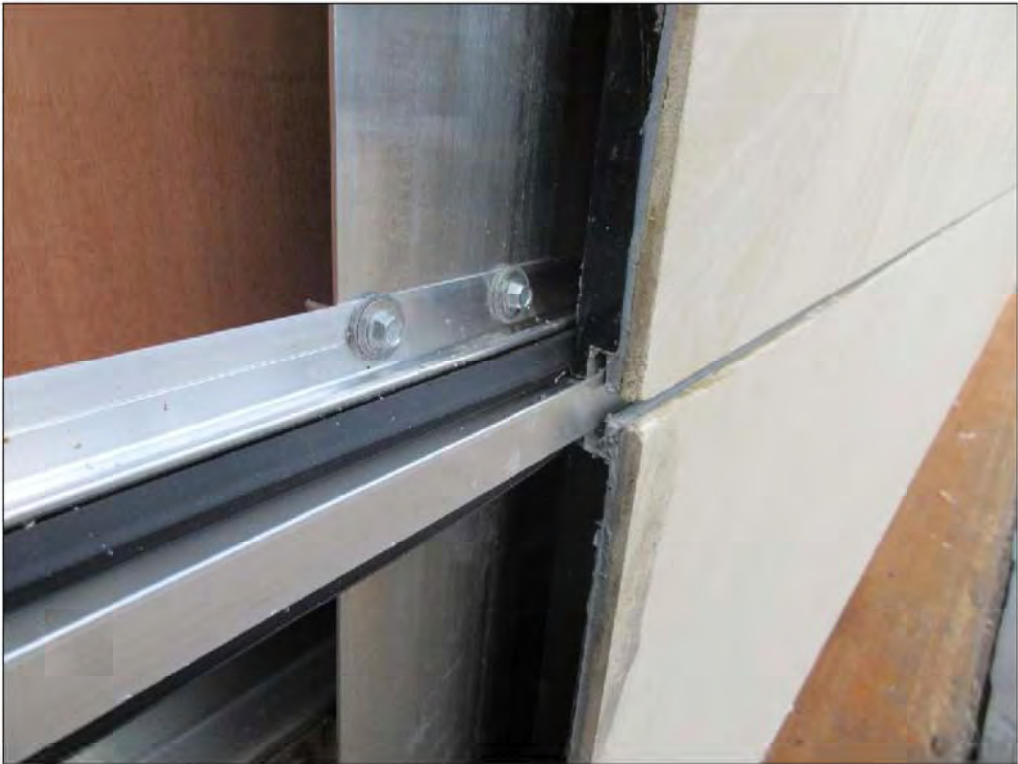
PHOTO 1655

SUPPORT FRAME AND EDGE OF PANELS

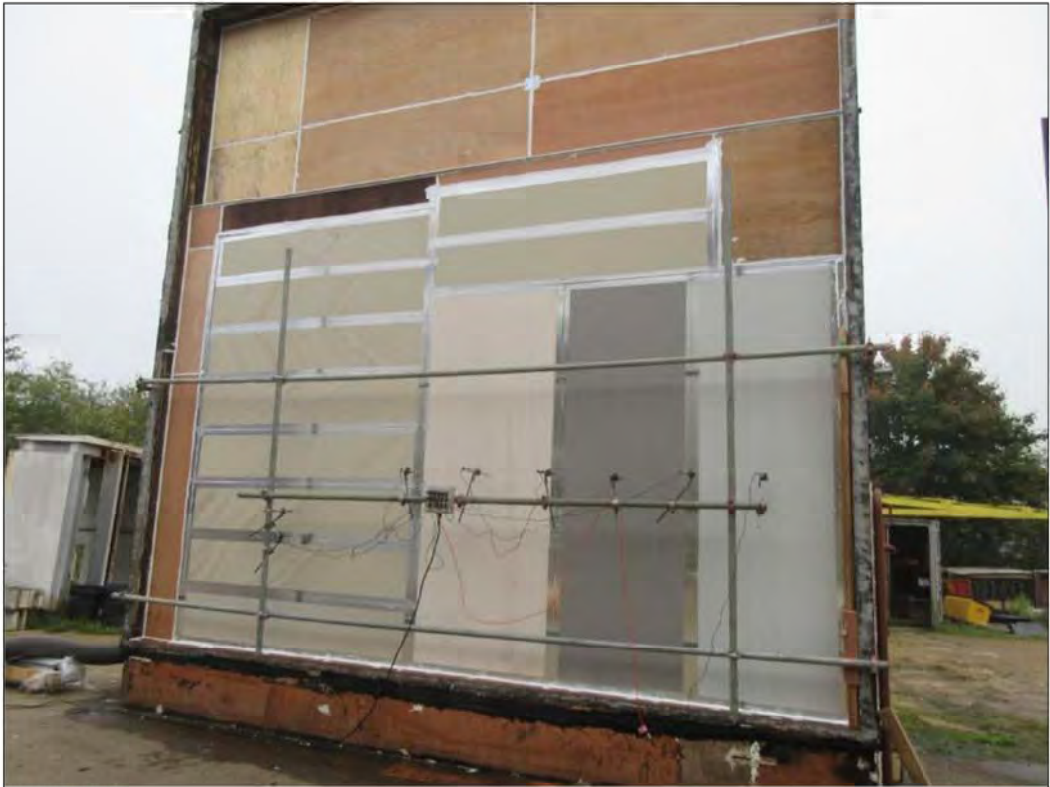
PHOTO 1658

TEST SAMPLE DURING WIND LOADING

No damage to the test sample was observed.

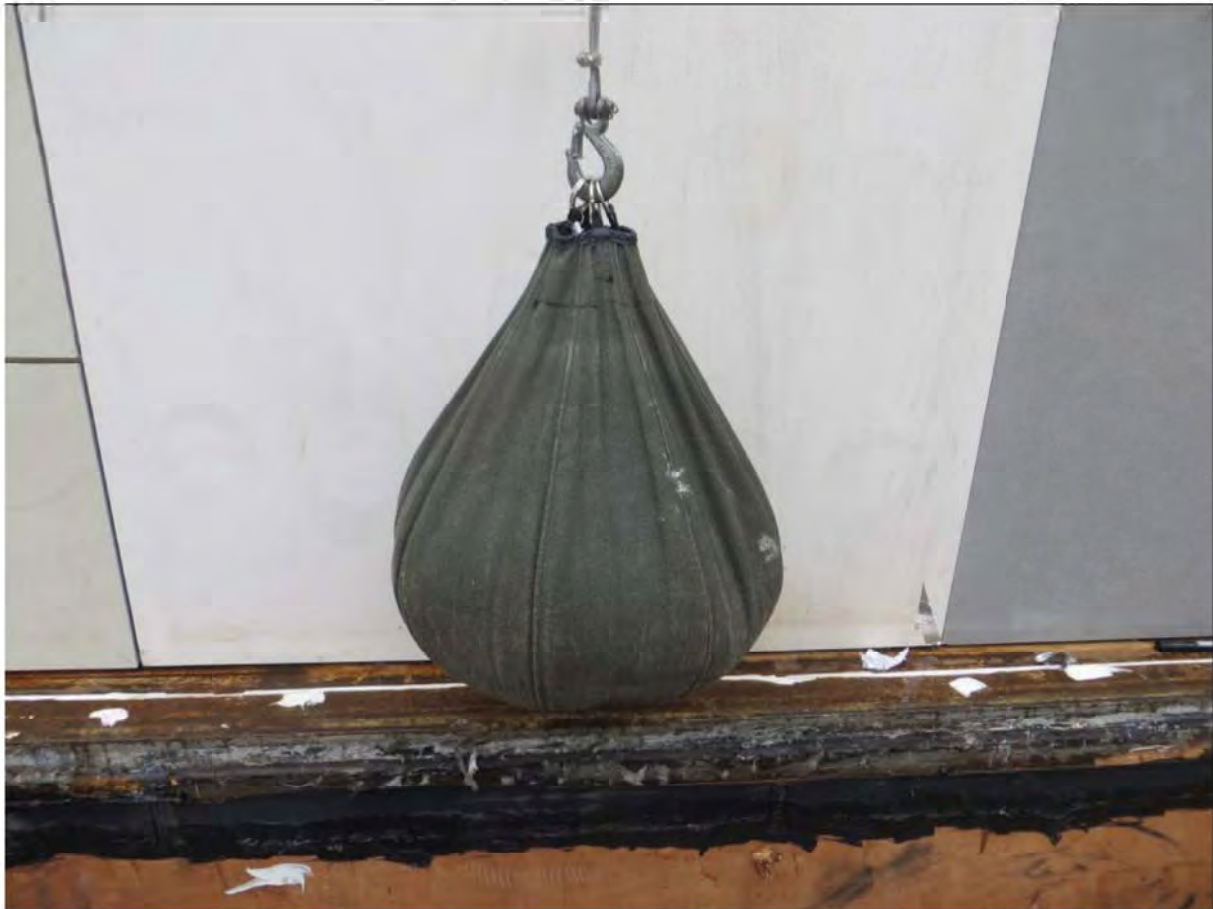
PHOTO 6024

SOFT BODY IMPACTOR

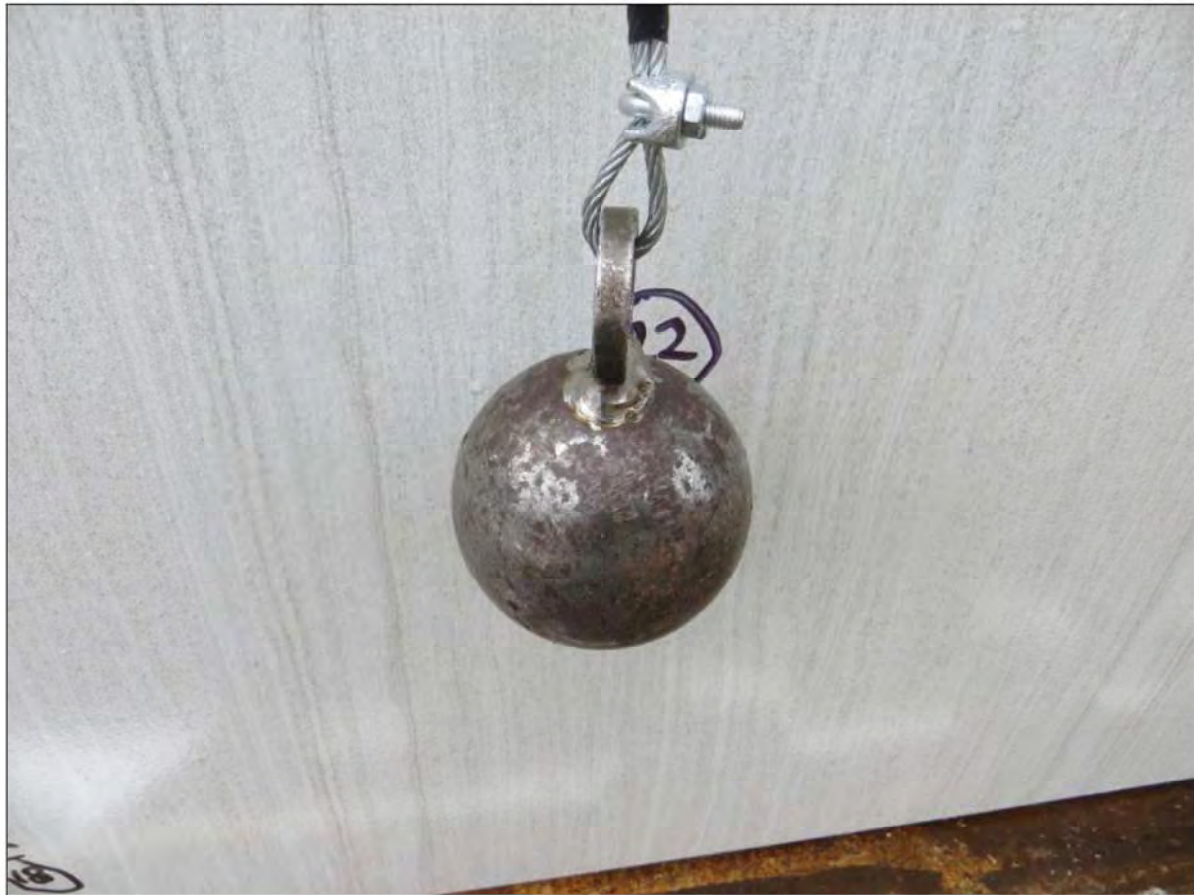
PHOTO 6038

The hard body impactor was a solid steel ball of 50 mm or 62.5 mm diameter and approximate mass of 0.5 kg or 1.0 kg.

HARD BODY IMPACTOR

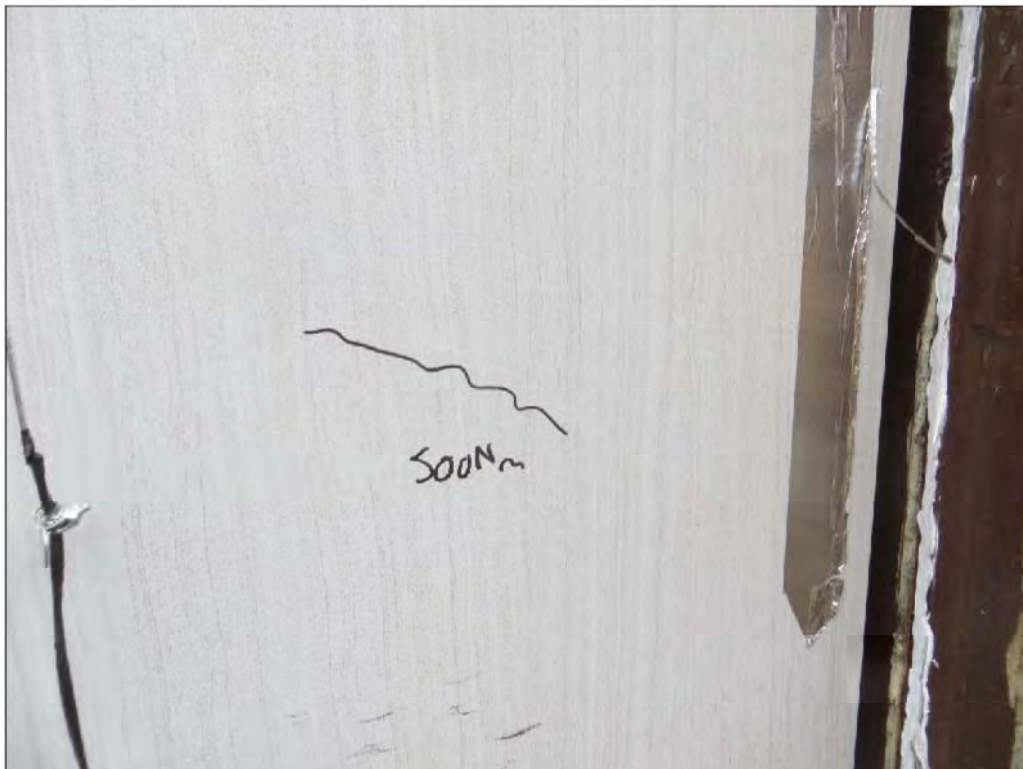
PHOTO 6026

SOFT BODY IMPACT AT LOCATION 14 (marker pen line along hairline crack)

After reviewing the test report there were no impacts that produced any fallout during testing. The only defects that were noted during testing were those of hairline cracks within the surface of the panel and small indents.

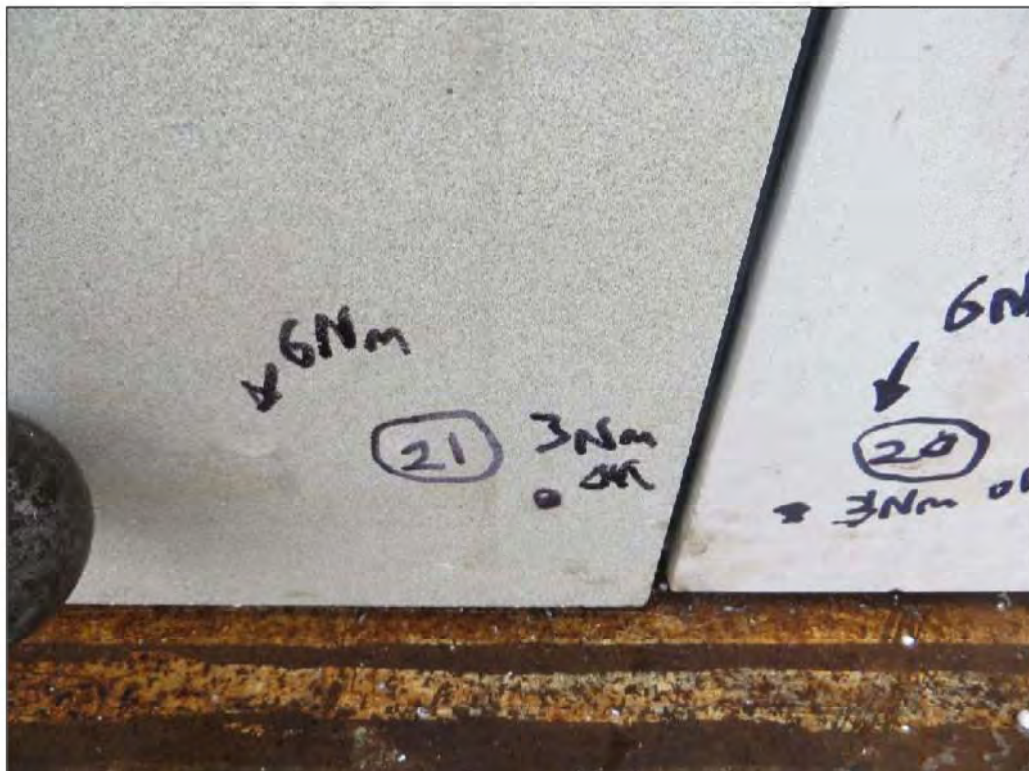
PHOTO 6037

HARD BODY IMPACTS AT LOCATIONS 20 & 21

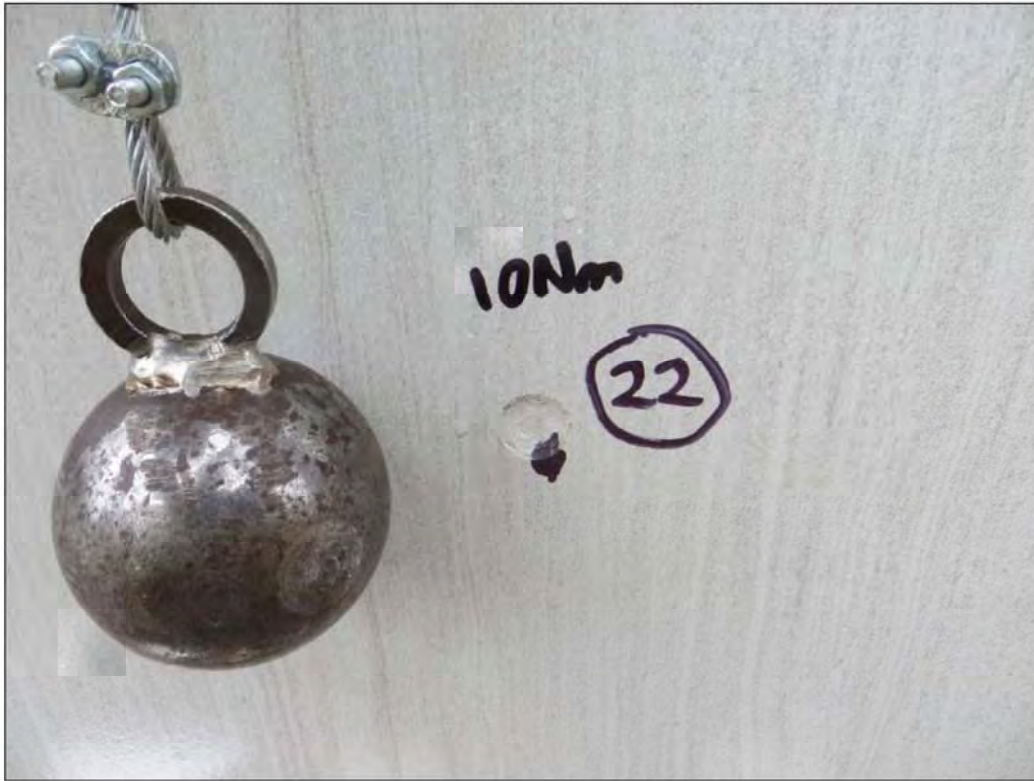
PHOTO 6039

HARD BODY IMPACT AT LOCATION 22

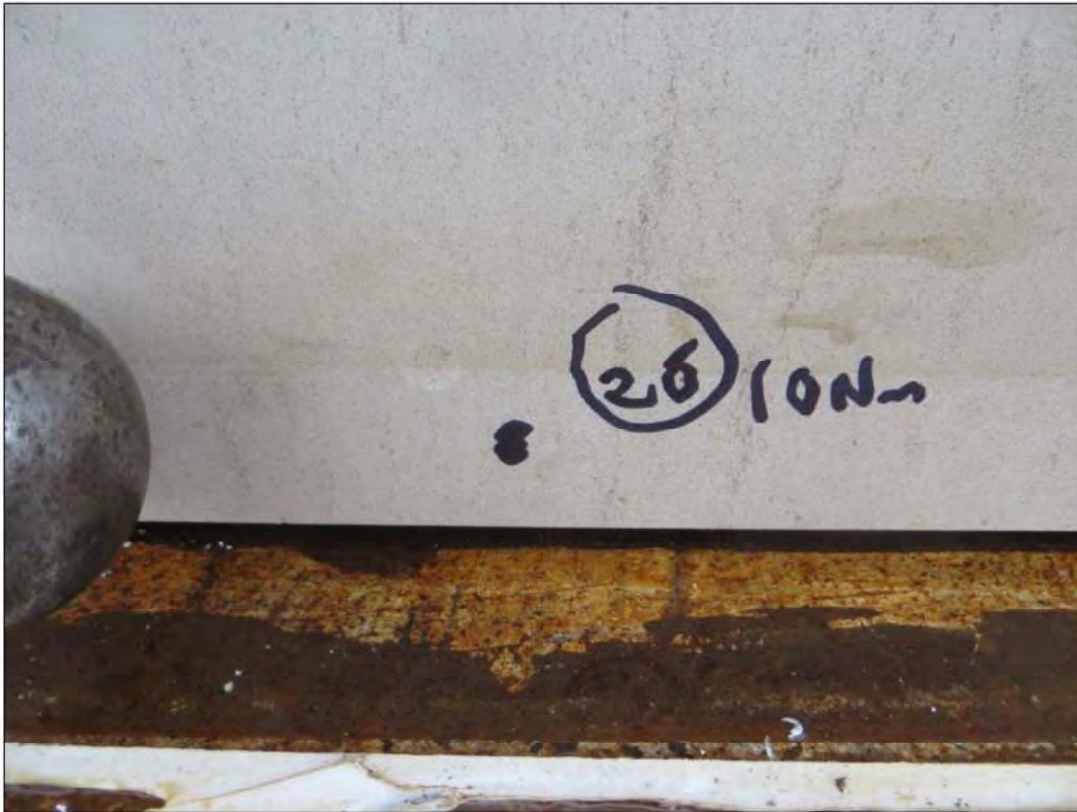
PHOTO 6042

HARD BODY IMPACT AT LOCATION 26

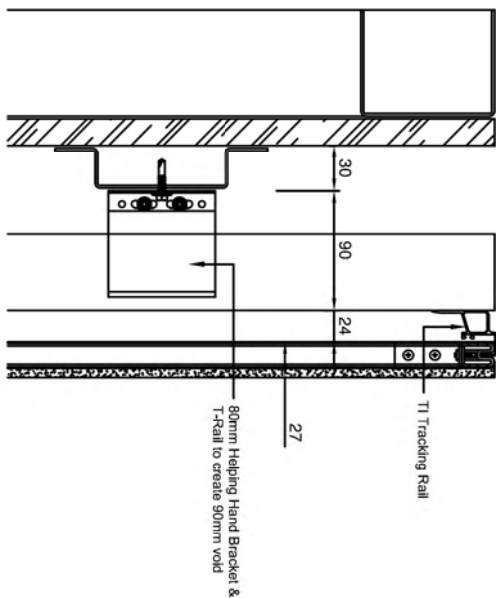
Extrusion Detail at 3m Panel

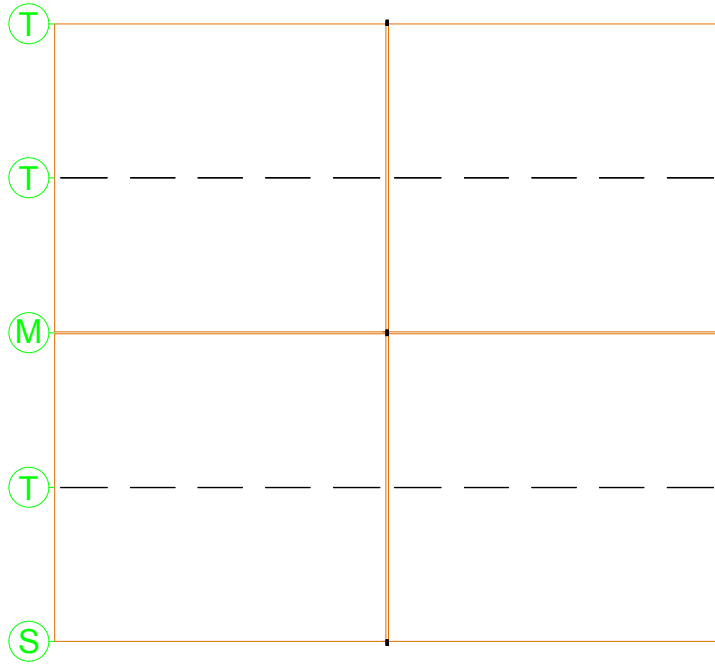
Typical Setting-Out (Multi Panel)
