**Place name:** General Store, Bakery (former) and House

**Architectural Style:** Federation Free style  
**Designer / Architect:** George H. Cain  
**Construction Date:** 1902

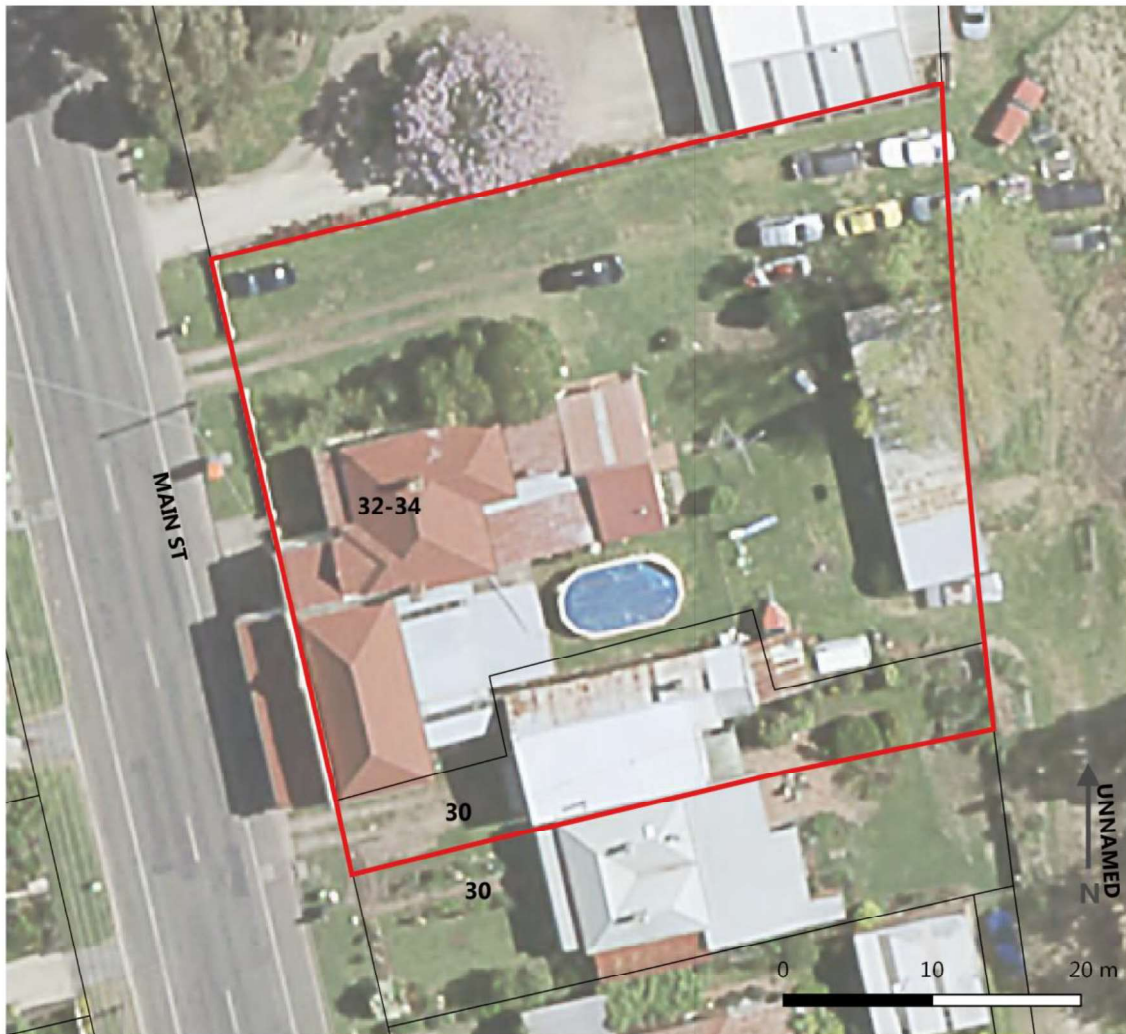
## Map of recommended boundary for Heritage Overlay

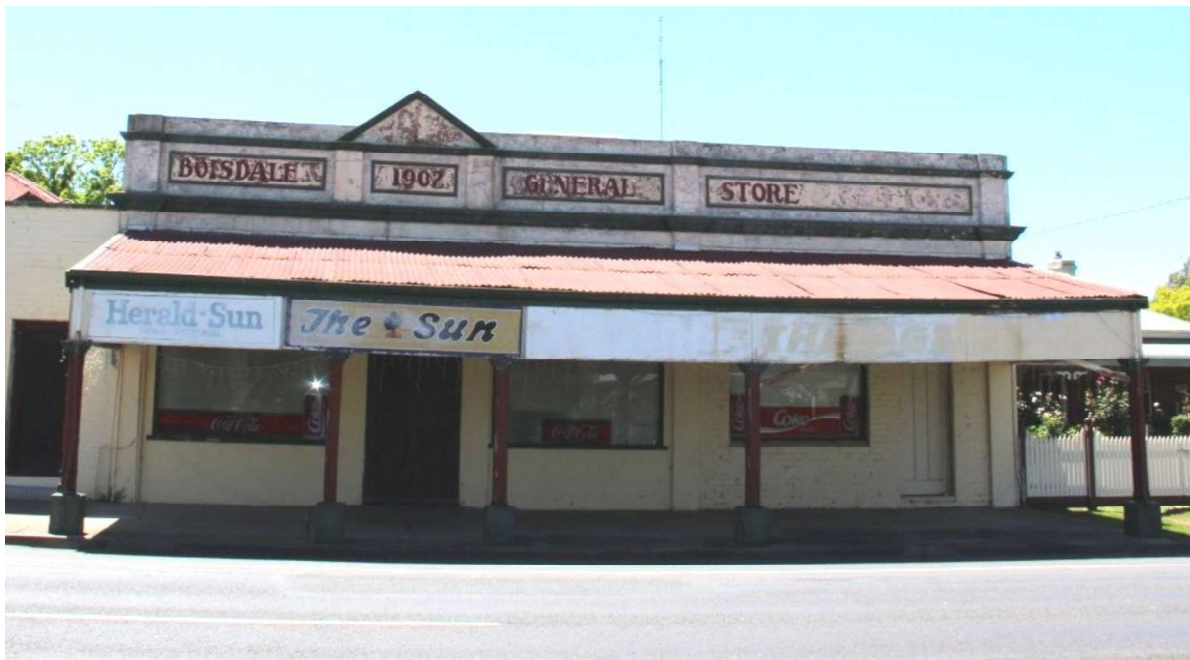
**Figure D1.** The brick general store has a tall parapet to the facade conceals the roof and has simple Classical mouldings and a pediment above the main entrance. The parapet has the (modern) painted words 'BOISDALE 1907 GENERAL STORE' over remnants of earlier painted words.

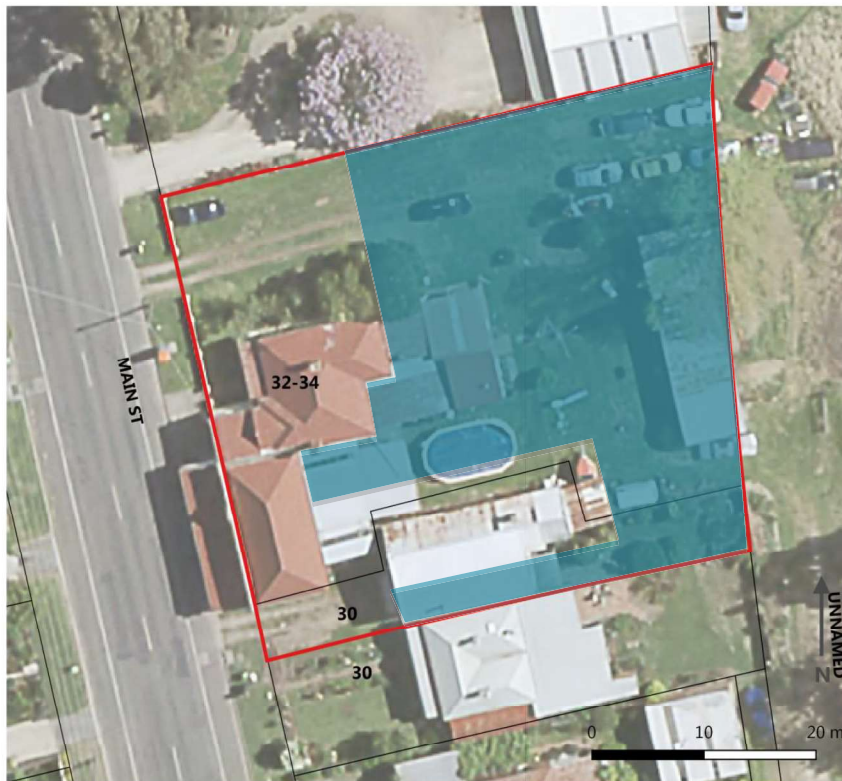
NOTE: The blue shaded area is the preferred location for additions and new development
