**Locality:** MAFFRA  
**Place address:** 95 JOHNSON STREET  
**Citation date** 2016  
**Place type (when built):** Hotel  
**Recommended heritage protection:** Local government level  
Local Planning Scheme: Yes  
Vic Heritage Register: No  
Heritage Inventory (Archaeological): No

**Place name:** Metropolitan Hotel (former)

Project: Wellington Shire Stage 2 Heritage Study  
Client: Wellington Shire Council  
Author: Heritage Intelligence Pty Ltd  
Date: 12/2/16

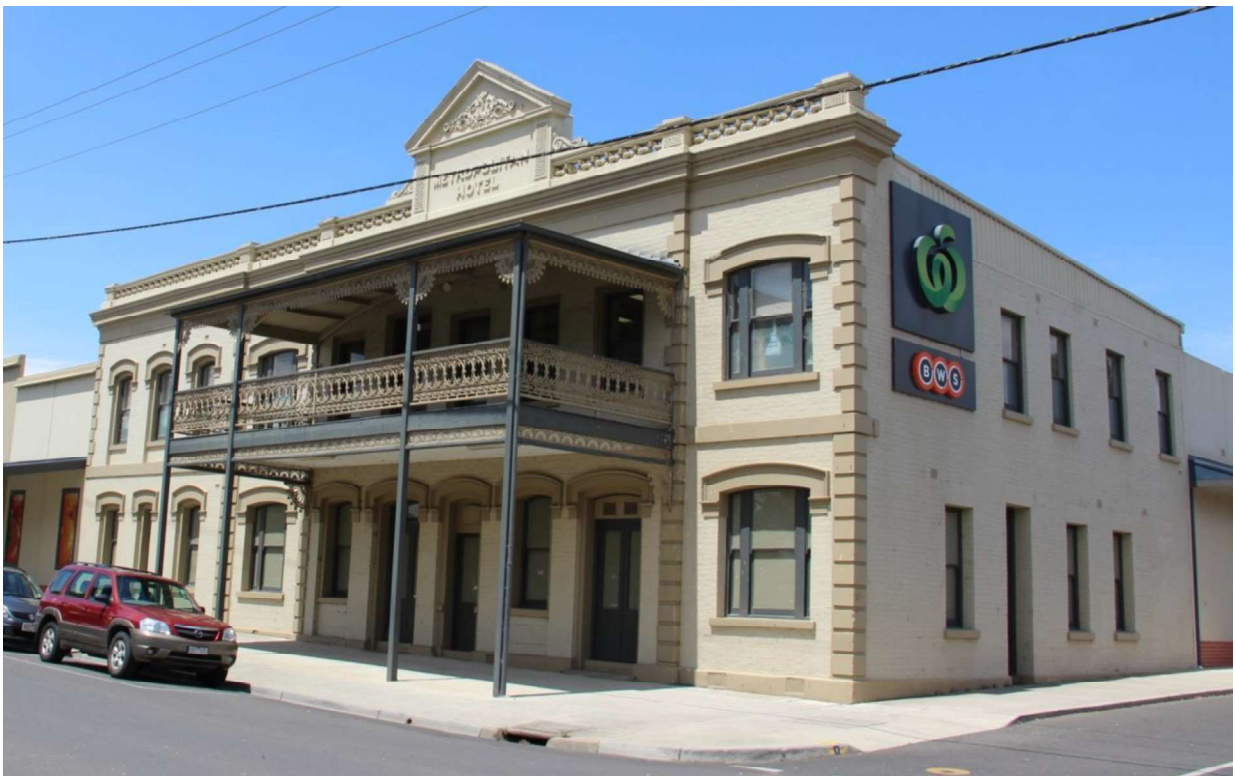
**Architectural Style:** Victorian Filigree  
**Designer / Architect:** Not known  
**Construction Date:** 1889-90

Metropolitan Hotel (former), 95 Johnson St, Maffra – 1889-90 two-storey brick hotel built in the Victorian Filigree style with elaborate Classical details. The two-storey verandah structure was rebuilt, but retains the original cast iron work. The building has been incorporated into a large supermarket building, but retains the two highly intact main elevations which are dominant elements in the Maffra streetscape. Recommended for the Heritage Overlay as part of this Study.

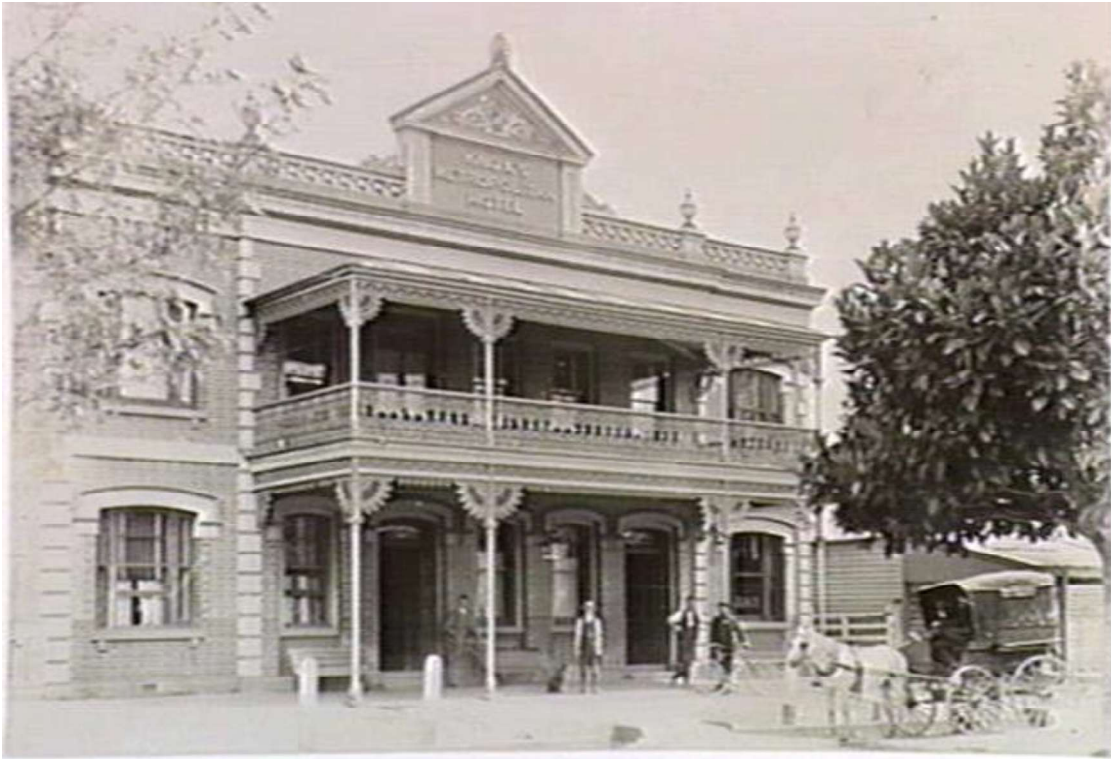
**Figure H1.** A photo dating to 1910 that showed the facade of the hotel. The parapet had urns atop each pier, while the pediment read '[indecipherable owner's name] Metropolitan Hotel'. The two-storey verandah had an ornate balustrade, a frieze to both floors, and round brackets to each supporting post (SLV).

In 1906, Ben Martin took over the Macalister Hotel. At this date the hotel was advertised as having the best accommodation, best brands of liquors and cigars, ample stable accommodation, livery at reasonable rates and a first-class billiard room. Prior to 1906, Martin had operated to the Orient Hotel in Warragul (*Maffra Spectator*, 2 Jul 1906:2). A photo dating to 1910 (Figure H1) showed the facade of the hotel (SLV). The parapet had urns atop each pier, while the pediment read '(indecipherable owner's name) Metropolitan Hotel'. The two-storey verandah had an ornate balustrade, a frieze to both floors, and round brackets to each supporting post (the same style as those that remain in 2015). The bays (divided by quoining) to each side of the verandah were also visible. The openings to the facade appeared as they remain in 2015.

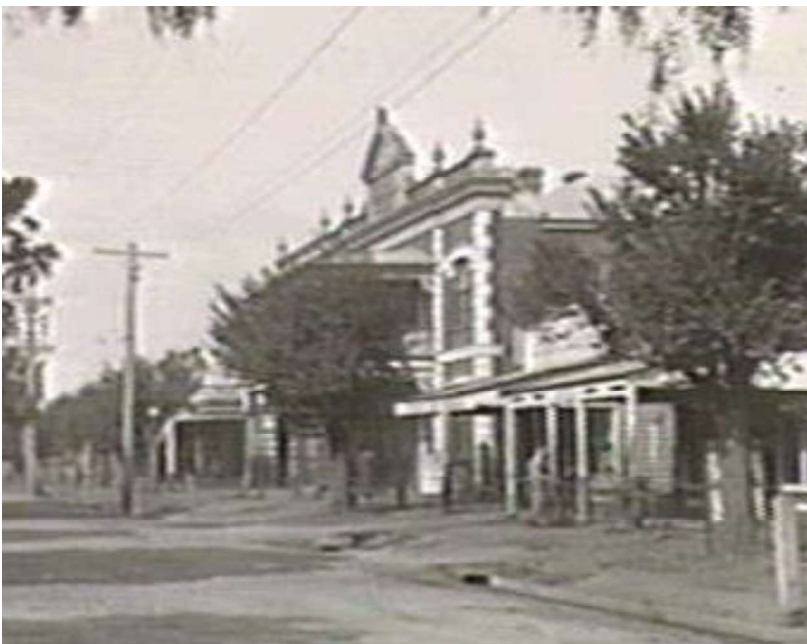
**Figure H2.** A photo dating to 1932 that showed the hotel from a distance, from the north-west. The quoining to the corners was painted bright white and atop the parapet was the pediment,

and five urns (since removed), indicating that the building comprised the eastern section) (SLV).

A photo dating to 1932 (Figure H2) showed the hotel from a distance, from the north-west (SLV). The quoining to the corners was painted bright white and atop the parapet was the pediment, and five urns (since removed), indicating that the building comprised the eastern section).

This building has had a major development without any heritage overlay in place. It appears to have been entirely demolished except for the brick walls along Johnson Street and Purdy Lane. Apart from the demolition of the roof, this is a logical outcome for all heritage buildings without interior controls on the Heritage Overlay. The historic roof structure is important and can be seen in Figs H2 and H4;

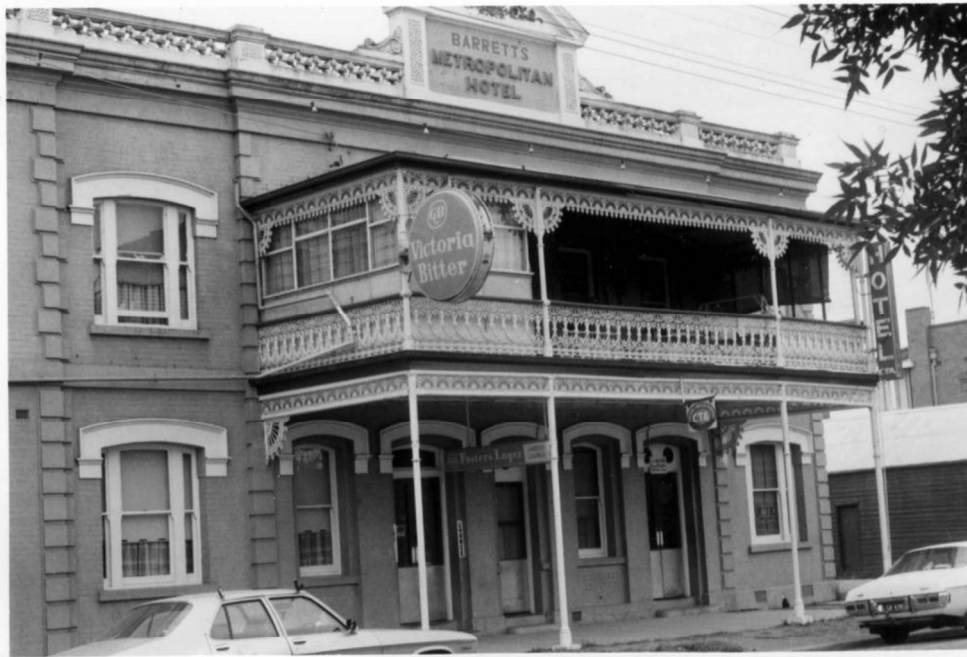
Figure H3. A photo dating to 1970 that showed that the pediment now read 'Barrett's (painted) Metropolitan Hotel' and that the urns had been removed by this date. Some of the round cast-iron brackets to the ground floor had been removed by this date and the verandah to the first floor had been in-filled at the east end (SLV).

Barrett's Metropolitan Hotel was shown in a photo dating to 1979 (Figure H3). The photo (SLV) showed that the pediment now read 'Barrett's (painted) Metropolitan Hotel' and that the urns had been removed by this date. Some of the round cast-iron brackets to the ground floor had been removed by this date and the verandah to the first floor had been in-filled at the east end. A more recent photo dating to the c1970s or 80s (Figure H4) showed the facade and west elevation which remained face-brick (NT).

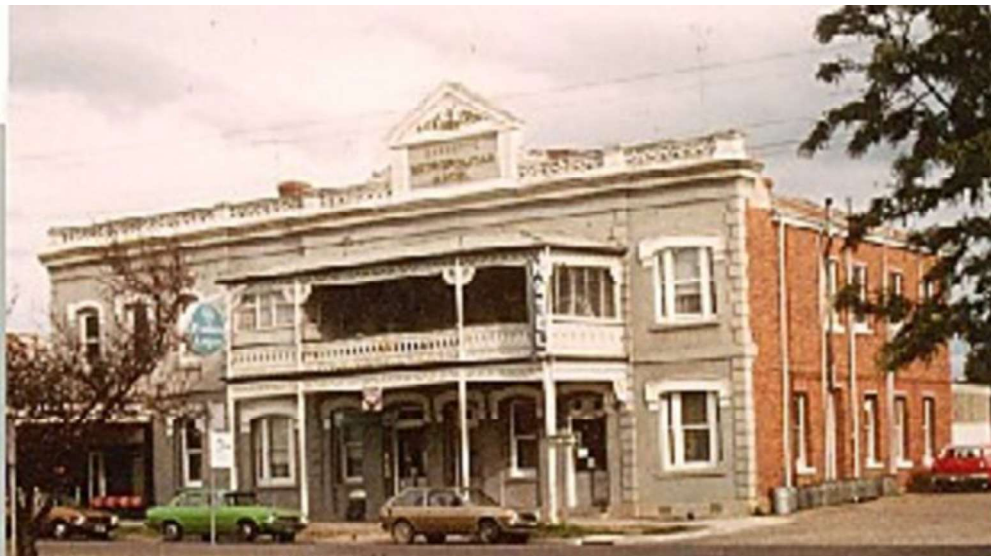
Figure H4. Barrett's Metropolitan Hotel (c1970s-80s) showed the facade and west elevation when it remained face-brick (NT).

The far east section of the ground floor has a rendered wall, indicating this section was altered (Figure H4) and has since been sympathetically restored to match the details of the remainder of the facade.

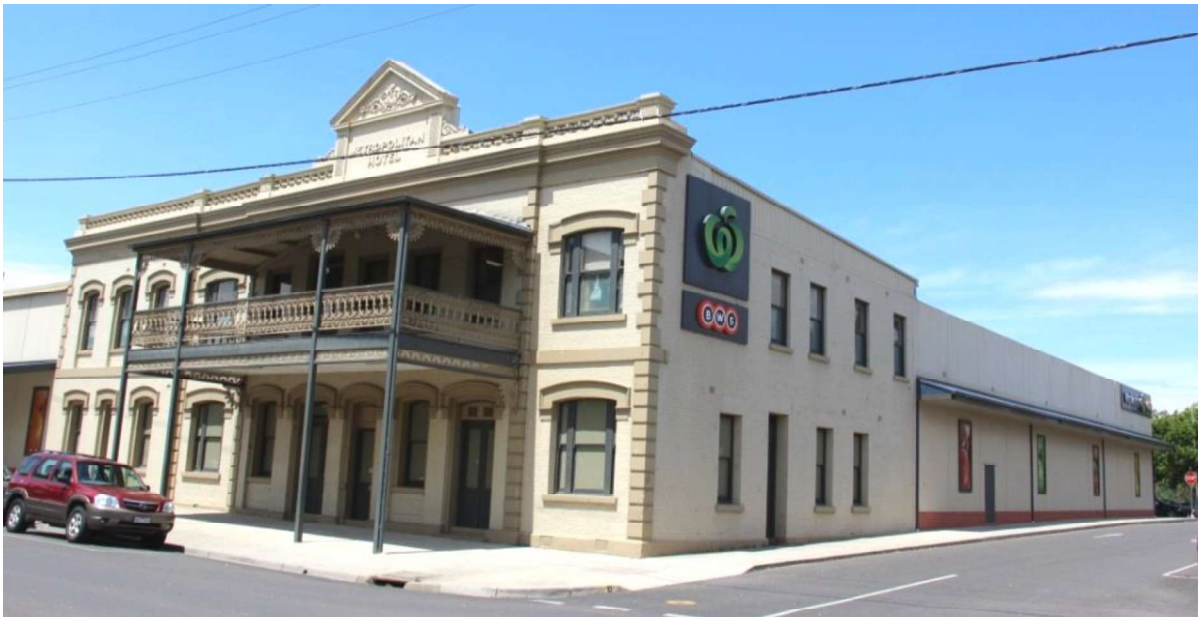
**Figure D1.** The two-storey building was constructed of brick (overpainted), with tuckpointing to the facade, on a rendered plinth. A decorative parapet to the facade stops at a pediment. The urns to the piers of the parapet were lost by 1970. Below the parapet is a bold cornice moulding. The pediment sits central over the two-storey verandah below. Following a collapse of the verandah floor in 1996, the verandah has been reconstructed and reinforced with metal bearers and pole supports. The original cast iron balustrade, frieze and brackets have been retained (the brackets to the ground floor are missing; lost by 1970, see Figure H3). The verandah roof retains its original hipped profile, clad with (recent) corrugated iron. Either side of the verandah are bays created by engaged piers with banded rustication which form quoining at the first floor.

Modern signage has been installed on the west elevation.

**Figure D1.** The two-storey building was constructed of brick (overpainted), with tuck pointing to the facade, on a rendered plinth. A decorative parapet to the facade stops at a pediment. The pediment sits central over the two-storey verandah below (reconstructed in 1996).

- 9.1. Ensure all signage is designed to fit around the significant architectural design features, not over them. The existing signage in Fig D1 is appropriate.

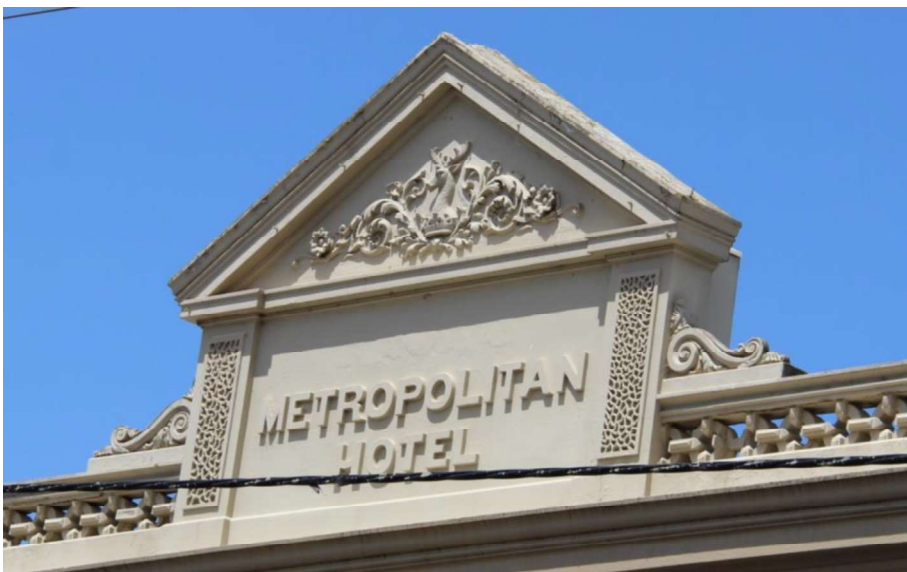
**Figure D2.** A detail of the pediment shows the staghead, crown and floral motif in relief. The words 'Metropolitan Hotel' (which has space above allowing for former owners' names; 'Knox's' can be made out) is flanked by panels of vermiculation and consoles.

Figure D2. A detail of the pediment shows the staghead, crown and floral motif in relief. The words 'Metropolitan Hotel' (which has space above allowing for former owners' names; 'Knox's' can be made out) is flanked by panels of vermiculation and consoles.

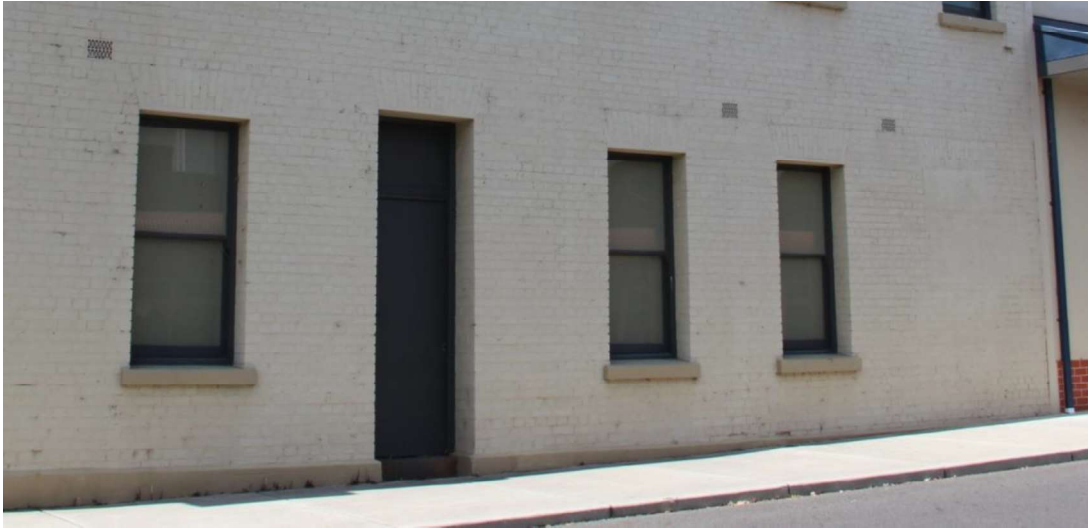
**Figure D3.** The west elevation fronting Purdy Lane, while overpainted, retains the original openings (one at the south end has been closed over). The square-headed openings have radiating voussoirs and a rendered sill.

Figure D3. The west elevation fronting Purdy Lane retains the original openings (one at the south end has been closed over). The square-headed openings have radiating voussoirs and a rendered sill.

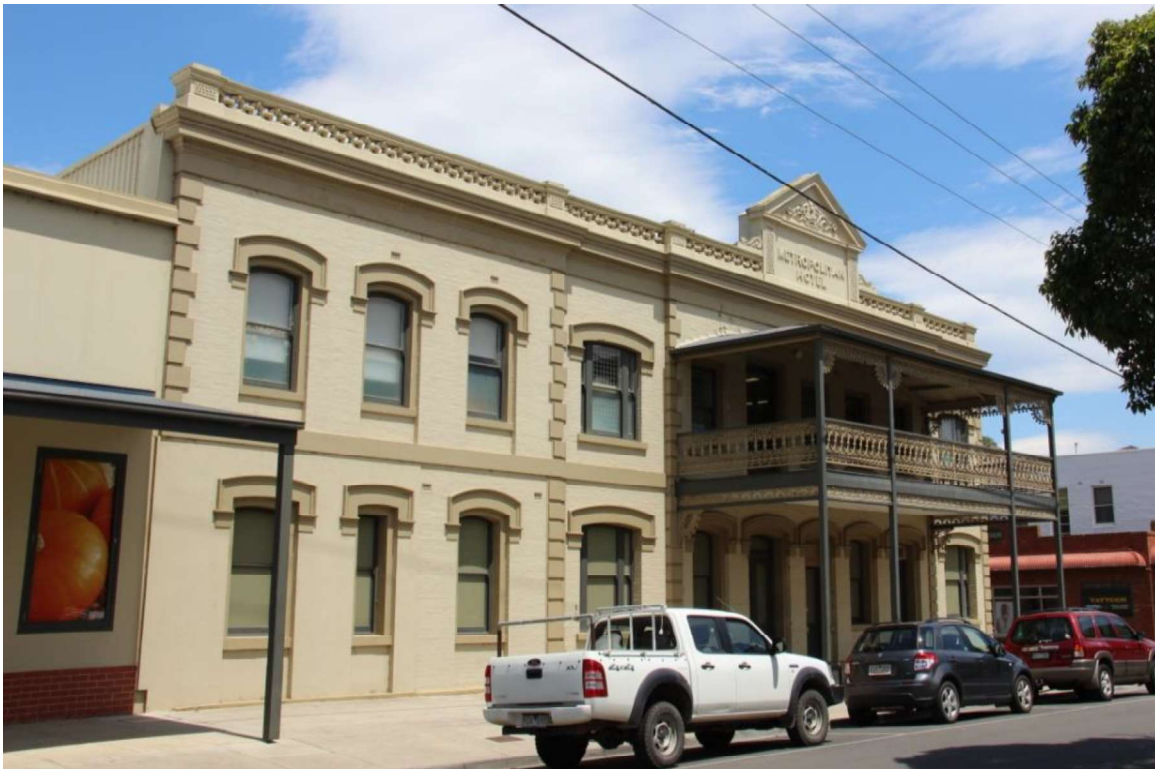
**Figure D4.** At the east end of the facade is a wide bay (accentuated by the quoining) with the same architectural detail as the 1889 building; this may be the addition constructed at a later date (and was definitely built by 1932, see Figure H2). Further investigation is required.

Figure D4. At the east end of the facade is a wide bay (accentuated by the quoining) with the same architectural detail as the 1889 building; this may be the addition constructed at a later date (and was definitely built by 1932, see Figure H2).

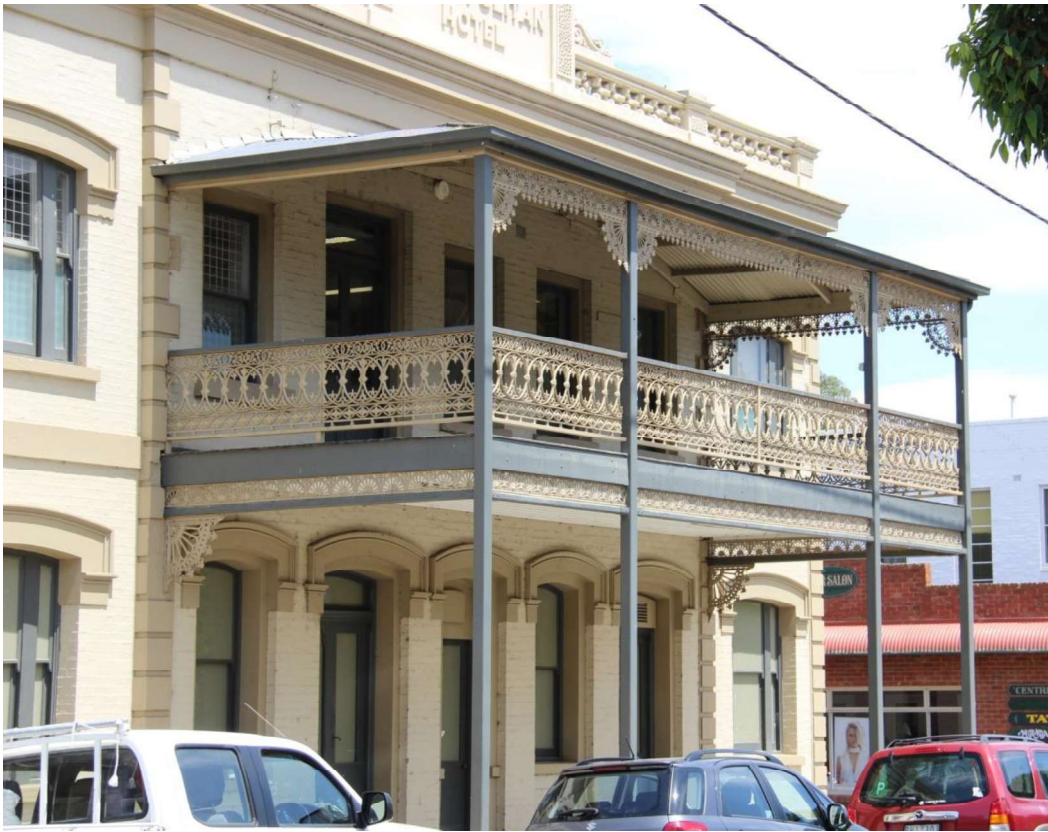
**Figures D4 & 5.** The many openings to the facade (except those under the verandah on the first floor) have bold segmental-arched mouldings to the top and are recessed within rendered surrounds. All windows have timber-framed one-over-one sash windows and most have a recessed panel below the sill. The windows in the two bays flanking the verandah are particularly wide, with narrow sash windows creating sidelights each side.

**Figure D5.** The many openings to the facade (except those under the verandah on the first floor) have bold segmental-arched mouldings to the top and are recessed within rendered surrounds. All windows have timber-framed one-over-one sash windows. The verandah posts are not original.
