## Tiger Torch Needle Valve Failure Results in Facial Burns

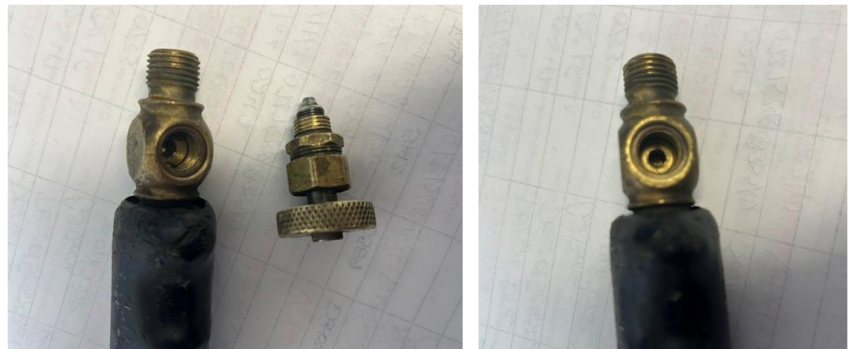
On July 12, 2026, a Journeymen Welder, working as a Welders Helper at a client's site, sustained burns to the face and neck when a tiger torch's needle valve blew off the handle during a routine preheating task.

- A propane smell had been noticed earlier and dismissed. The odor was assumed to be from a valve left open the previous day; it was closed and the smell went away — but this was not treated as a signal to inspect or remove the equipment from service.
- No pre-use inspection was performed. The propane bottle, hose, and torch valve were not formally inspected or leak-tested before the task began.
- The torch was worn from extended use and had no backout-prevention safeguard on the valve assembly — confirmed by the manufacturer as a longstanding design feature, not a defect unique to this unit.
- Confined, congested workspace. The task was performed in a tight space with limited room to move the torch away from the body once the flare occurred.

All propane torches were inspected that day in response to the incident. Any units showing signs of wear, age, or defects were removed and replaced with new equipment

- Pre-use inspection of all tiger torch assemblies is now required — documented on the FLHA — prior to first use on an employee's first day back from scheduled days off.
- Inspection must verify the needle valve is secure, and check the torch handle, hoses, fittings, and connections for damage, wear, looseness, or leaks.
- All pressurized gas connections must be leak-tested using an approved leak-detection solution (e.g., Snoop) before the torch is placed into service.
- Any equipment found damaged, loose, or leaking must be removed from service until repaired or replaced.
