OFFSHORE CRANE TIP REPLACEMENT

Total E&P Netherlands BV awarded Conbit the contract to replace the tip of one of their deck cranes on the L7P platform. The scope of work consisted of preparing the method statement, load out assistance, offshore replacement works, bolting and load testing.

Offshore Deck Crane Replacement

01SD045-D

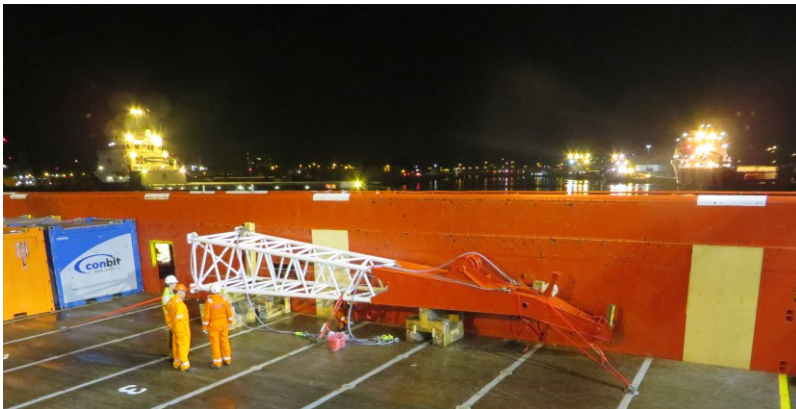
Photo: Seafastened on supply vessel

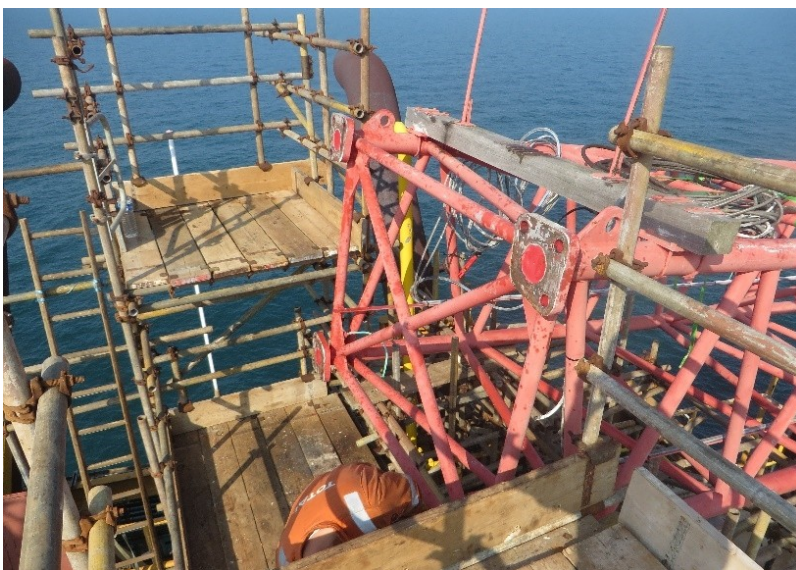
Photo: Deck crane without crane boom tip

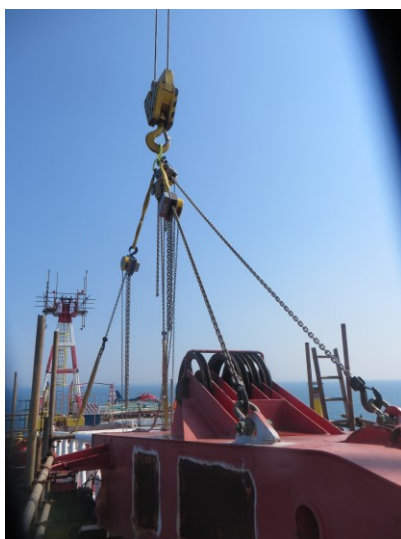
Photo: Lifting configuration attached to the old crane boom tip

The actual lifting was performed using the platform crane. The platform crane had sufficient reach to lift the L7P6 crane boom tip from the supply vessel onto the deck and from the deck to its final position.

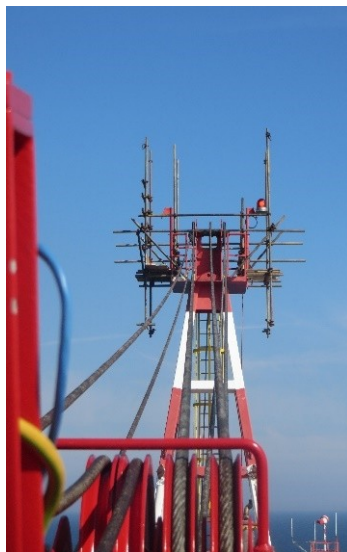
Photo: New crane boom tip
