**Test Report No: RJ9490P-1**

**SAMPLE ID:** Stone Coated Metal Roof Tiles

**TEST REQUESTED:** UL 2218, Impact Resistance Test of Prepared Roof Covering Materials.

## **IMPACT RESISTANCE TEST PER UL2218**

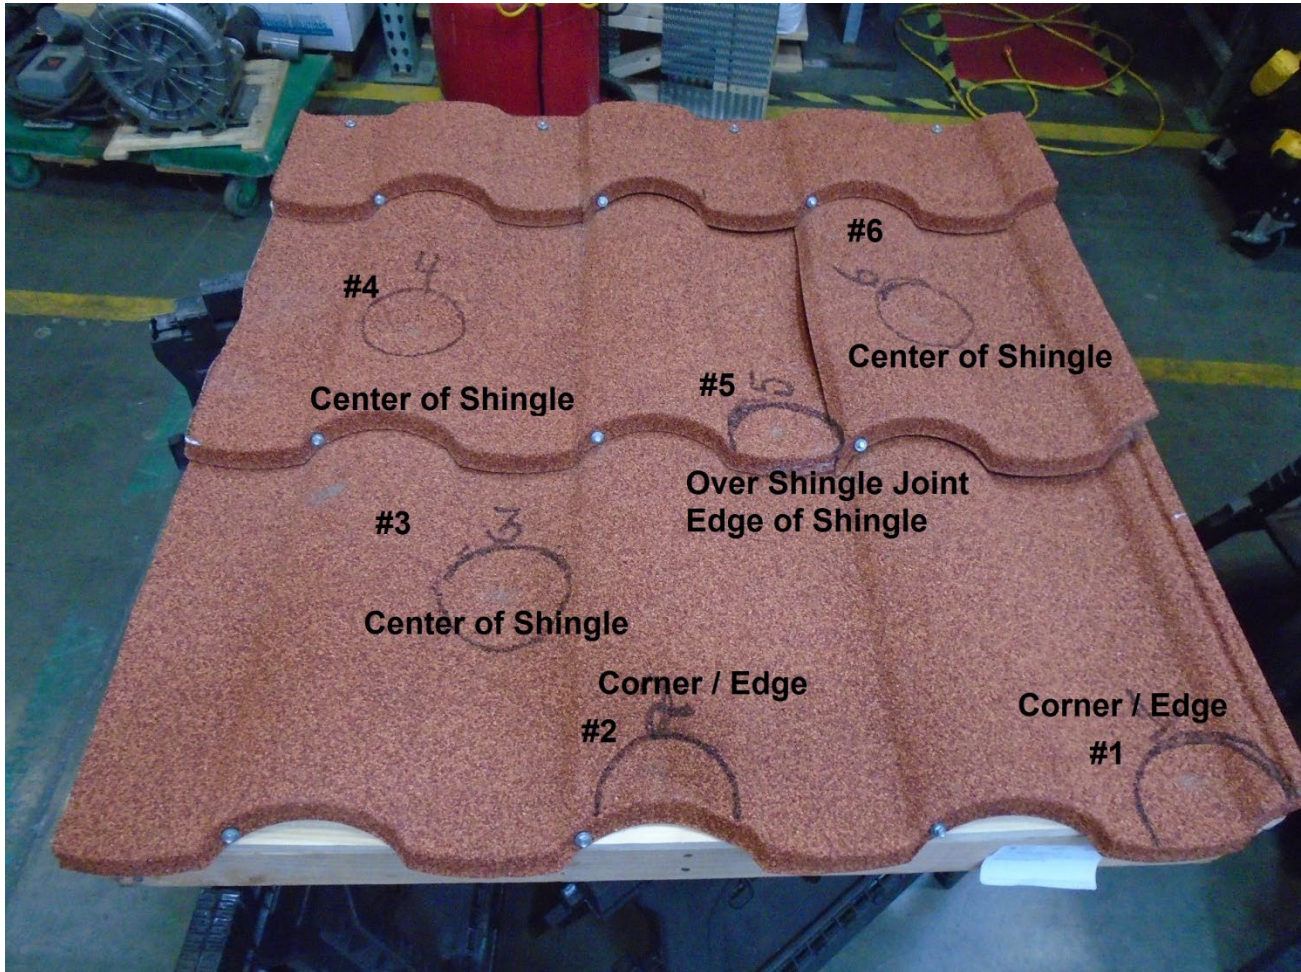
**Photo 1:** *Impact Locations for Novatik NATURA Roman metal coated shingle deck*

<b>Drop Location</b>	<b>Description.</b>	<b>Evidence of tearing, fracturing, cracking, splitting, rupture, crazing through any layer.</b>
#1	Corner/Edge of Shingle	No
#2	Corner/Edge of Shingle	No
#3	Center of Shingle	No
#4	Center of Shingle	No
#5	Over Shingle Joint/Edge of Shingles	No
#6	Center of Shingle	No

No tearing, fracturing, cracking, splitting, rupture, crazing or other evidence of opening through any prepared roof covering layer was observed at any of the six impact locations when viewed through 5X magnification. Minor cosmetic damage was observed at the impact location but did not meet the failure requirements.

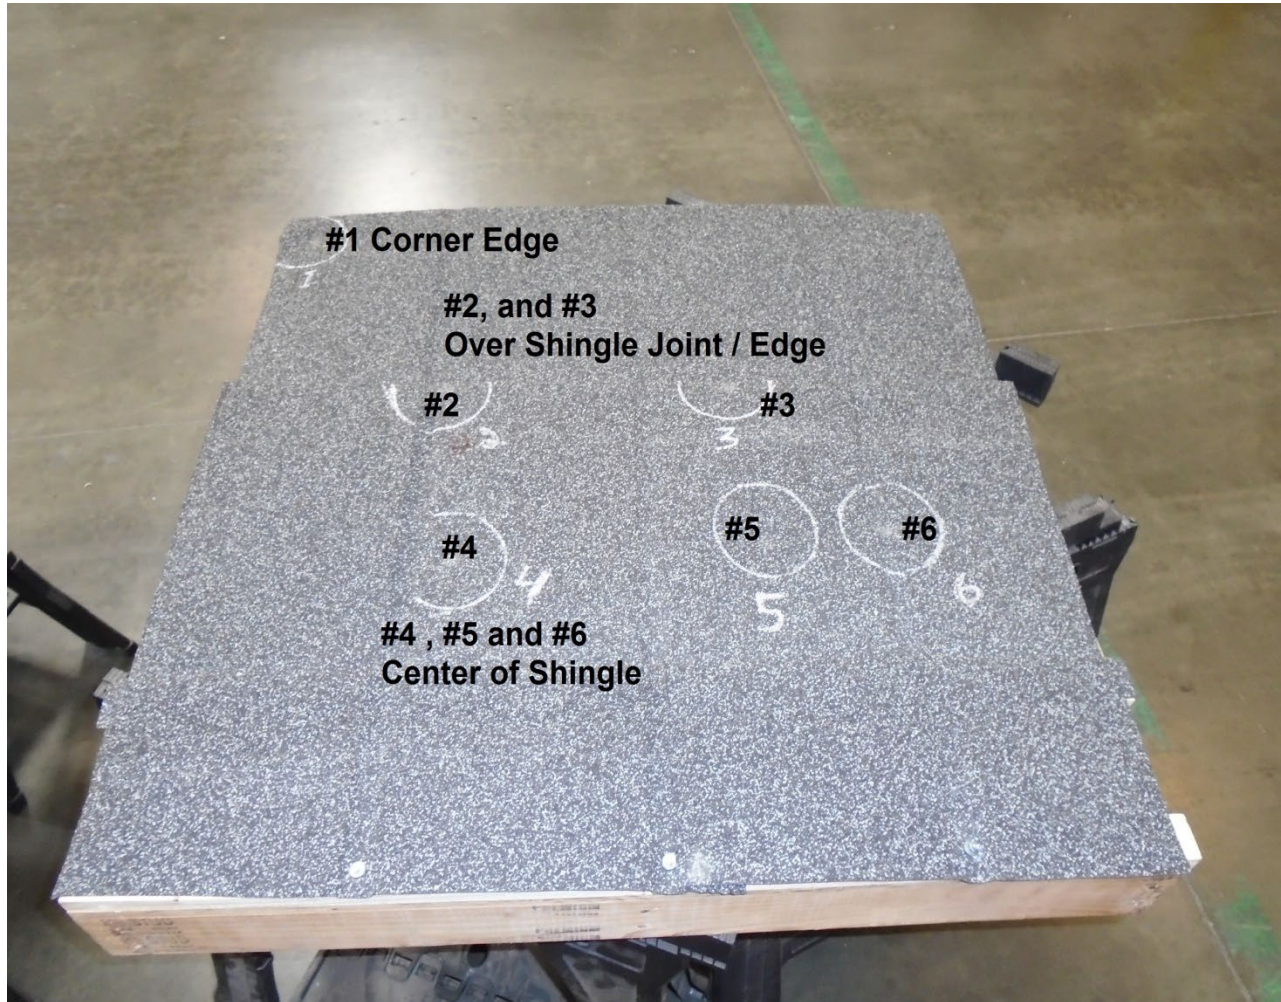
**Photo 2:** *Impact Locations for Novatik NATURA Slate metal coated shingle deck*

<b>Drop Location</b>	<b>Description.</b>	<b>Evidence of tearing, fracturing, cracking, splitting, rupture, crazing through any layer.</b>
#1	Corner/Edge of Shingle	No
#2	Over Shingle Joint/Edge of Shingles	No
#3	Over Shingle Joint/Edge of Shingles	No
#4	Center of Shingle	No
#5	Center of Shingle	No
#6	Center of Shingle on Groove	No

No tearing, fracturing, cracking, splitting, rupture, crazing or other evidence of opening through any prepared roof covering layer was observed at any of the six impact locations when viewed through 5X magnification. Minor cosmetic damage was observed at the impact location but did not meet the failure requirements.
