# An Investigation of the Masonry of the Hayes House Kitchen Wing and Porch Piers

Jessica Ridder  
Independent Study in Historic Preservation  
HP 8930-001  
Professor Frances Ford -  
Independent Study Advisor  
Spring 2025

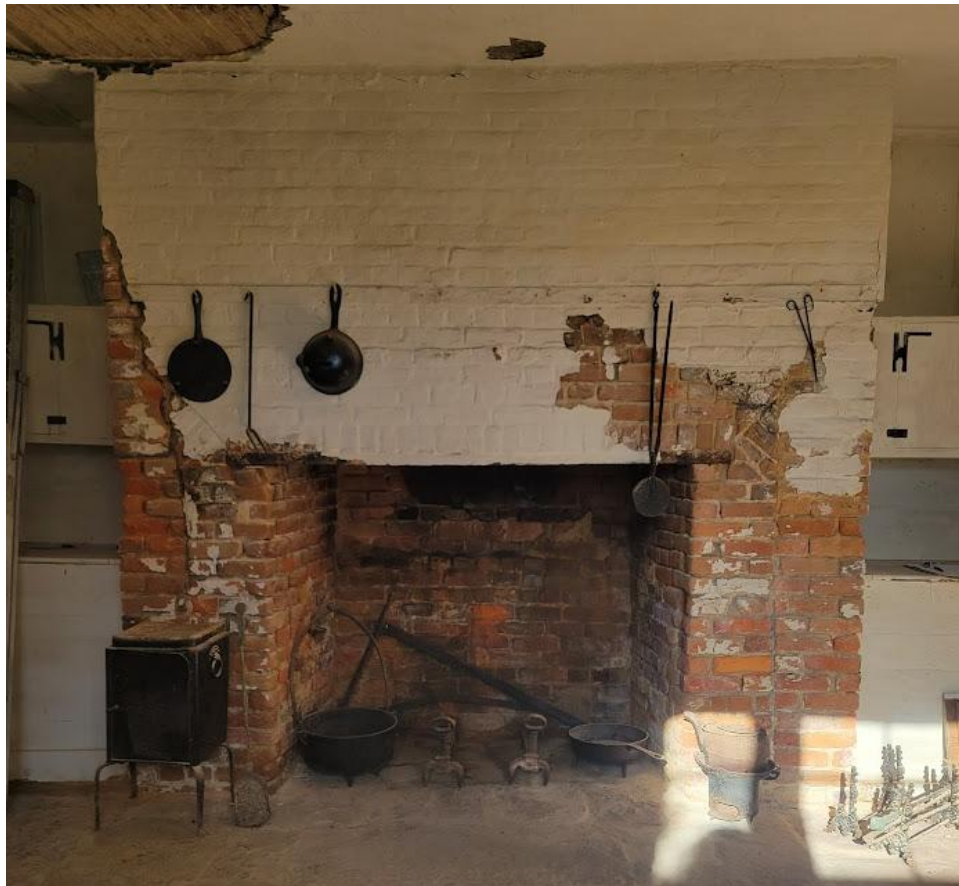
*Figure 3 South Room Facing Chimney Block*

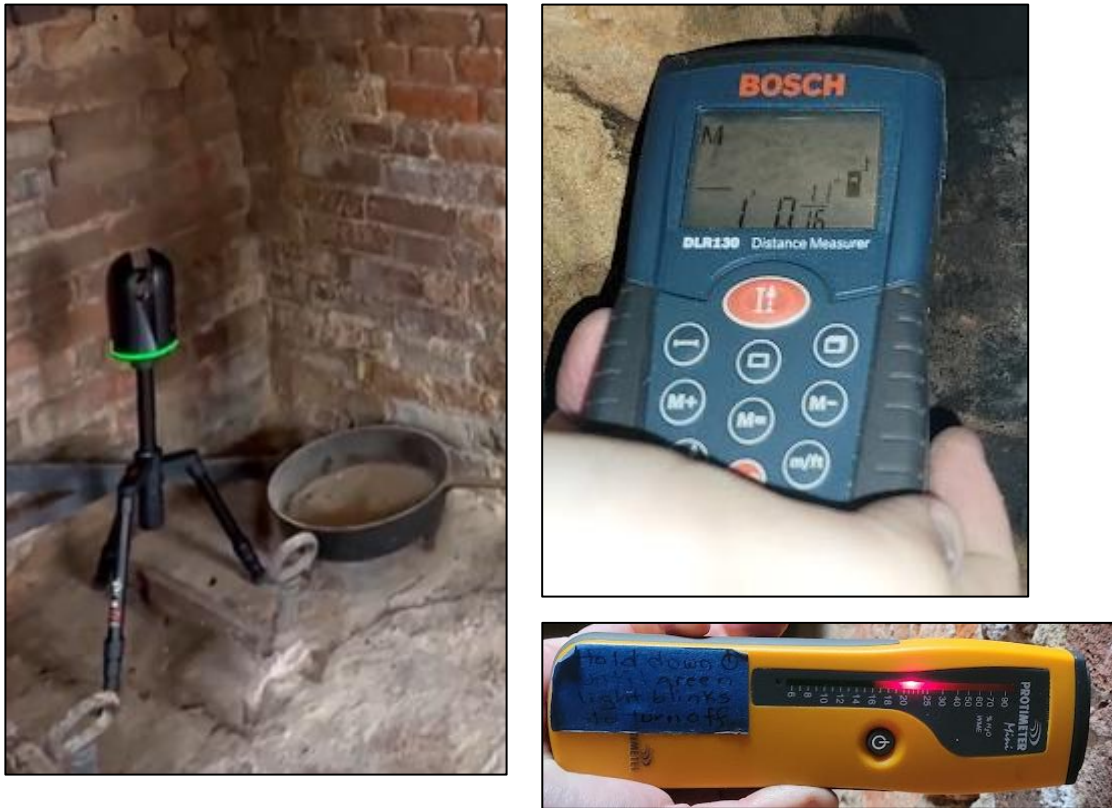
*Figure 4 Tools Used.  
Showing the Laser Scanner, Laser Tape, and Moisture Meter*

The tools and equipment used while in Edenton included drafting equipment such as graph paper, pencils, an architectural scale and straightedge. Measurement tools included a 25-foot metal tape measure, a Bosch laser tape measure, and a Protimeter® Mini BLD2000 moisture meter. A personal Samsung cell phone was used to take photos, and a flashlight was used in the loft for visibility. These photos were taken on the default setting and optimized by the phone for photo settings. The Laser Scanner used was a Leica model BLK360 and utilized an iPad Pro for

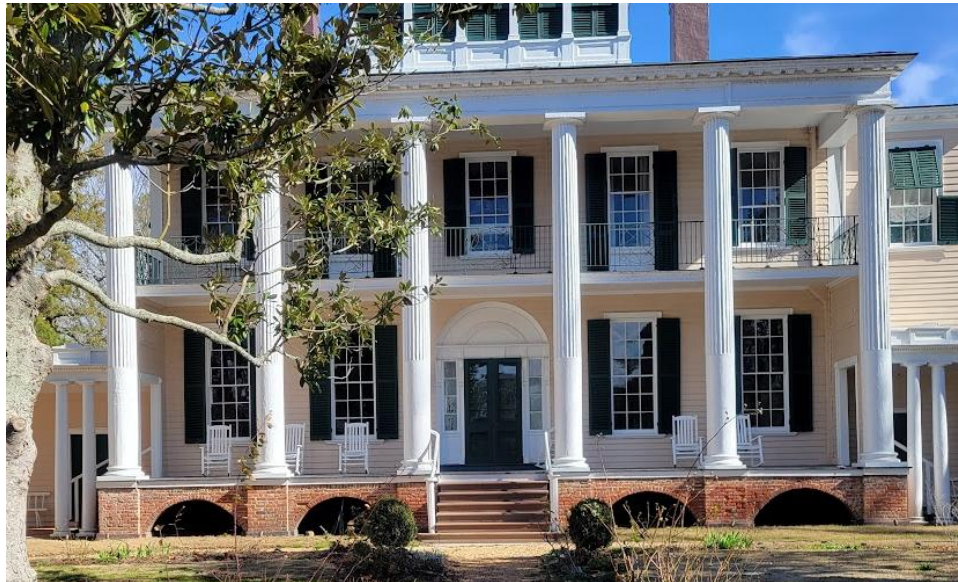
*Figure 5 South Porch of Hayes*

The third day lasted only half a day, and was comprised of an assessment of the masonry piers of the south porch and the brownstone steps on both the north and south porches. Moisture contents were checked in various areas and were inflated due to rain the night before. This site visit ended with a final walkthrough with Robert, Andrew, and Wade to discuss what had been done so far, the next steps, and the goals of the project. One of these next steps was removing the infill from the north room's fire box which had been closed up sometime before the boiler system was placed in the north room. This would be completed before the second site visit occurred.

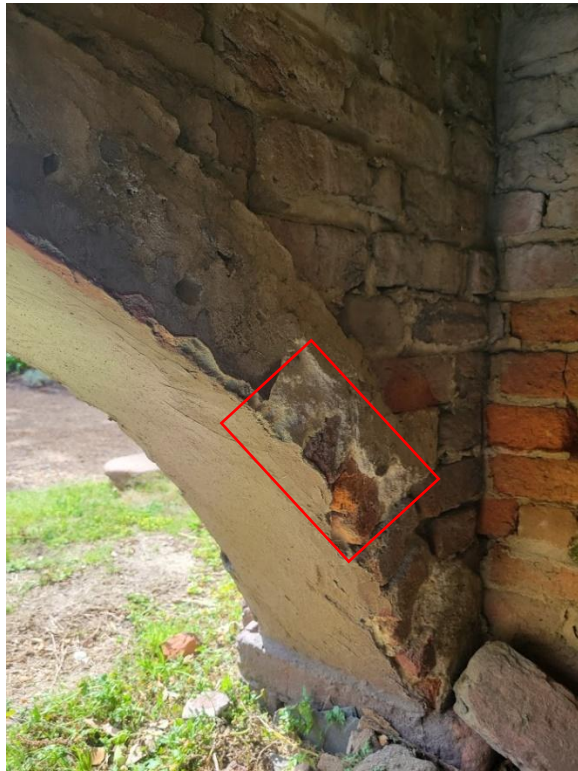
*Figure 6 Sample HP-01 Location.*

That afternoon included collecting two mortar samples to take back to Charleston for analysis. One sample was collected from underneath the south porch on the back side of the arch near the stairs. This was near a potential area of repointing and included some of the parging on the intrados of the arch. It was given the designation of HP-01 for Hayes Porch. The other location was the interior of the uncovered north room chimney about five feet off the ground where the mortar was already loose and failing. It

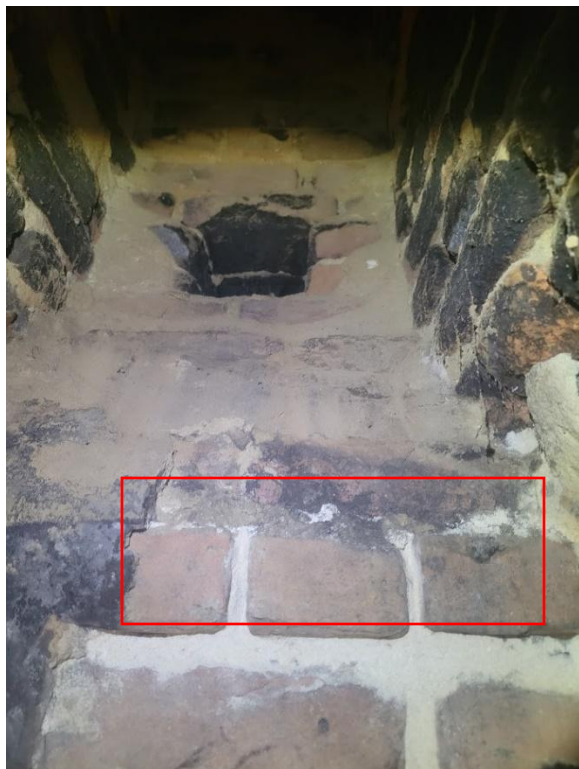
*Figure 7 Sample HC-01 Location*

was designated HC-01 for Hayes Chimney. These two sample locations were documented and the samples carefully collected with a hammer and chisel before being placed into a labelled bag.

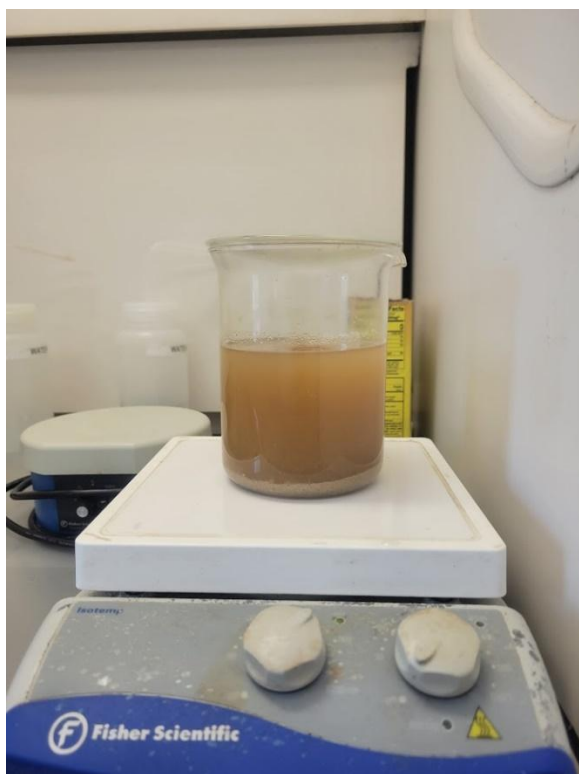
*Figure 8 Sample HC-01 During Acid Digestion*

Upon return to Charleston the samples were analyzed as whole pieces and fibers within the HP-01 sample removed for further analysis. The samples were then powdered before being placed into a beaker within the fume hood and slightly saturated with water before adding Muriatic Acid creating a chemical reaction. The particles lifted up the sides of the beaker were washed down with water and more acid and water added until the reaction was not so violent. A magnetic stirring rod was then placed carefully into the beaker and the beaker stirred on a Fisher Scientific Isotemp self-stirring machine within the fume hood for 24 hours. A watch glass was placed on the top of the beaker to prevent any type of contamination and to prevent splashes and fumes from rising from the acidic solution. After 24 hours passed, the beaker was removed from the self-stirring machine and tested with more muriatic acid for a reaction. Finding none, a piece of filter paper was weighed and placed into a funnel in an Erlenmeyer flask and the liquid carefully poured into the funnel to separate the fines from the aggregate. At this point the second mortar sample was started within the fume hood following the same process as the first. Over the next 24 hours, the filter paper was refilled with

liquid from the beaker until no more filtered out. The beaker was then placed within an incubator manufactured by Lab-Line Instruments, Inc. Model No. 120 to dry. Once the last filtration had completed, the filter paper was placed on a watch glass and set in the incubator for 24 hours as well. This process was completed on the second sample concurrently. Once the beakers and filter paper for each sample was dry, they were removed from the incubator and weighed. The now dry aggregate within the beaker had to be moved to a plastic weigh boat to not overload the scale. This aggregate was then placed into a U.S.A. Standard Test Sieve manufactured by Gilson Company, Inc. This sieve stack was manually shaken for 10 minutes to sort the particles by size. Weigh boats were also labelled for each section of the sieve stack and weighed before the aggregate was added. Once sorted in the sieve stack each numbered pan was carefully poured into the corresponding weigh boat and weighed to find the weight of the aggregate sample. Both mortar samples went through this process. After sorting the aggregates of each mortar sample, the now sorted aggregate was analyzed for size, shape, sphericity, and color to finish the mortar analysis. Those findings are within the Mortar Analysis section of this report.

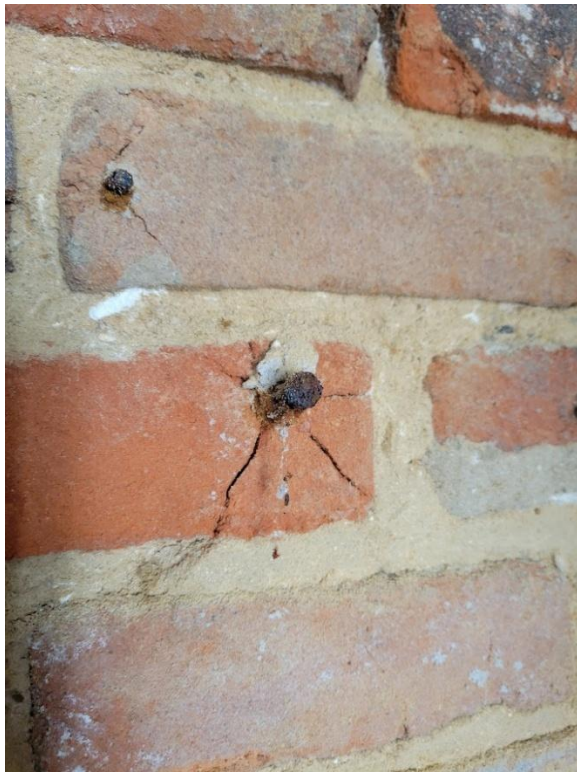
*Figure 10 Nails within the bricks*

Another finding within the masonry are multiple nails stuck into either bricks or the mortar joints that are now corroding. This is causing the bricks to crack as the corrosion expands the iron. As with the mortar joints, if left long enough, this could cause bricks to start spalling, which is the name for the face of the brick falling away leaving the interior of the brick exposed. This is bad for multiple reasons as the hardened outer surface of the brick that is glazed during the firing process provides some protection to the brick from physical damage as well as moisture problems that could erode the interior of the brick. Another sign that moisture is present is the salt efflorescence on the surface of some bricks towards the floor of the south room. This is just salt that has been absorbed into the brick along with water and as the water evaporates from the porous brick, it leaves behind the salt which can build up deposits as seen in Figure 12.

A moderate recommendation is to remove the metal nails from within the bricks. While they have already cracked some bricks, removing them regardless of corrosion status will still leave the holes in the bricks. Removing them will just prevent further cracking which could start breaking the bricks out of the masonry completely.

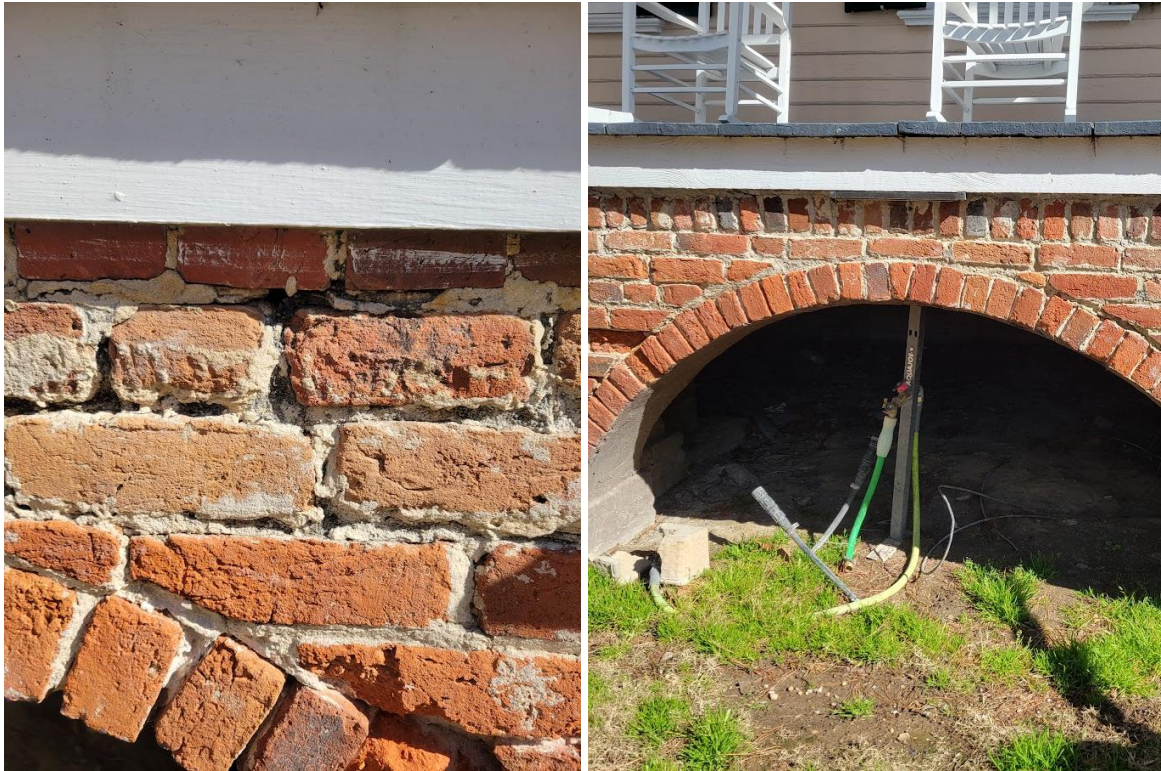
*Figure 13 Mortar loss and bio-growth (left), Water pipe under arch (right)*

The porch piers under the south porch are in good condition with only some areas of mortar loss mainly towards the top where the porch sits against the brick. This is causing the mortar loss between the bricks and leading to the bio-growth within these joints. The presence of the water pipe underneath one of the arches is of note due to the chance of leaking or spraying water in close proximity to the masonry that could lead to deterioration.

The low priority maintenance recommendations include monitoring the water pipe underneath the south porch for signs of leaking which could compromise the masonry arch surrounding it. This level of recommendation also includes either removing the patches of parging from the brick surface that have created staining, leaving them alone to show the progression of finishes on the masonry surface, or replastering the masonry surface to return to the parged look. This should be based on the preservation treatment that Hayes receives and what the period of significance is chosen.

When selecting a mortar to repoint these areas, I recommend using the Type O for the porch piers when only a shallow joint needs repointed. If a deeper joint is found, use a higher compressive strength mortar that will support the bricks without causing damage. The Chimney may be able to have Type K mortar used on it if the joints are shallow and the rest of the bricks are supported by a stronger mortar type. Otherwise, a higher compressive strength mortar should be used here as well.

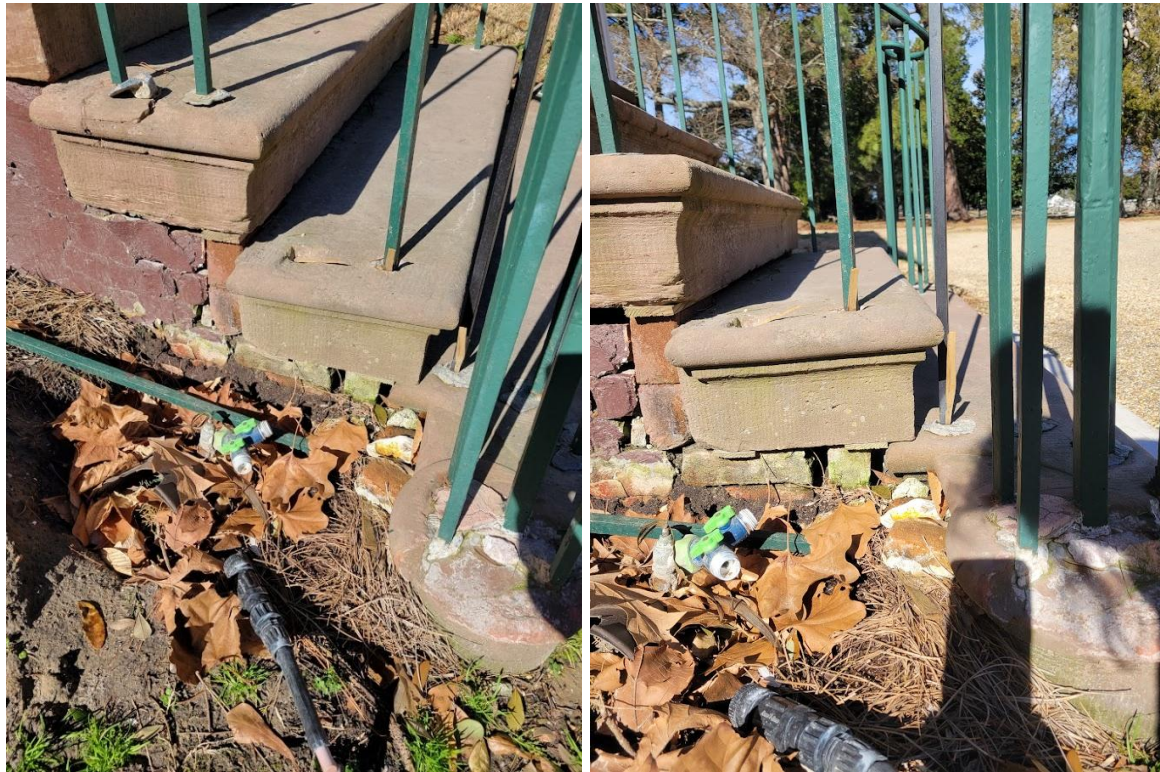
*Figure 14 Bottom step cleaving on north stair and baluster missing with broken sets in stone*

The stone steps on the north and south porches are made of the same brownstone, most likely acquired from New England as it is local to that region. These brownstone steps are hewn out of larger pieces of rock and show the ghost marks of tools used to split them and shape the sides. As a sedimentary stone, brownstone is formed in layers of deposited silt, sand, and mud that can be cleaved along those layer lines. This can be a problem for brownstone if it gets damaged exposing multiple layers that water or material wear could exacerbate. These steps show some signs of this cleaving on the edges of the stone shown below in Figure 14. The steps

on the north side also show signs of metal deterioration on the balusters with one even completely missing and laying on the ground next to the stairs. There are others that have shims stuck down beside them in the setting

The stone steps show signs of cleaving along the sedimentary layers and settlement away from the South Porch. The railings on the north stairs are also showing signs of failing with shimmed or missing balusters, signs of corrosion, and loose settings.

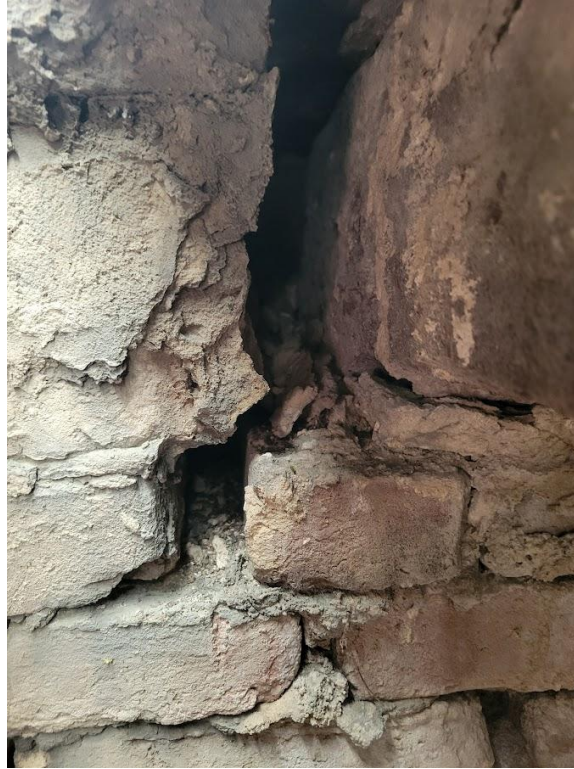
*Figure 15 South Stairs Stone Step and Header*

The south porch stairs are also showing signs of settling and moving away from the porch. Figure 15 shows the gap between the pier and the stair support. This could be caused by the different weight between the piers and the stair supports which appear to just sit on the surface instead of having any other sort of foundation. The lack of foundation has slowly allowed the dirt to settle and the stairs to pull slightly away from the porch.

After reviewing the conditions assessment results, my recommendations are to repoint the areas of mortar loss that could cause bricks to fall and potentially cause a total collapse if enough of them are displaced. Repointing would also take care of the bio-growth issue on the porch piers within the failing mortar. Another recommendation is to shore up the south porch stairs that are

pulling away from the porch which could lead to a large gap between the stairs and the porch causing a safety hazard.
