**Cross-section Paint Microscopy Report  
Exterior and Interior Paints Phase II**

**Cupola House  
The Cupola House Association  
Edenton, North Carolina**

For: Robert Leath, Executive Director  
Edenton Historical Commission  
108 North Broad Street  
Edenton, NC 27932

Conservator: Susan L. Buck, Ph.D.  
303 Griffin Avenue  
Williamsburg, VA 23185

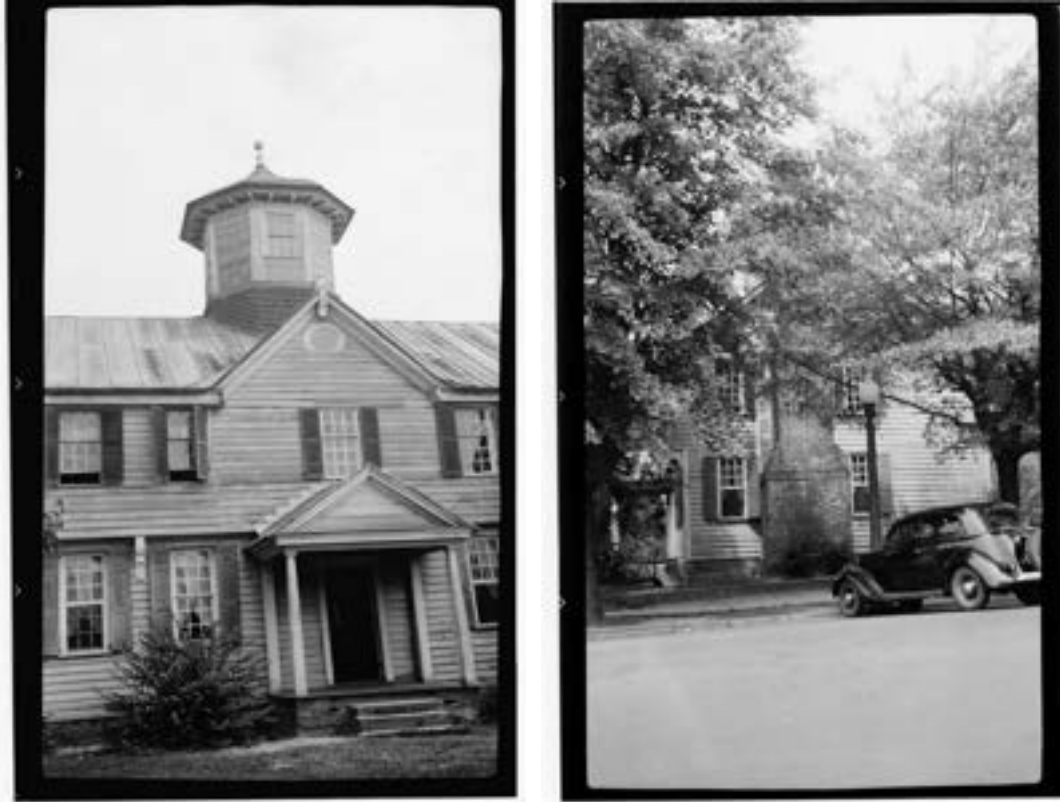
The building was photographed for the Historic American Buildings Survey (HABS) in 1939 by preservation architect Thomas T. Waterman. The exterior paints appear badly worn in these images. Elevations and floor plans were completed by a HABS team in 1940. Some of those photographs and drawings are included in this report as references.

HABS, Thomas T. Waterman, South and East Elevations, 1939

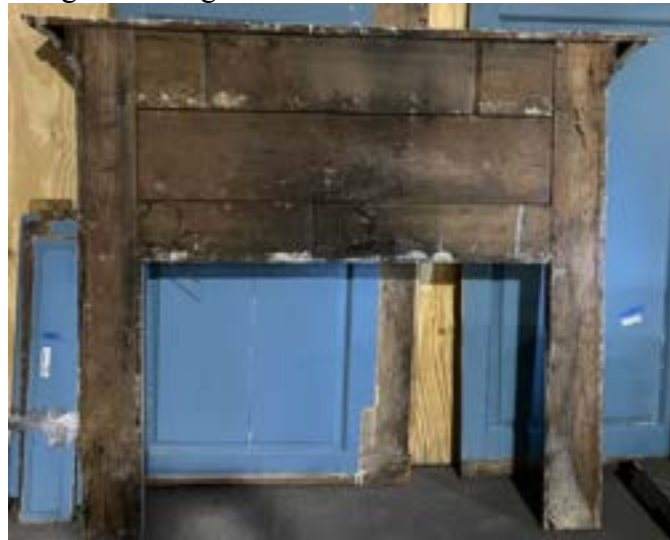
The original rusticated siding on the house was likely replaced with the current weatherboards around the first quarter of the nineteenth century or up to the 1830s.<sup>6</sup> Some of the original boards were re-used in the roof structure of the porch. These boards are not easily accessible. However, when the woodwork was returned from the Brooklyn Museum, a section of reused siding was found on the back of the mantel from the first-floor northwest room (105), and the fragmentary paints were analyzed.

Reused Original Siding on the Back of the Mantel from Room 105

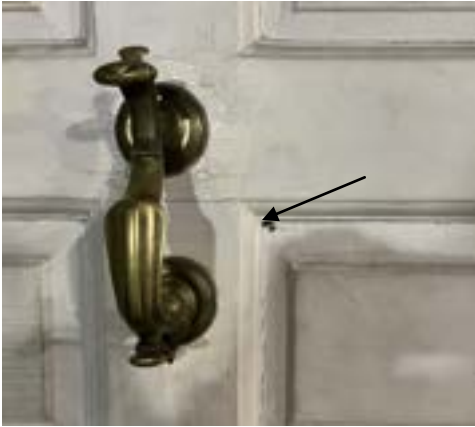
Front Door and Door Architrave. No insights into the early paints on the front door could be gleaned from the cross-sections. Door-1 was taken from near the knocker and there is a thick layer of grit and polish residue on the wood, followed by a later cream-colored paint that cannot be identified as it does not match any of the trim paints. In Door-2 there is a thin gray paint on top of a film of grime, followed by clean, finely ground off-white paints that are consistent with twentieth-century manufacture. So, no information about early exterior door paints could be gleaned from these samples.

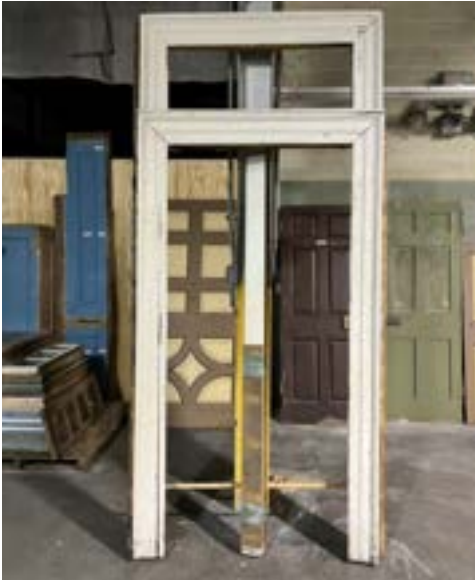
Architrave-1 came from the ghost of where the weatherboards abutted the door architrave. Its chronology is missing the earliest white lead-based cream colors as the first layer on the wood can be aligned with generation 3 in the chronology of paints from the brackets (see S-5).

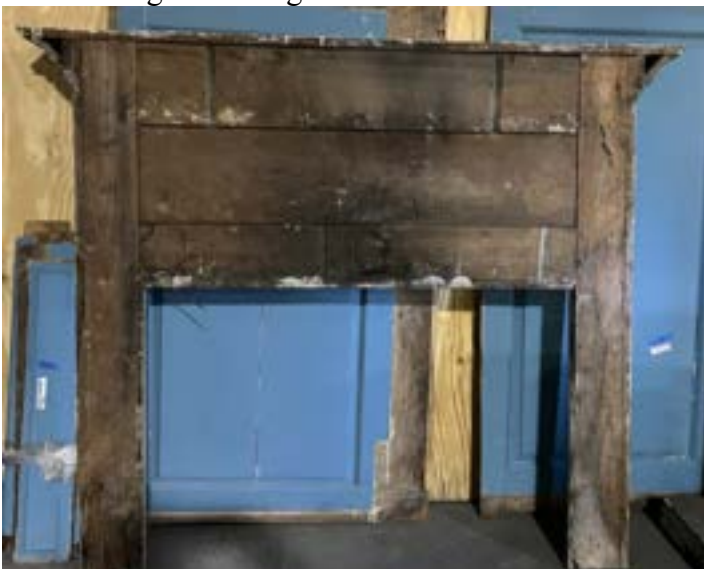
Reused Original Siding

Reused Rusticated Siding. There is an uneven film of off-white paint trapped in the deepest carving of the rusticated siding which was sampled for analysis. The cross-section for Siding-1 shows there is one thick layer of oil-bound, cream-colored paint on the wood which is now cracked and weathered. This paint flowed deeply into the clean wood fibers, confirming it as the first paint applied to the siding. This cream-colored paint is almost identical in color, composition and context to the original cream-colored paint identified in sample S-5 from the side of a bracket which was analyzed in 2018. This comparison helps to confirm that the siding and the brackets were originally painted the same color, suggesting the building was a monochromatic cream color after construction.

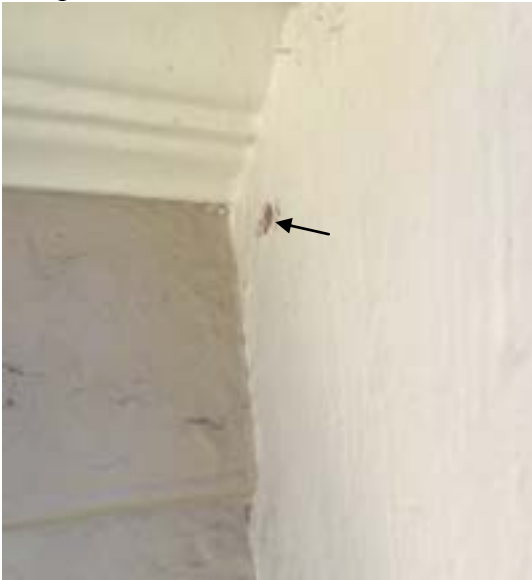
### Sample S-5

The most complete cross-section is S-5 from one of the brackets on the south. This element is original to the building and 21 generations of paint can be identified in the cross-section. But, only the first two white lead-based, cream-colored paints might date to the eighteenth century. These two paints are fragmentary, consisting of only two discrete lumps, and are surrounded by later paints which flowed into cracks. The third generation of paint is an off-white paint with a sparkly blue autofluorescence that marks the presence of zinc white, dating this paint to not before about 1845 when zinc white became commercially available. Most of the paint colors on this bracket are creams and off-whites, with the exception of more recent tan paints in generations 16 and 17, as shown in the photomicrographs below.

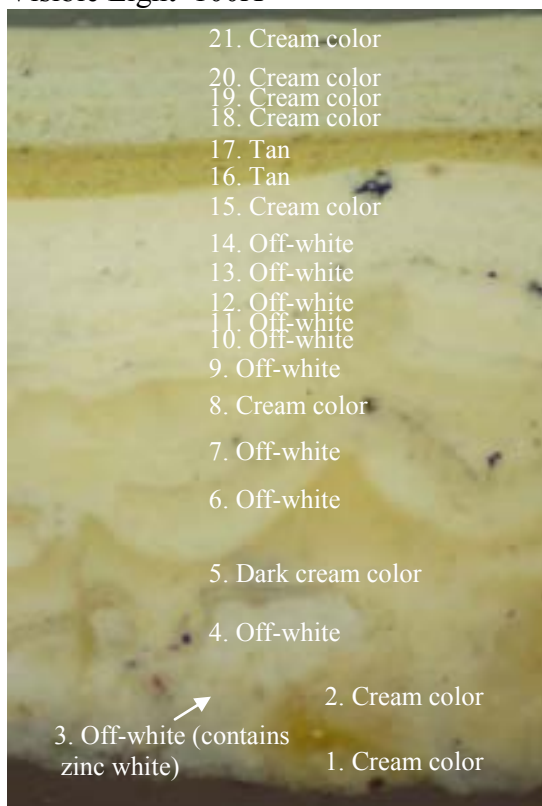
Visible Light 100X

S-5. South elevation, west side, side of bracket.

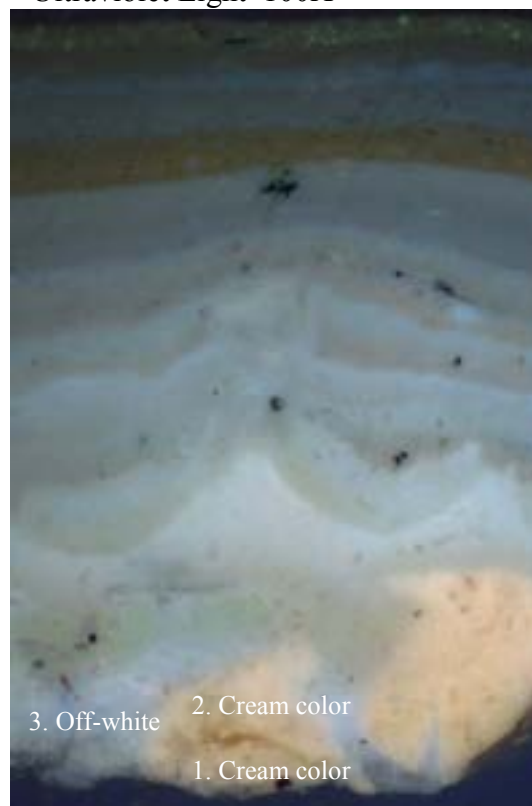
Ultraviolet Light 100X

The 2018 analysis showed that most of the paints on the exterior trim, pediment and weatherboards are varying shades of off-whites and cream colors which are difficult to confidently distinguish in reflected visible light. However, many of these paints have distinctive autofluorescence colors in the reflected ultraviolet light cross-section images. The earliest white lead and linseed oil-based paints have a characteristic pinkish-yellow or pinkish-orange autofluorescence colors which are readily discernible in this group of samples. Paints with zinc white, a pigment commercially available for architectural paints after about 1845, have a characteristic sparkly bluish appearance in reflected ultraviolet light. Paints containing titanium white, a tiny bluish-white pigment commercially available after about 1920, typically have a pale bluish or grayish autofluorescence.

These differences in autofluorescence make it possible to locate where the earliest white lead-based, cream-colored and off-white paints survive, and to reconstruct an early paint chronology for the exterior of the building.

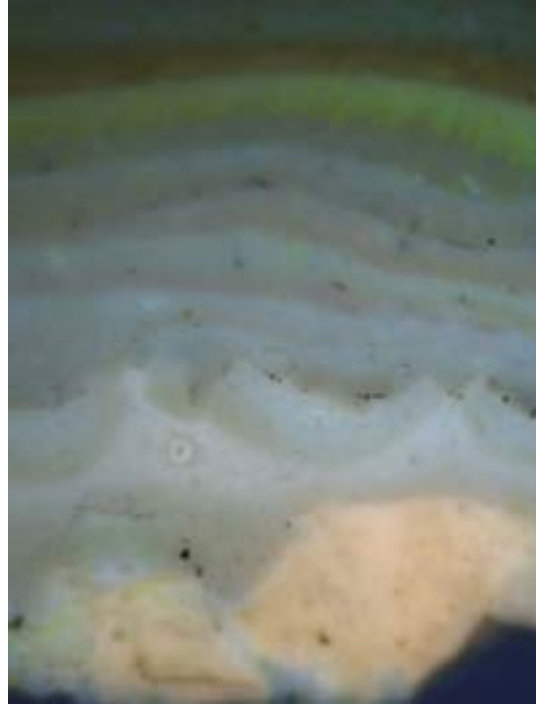
Binding media analysis of sample S-5 shows that all the paints contain oil components. There are carbohydrate components in generations 7 through 21 which could be organic additives to thicken or toughen the paint (such as natural gums and casein) or cellulosic fillers. The paints in generations 15 through 21 contain protein components, likely surfactants (with amine groups) added to these modern paints to improve their wetting properties. Polarized light microscopy pigment identification of the components in the first cream-colored paint could not be done with confidence because this paint layer is so fragmentary and compromised by penetration of later paints into the cracks in the earliest layer (at the bottom of the cross-section).

UV Light & DCF for lipids (oils)  
+ reactions in all paints

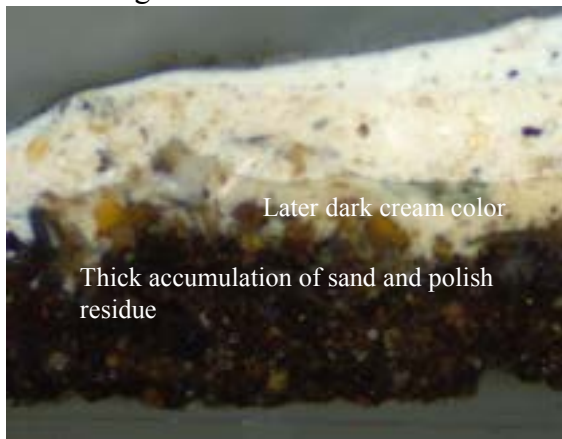
Visible Light 100X

Door-1. Original front door, near knocker.

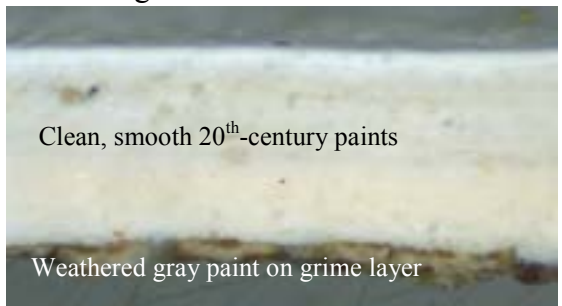
Visible Light 100X

Door-2. Original front door, chamfer of left panel.

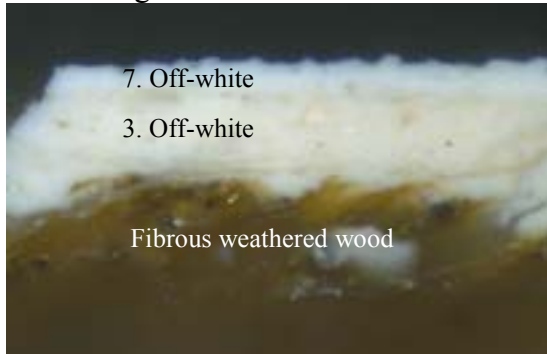
Visible Light 200X

Architrave-1. Possible original front door architrave, right side at accumulations of paint at ghosts of siding.

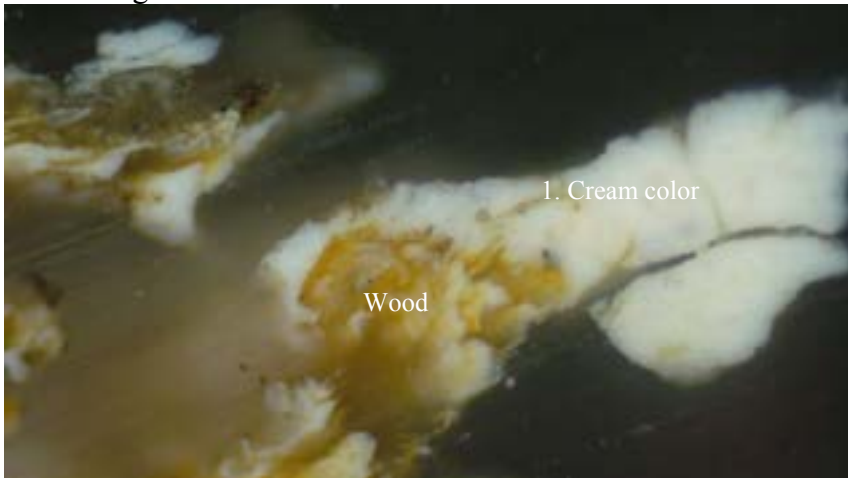
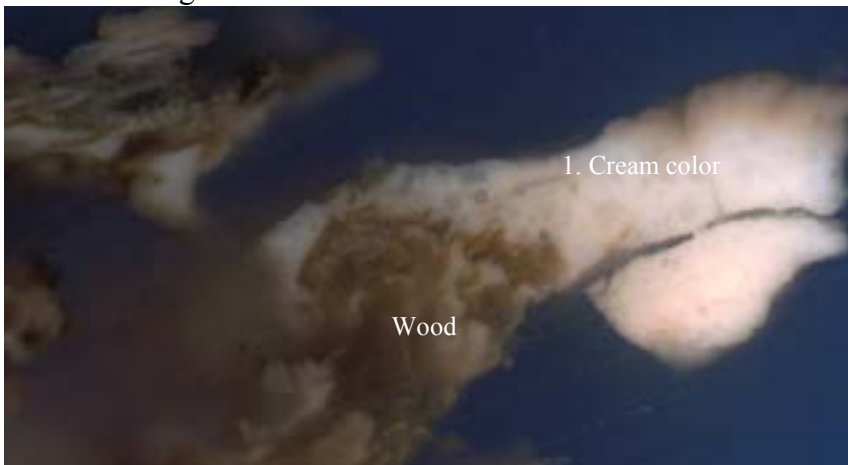
Siding-1. Reused section of rusticated siding reused at the back of the Federal-period mantel for room 105.

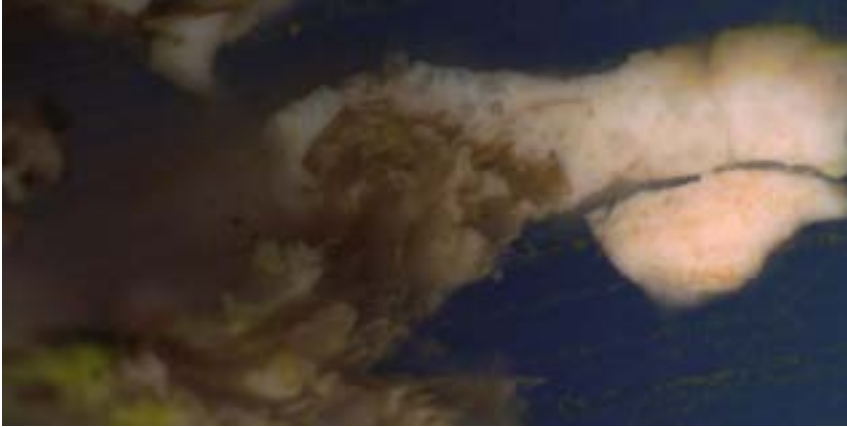
Siding-1. Reused section of rusticated siding reused at the back of the Federal-period mantel for room 105.

Weak + reactions for oils in the weathered cream-colored paint

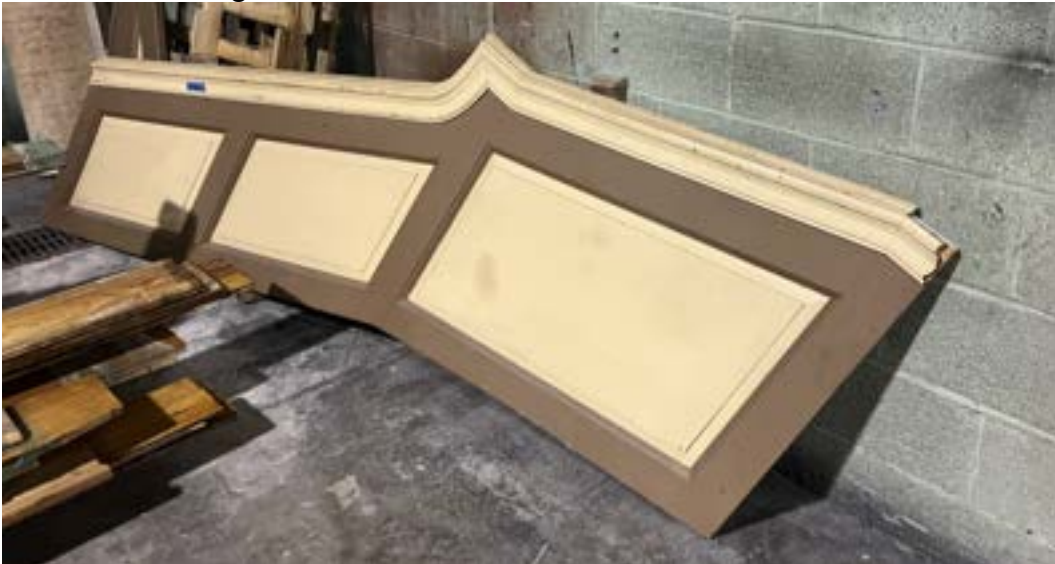
Wainscot with original section of chair rail

Two samples were taken from a section of wainscot returned by the Brooklyn Museum. Andrew Ownbey felt that a section of chair rail at the lower end was original, which much of the rest of the rail was replacement. Comparison of the evidence in these chair rail samples 101-14 and 101-15 shows that sample 101-14 from the left end of the chair rail contains the same red-brown paint identified as the original paint on the woodwork in this space. By comparison, the evidence in 101-15 from a section of chair rail at the joint for the upward curve shows that the wood is comparatively fresh and the coating history begins with brown stain that aligns with generation 3 in the coating sequence.

Comparative samples from two sections of chair rail from the returned wainscoting that runs along the lower staircase shows that the section at the lower end (left side) retains fragments of the original red-brown paint on a shellac primer (see 101-14). The cross-section from the joint at the curved upper section of the wainscot shows that its coating history begins at the brown stain identified as generation 3 in the paint stratigraphy.

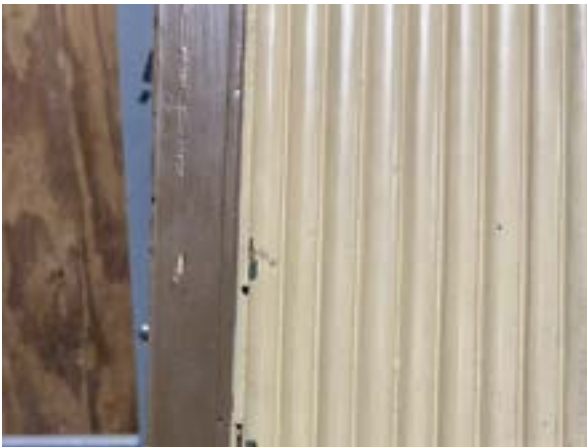
101-1 and 101-2

- 101-1. Pedimented door trim, right stile, five-feet up.
- 101-2. Pedimented door trim, right side, pilaster (yellow).
- 101-3. Pedimented door trim, base plinth.

The pigments in the original red-brown paint consist of stable, relatively inexpensive earth-based pigments including red ochre, burnt sienna, haematite and calcium carbonate. It is a similar color to the red-brown paint on the interior of the lower case of the built-in cupboard in the Dining Room (102) but they differ in their pigment combinations as the paint cupboard interior paint is composed of red ochre, red lead and calcium carbonate. Binding media analysis with the fluorochrome DCF confirms that the original red-brown paint is oil-bound.

101-1. Pedimented door trim, right stile, five-feet up. Pigments in the original red-brown paint: red ochre, burnt sienna, haematite, calcium carbonate.

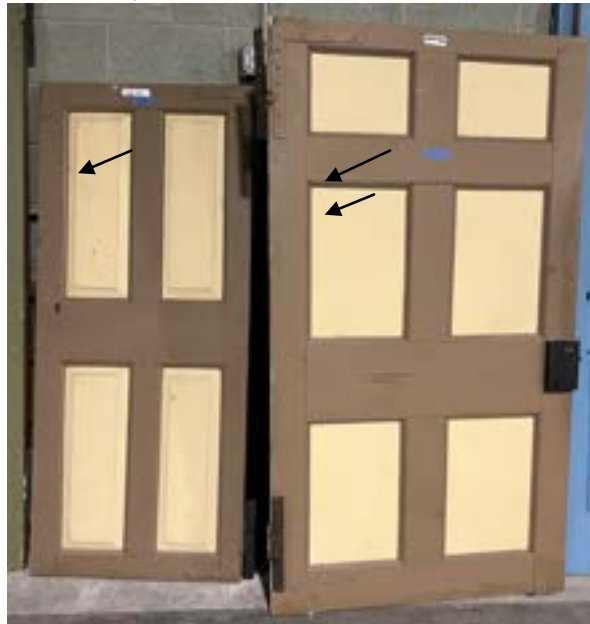
101-8, 101-9 and 101-23

The wide door that had been located at the back of the stairhall (center passage) by the Brooklyn Museum was re-sampled to obtain a more complete paint history as the initial sample 101-8 from this door was incomplete. Sample 101-23 has a paint history that begins with a thin brown paint in a light gray primer not found elsewhere in the first-floor paint history. The two most recent paint generations can be aligned with generations 5 and 6 in the stairhall (see sample 101-9). It is possible that this door came from another building and was installed by the Brooklyn Museum.

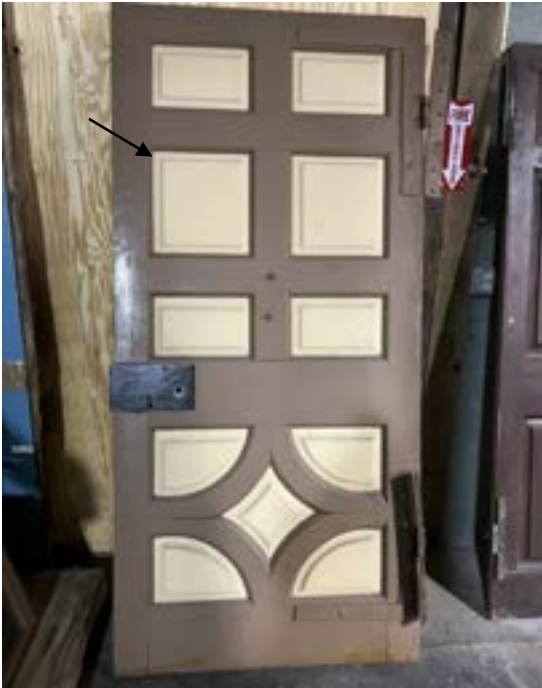
Door-3

The original red-brown paint on wood primed with shellac for the closet door below the stair case is consistent with the earliest paint history in the stairhall, as shown in the sample labeled Door-3, which follows. But this closet door was painted gray in generation 3, which was not found on other stairhall doors.

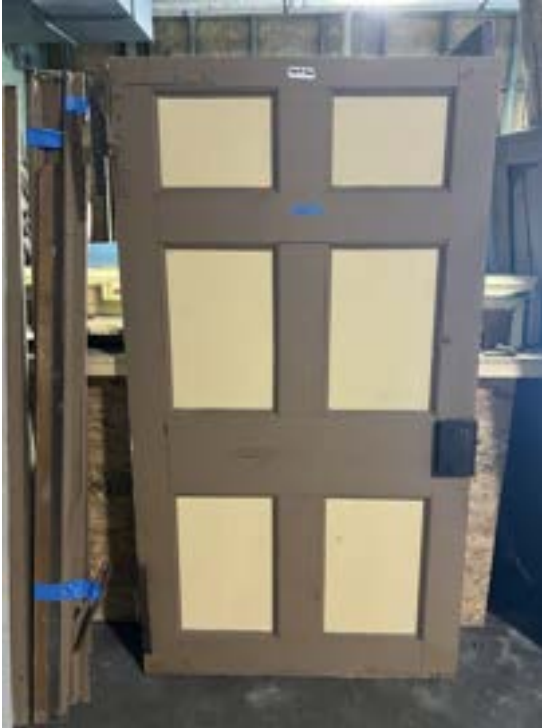
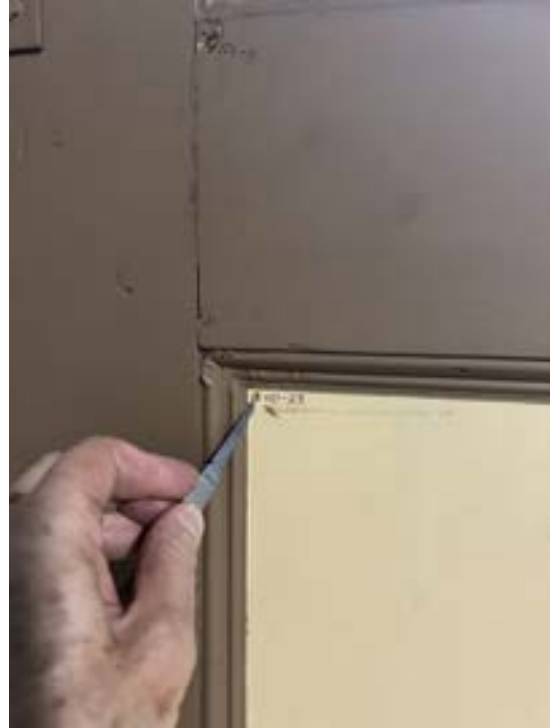
101-23

101-23. Wide door formerly located at back (not original). Replaces sample 101-8.

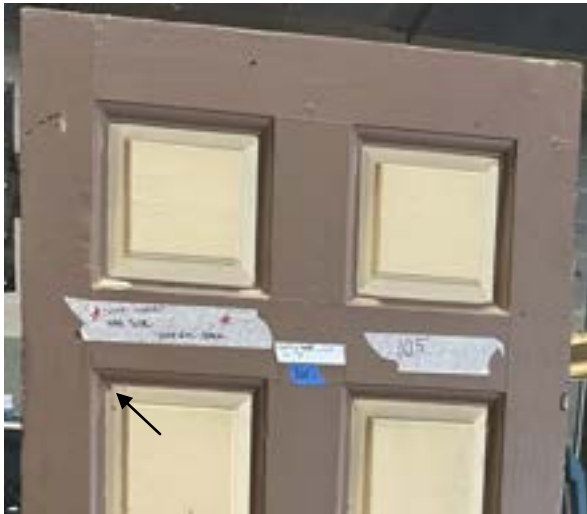
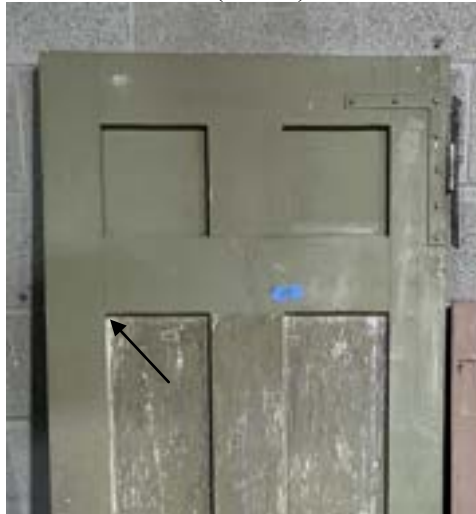
Raised Panel Side 101-20

The July 2025 investigation of two puzzling doors includes the door labeled 101 leading into 105. The cross-section 105-1 from the back of the door begins with a light cream-colored paint followed by the chrome green-based paint that links this door to room 105. Sample 101-20 was taken from raised panel side of the door labeled as being from 101 and leading into 105 (the rear parlor). But could this door have originally been positioned in the partition wall dividing rooms 103 and 105, or did it lead from the stairhall into 105? The paint history in 101-20 and 105-1 compared with the door that the Brooklyn Museum had installed leading from the stairhall into the pantry (104-10) suggests the door shown below led from the stairhall into the rear parlor.

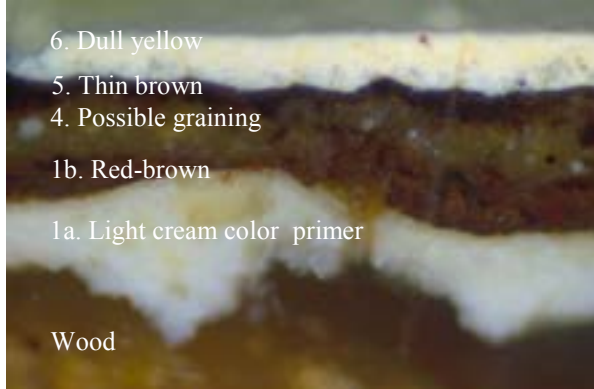
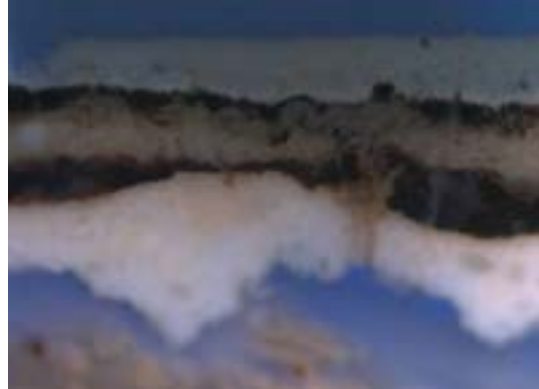
101-20. Door from 101 leading into 105 (opposite side is sample 105-1).

The paint history in 101-20 begins with a thick layer of cream-colored primer followed by red-brown paint. The second and third generations are missing, but generations 4 through 6 align with the raised panel sides of the other stairhall doors.

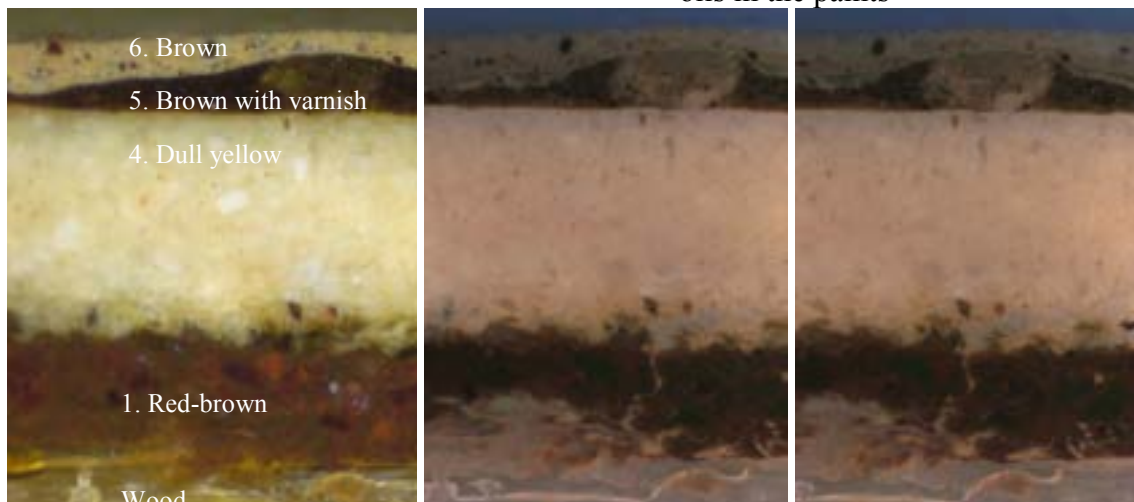
UV Light & DCF

Weak + reactions for the presence of oils in the paints

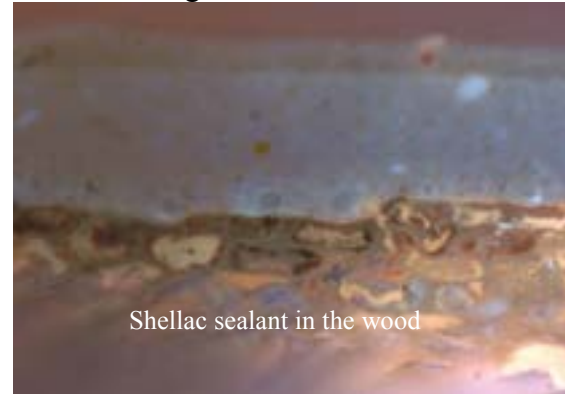
101-14. Fragment of wainscot with section of original chair rail from staircase.

UV Light & DCF for the presence of oils 200X

+ for oils in all paint layers

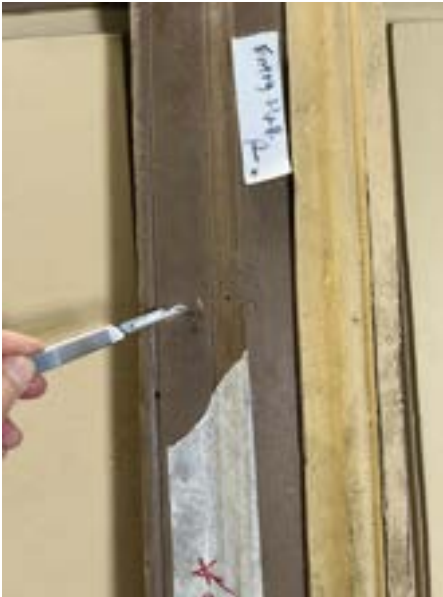
101-21

A section of door architrave that had been in the stairhall (center passage) was sampled during the July 2025 site visit to see if comparative cross-section analysis could put it into context. The paint chronology begins with the same oil-bound red-brown paint found as the original paint on the woodwork in the stair hall. Generations 2 and 3 are missing. But there is a thick dull yellow and a thin brown paint combination that might represent a graining sequence identified as generation 4. The uppermost paint is the brown paint applied by the Brooklyn Museum in generation 6. The paint evidence suggests this door architrave was originally installed in the stairhall and was repositioned by the Brooklyn Museum.

101-21. Unknown door architrave.  
Visible Light 200X

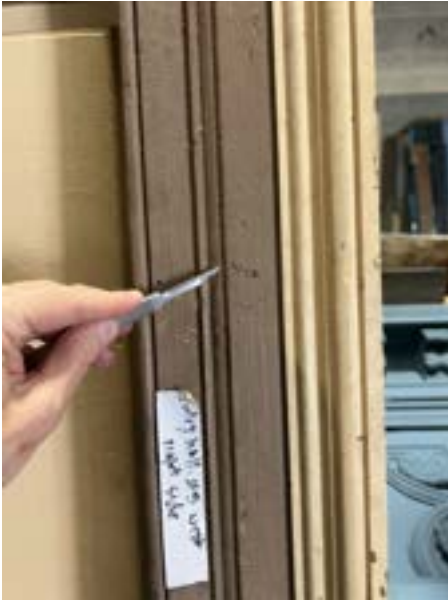
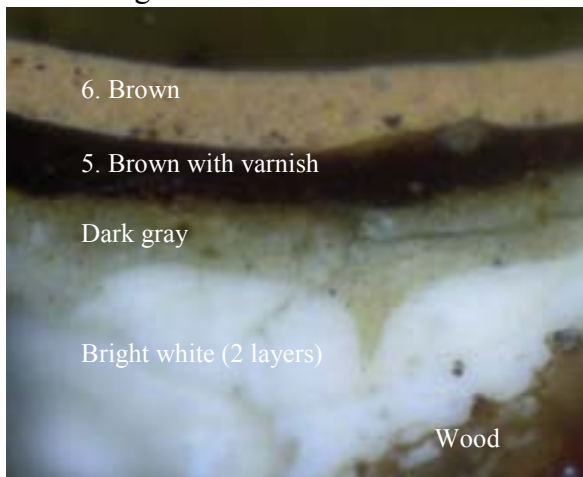
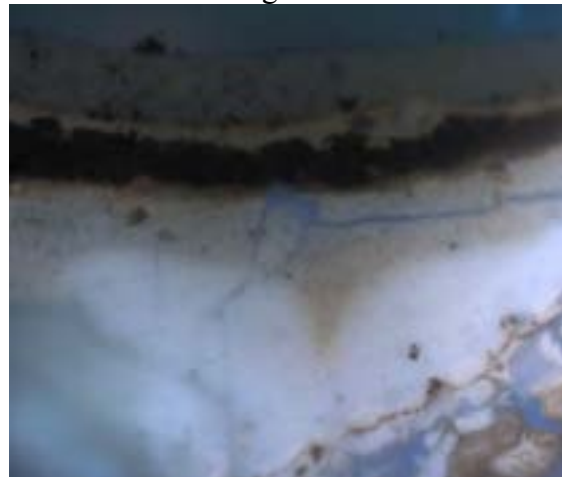
101-22. Unknown door architrave, was located in 101.

A different door architrave that had been positioned in the stairhall in the Brooklyn Museum installation was questioned because of slight differences in molding profiles. Comparative cross-section analysis shows that the earliest bright white paint, followed by a thick dark gray paint, does not match any of the early paints in the Cupola House. The two most recent paints – brown with a varnish layer followed by a lighter brown – align with generations 5 and 6 in the stairhall stratigraphy. So this element may be an early architrave from another house that was installed by the Brooklyn Museum when they constructed the period rooms in the Museum.

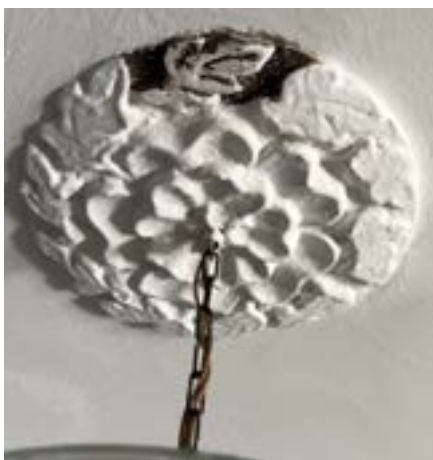
Carved Wood Ceiling Medallion. The March 2025 site visit provided the opportunity to examine the two ceiling medallions in the Center Passage more closely, and it was an grand surprise to find that the medallions are made of carved wood, not plaster. The central flower form is similar to the carved flower decorations on the woodwork in the Dining Room, but the leaves that encircle the flower are not used elsewhere in the house.

While on site, the most recent white paints were scraped from an area of the border leaves with a scalpel (see below). It was difficult to get the scalpel into the carving details, but enough was revealed to show that the border is meant to represent oak leaves. Careful overpaint removal with a gentle chemical stripper like Citrustrip may be a more effective way to reveal the carving by removing the white overpaints without compromising the original red-brown paint. Sample 101-19 shows the original finish was a thick layer of the same coarsely ground, red-brown, oil-based paint found on the woodwork in this space.

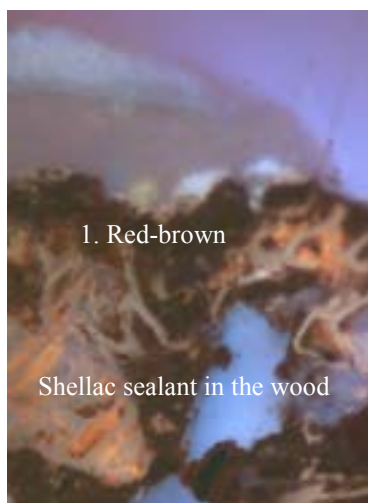
101-19. Central ceiling medallion with wood substrate.

UV Light & DCF  
+ for oils in all layers

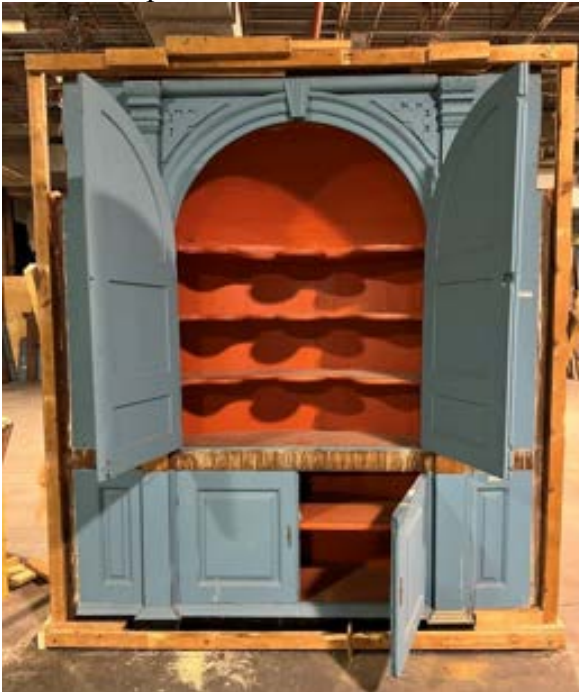
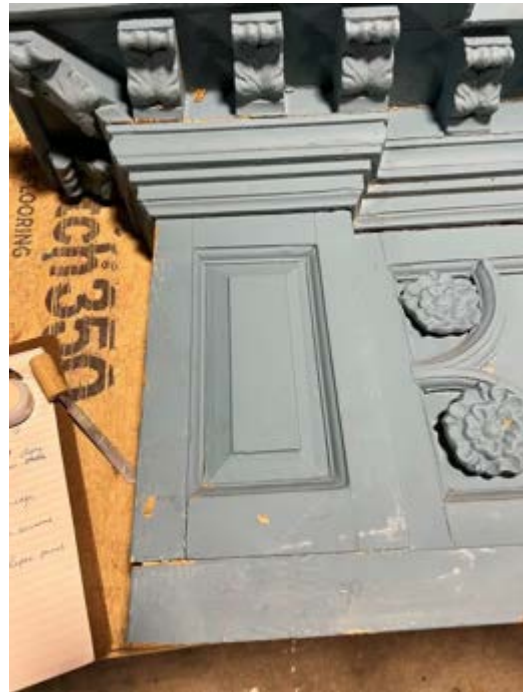
Room 102 Dining Room Sample Locations

- 102-1. Cupboard, upper case interior, left edge of bottom shelf.
- 102-2. Cupboard, upper case interior, back board above base shelf, left side.
- 102-3. Cupboard, upper case interior, inner surface of dome, right side.

- 102-18. Back of the built-in cupboard. (Room 104 for the analysis findings.)
- Door-6. 102(R). 102D3 Dining Room side. (Ownbey sample.)
- Door-8. 102(L). 102D2 Dining Room side. (Ownbey sample.)

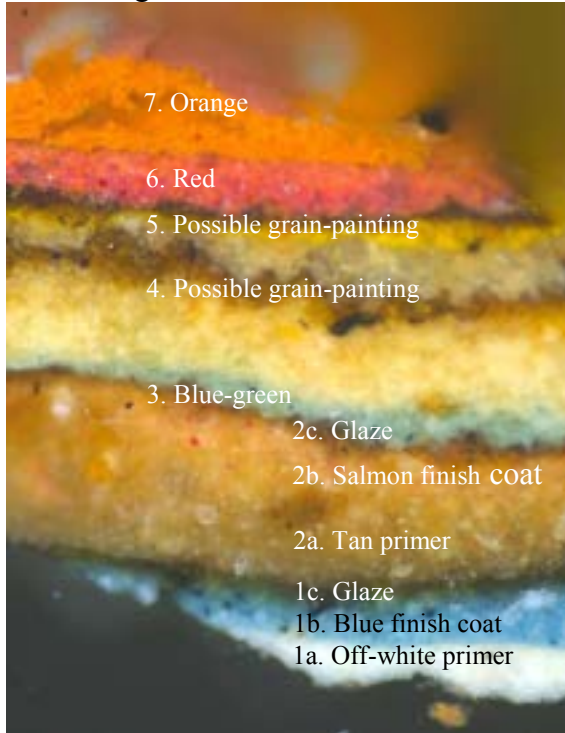
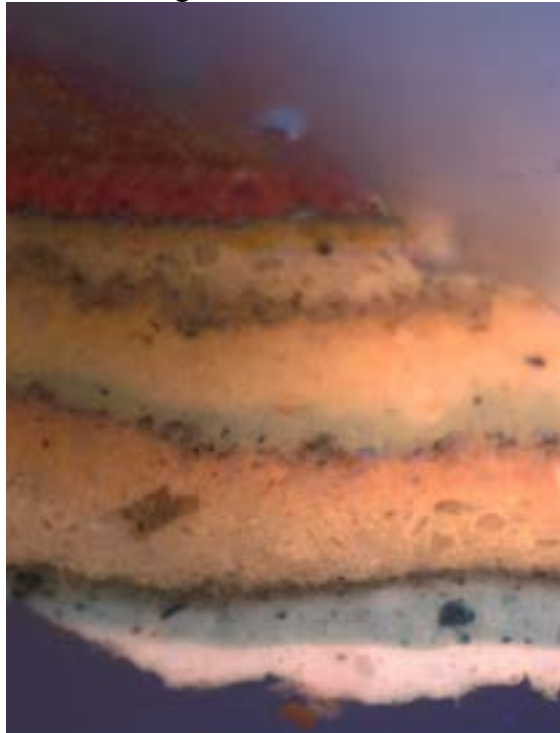
It was fascinating to find that the entire interior of the upper case of the cupboard was painted in the same manner as the paneling and mantel, beginning with an off-white primer and a rich blue finish coat made of Prussian blue, white lead and calcium carbonate. There is an oil-resin glaze layer on top of the blue paint on the upper case interior, but this glaze was not found consistently in the samples from the paneling and architraves from this room. The upper case cupboard interior was a salmon color in the second generation, but then was repainted blue-green in the third generation. Samples 102-1 from a shelf and 102-3 from the dome clearly show the color changes over time on the interior of the upper case. Door-6 from one partition wall door confirms that the two partition wall doors were painted to match the partition wall paneling from the original rich blue paint to the most recent Brooklyn Museum blue paint.

102-1. Cupboard, upper case interior, left edge of bottom shelf. Pigments in the original blue paint: large and small Prussian blue particles, white lead, calcium carbonate.

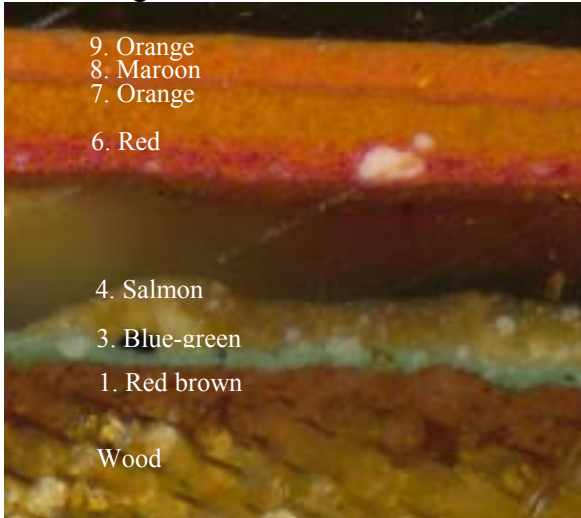
102-7. Cupboard, lower case, backboard above shelf, right side.

By comparison, the cross-section samples from the lower case of the cupboard show that it was originally painted red-brown. It was also repainted less frequently compared to the upper case interior as the chronology in 102-7 from the lower case backboards is missing generations 2 and 5. It is not surprising to find a more practical red-brown paint made with less expensive pigments red ochre, red lead and calcium carbonate on the interior of the lower case as it was likely not intended for display of precious silver or ceramics like the upper case.

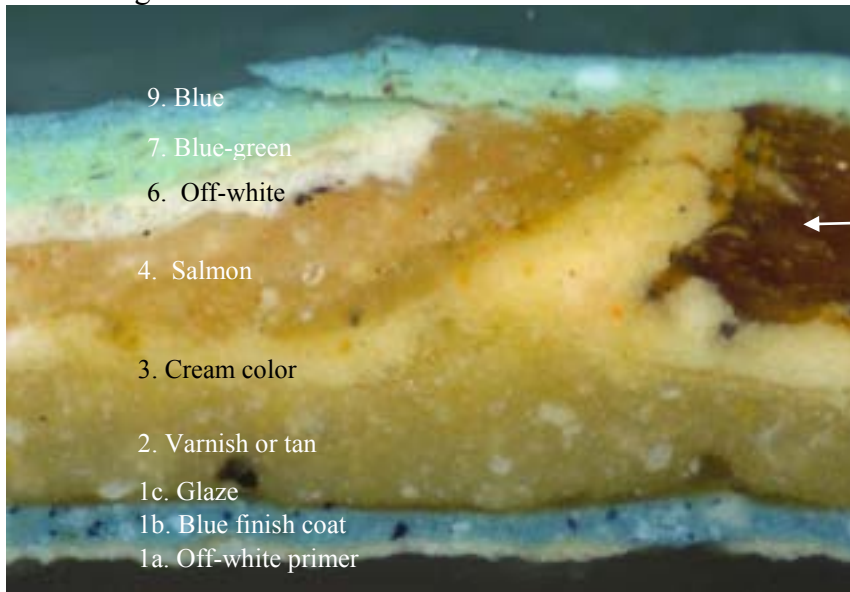
102-16. Original west door, top left corner of middle left panel.

Wood fragment caught up in later paint

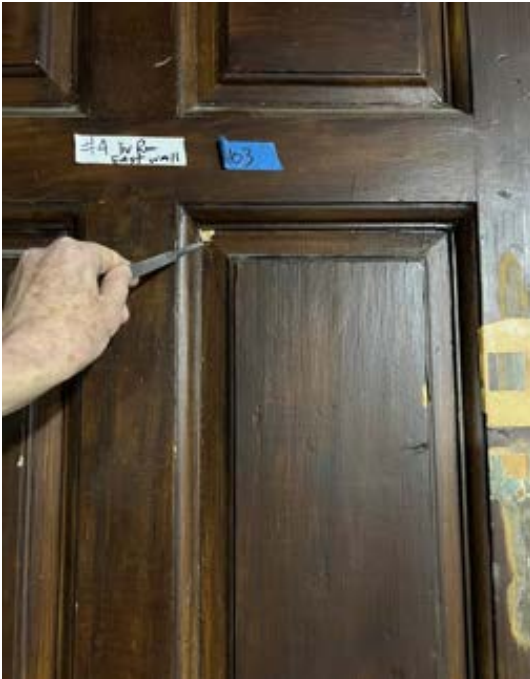
Room 103 Door

Room 103 Door. The door now has a glossy darkened appearance that appears to have been a decorative paint (graining) to replicate a dark figured wood. This most recent coating sequence is generation 9 in 103-1 from the door, and it consists of a yellow base coat, a thin brown paint to create the figure of the wood, and a thin varnish coating.

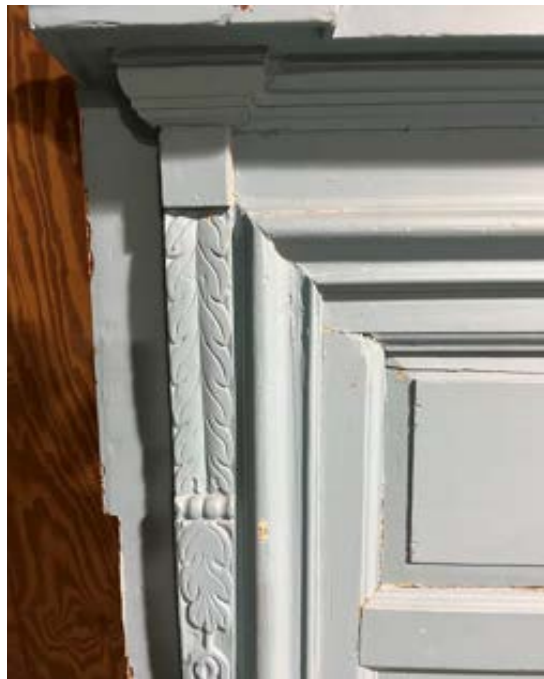
Room 103 Mantel Detail

Room 103 Mantel and Adjacent Stud. The best example of the original light cream-colored paint on the woodwork was found in sample 103-2 from carving on the mantel. By comparison, the paint history on the later overmantel panel (103-3) begins at generation 4, and it is a resinous tan paint that matches the first layer found on the chair rail cap in 103-7.

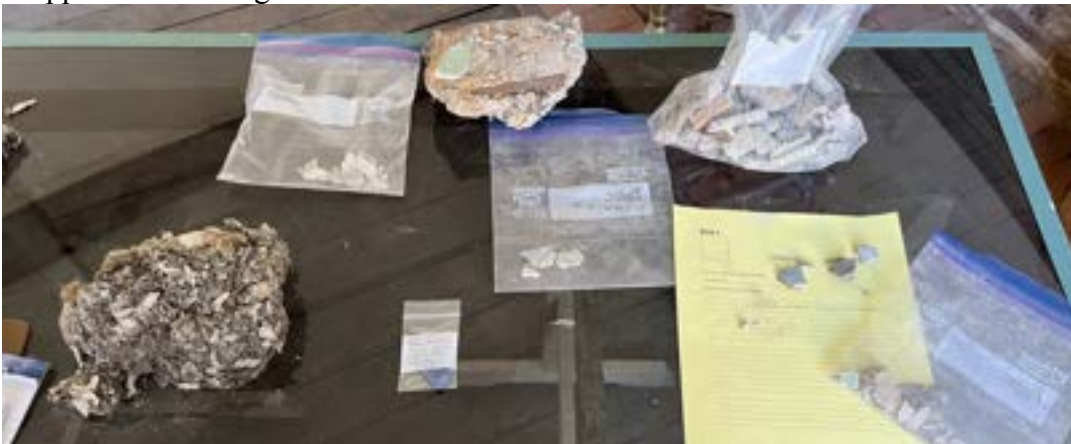
Trapped Plaster Fragments from Rooms 103 and 105

During the March 2025 site visit fragments of painted plaster were found trapped behind the baseboards when the reproduction woodwork was removed. Two fragments with blue paint on their surfaces and one fragment with green paint on its surface were selected for paint analysis.

Room 103 Plaster Fragments. When the reproduction woodwork was being removed during the March 2025 site visit, a number of plaster fragments were found trapped between the joists behind the baseboards. These fragments were grouped based on the chalky colored layers on their surfaces. So in this room representative plaster fragments with white surface coatings, green surface coatings and light blue surface coatings were chosen for analysis.

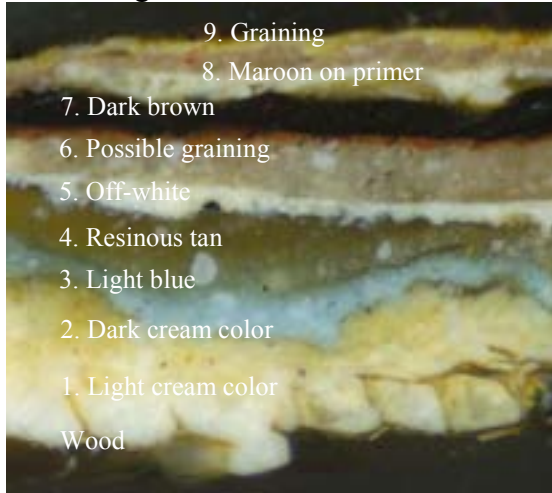
103-1. Door to center passage, upper left corner middle right panel.

There are approximately eleven generations of paint on the woodwork in the Parlor. The door (103-1) was grain-painted in generations 6 through 9, but this cross-section is missing the most recent blue paints found on the rest of the woodwork in room 103.

More importantly, the original paint on the door is a light cream-colored, oil-bound paint that was also found on the woodwork in this room. Polarized light microscopy analysis shows that the original light cream color is composed of white lead, a few red ochre particles and calcium carbonate. The second generation is a dark cream color with a darkened, discolored surface, and the third generation is light blue. This light blue is likely the paint that was interpreted as the original finish coat during the 1976-77 paint investigations.

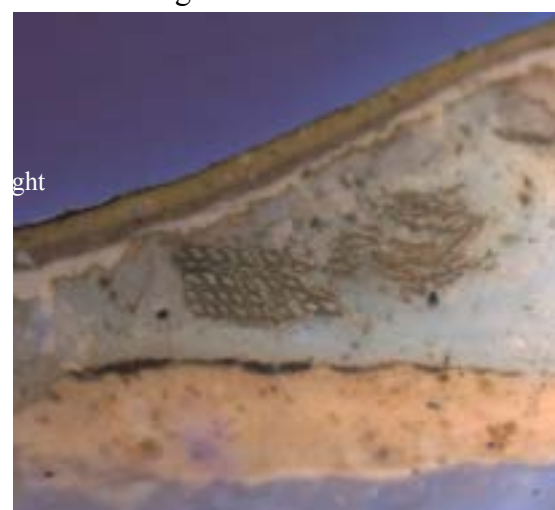
103-5. Crown molding above mantel, at abraded area.

Room 103 Architraves, Cornice and Chair Rail. As noted earlier, the original light cream-colored paint was found in samples from the cornice (103-5 and 103-6), the window architrave (103-4) and the surbase of the chair rail (103-8). However, the paint history on the cap of the chair rail (103-7) begins at generation 4. So this particular element may have been a later addition or alteration to the room, perhaps related to the change in the original door opening that connected the Parlor (room 103) and the rear northwest room (room 105). Clear evidence for this door opening was found in March 2025 when the reproduction woodwork was removed and an opening was made in the north plaster wall to reveal the original framing for this door.

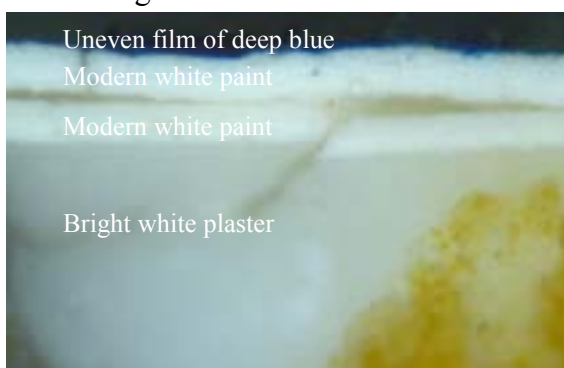
103-9. Plaster fragment northwest cavity with blue mark.

One fragment with a deep blue mark on the white surface of the plaster seemed peculiar, and in cross-section the blue layer is thin and uneven on top of a finely ground, bright white paint (see 103-9). Analysis suggests that this fragment contains white gypsum plaster with two layers of finely ground bright white paint. The blue layer may be from a pen or grease pencil as it does not look like a paint layer.

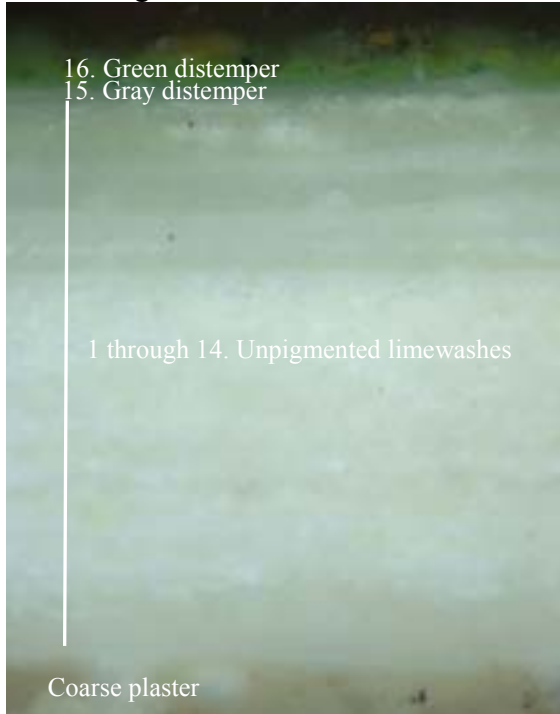
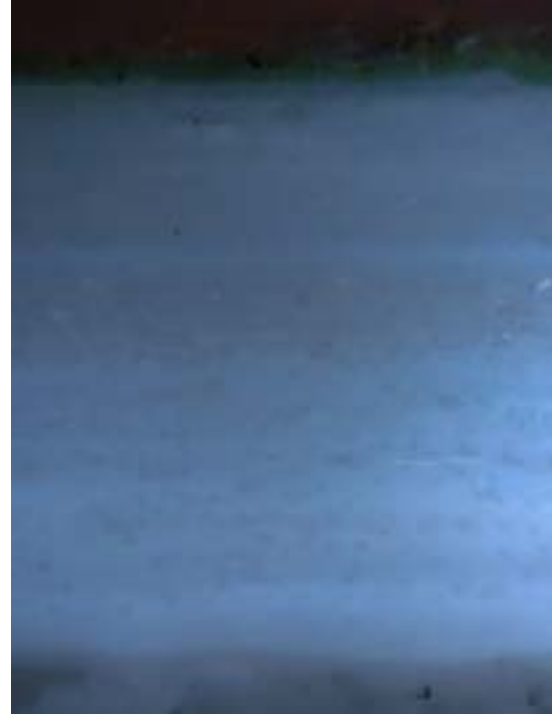
Sample 103-11 represents the coarse plaster fragments which retain a matte green paint on their surface. It was applied on top of approximately fourteen generations of unpigmented limewash. There is no evidence of wallpaper fibers or starch paste residues trapped between any of the coatings, but there are fine films of dirt between many layers suggesting they were exposed for at least several years before new washes were applied. The chalky green distemper paint contains the pigments Prussian blue, yellow ochre, chrome yellow, calcium carbonate. The presence of chrome yellow dates it to not before about 1825.

103-11. Plaster fragment with green paint, southwest corner cavity. Pigments in the green wall paint: Prussian blue, yellow ochre, chrome yellow, calcium carbonate.

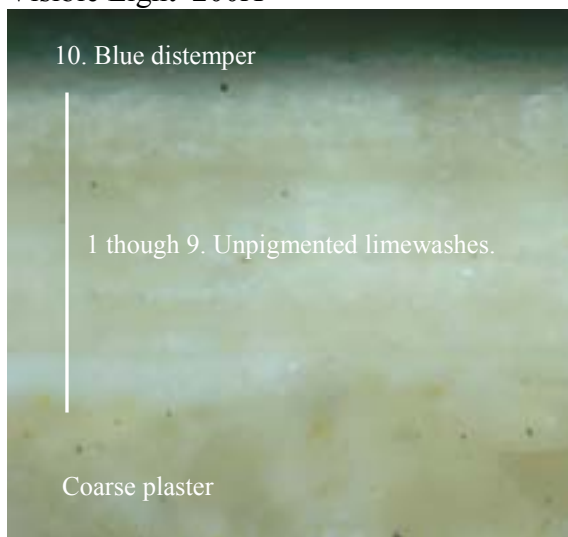
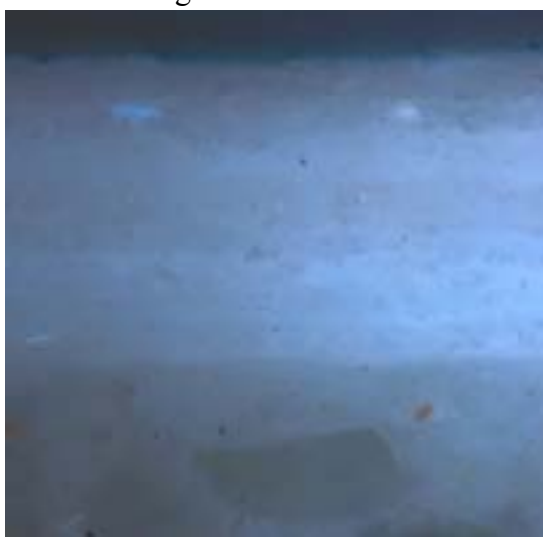
103-12. Plaster fragment with blue paint, southwest corner cavity. Pigments in the chalky blue wall paint: synthetic ultramarine, calcium carbonate.
