**Cross-section Paint Microscopy Report  
Exterior and Interior Paints Phase II**

**Cupola House  
The Cupola House Association  
Edenton, North Carolina**

For: Robert Leath, Executive Director  
Edenton Historical Commission  
108 North Broad Street  
Edenton, NC 27932

Conservator: Susan L. Buck, Ph.D.  
303 Griffin Avenue  
Williamsburg, VA 23185

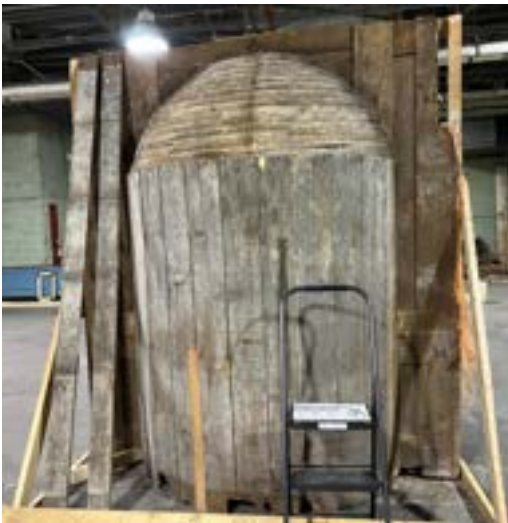
Rear of Cupboard with Re-used  
Partition Boards

In addition, several limewashed boards were found reused in the Parlor (room 103) when it was being deconstructed, and the degraded washes on these boards appeared very similar to those on the back of the cupboard (see below). Samples were taken from the architraves of both windows to identify the earliest paints and to look for possible traces of early limewashes that might have related to a partitioned closet. As the analysis work progressed, Andrew Ownbey, Andrew Ownbey LLC, contacted this author with the news that partial deconstruction of the woodwork in this space on April 22, 2025 revealed that the window architraves were secured with modern wire nails. So, he felt the architraves and cornice on the north wall likely date to the 1920s.

Two samples were taken from one of the detached partition wall boards to see if the coatings can be aligned with those on the back of the cupboard. The coatings are quite degraded, but in 104-6 from the whiter side of the partition board there are remnants of two layers of limewash which resemble those in sample 102-18 from the back of the cupboard. There is only one layer of grayish limewash in sample 107-7 from the opposite, grayer side of the partition board. This limewash resembles the third layer of limewash found in the partition wall door cross-sections, but the evidence here is truly just fragmentary.

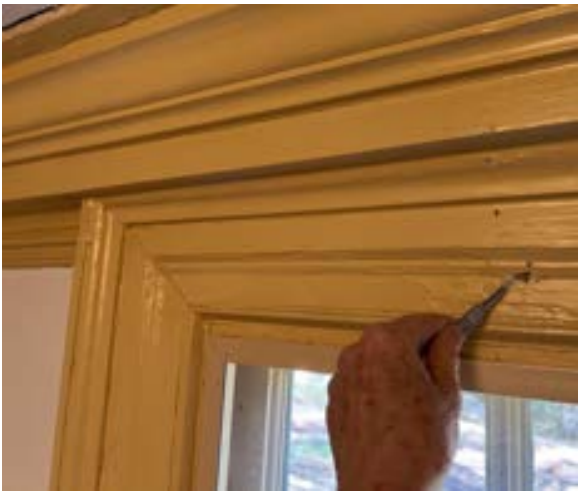
Room 104 Paints on Woodwork. Three samples were taken from the trim for the two windows on the north wall and two samples were taken from the cornices above both windows. The most complete paint history was found in 104-1 from the front of the architrave for the east window. There are 13 generations of paint in this cross-section, beginning with a distinctive tannish-yellow paint, which was also found as the original paint on the left side of the same window (104-2) and the northwest window architrave (104-3). Polarized light microscopy analysis shows that this original tannish-yellow paint contains yellow ochre, white lead and calcium carbonate. These were all stable, relatively inexpensive pigments and would be equally appropriate in the eighteenth century as the twentieth century. But, more recent physical investigations undertaken by Ownbey and Rogers as the woodwork was dismantled showed that the cornice is a later

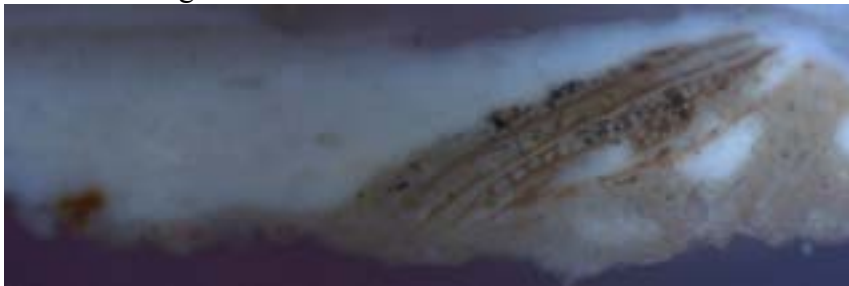
104-8. North wall, cornice above northeast window.

The cornice on the north wall of room 104 was sampled above each window to help comparatively date its installation. The evidence in both samples 104-8 and 104-9 confirms that the cornice dates to the same period as the windows as the tannish-yellow paint was found as the earliest coating. Generations 2 and 3 are missing in both cornice samples, but it was repainted in generations 4, 5 and 6 to match the window architraves.

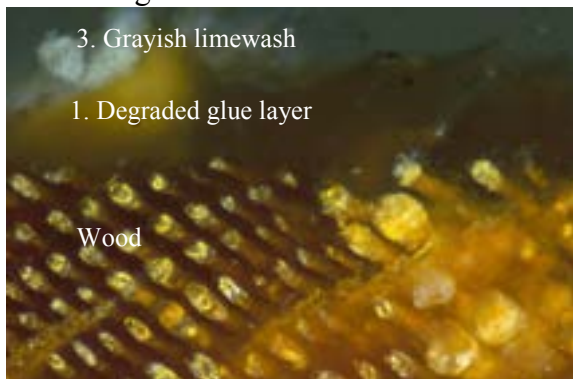
104-5. Back of cupboard, possible glue residues at join.

One sample 104-5 was taken from the back of the cupboard at a joint with an accumulation of translucent brownish material on either side of it. In cross-section there is a thick, translucent layer which has a dull autofluorescence characteristic of hide glue. A remnant of grayish limewash is on the surface of this aged glue layer. Perhaps the glue was used to adhere paper or textile across the joint to cover it.

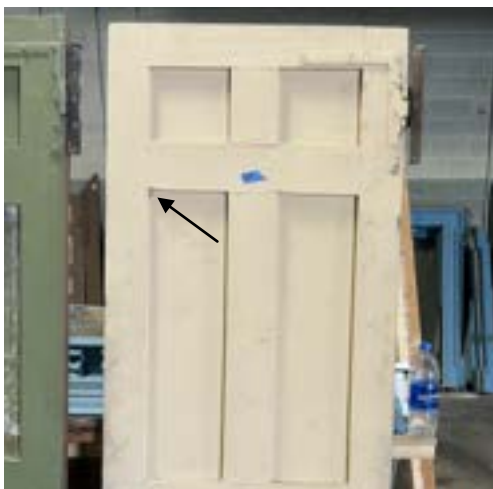
The paint history from the corner of a recessed panel on the back of the door is disrupted and confusing. But the evidence from the cast cross-section and uncast portions of sample 104-10 suggests that the original paint is light cream color, followed by remnants of a thin brown paint, and then gray paint in the third generation. The light cream color matches the light cream color found as the original paint on the woodwork in rooms 103 and 105. The gray paint resembles the third generation gray paint on the woodwork in room 105, which was applied after the chrome green-based paint which marks the installation of the mantel and chair rail (see 105-6 below).

Room 104 Pantry Doors. The original location of a paneled door that had been installed in the stairhall (101) leading into the pantry (104) was questioned because building investigations confirmed that there was originally no door opening from the stairhall into the pantry. The cross-section from the back side of the door is labeled 104-10 because that is where the door was most recently installed. The raised panel side of this door was sampled during an earlier phase of research (see below), but the opposite side had not been sampled. The cross-sections from both sides of this door are included here for comparison.

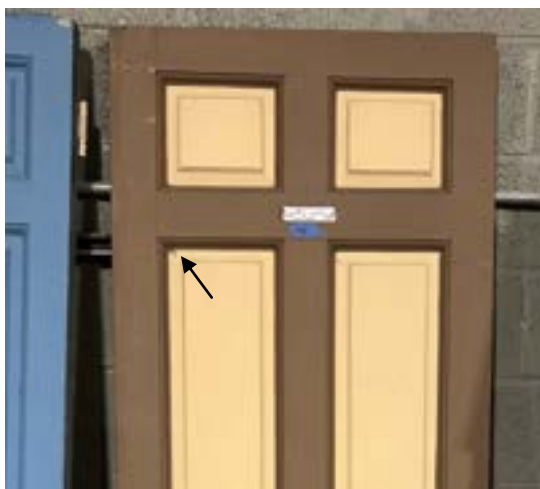
Sample 101-6 from the raised panel side of this door shows a disrupted paint history that is consistent with the original chronology of the doors found in the stairhall. So, the combined evidence suggests that this may be the original door in the partition wall between 103 and 105. The raised panel side was painted in the same manner as the original stairhall doors, while the back of the door was painted to match the woodwork in room 105 in generations 1 and 3. It was likely moved after generation 3, which just predates the Brooklyn Museum period.

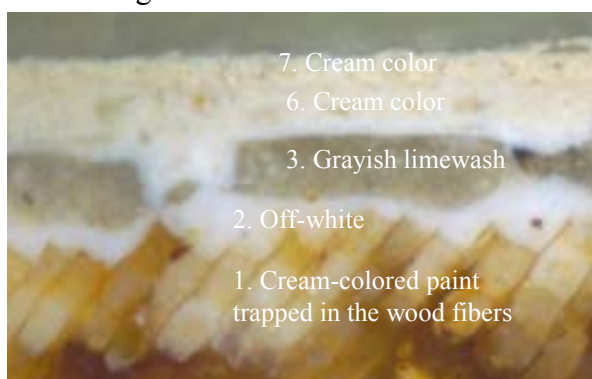
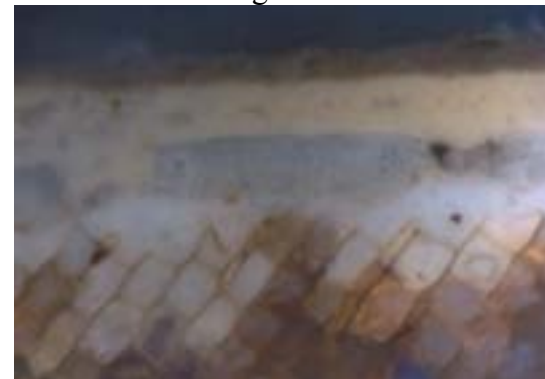
Door 5. 102(R). 102D3 Pantry side. (Ownbey sample.)

Two samples from the Pantry side of the two partition wall doors were provided by Andrew Ownbey for analysis and comparison. The evidence in Door-5 and Door-7 indicates that they were likely originally a lead white and oil-based cream-colored paint similar to the original paint in rooms 103 and 105. This is followed by an off-white paint, and then the grayish limewash found on the back of the cupboard. This makes the grayish limewash generation 3 in the coating chronology; the most recent cream-colored paints in Door-5 and Door-7 align with generations 6 and 7.

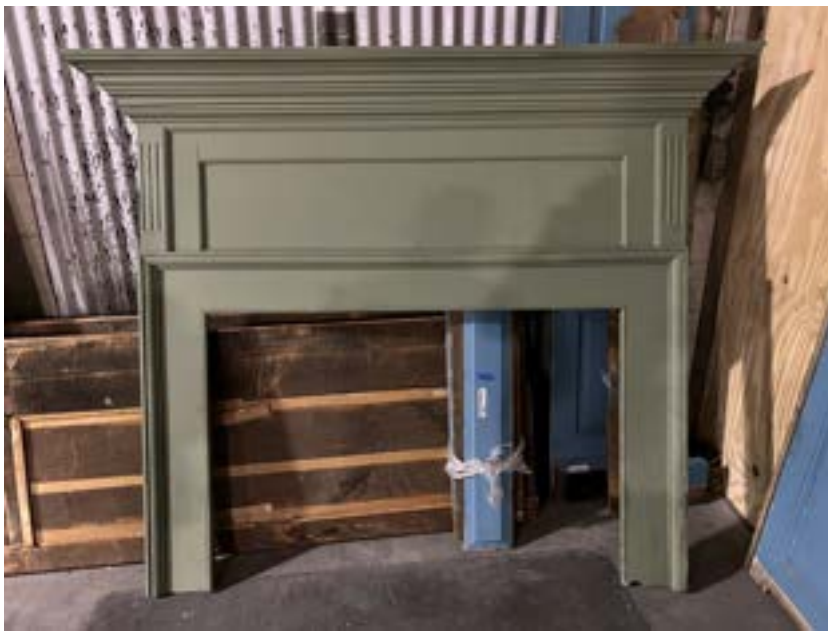
#### Room 105 Rear Room Sample Locations

The current Brooklyn Museum woodwork color in room 105 is a matte, dull, dark green. The mantel is believed to date to a Federal-period redecoration of this room, and a section of original re-used rusticated siding was found incorporated into the overmantel panel, confirming it as a later construction. Six samples were taken from representative woodwork elements to conduct paint archaeology using the comparative paint stratigraphies on the original and later elements. During the removal process for the reproduction woodwork in March 2025 a number of plaster fragments and one ghost of a molding related to the original door opening on the south wall were all found. Selected elements were sampled to learn more about possible early wall treatments.

- 105-1. Door, at join of top middle rail with central stile.
- 105-2. Section of cove molding of chair rail in crack at edge.
- 105-3. Fascia of chair rail at edge.
- 105-4. Federal period mantel (with rusticated siding at back) left side of overmantel panel.
- 105-5. Mantel, fluting on left side of panel.
- 105-6. Crown molding of chair rail, left side.
- 105-7. South wall cavity, trapped greenish paint on plaster.
- 105-8. Light blue plaster trapped in later plaster.
- 105-9. Plaster with whitewash layers found in east wall cavity.
- 105-10. South wall, outline of door opening, right side.

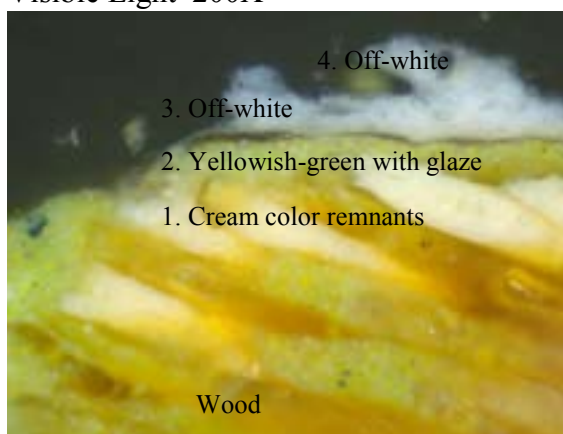
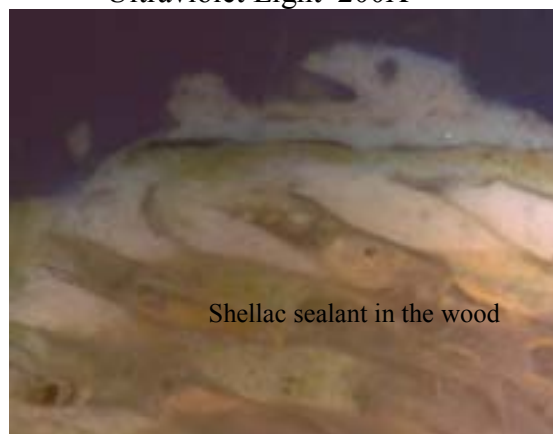
105-1. Door, at join of top middle rail with central stile.

Room 105 Doors and Chair Rail. The most complete early paint history in this room was found in sample 105-3 from the fascia of the chair rail. The original cream-colored paint in this cross-section was applied on top of a shellac sealant (resinous material trapped in the wood which has a characteristic orange autofluorescence). The original cream color in this cross-section has a fissured surface, showing that it had aged and cracked before it was repainted with a yellowish-green paint. This original cream color was also found on the door (105-1).

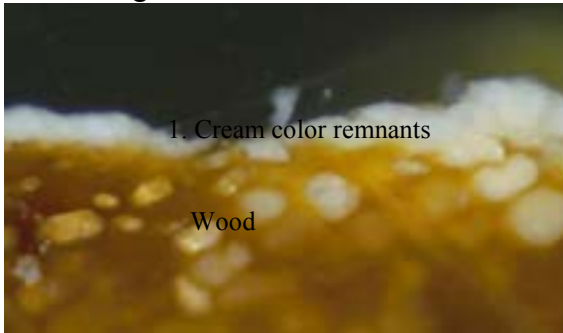
105-2. Section of cove molding of chair rail in crack at edge.

The second-generation yellowish-green has a glaze layer on its surface indicating it was intended to be glossy. The pigments in this yellowish green paint are chrome yellow, white lead, scattered Prussian blue particles and calcium carbonate. In the third generation the mantel (105-5) and chair rail crown molding (105-6) were gray, while the door was off-white. The cornice crown molding and the mantel are missing the original cream color, indicating they were later installations.

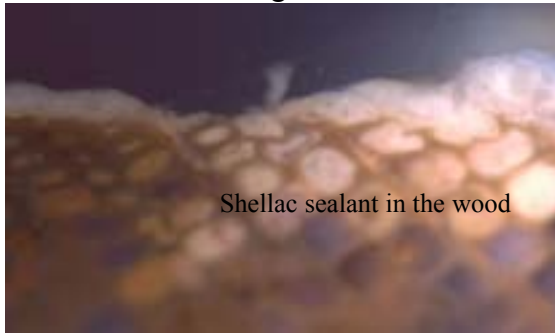
Ultraviolet Light 200X

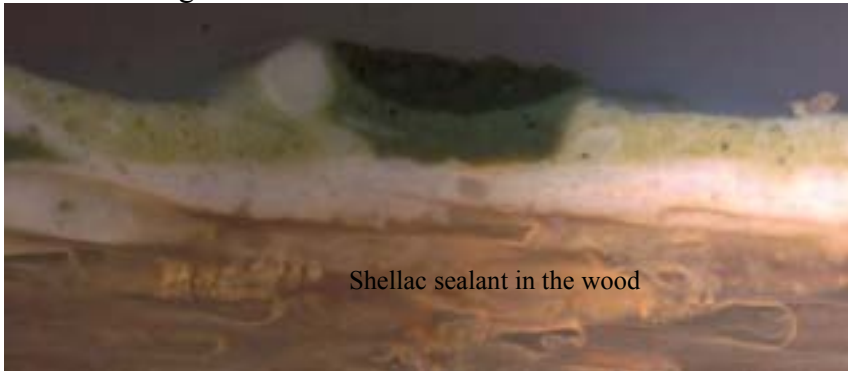
105-3. Fascia of chair rail at edge.

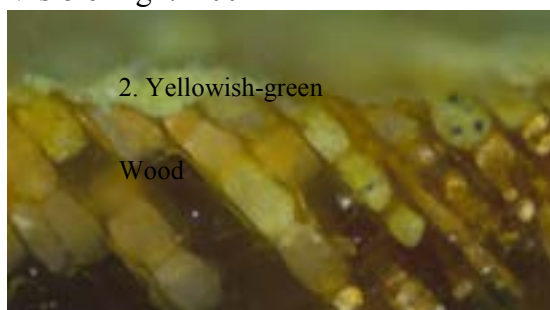
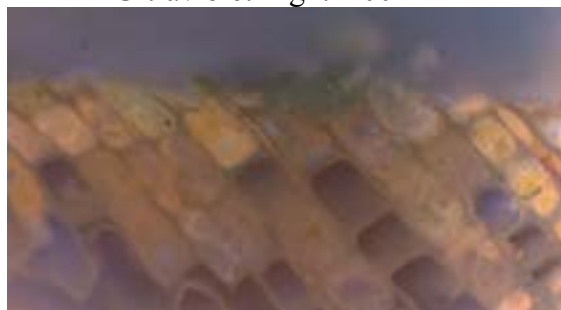
Room 105 Mantels. Two samples (105-4 and 105-5) were taken from different areas on the Federal-period mantel, and both confirm that the second-generation yellowish-green paint is the first layer on this element. The notable characteristic of this yellowish-green paint is that it is composed of chrome yellow, white lead, a few Prussian blue pigments and calcium carbonate. The presence of chrome yellow dates this particular paint to after about 1830 when chrome yellow became more regularly available and affordable for architectural paints. Chrome yellow was generally available by 1820 or 1825 but was less commonly used for architectural paints. The yellowish-green has a thin oil glaze on its surface, followed by dark gray paint that aligns with the third generation identified on the woodwork in this room.

105-4. Federal period mantel (with rusticated siding at back) left side of overmantel panel. Pigments in the Federal-period yellowish-green paint: chrome yellow, white lead, scattered Prussian blue particles, and calcium carbonate.

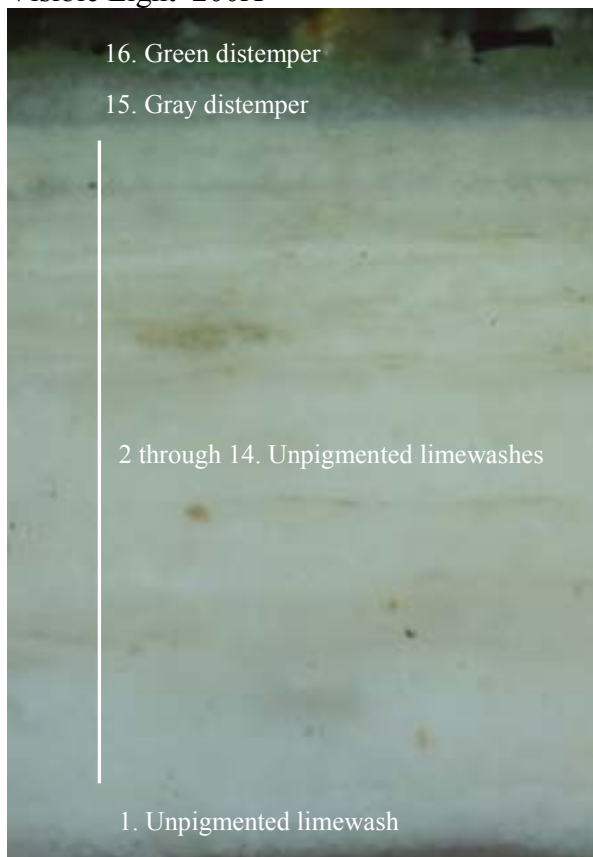
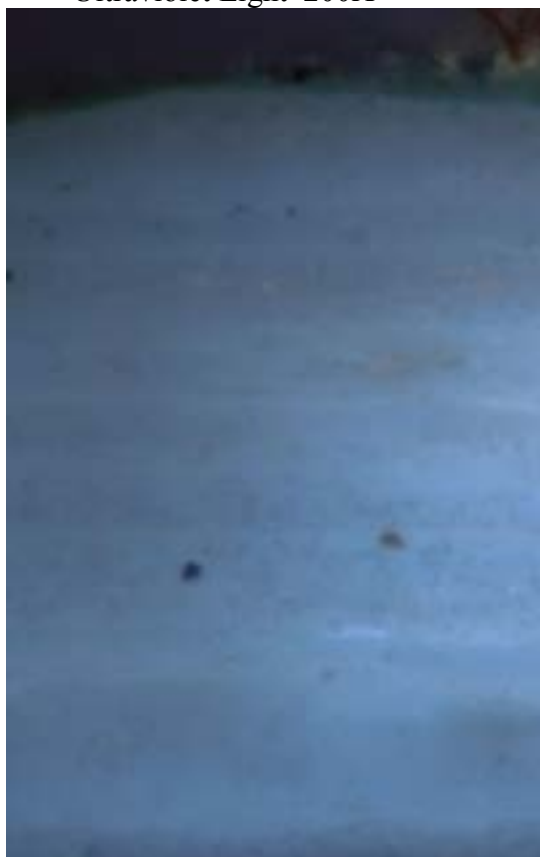
Room 105 Paints on Plaster Fragments and Door Opening Outline. Two fragments of plaster with colored paints on their surfaces were selected for cross-section analysis. Like the plaster fragment found behind the baseboards in the adjacent Parlor, there is a long sequence of unpigmented limewashes on the coarse plaster substrate before the colored distempers were applied. Cross-section 105-7 has 14 generations of unpigmented limewashes followed by a gray distemper and a green distemper. This green distemper is composed of Prussian blue, chrome yellow, yellow ochre, and calcium carbonate, which is similar to the green distemper found in trapped plaster fragments from the Parlor.

105-7. South wall cavity, trapped greenish paint on plaster. Pigments in the most recent green distemper: Prussian blue, chrome yellow, yellow ochre, calcium carbonate.

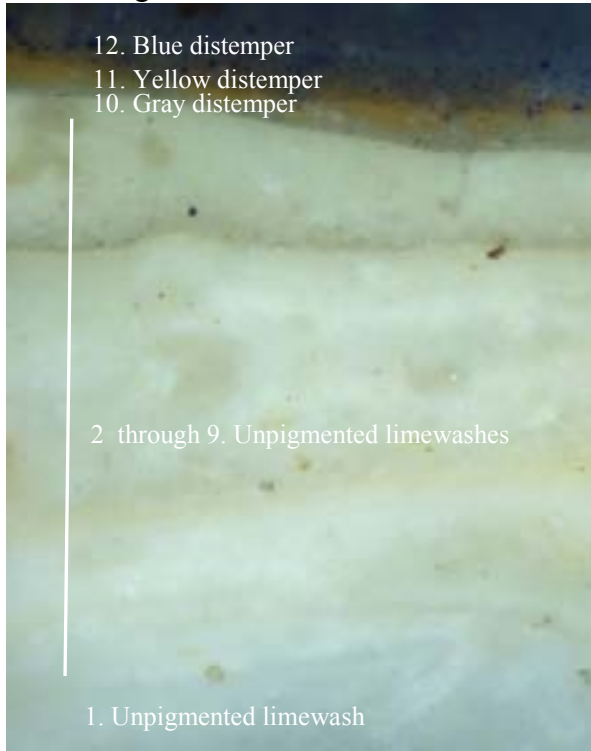
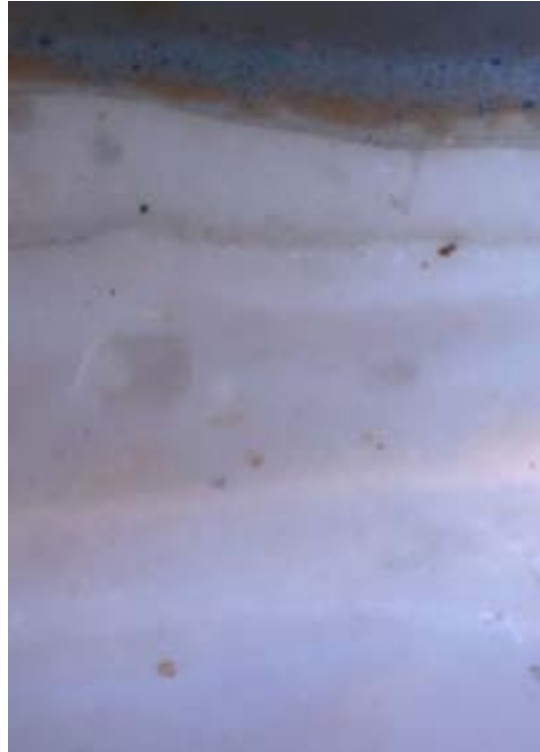
105-8. Light blue plaster trapped in later plaster. Pigments in the light blue distemper: Prussian blue, scattered yellow ochre, calcium carbonate.

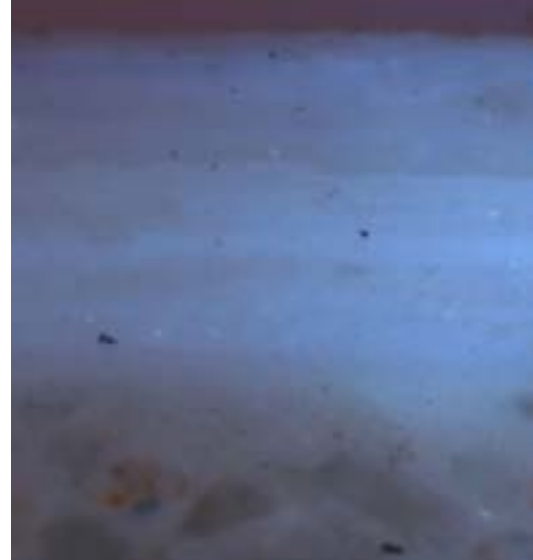
105-9. Plaster with whitewash layers found in east wall cavity.

One plaster fragment with only white coatings was found in the east cavity. Cross-section 105-9 shows it retains nine generations of unpigmented limewash on a coarse plaster substrate. It may or may not be contemporary with the fragments with the green and blue distempers.

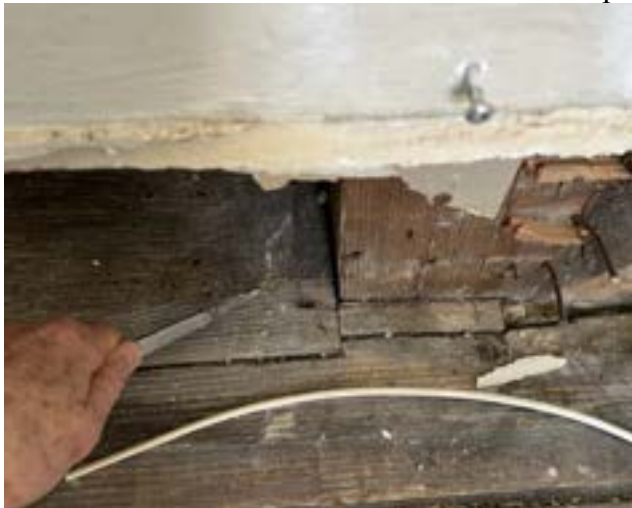
Painted Outline on floor at South Wall Door Opening

Sample 105-10 came from the edge of the outline for the original door frame on the south wall, as shown below. It was hoped that it might help to date this opening, before the wall was actually opened up to reveal the original framing at the end of March 2025.

In sample 105-10 there is only one grimy lump of modern, nonfluorescent off-white paint. So this ghost outline may be from the time when there was a later opening in the wall, as shown in the 1940 HABS drawing.

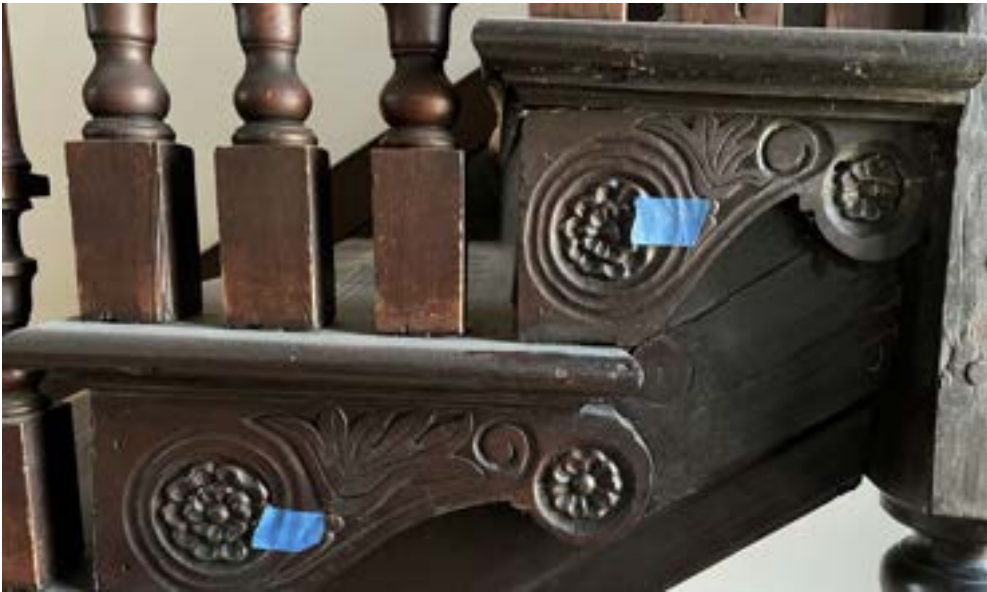
101-13. *In situ*, on side of newel post at landing, above ghost of join of handrail with post.  
Visible Light 200X                      Ultraviolet Light 400X

Room 201 Stair Bracket Finishes. The comparative cross-section samples taken from two stair brackets with slightly different carving shows there is a subtle, but distinct difference between their finish histories. The complete finish history on other original staircase elements can be seen in sample 101-13 from the south side of the newel post at the landing. Cross-section 101-13 was taken from just above the ghost for the join of the original handrail with this newel post, and it begins with a thinly applied, red-brown pigmented stain on top of the wood. It is followed by three generations of plant resin varnish separated by thin films of dirt (see below). The finish history in sample 201-1 is virtually identical to 101-13, beginning with the same red-brown pigmented stain.

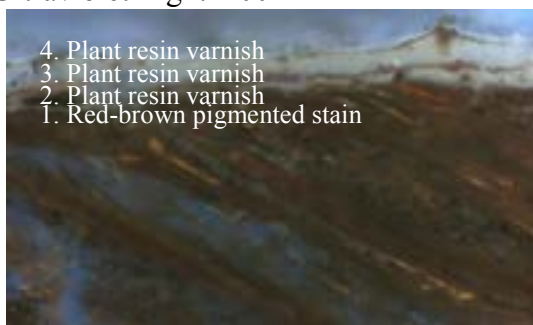
The red-brown pigmented stain on the wood in sample 201-1 is most obvious in the reflected visible light cross-section image, while the three generations of plant resin varnishes separated by films of grime are readily discernible in the reflected ultraviolet light image.

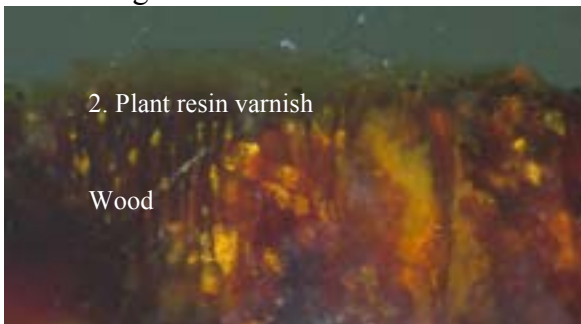
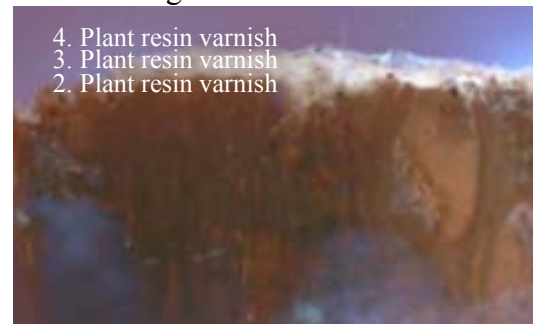
201-2. Stair bracket carving.

It is not possible to see a pigmented stain on the wood in sample 201-2 from the other slightly different stair bracket, but there are the same three generations of plant resin varnish present. This comparison suggests that these brackets were not installed at the same time, but perhaps not much time elapsed before their installations.

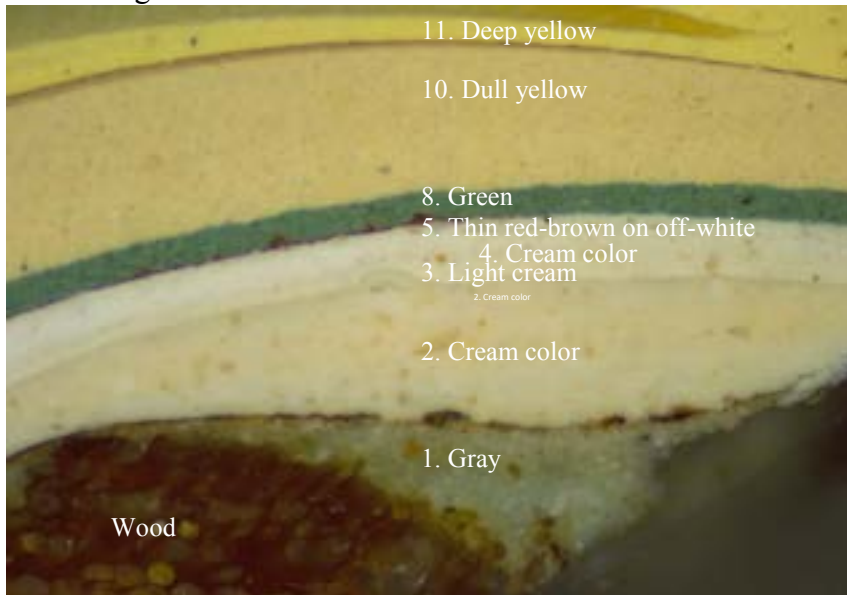
CH-2. East wall, right edge of architrave for north door.  
Visible Light 100X

Room 201 Paints on Door Architraves. The 2018 paint investigation of the second-floor woodwork identified the original paint in the second-floor stair hall as a gray and found that there are eleven generations of paint on the woodwork in this space. Sample CH-2 from the 2018 report is included below for reference.

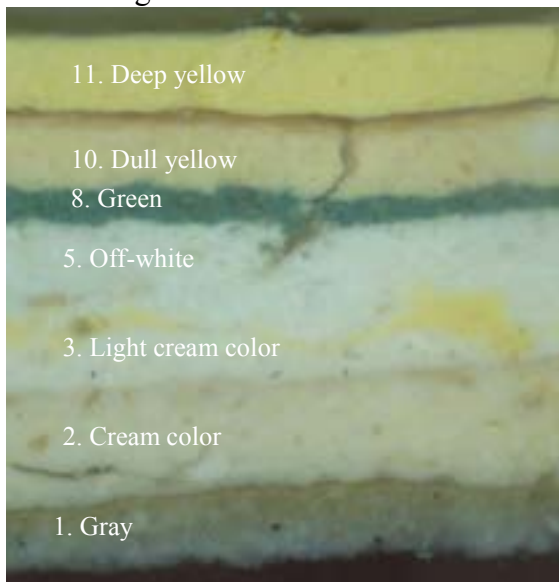
In this second round of sampling the same essential paint stratigraphy, beginning with an oil-bound gray paint, was found in sample 201-3 from the east wall door architrave for the opening leading into the east chamber.

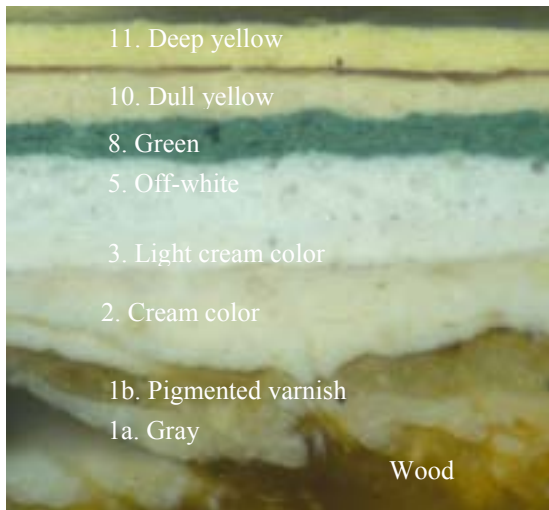
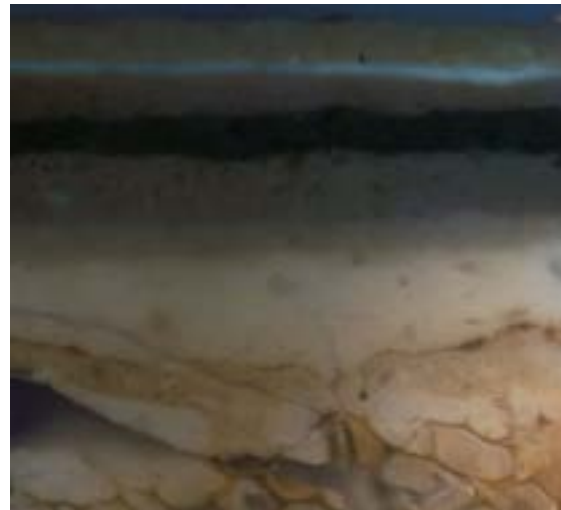
There is a slight difference to the original paint coating in sample 201-4 taken from the west wall door architrave. The first paint on the wood is gray, but it is followed by what appears to be a pigmented varnish which may have been applied to add gloss to the original gray paint. The later paints can be aligned with those found on the east wall door architrave.

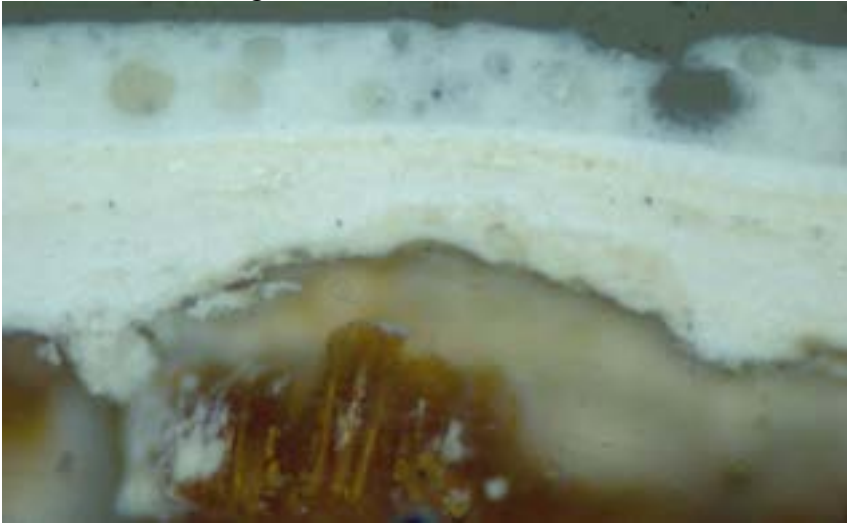
201-5. Wood ceiling medallion.

Room 201 Paints on Carved Wood Ceiling Medallion. The paint history in the samples taken from the carved wood ceiling medallion on the second floor was incomplete as this element appears to have been partially stripped, while the two on the first floor were left relatively untouched. The next step for a better understanding of the original appearance of this carved wood element would be to remove the paints from a portion of the carving, perhaps a quarter of the circle, to reveal the carving and any remnants of the earliest paint that might remain. A comparatively gentle commercial paint stripper like Citrustrip (the solvent n-methyl-2 pyrrolidinone in a paste form) using multiple applications and removals with cotton wadding to slowly remove the later overpaints might be appropriate. Testing on site would be needed to make sure this approach is controllable and effective.

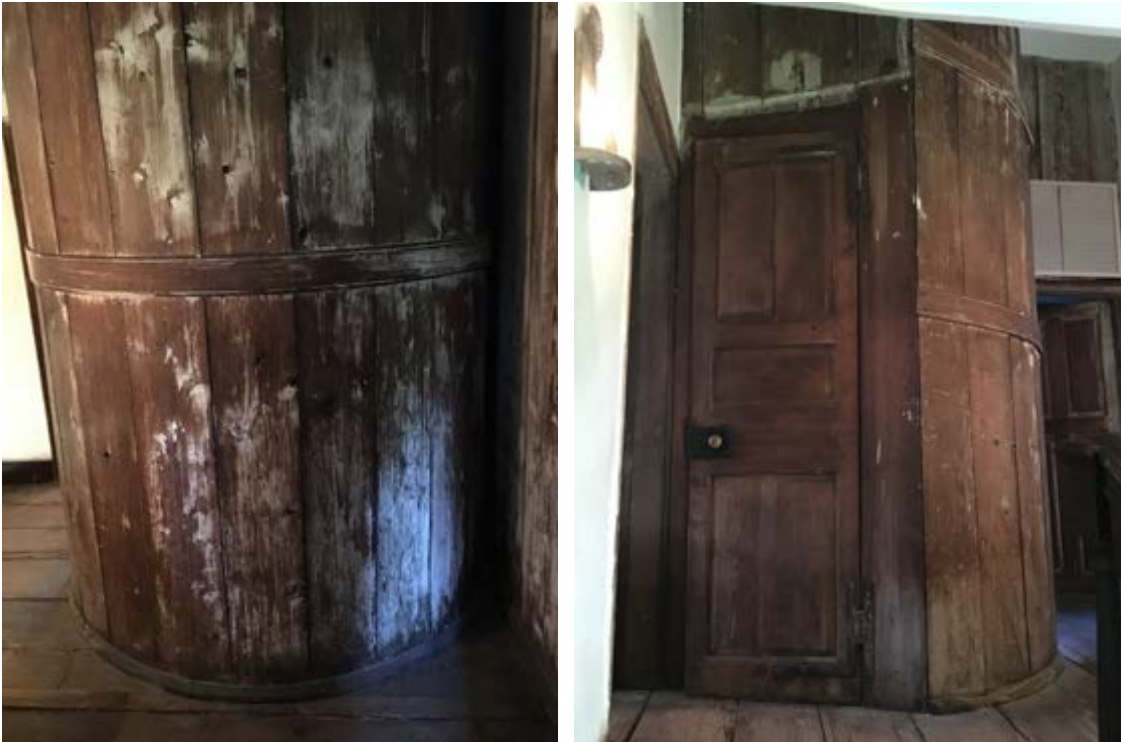
Third-floor Surround for Attic Stair

There are fragile remnants of limewashes remaining on some areas of the third-floor woodwork. Andrew Ownbey provided samples from the partition wall and the door in the third-floor stairhall for analysis. Cross-sections 301-1 and 301-2 contain only the tiniest fragments of unpigmented limewash on top of the wood substrate so it is not possible to be certain when the limewash was applied. However, the grimy, embrittled condition of these coatings suggests they are early, possibly original.

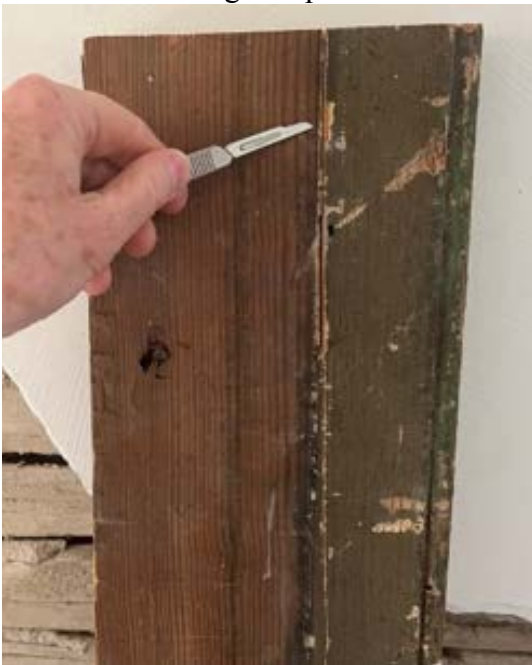
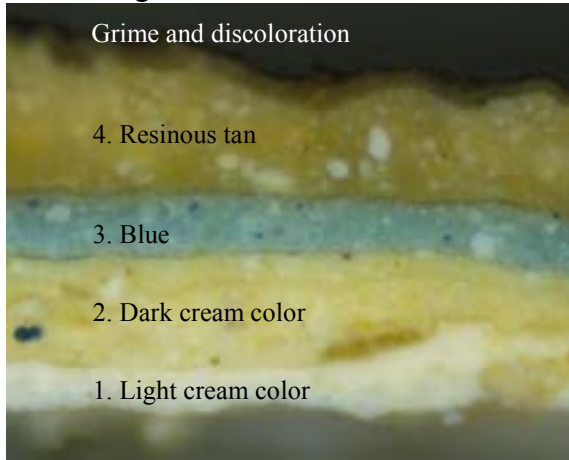
### Molding Fragment-1

During the April 2025 site visit two detached elements were sampled to hopefully identify their original location in the house. It was proposed that the detached molding fragment might have come from the rear northwest room 104. However, the paint history on this molding exactly matches generations 1 through 4 on the room side of the door for the Parlor (room 103). It retains the original light cream color on the wood which has a defined boundary on its surface from oxidation, and it is followed by the dark cream color in generation 2, also with a grimy surface. The third generation is blue and the top layer is a darkened resinous tan.

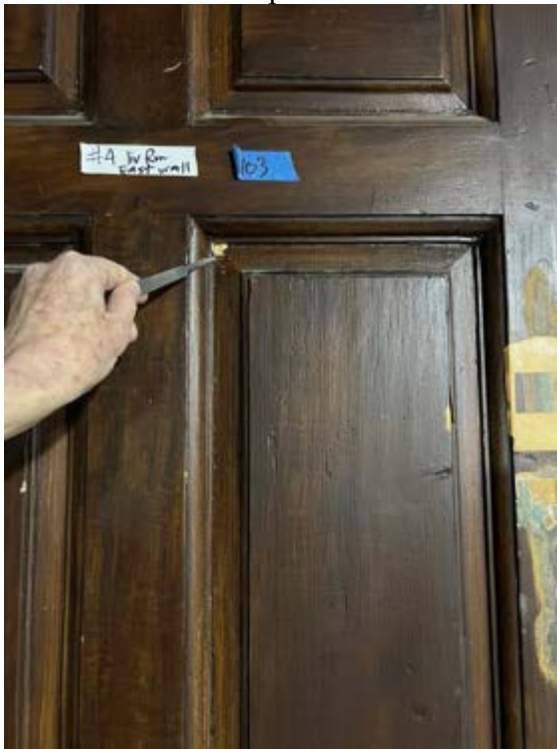
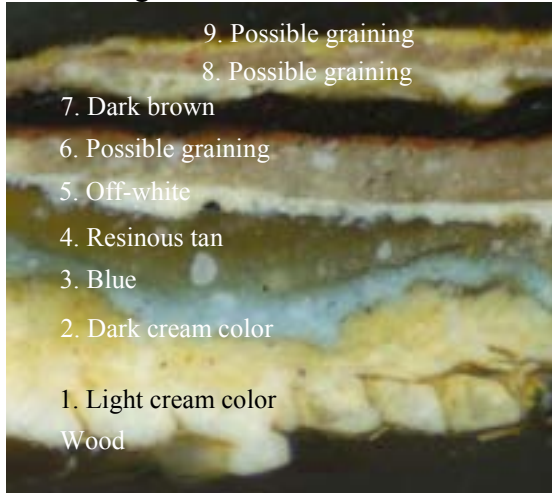
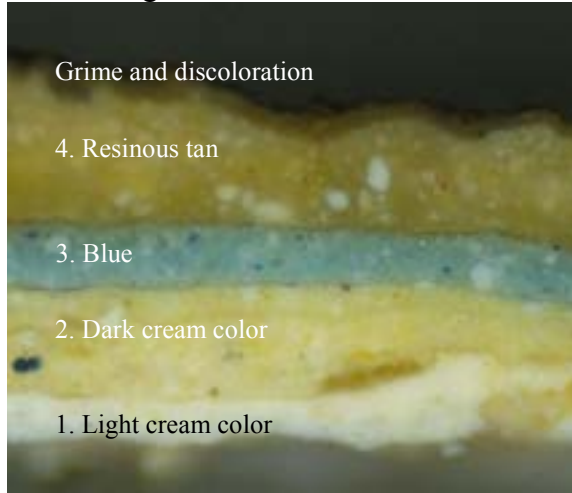
103-1. Door to center passage.

A side-by-side comparison of the cross-section from the door with the cross-section from the detached molding is included to show how well the first four generations of paint on the molding fragment align with those on the room side of the door leading into the Parlor from the Center Passage (sample 103-1).

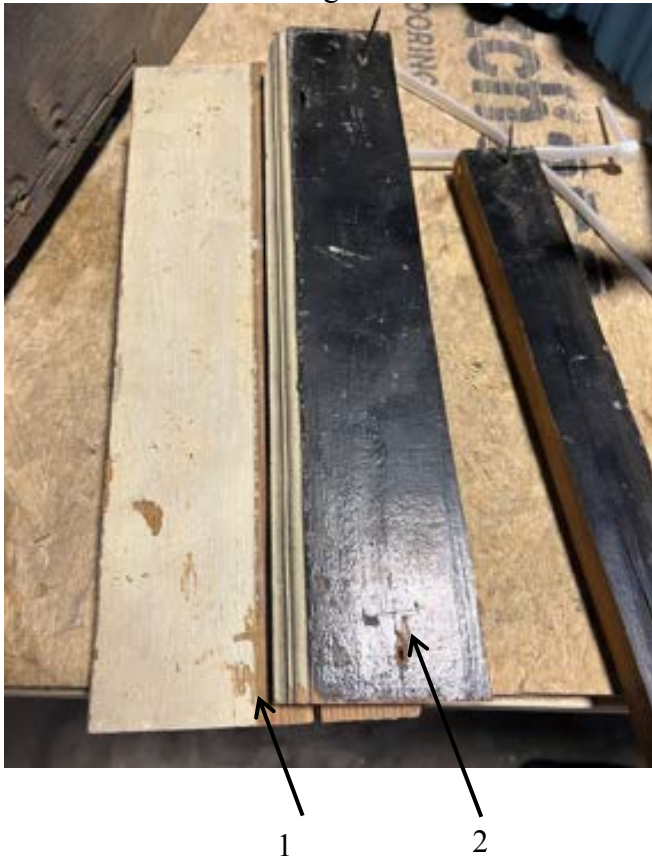
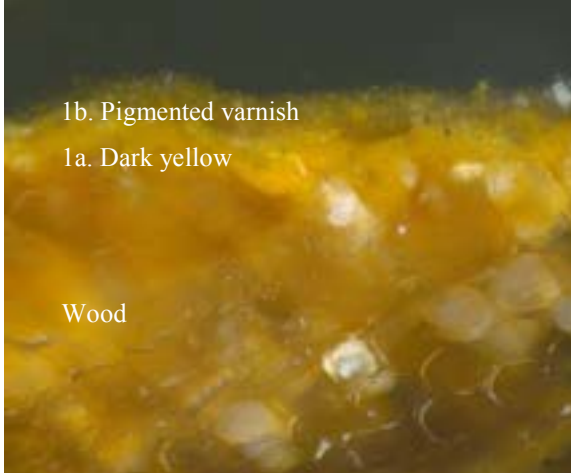
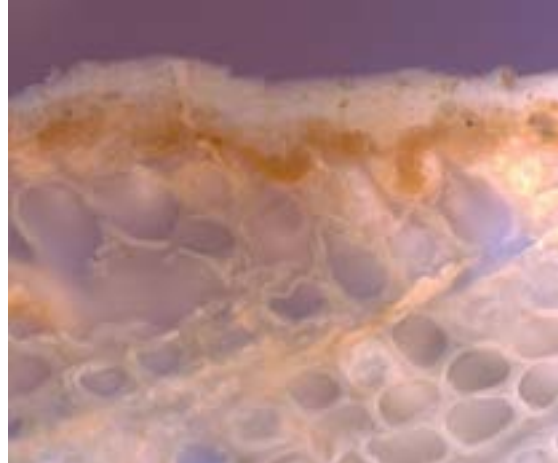
Baseboard Plinth-1

During the April 2025 site visit the cream-colored plinth and black base of the baseboard fragment was also sampled to identify the paint histories. The upper plinth begins with a deep yellow paint and an associated pigmented varnish. This paint history was not found on any of the architectural elements examined *in situ*. The black base was originally dark gray, followed a resinous gray paint. The uppermost thin black paint is generation 3. This element is quite thinly painted and its paint history does not match any baseboards in the Cupola House. Perhaps this fragment came from another building and is not related to the Cupola House.

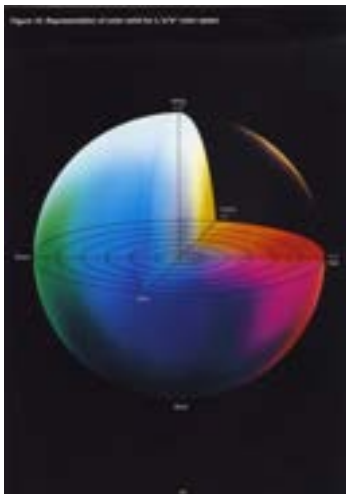
**CIE  $L^*a^*b^*$ :** Equal distances in the CIE x,y Chromaticity Diagram do not represent equal differences in color as perceived. The CIE  $L^*a^*b^*$  color system, however, more closely represents human sensitivity to color. Equal distances in this system approximately equal perceived color differences.  $L^*$  is the lightness variable;  $a^*$  and  $b^*$  are the chromaticity coordinates.

CIE Yxy (CIE 1931): In the Yxy (CIE 1931) color system, Y is a lightness factor expressed as a percentage based on a perfect reflectance of 100%, x and y are the chromaticity coordinates of the CIE x, y Chromaticity Diagram.

**ΔE:** ΔE (Delta E) is the industry measure used to determine how closely two colors match in the CIE L\*a\*b\*. The symbol Δ means “the change in”. It is based on calculating the sum of the differences between each measure. The calculation is:  $\Delta E = \sqrt{(\Delta L^*)^2 + (\Delta a^*)^2 + (\Delta b^*)^2}$ , or, the color difference equals the square root of the squared sums of the differences between each of the three L\* a\* b\* tristimulus values. Industry color standards indicate a ΔE of 1 is barely perceptible to the human eye, and ΔE of 6 to 7 is acceptable for color matches in the printing industry.

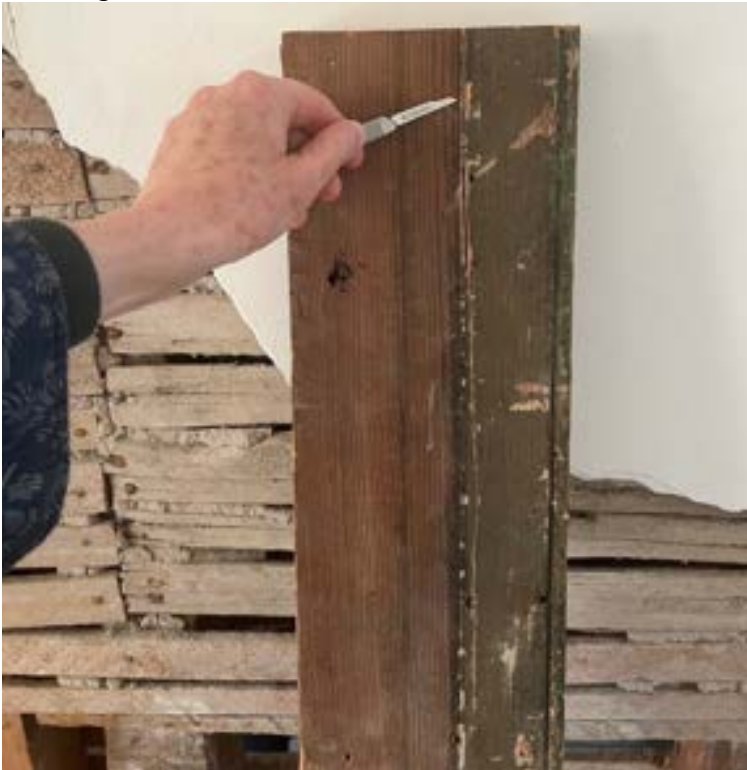
Molding-1. Possible cornice element from Room 103 or 105

#### Detached Molding Found During Room Deconstruction

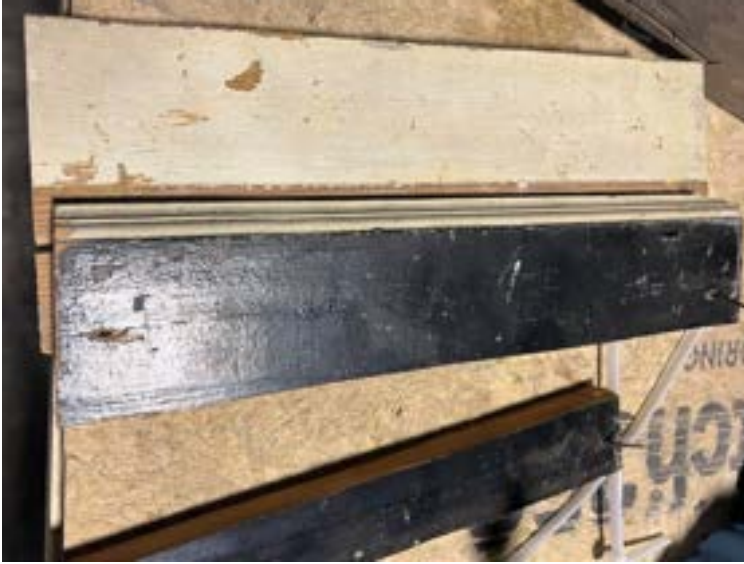
#### Detached Baseboard

- 1. Plinth
- 2. Black base molding
