# New York City Oyster Monitoring Report

2018

The Nature  
Conservancy

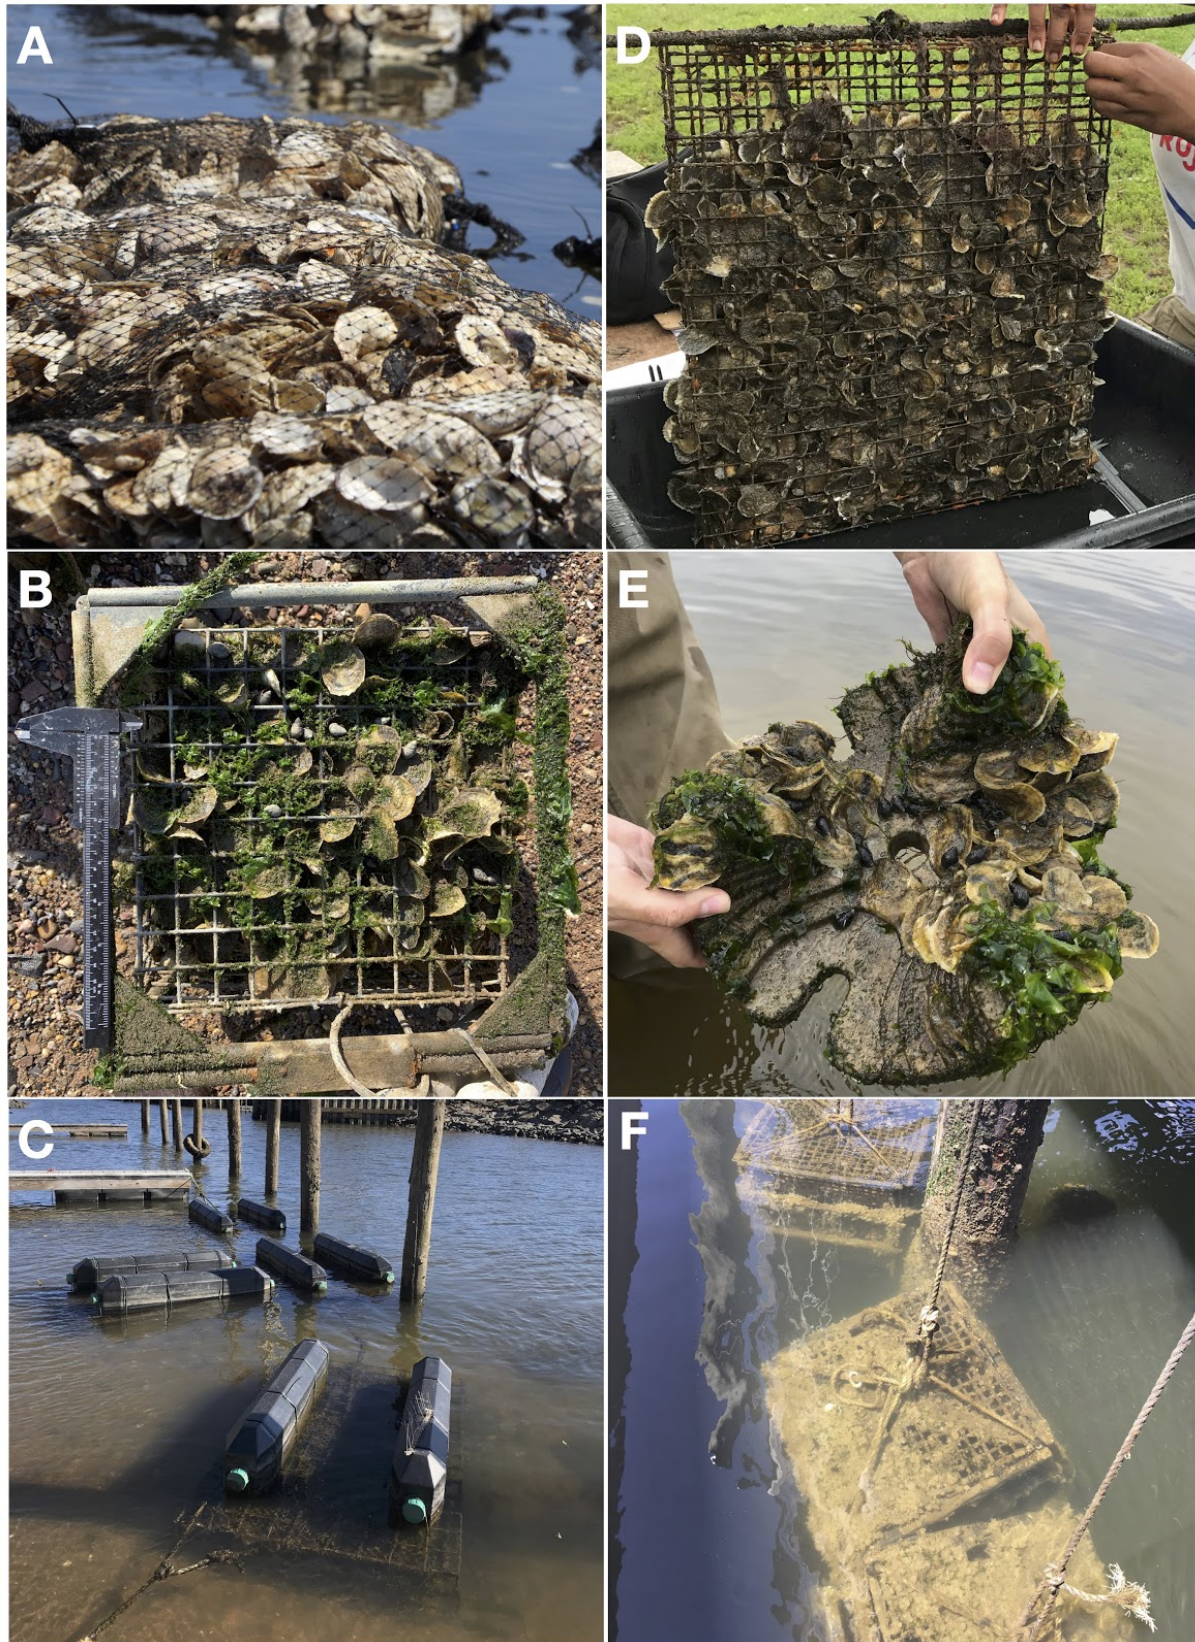
**Figure 4.** Examples of structures employed to install oysters: (A) bags, (B) gabions, (C) OysterGros®, (D) community reef files, (E) EConcrete® discs, and (F) Super Trays.

A variety of different restoration approaches and structures were used, depending on unique site conditions, project objectives, and our continually developing understanding of best practices for oyster restoration in these waters. Community reefs are welded, steel rebar structures that hold cages of oysters off the bottom (Fig. 1D). These structures allow the cages to be removed for monitoring above the water surface. The term “nursery” describes restoration sites where oysters are held off the bottom in floating or suspended structures, regardless of the size or age of the oysters. Nursery gear types include OysterGros® (Fig. 1C) and Super Trays (Fig. 1F), both of which are used in commercial aquaculture. 2018 was the first year in which several restoration approaches were tested, including bagged shell reefs (Fig. 1A) and EConcrete® discs (Fig. 1E). Smaller versions of gabions (Fig. 1B) that have been piloted at the Hudson Reefs near the Mario Cuomo Bridge (formerly the Tappan Zee Bridge) were used at Lemon Creek Lagoon.

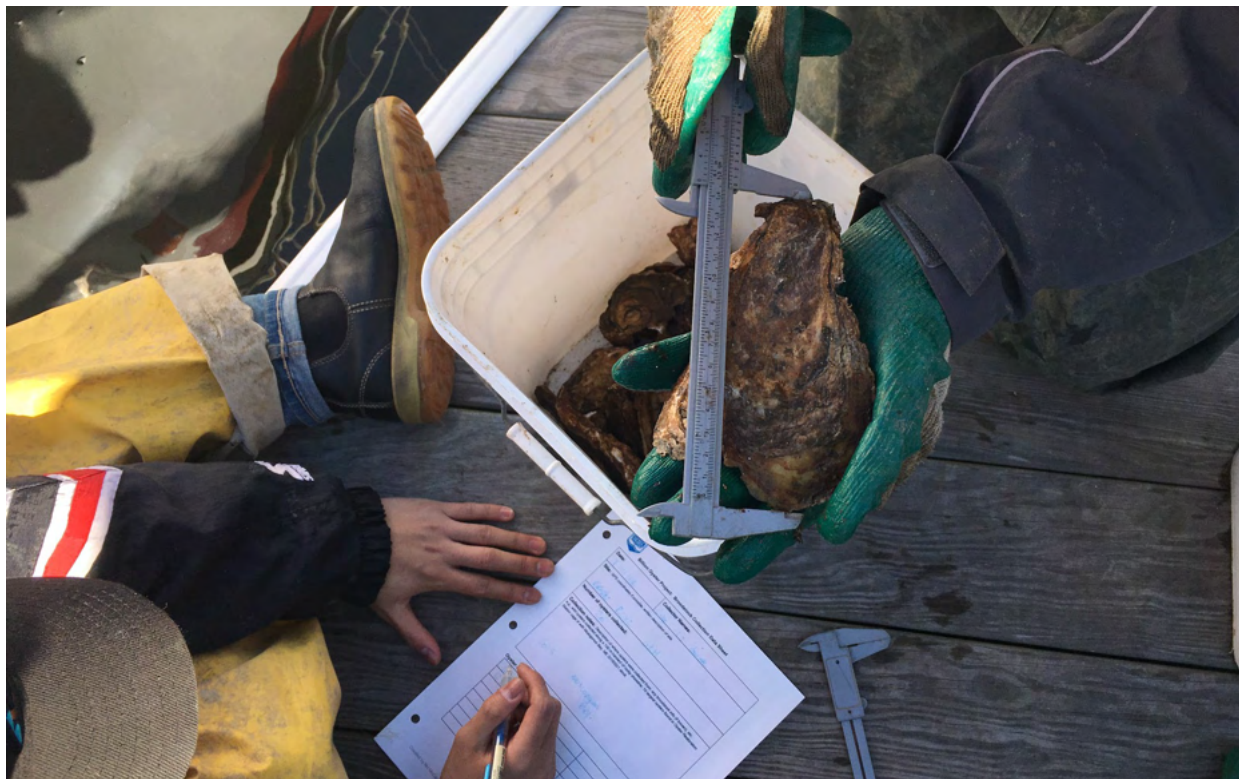
**Figure 8.** Field technicians measure oyster growth at Great Kills Harbor.

Oyster growth was quantified by measuring change in shell height through time. Shell heights were measured with calipers to the nearest millimeter (Fig. 8). Only the shell heights of live oysters were included in the analysis. The methods for measuring oyster shell height depended on the specifics of the oyster restoration structure and the nature of oyster growth. At some sites, oysters remained in loose clumps and could be separated from each other. At those sites, typically all the individuals in a clump were measured. This method was possible at all sites except for the Canarsie, Coney Island Creek, and Sunset Park Community Reefs and the Lemon Creek Lagoon gabions and EConcrete® discs.

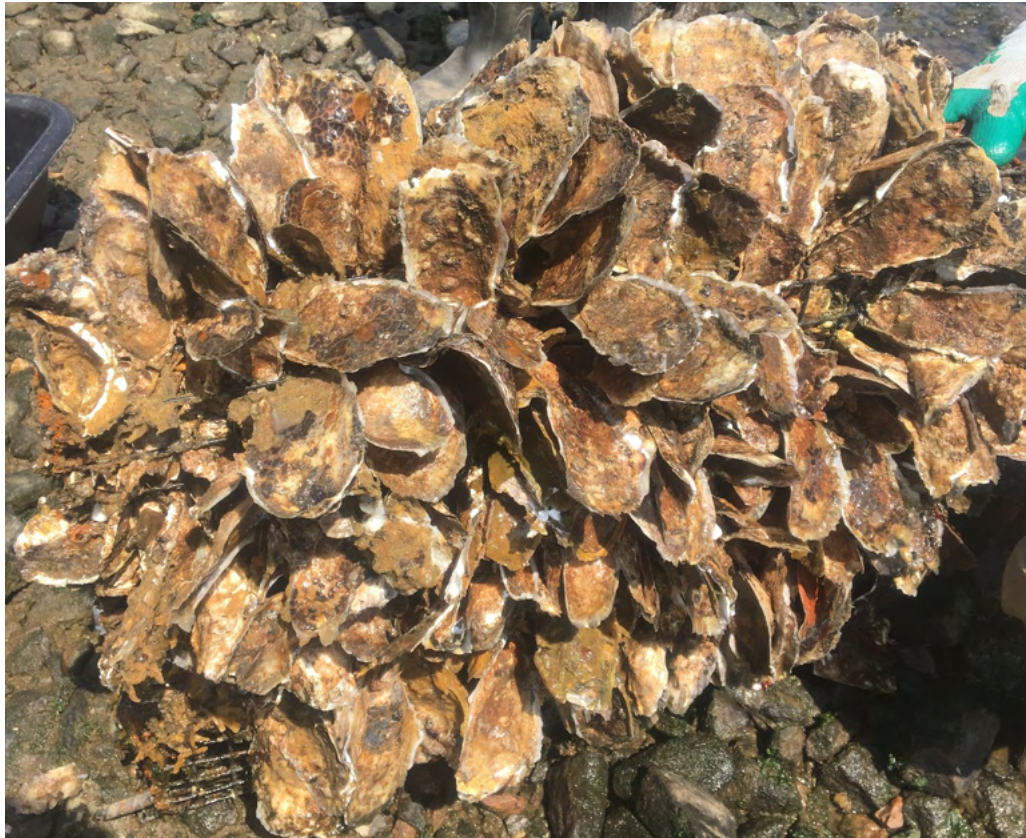
**Figure 12.** These oysters grew through the bottom of a community reef file at the Sunset Park Community Reef.

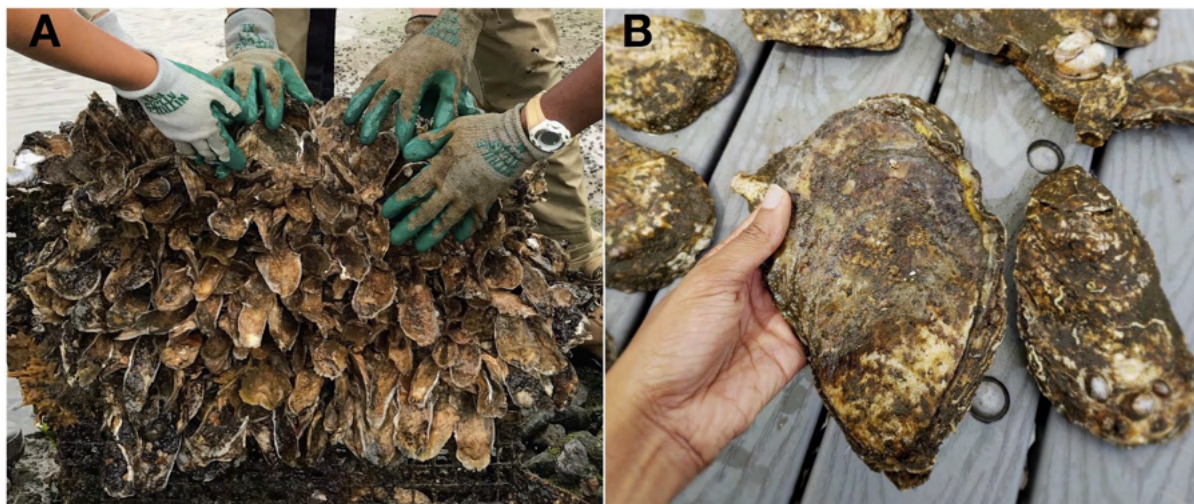
**Figure 27.** (A) Thinner morphology oysters growing through files at the Sunset Park Community Reef, and (B) thicker morphology oysters collected from an Oyster Research Station at the Canarsie Community Reef.

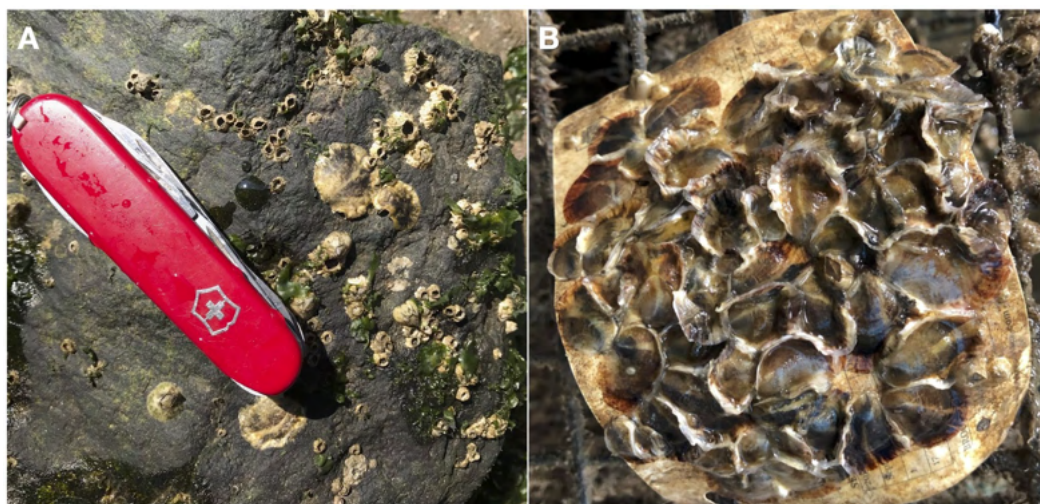
One of the performance metrics listed in Table 4 is “Spat on unseeded or off-reef structures.” The presence of juveniles or “recruits” is a positive sign for restoration (Fig. 30). Although there is no guarantee that the young oysters are the offspring of the oysters restored at that site, the presence of recruits is promising because it indicates that conditions are suitable for larval survival and transport at that site. For example, the juvenile oysters observed on intertidal rocks at Coney Island Creek were not the offspring of the oysters restored at that site, which were less than one year old and not reproductively mature. Regardless, their presence indicates that a source population is nearby and that conditions at the site are suitable for larvae.

**Figure 30.** (A) Wild oyster recruits, along with barnacles and anemones, on intertidal rocks adjacent to the Coney Island Community Reef in summer 2018 (Swiss Army multitool for size comparison), and (B) wild oyster recruits seen at West Harlem Piers Park at 125th Street in Manhattan.

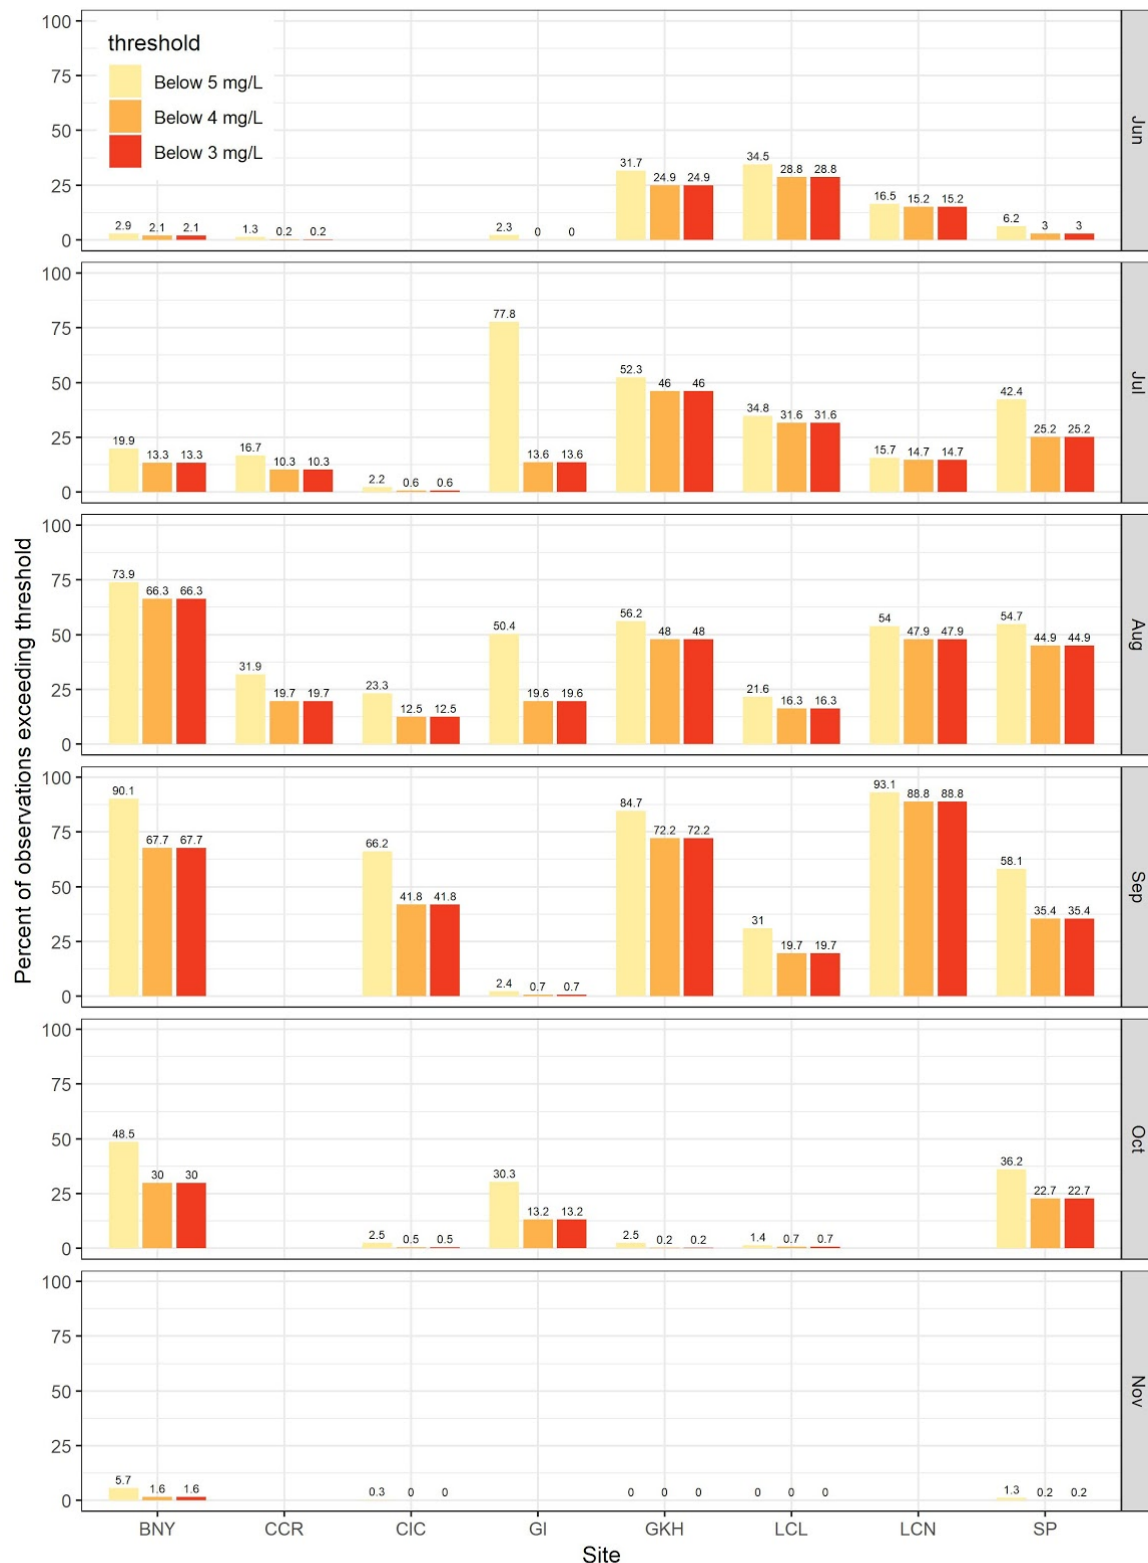
**Figure 38.** Percent of high-resolution (recorded every 15 minutes) dissolved oxygen measurements below 3, 4, and 5 mg/L in each month in 2018 for Brooklyn Navy Yard (BNY), Canarsie Community Reef (CCR), Coney Island Community Reef (CIC), Governors Island EcoDock (GI), Great Kills Harbor (GKH), Lemon Creek Lagoon (LCL), Lemon Creek Nursery (LCN), and Sunset Park Community Reef (SP).
