# New York City Oyster Monitoring Report 2019

You are reading the third edition of the *New York City Oyster Monitoring Report*, which summarizes data from the 2019 field season. These data were collected based on protocols developed by Dr. Michael McCann. For more information about past oyster restoration projects, refer to *Restoring Oysters to Urban Waters* (McCann 2019), available on our website.

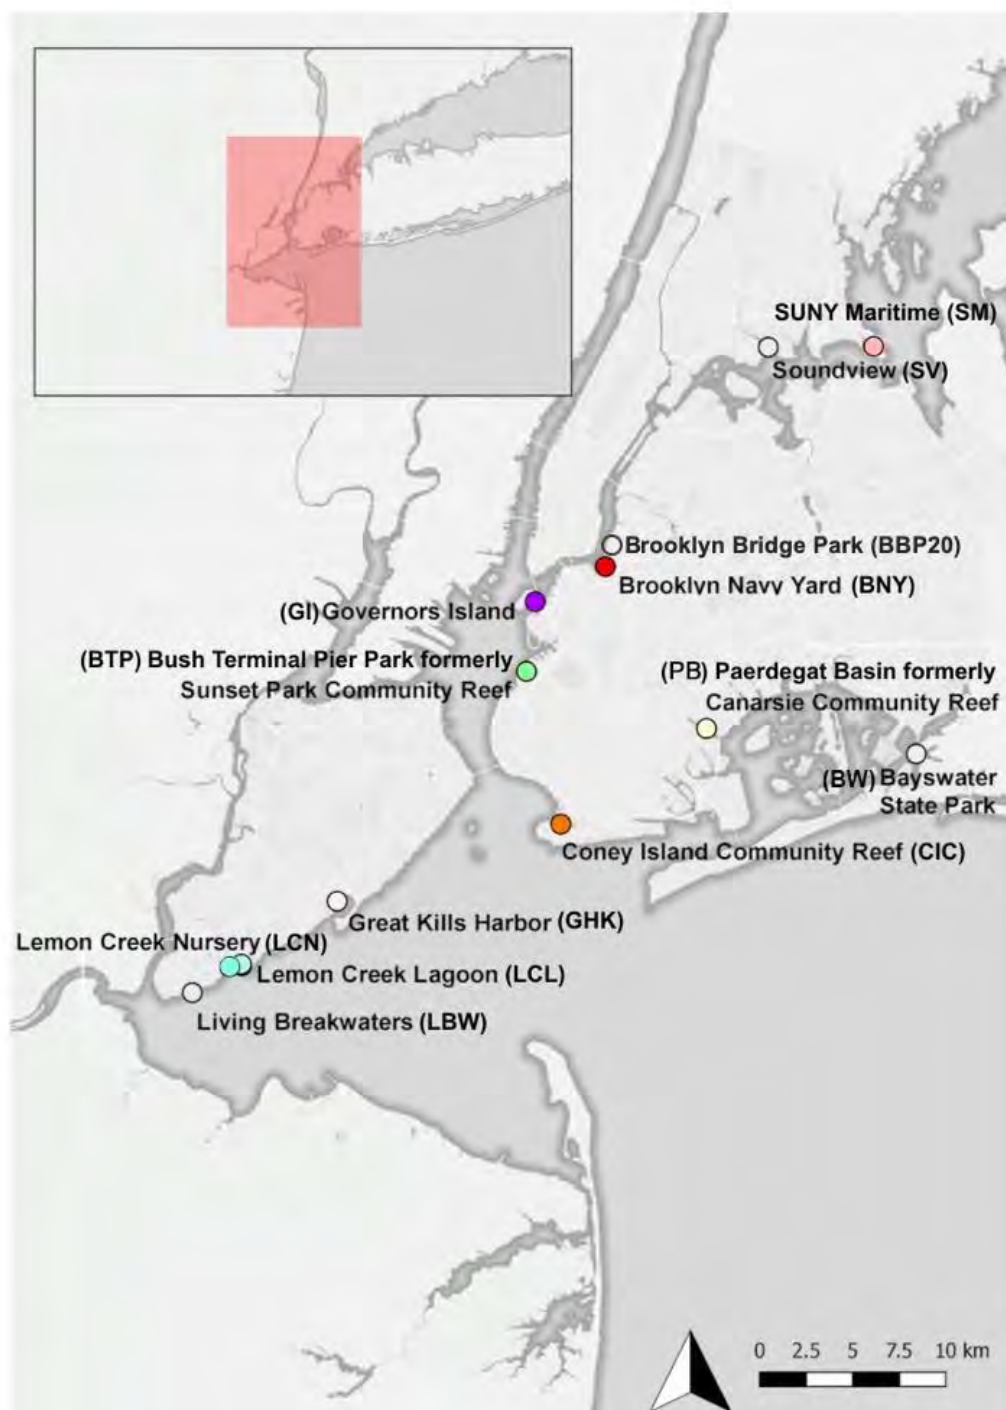
**Figure 1.** The nine current oyster restoration sites in New York Harbor described in this report are represented by colored circles. The future restoration sites are indicated with white circles.

This report shares the results of monitoring at nine oyster restoration sites in New York Harbor (Table 1, Fig. 1). All sites were permitted and installed by Billion Oyster Project. The SUNY Maritime nursery was established in 2019. Several sites include cohorts of oysters installed over multiple years or in multiple types of gear (see *Restoration Structures* below). For example, the Sunset Park site at Bush Terminal Park has Community Reef cabinets that were installed in 2016 and 2018 and a bagged-shell reef installed in 2018. The results of each cohort or structure are typically reported separately for oyster growth, disease, and reproduction, while results for water quality are reported for the entire site. Both the Brooklyn Navy Yard and Governors Island EcoDock host floating nurseries that hold many oysters. These sites were permitted and installed prior to 2016, and this document reports on a subset of oysters that were installed at each site in 2017 or 2018 specifically for monitoring. Numbers of oysters deployed at each site are summarized in Table 1. Figure 4 shows the density of spat per shel among the seeded shells that were placed at the SUNY Maritime nursery.

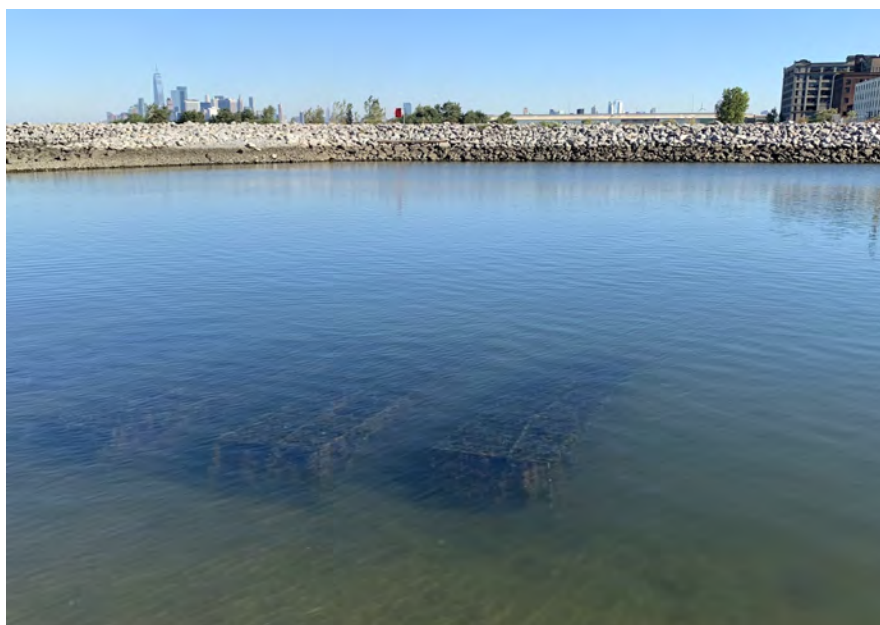
**Figure 3.** Cabinets were installed at the Bush Terminal Park site in Brooklyn. (photo courtesy of Elizabeth Burmester)

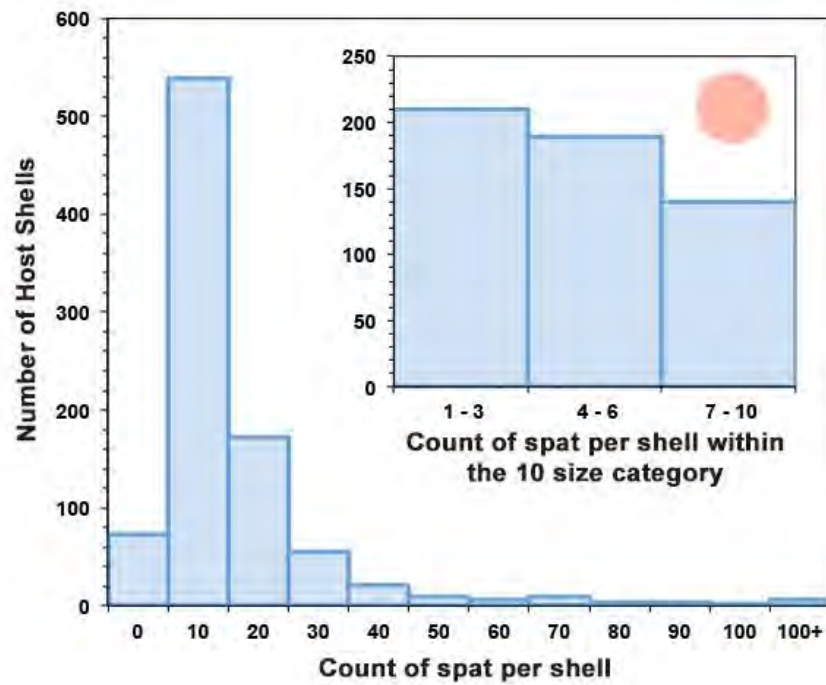
**Figure 4.** Distribution of spat counts. Oysters were deployed in Super Trays at the newly established SUNY Maritime (SM) site.

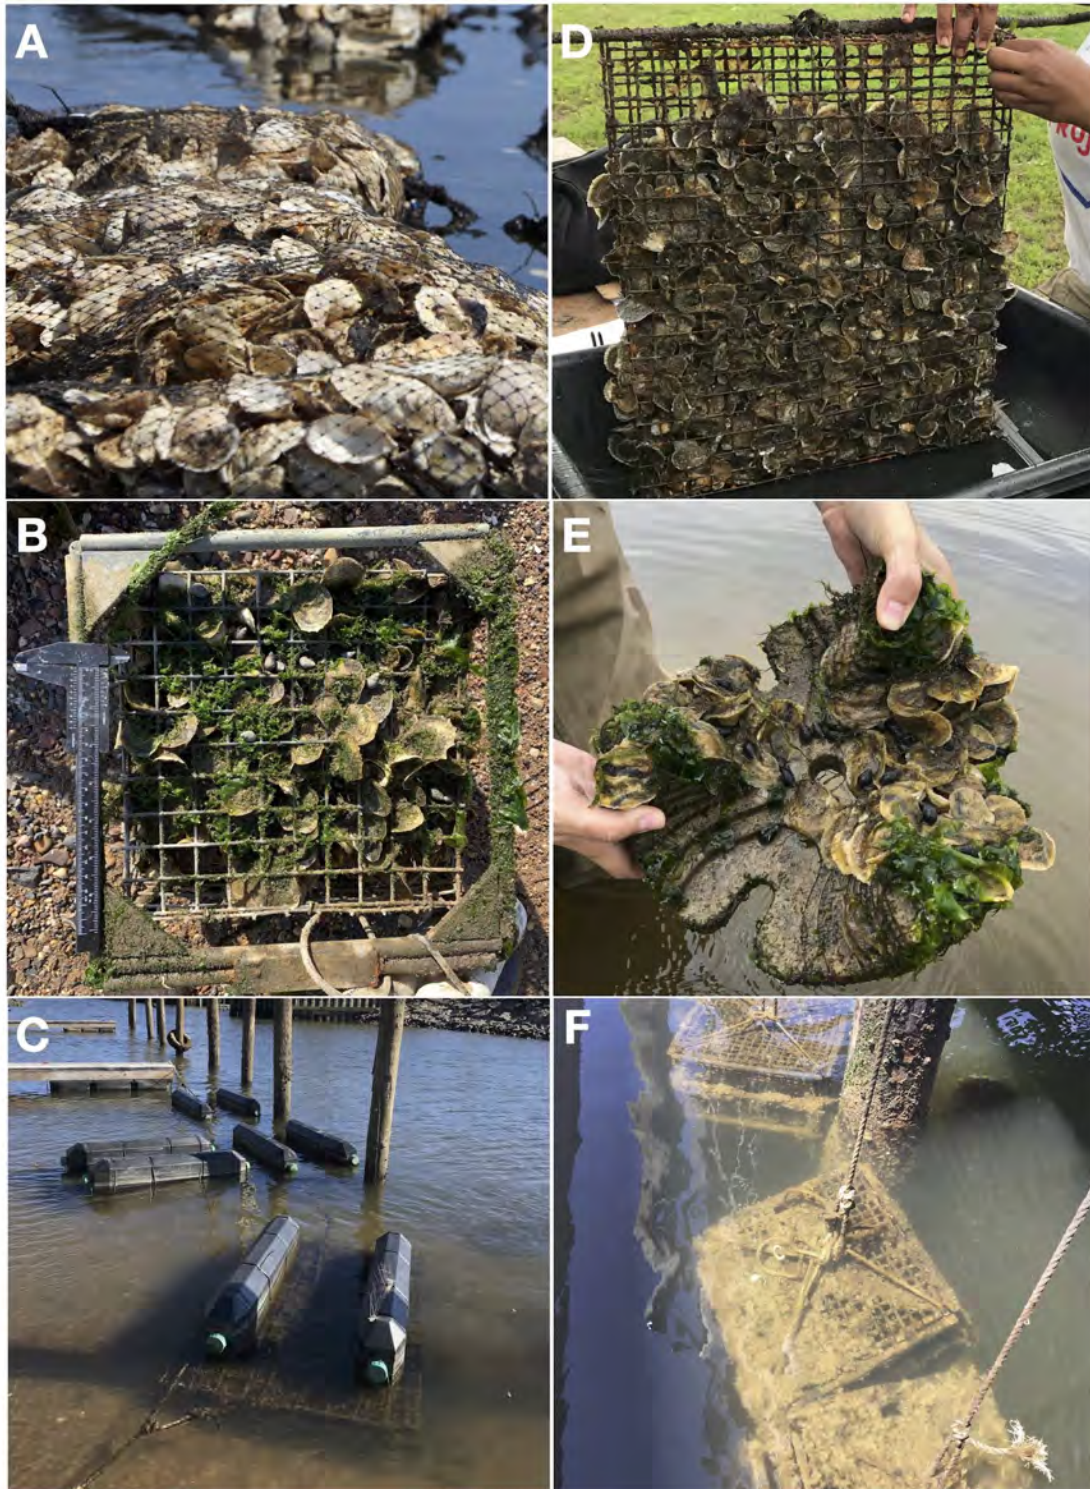
**Figure 6.** Examples of structures employed to install oysters: (A) bags, (B) mini-gabions, (C) OysterGros®, (D) community reef files, (E) EConcrete® discs, and (F) Super Trays. (Photos courtesy of Finola Fung-Khee, Dr. Elizabeth Burmester, Robina Taliaferrow, and Dr. Michael McCann)

A variety of different restoration approaches and structures were used, depending on unique site conditions, project objectives, and our continually developing understanding of best practices for oyster restoration in urban waters. Community Reefs are welded, steel structures that hold cages of oysters off the bottom (Fig. 3). These structures allow the cages to be removed for monitoring above the water surface. The term “nursery” describes restoration sites where oysters are held off the bottom in floating or suspended structures, regardless of the size or age of the oysters. Nursery gear types include OysterGros® (Fig. 6C) and Super Trays (Fig. 6F), both of which are used in commercial aquaculture. 2018 was the first year in which several restoration approaches were tested, including bagged-shell reefs (Fig. 6A) and EConcrete® discs (Fig. 6E). Smaller versions of gabions (Fig. 6B) that have been piloted at the Hudson Reefs near the Mario Cuomo Bridge (formerly the Tappan Zee Bridge) were used at Lemon Creek Lagoon.

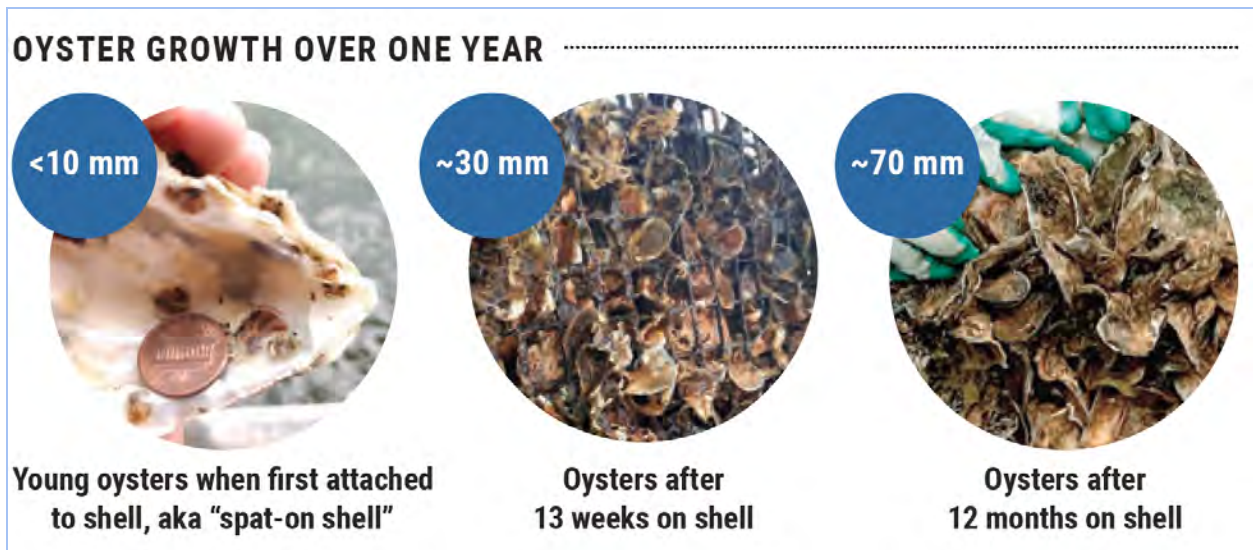
**Figure 7.** These photos show oyster growth in the first year of restoration at sites with fast growth. (Photos courtesy of Billion Oyster Project Staff)

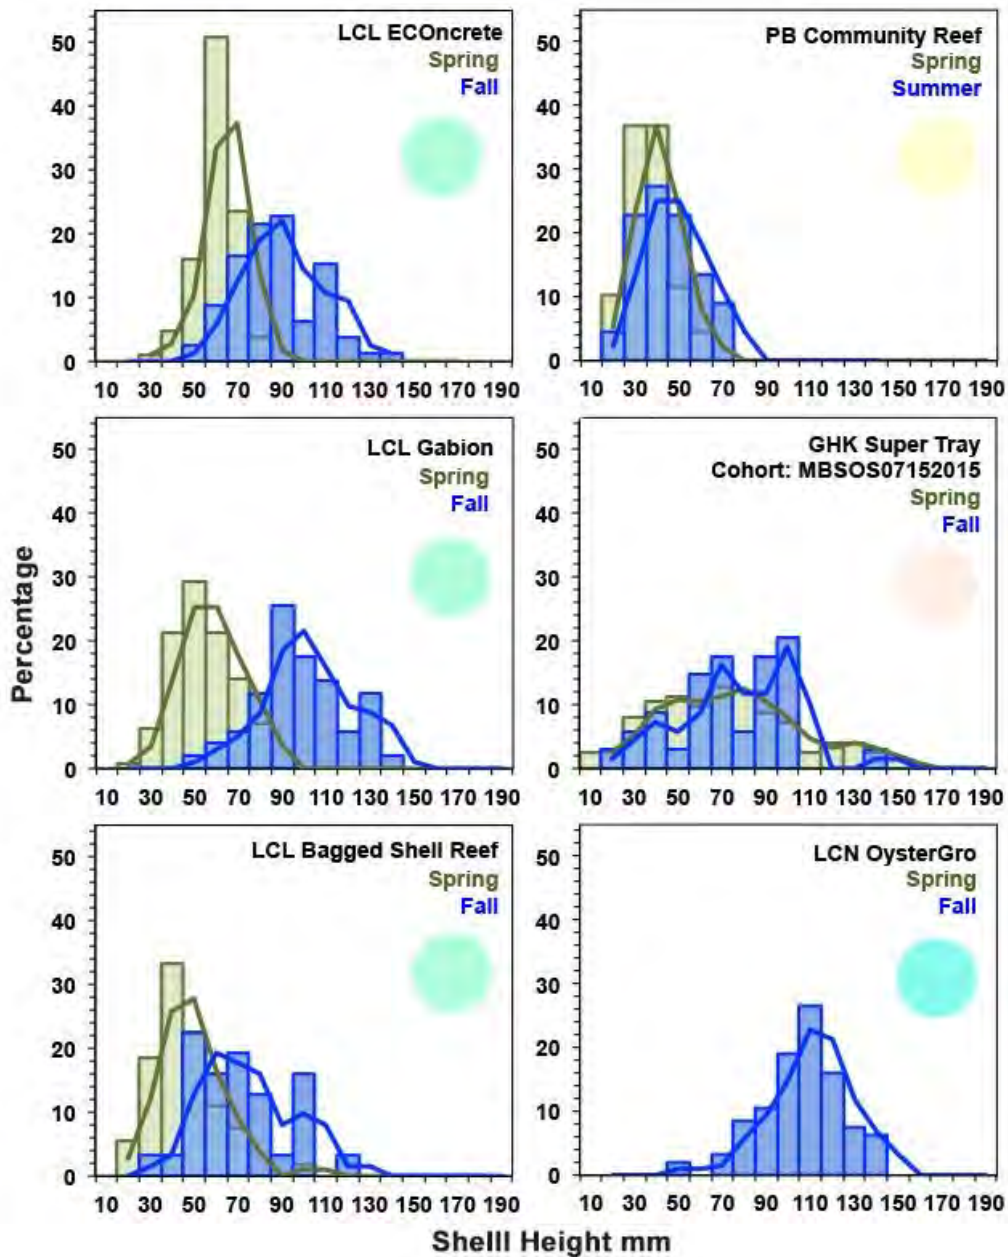
**Figure 9.** Size frequency is expressed as % of all live oysters that fall into a specific shell height category. Oysters were held in various structures, including bagged shell, community reef cabinets, ECONcrete®, OysterGro®, gabions, and Super Trays. Oysters were measured at different times from June through November of 2019.

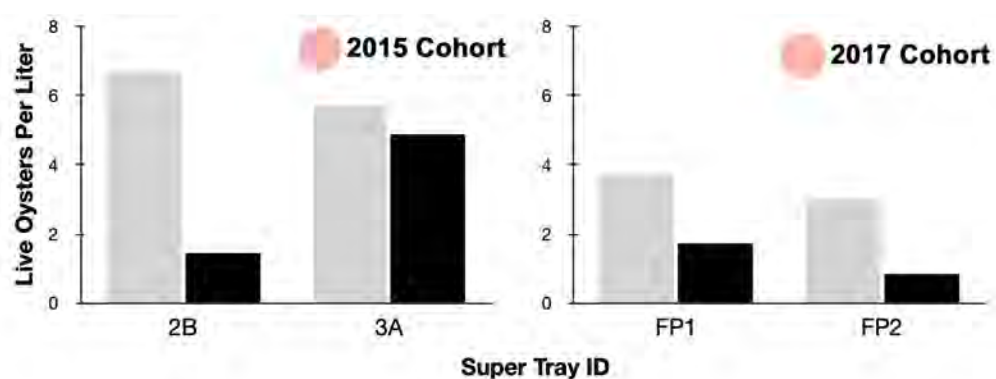
**Figure 10.** Densities of live oysters from 2015 and 2017 cohorts from Great Kills Harbor based on data collected in 2019.

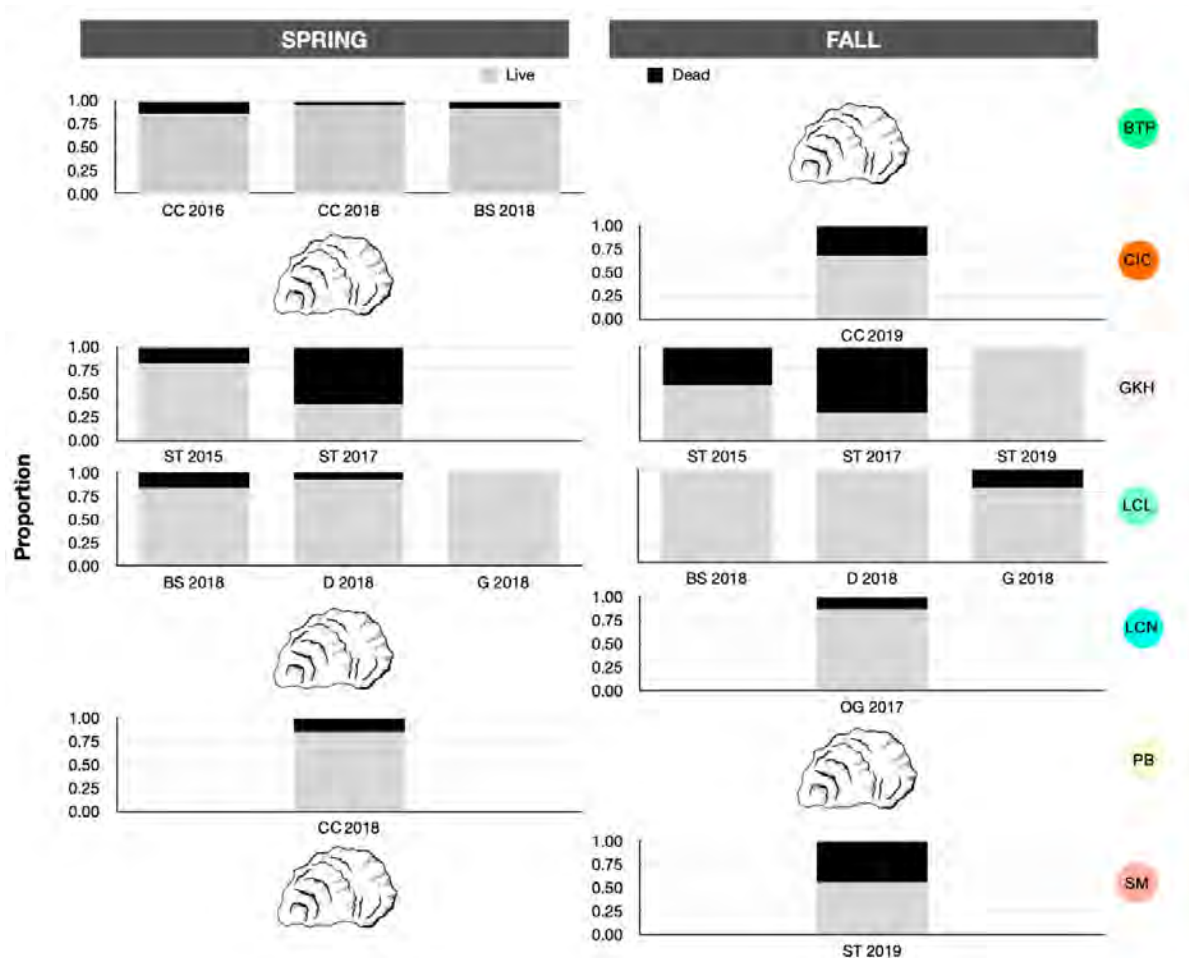
**Figure 11.** The proportion of live and dead oysters across sites based on the 2019 monitoring. Oyster pictures appear where the measurements were not taken or oysters were not yet installed.

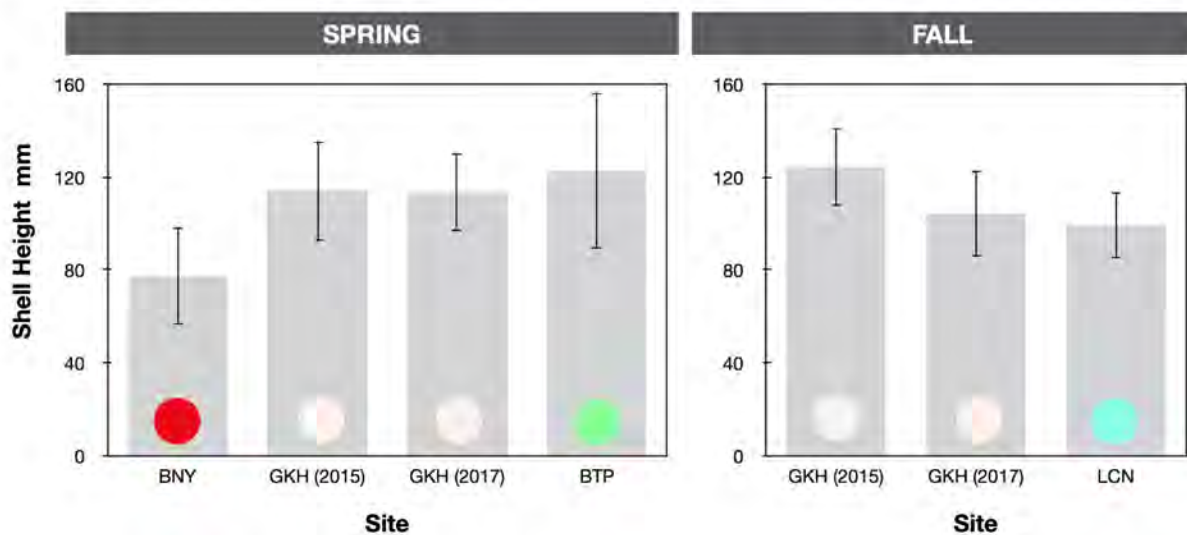
**Figure 12.** Mean shell heights of oysters that were tested for disease (see data in Table 5 and Figure 24). Error bar = standard error (n = 28 - 30 oysters). Oysters sampled at BTP represented the 2016 cohort.

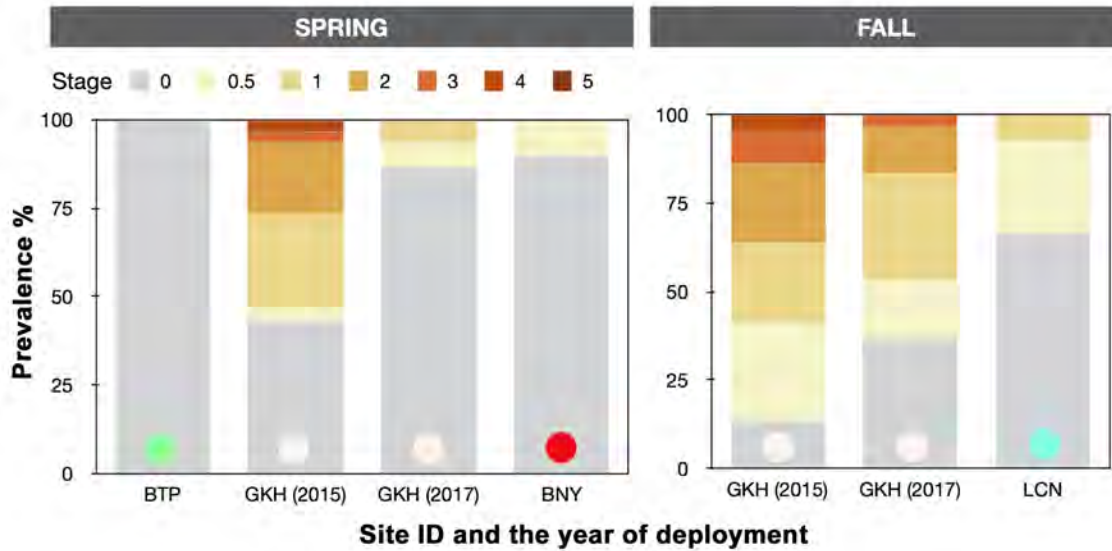
In 2019, Dermo was the primary disease of concern. According to the Mackin scale, the intensity above 3 indicates lethality. Prevalence was highest in fall (Fig. 13). A comparison of two oyster cohorts from Great Kills Harbor showed that the older oysters were more severely impacted. In fall 2019, 13.6% of the tested individuals from the 2015 cohort and 3.3% of the 2017 cohort reached or exceeded level 3 at this site. About a third of the oysters collected from the Lemon Creek Nursery tested positive for Dermo but had relatively low-intensity levels, suggesting minimal mortality risks due to this disease. Among the various oyster groups that were tested, the only group that was impacted by MSX was from the Lemon Creek Lagoon. The prevalence of MSX was, however, low and intensity moderate (Table 7).

**Figure 13.** Dermo (*P. marinus*) prevalence (%) and intensity (stages) in oysters from three of Billion Oyster Project's field stations sampled in June and October of 2019. Stage 3 and higher is considered lethal.

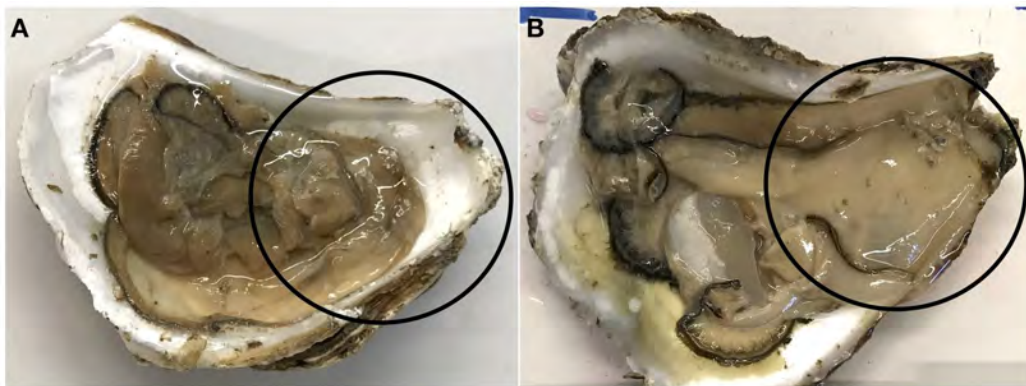
**Figure 14.** These pictures compare gonad development (circled) in (A) inactive or “unripe” and (B) “ripe” oyster tissue. (Photos Courtesy of Dr. Elizabeth Burmester and Dr. Michael McCann)

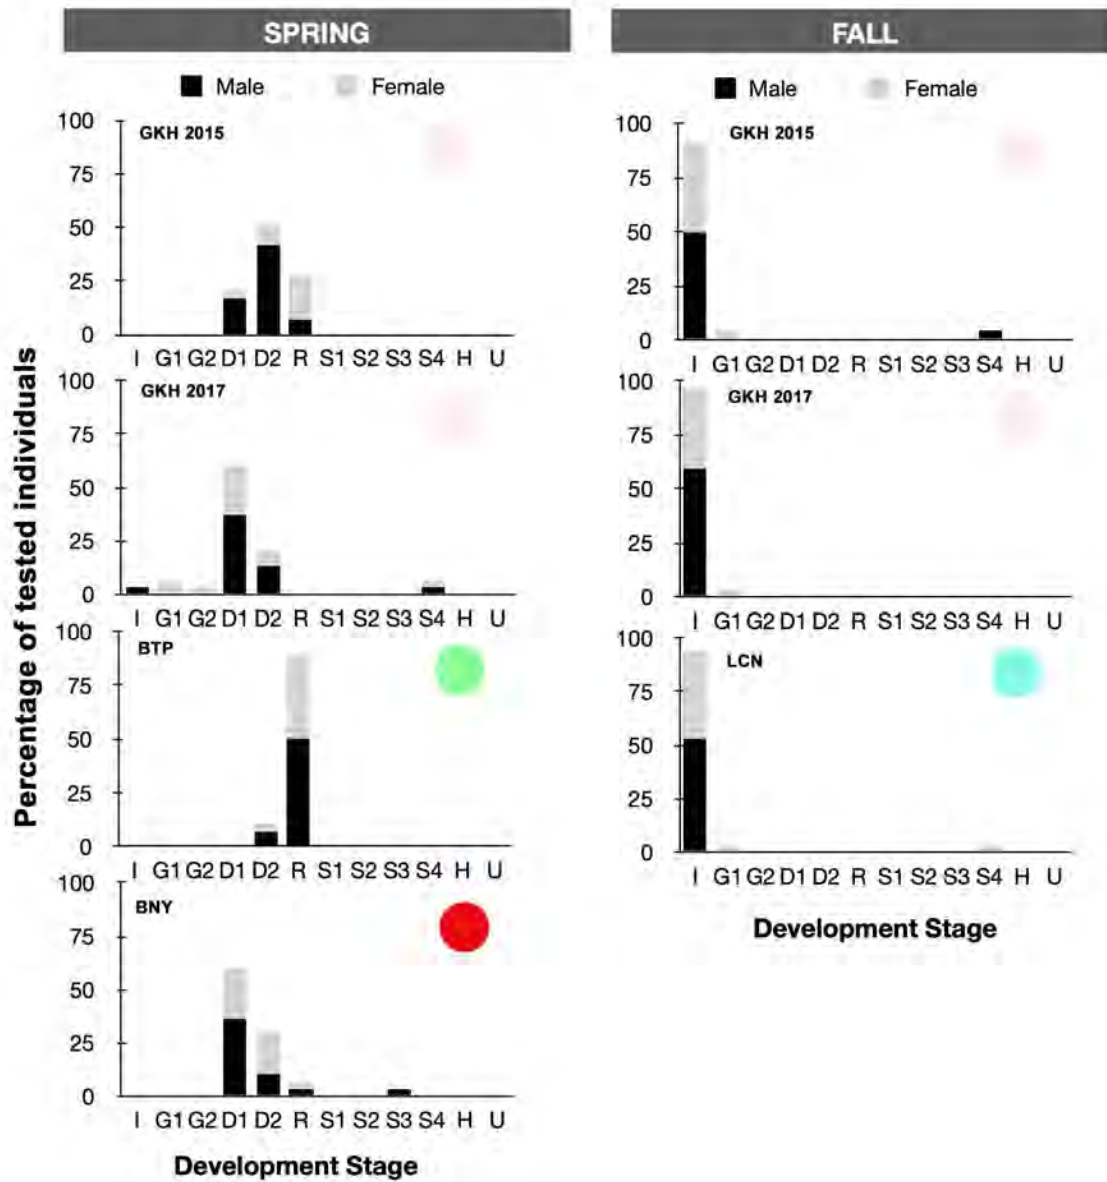
Sexual differentiation and stages of gonad development among the tested individuals were performed by Dr. Basse Allam. Samples from summer (i.e., collection in June) were assumed to represent oysters' reproductive status because, after spawning, oysters resorb their gonads. Spawning season is not well understood for NY Harbor, but it is safe to assume that oysters no longer reproduce in October. To assess the reproductive status of the Great Kills Harbor oysters, the 2015/2016 cohort was sampled on June 18<sup>th</sup>, 2019, and the 2017 cohort was sampled on June 26<sup>th</sup>, 2019. Oysters from the Bush Terminal Park (2016 cohort) were sampled on June 19<sup>th</sup>, 2019 and from Brooklyn Navy Yard on June 18<sup>th</sup>. We found that oysters from the Brooklyn Navy Yard were male-skewed (only 34% were females). Among these oysters, only 27.6% were sexually mature. Oysters from Great Kills Harbor were at even sex ratios for both tested cohorts. Gametes of some of the oysters were in early stages of development, and some oysters were spent (Fig. 15, Table 4). Bush Terminal Park was the only site at which oysters were at an even sex ratio and spawning (Fig. 15, Table 4).

**Figure 15.** Sex and stage of reproductive development (I - Inactive, G1 - Gametogenic Stage I, G2 - Gametogenic Stage II, D1 - Developing Stage I, D2 - Developing Stage II, R - Ripe Stage, S1 - Spawning Stage I, S2 - Spawning Stage II, S3 - Spawning Stage III, S4 - Spawning Stage IV, U - Undetermined) of oysters from four of Billion Oyster Project's field stations (30 oysters from each site). Color dots correspond to the color code of a site, as displayed in Fig. 1. Refer to Table 8 for a full description of the reproductive stages.

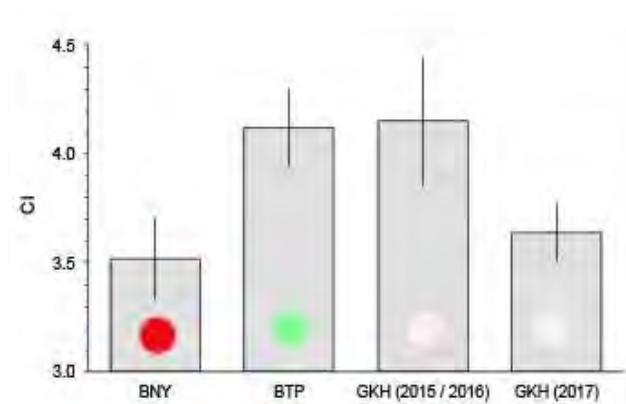
In June of 2019, the average CIs of oysters from the three sites were similar, ranging from 3.5 at Brooklyn Navy Yard to 4.1 at Bush Terminal Park (Fig. 16). The level of variability was relatively high within the site, possibly resulting from differences in spawning status among individuals.

**Figure 16.** Condition Index (CI - y-axis) of oysters from Brooklyn Navy Yard (BNY), Great Kills Harbor (GKH) 2015 and 2017 cohorts, and Bush Terminal Park (BTP) collected in June 2019. Sites are indicated on the x-axis. CI data displayed in this figure on the y-axis represent mean values (n = 28 - 30). Error bars = standard error.

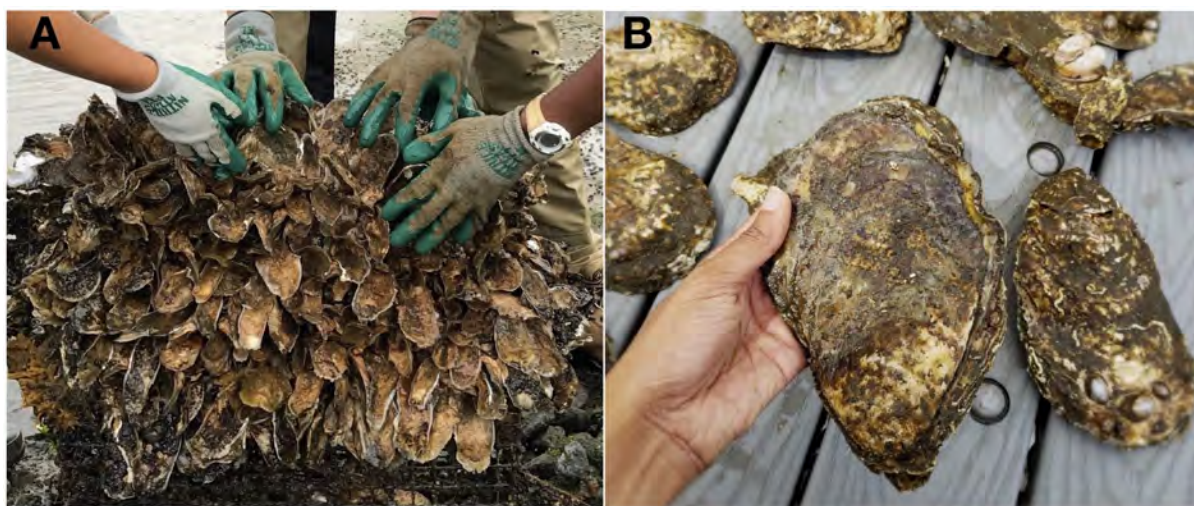
**Figure 17.** (A) Thinner morphology oysters growing through files at the Sunset Park, Bush Terminal Park Community Reef, and (B) thicker morphology oysters collected from an Oyster Research Station at the Canarsie Community Reef. (Photos courtesy of Finola Fung-Khee)

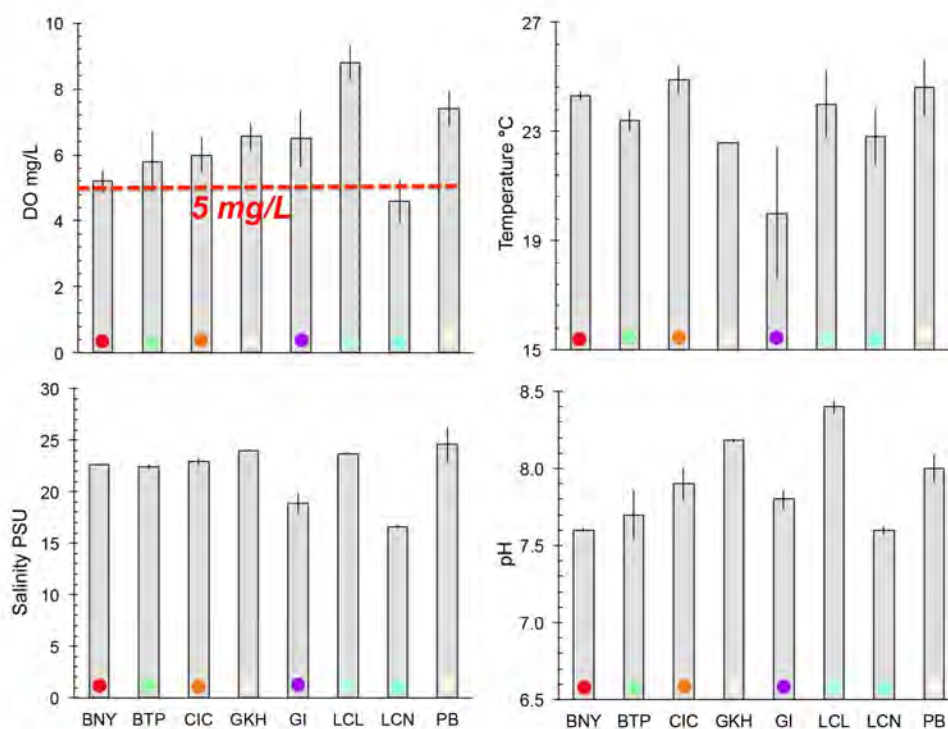
**Figure 18.** Average values of temperature, dissolved oxygen (DO), salinity and pH from June through September 2019, based on discrete point sampling. Measurements were performed three times at each specific date and time and each site was visited 2 (site BTP), 3 (sites BNY, CIC, GI), 4 (sites GKH, LCL and LCN), or 5 (e.g. PB) times. Sampling sites were: Brooklyn Navy Yard (BNY) (n = 3), Bush Terminal Park Community Reef (also referred to as the Sunset Park Community Reef) (n = 4), Coney Island Community Reef (CIC) (n = 5), Governors Island (GI) EcoDock (n = 6), Great Kills Harbor (GKH) (n = 4), Lemon Creek Lagoon (LCL) (n = 5), Lemon Creek Nursery (LCN) (n = 4), Canarsie Community Reef in Paerdegat Basin (PB) (n = 4). Error bar = standard error.

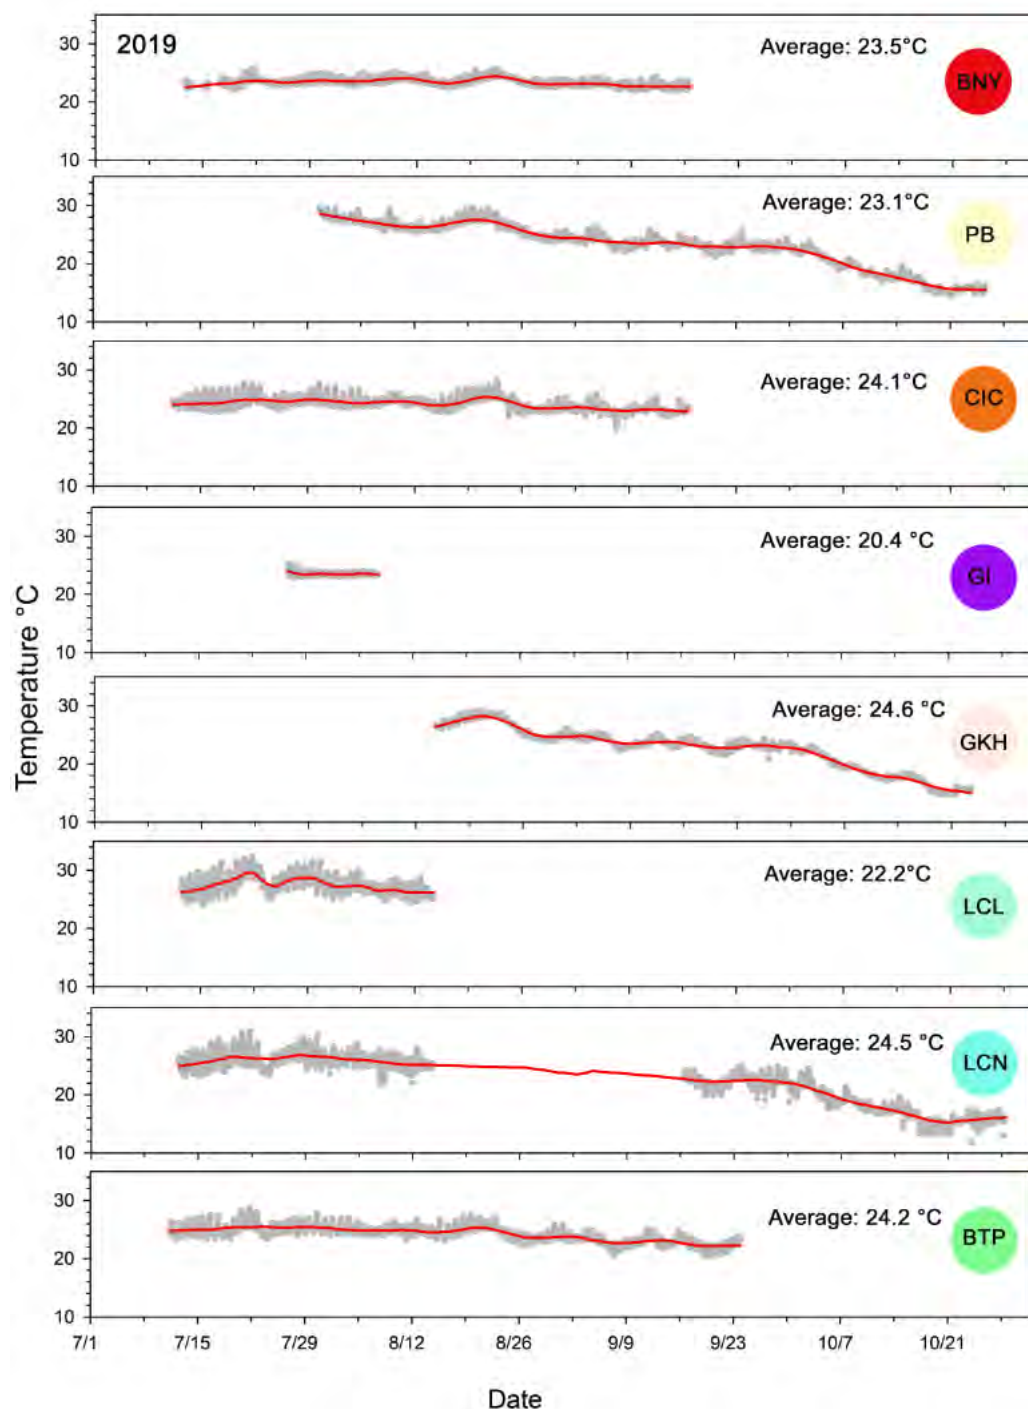
**Figure 20.** High-resolution (recorded every 15 minutes) temperature data for Brooklyn Navy Yard (BNY), Paerdegat Basin (PB), Coney Island Community Reef (CIC), Governors Island EcoDock (GI), Great Kills Harbor (GKH), Lemon Creek Lagoon (LCL), Lemon Creek Nursery (LCN), and Bush Terminal Park (BTP).

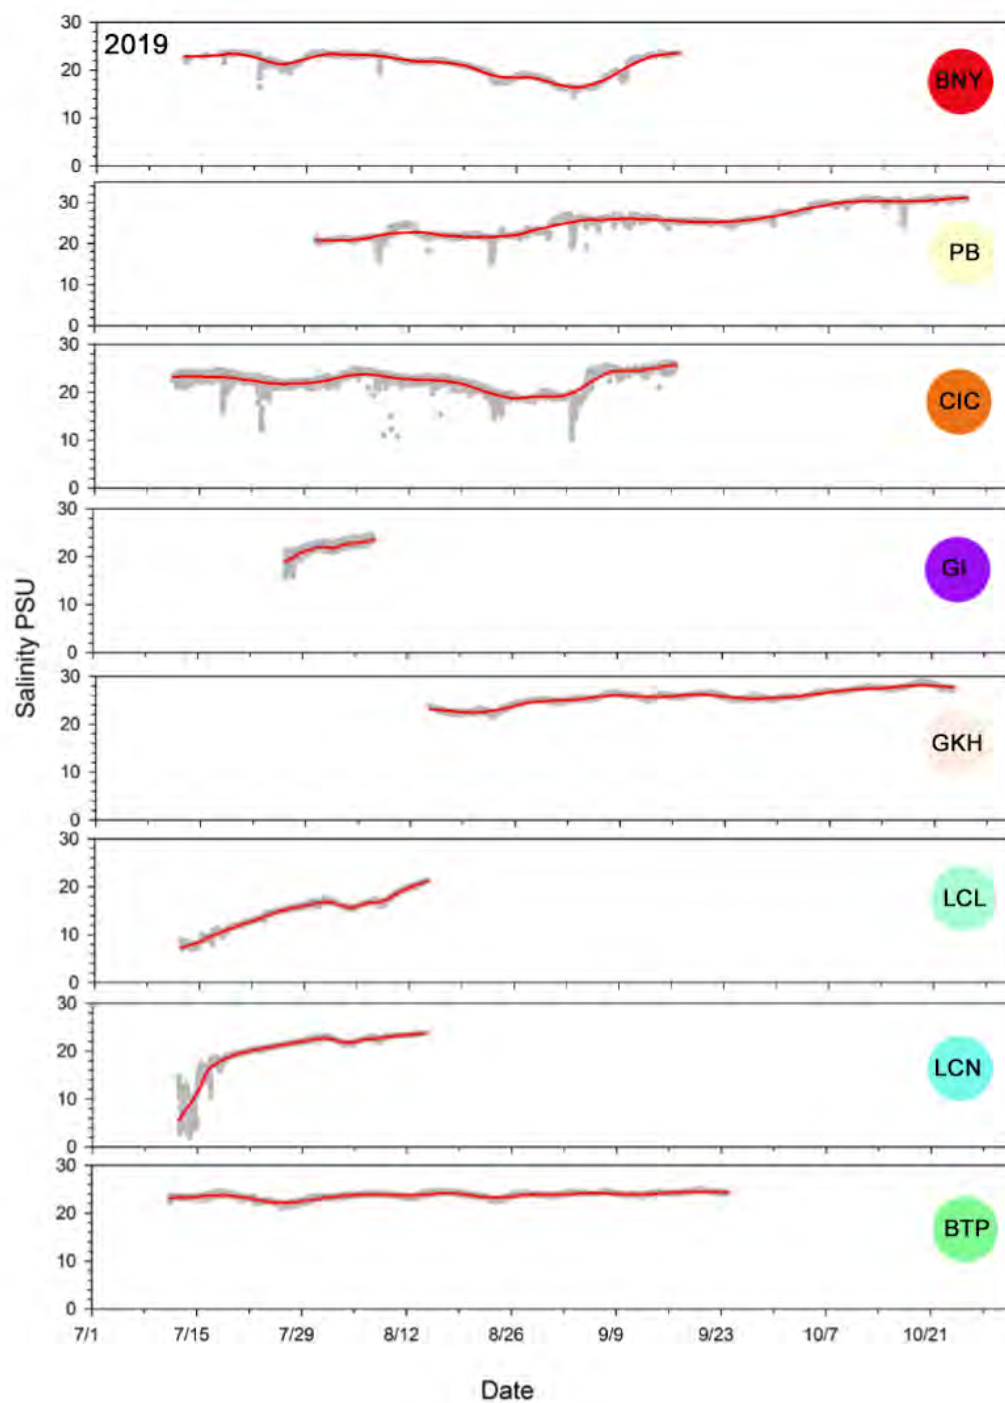
**Figure 21.** High-resolution (recorded every 15 minutes) salinity data for Brooklyn Navy Yard (BNY), Paerdegat Basin (PB), Coney Island Community Reef (CIC), Governors Island EcoDock (GI), Great Kills Harbor (GKH), Lemon Creek Lagoon (LCL), Lemon Creek Nursery (LCN), and Bush Terminal Park (BTP).

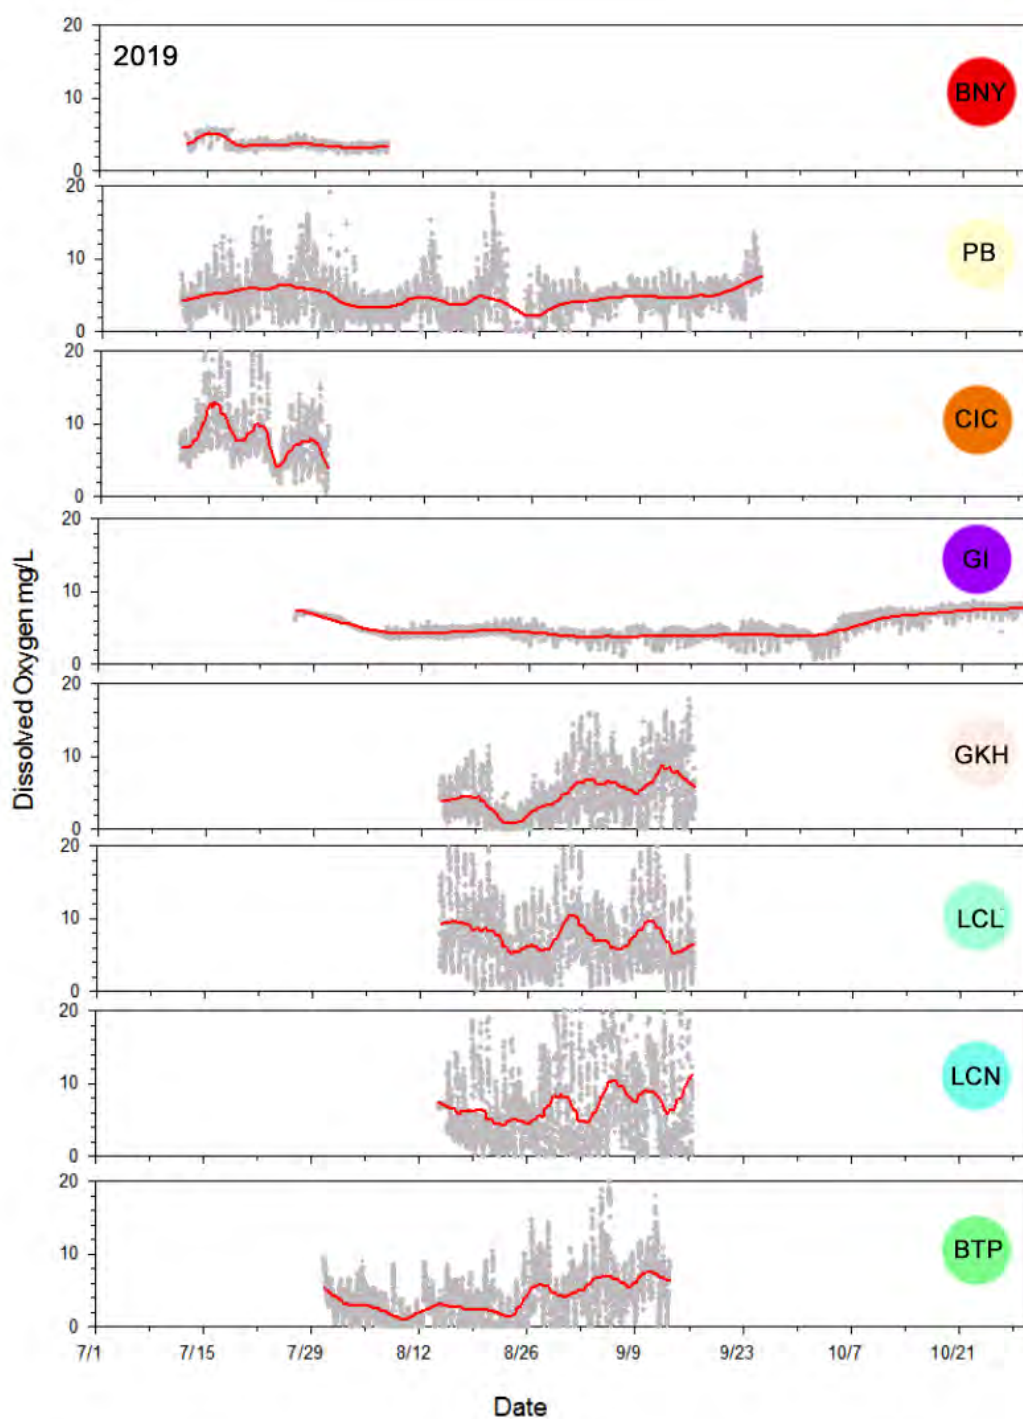
**Figure 22.** High-resolution (recorded every 15 minutes) dissolved oxygen data for Brooklyn Navy Yard (BNY), Paerdegat Basin (PB), Coney Island Community Reef (CIC), Governors Island EcoDock (GI), Great Kills Harbor (GKH), Lemon Creek Lagoon (LCL), Lemon Creek Nursery (LCN), and Bush Terminal Park (BTP). Red lines indicate dates when loggers were cleaned, calibrated, and redeployed. Levels below 5 mg/L are considered stressful for oysters.

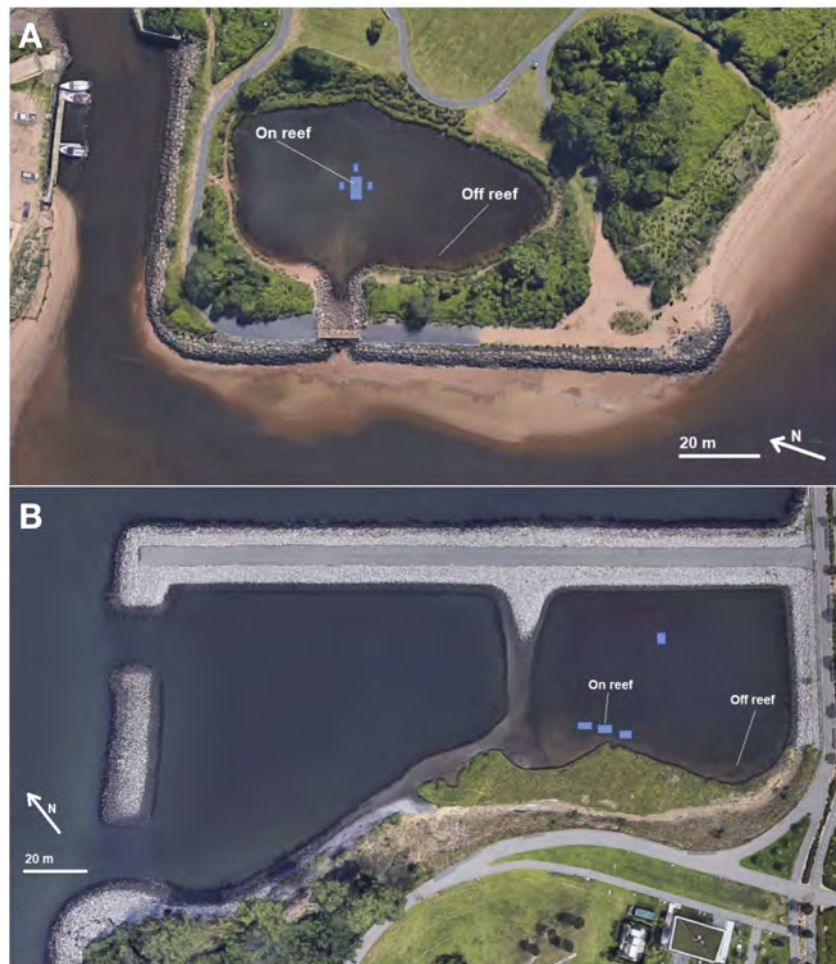
**Figure 23.** Aerial view of biodiversity study sites at (A) Lemon Creek Lagoon and (B) Sunset Park Community Reef at Bush Terminal Park. Blue polygons indicate approximate size and location of oyster restoration projects. (Diagrams courtesy of Dr. Michael McCann).
