# PlasLOC<sup>+</sup>

High-Performance Plastic Baling Wire

## Validation Study

Commercial Evaluation of  
PlasLOC+ Bales

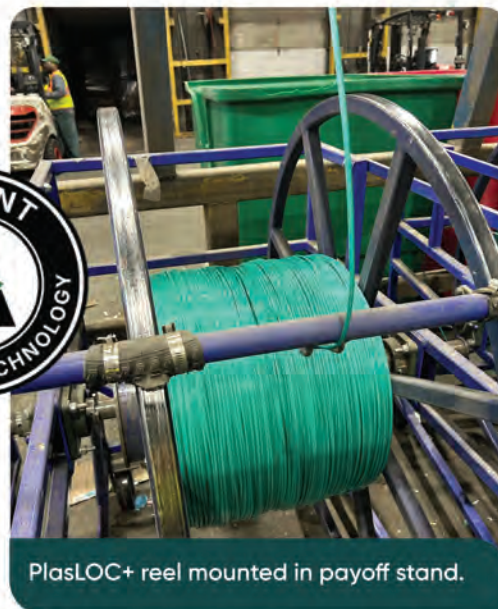
PlasLOC+ reel mounted in payoff stand.

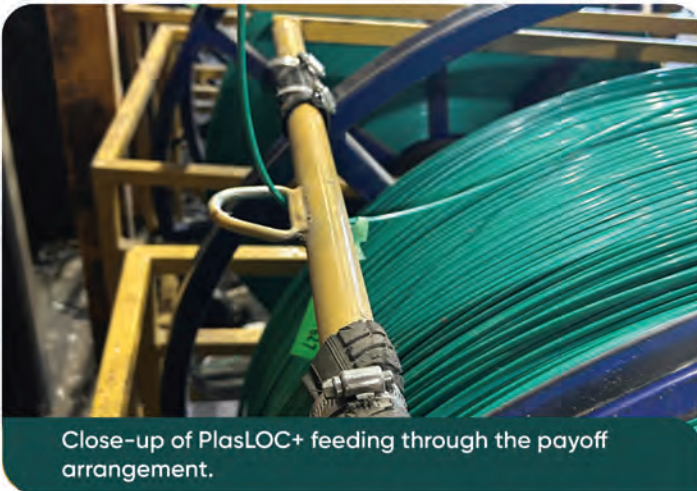
Close-up of PlasLOC+ feeding through the payoff arrangement.

During initial implementation, the plant experienced a learning curve related to finger adjustments and reel setup. Some modifications were made to optimize the baler for PlasLOC+. Once completed, the wire demonstrated consistent feeding and payoff performance, with no recurring issues reported during continued operation.

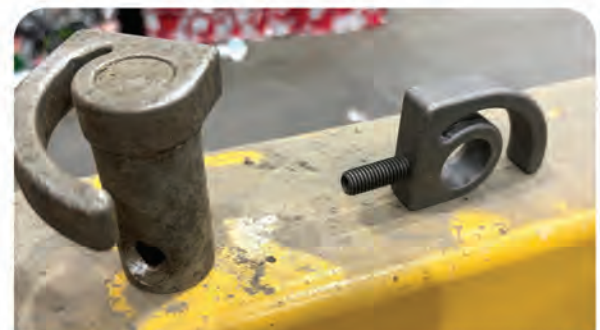
Steel-wire twister component compared with PlasLOC+ twister component.

| AREA | STEEL WIRE BASELINE | PLASLOC+ RESULT / OBSERVATION |
|---|---|---|
| Twister mechanism | Steel wire places higher stress on fingers/twisters and was associated with breakage. | No finger breakage reported since PlasLOC+ conversion; adjustments remain a follow-up item. |

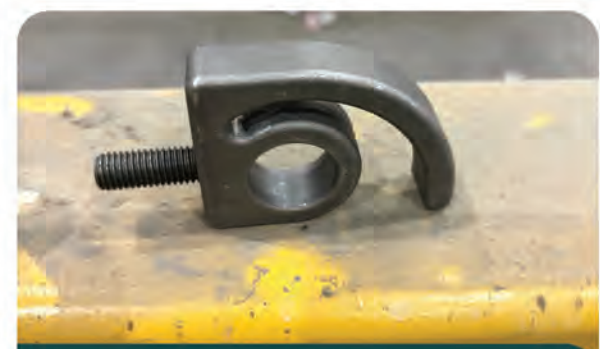
PlasLOC+ twister hardware detail.

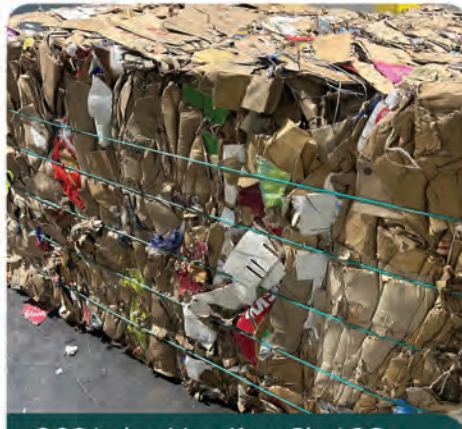
OCC bale with uniform PlasLOC+ spacing visible.

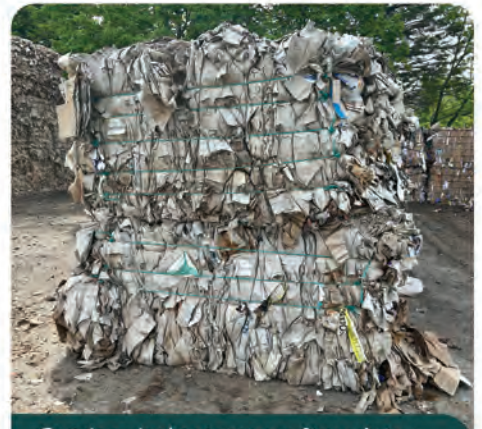
Outdoor bale storage after winter exposure.

One of the most common initial concerns to PlasLOC+ bales was long-term outdoor performance. Outdoor bales remained exposed throughout the six-month fall and winter period with no wire-related issues, loosening, or bale expansion observed.

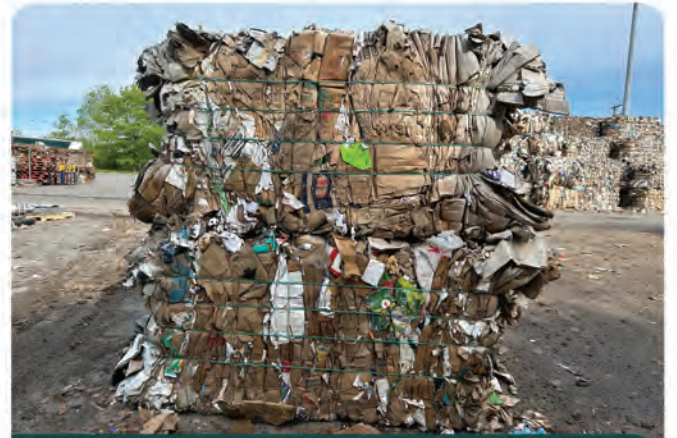
Outdoor storage validation: PlasLOC+ remains visible and intact.

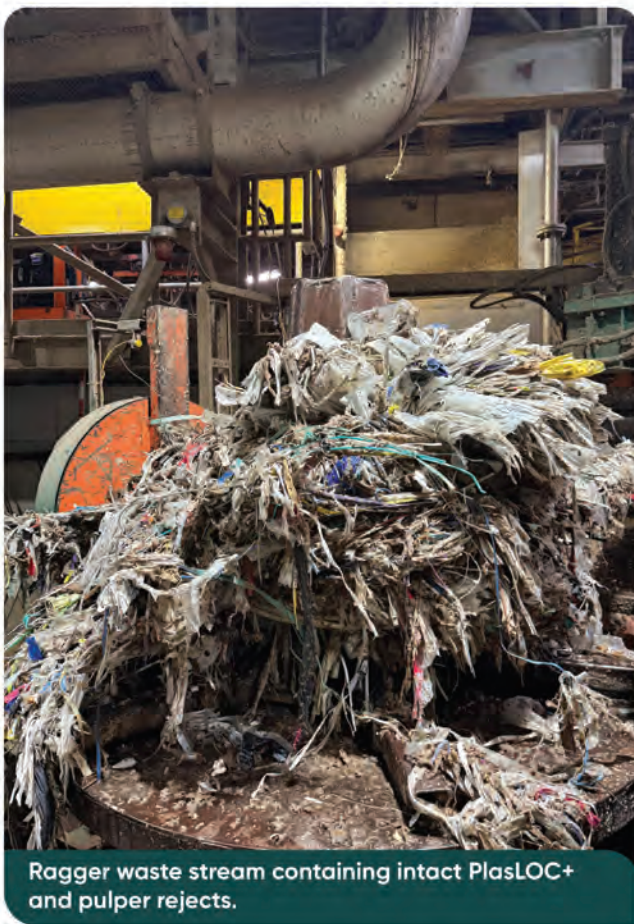
Ragger waste stream containing intact PlasLOC+ and pulper rejects.

- No production issues occurred during tests in continuous pulpers with and without raggars.
- Conveyor guillotines were able to process PlasLOC+.
- PlasLOC+ wrapped around the raggar and remained intact; no fragmentation was observed.
- In pulpers without raggars, PlasLOC+ clumped into a removable ball.
- A third-party receiving mill trial was successful, and no negative feedback from other receiving mills was reported.
