## Static Spark from Explosive Vapours Ignites Road Tanker

Source: "Fire and Explosion of Highway Cargo Tanks, Stock Island, Key West, Florida". Hazardous Materials Accident Report. NTSB, (1998).

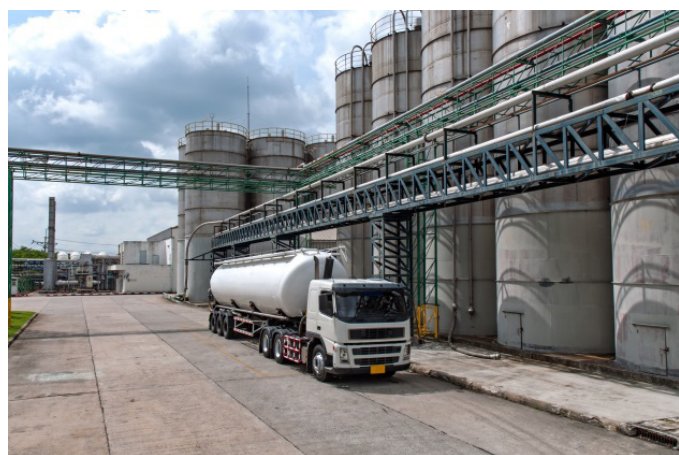
Tank truck operations can be conducted in remote locations where designated grounding points are not always available.

That said, due to the remote nature of the sites in question, should these designated grounding points be available they may not be tested on a regular basis and this means that their low resistance connection to true ground can be affected by environmental conditions and lifecycle effects.

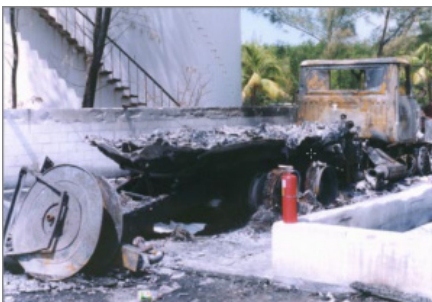
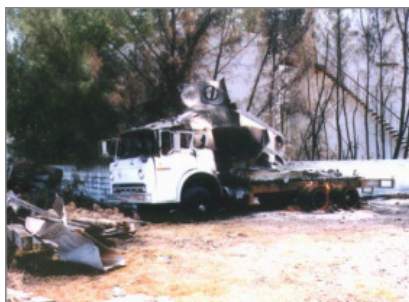
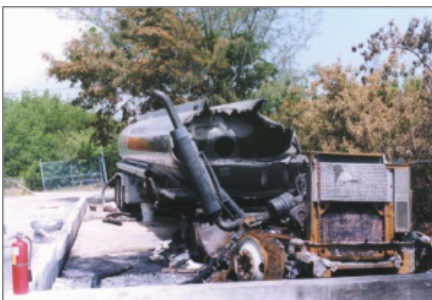
Fig. 2 – Top to bottom, Vehicle 1, 2 and 3. The NTSB concluded that the damage and fire on the other two vehicles resulted from exposure to heat from the fire on Vehicle 1. Combined all vehicles contained approximately 9,200 gallons of fuel that would have fuelled the blaze.

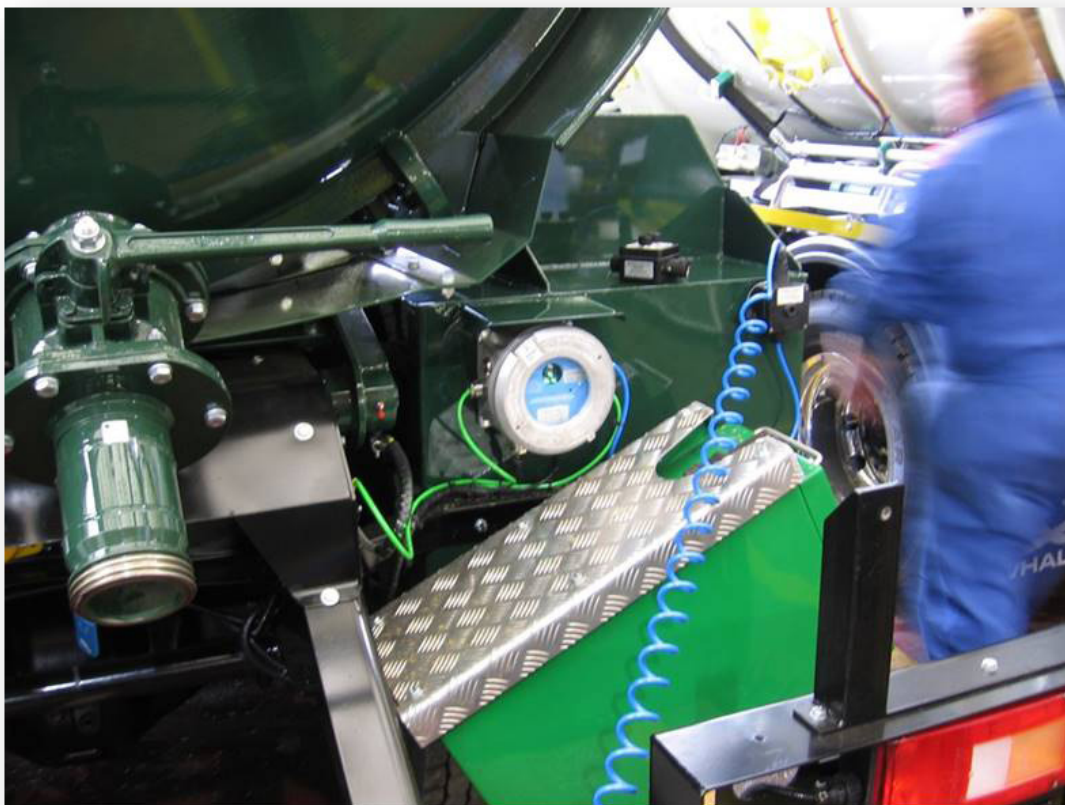
*Fig. 3 – When the Earth-Rite MGVS confirms the truck is fully grounded, three high intensity green LEDs pulse to indicate that the vehicle has established a static dissipative ground connection*

The Earth-Rite MGVS system has a user-friendly operator interface which indicates when transfer operations are safe to begin. From the operator's perspective, this is identified visually (in the form of flashing green LED lights) and grounding the vehicle couldn't be simpler. The grounding system can be connected with a static grounding clamp to either buried structural metal work or to rods that are hammered into the ground. When the operator connects the clamp to a metal object buried in the ground the system will verify whether or not the resistance into the true ground via the metal object is low enough to dissipate static charges that could build up on the trucks transfer system. This function is referred to as **"Static Ground Verification"**.

Once this resistance to true ground has been confirmed then the Earth-Rite MGVS switches to continuously monitor the connection resistance of the truck to the verified grounding point for the duration of the transfer process; this is referred to as **"Continuous Ground Loop Monitoring"**. The connection resistance must be maintained at 10 Ohms or less for the duration of the product transfer process.

**Both the Static Ground Verification and Continuous Ground Loop Monitoring checks need to be positive in order for the ground status indicators to change from red to green.**

An additional layer of safety can be introduced by interlocking the pump with the grounding system relay contacts, so that if the truck loses its ground connection, the transfer process is shut down automatically.
