## Risk of Electrostatic Ignition during Storage Tank Cleaning Operations

Source: "Safety Alert: Explosion in tank during HP activities, SIR, (2018)".

### Tank Cleaning Incident

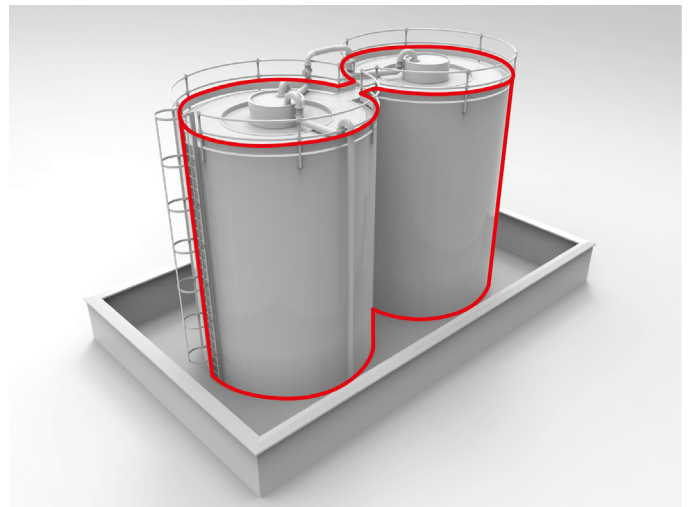
*Fig. 1 – Storage tanks within close proximity of each other, means fires can viciously propagate through a tank farm if an incident is to occur.*

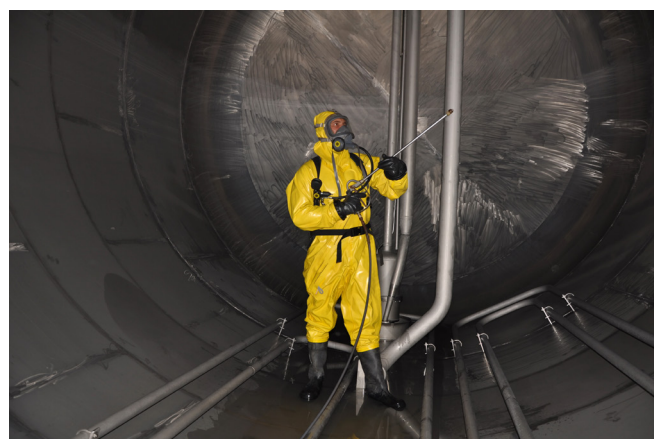
The minimum ignition energy (MIE) necessary to produce a self-propagating flame in a mist is affected by a number of factors – most significant of these is the droplet size, but fuel concentration, volatility, air velocity and the presence of any fuel vapour is also important. Sprays produced by a release of pressurised liquid through a nozzle are usually composed of larger droplets. The pressure of any vapour reduces the MIE of a mist. As the fuel volatility is increased, the amount of energy required to vaporise the droplets is reduced and therefore the ignition requires less energy.

Vapour was generated by the hose held by the operator used to clean the surface of the tank where petroleum residue acted as fuel. If an ungrounded conductor (such as a hose) is lowered into the charged mist, it becomes charged to a voltage which may be high enough for an incendive spark to jump to some part of the tank structure. If a hose with the wrong electrical resistance is selected there is potential for static sparks that could interact with the mist. Charged mist is often present for the duration of the cleaning process and can take several hours to fully relax. The properties of the material itself are fundamental to understanding both charge generation and relaxation. The lower the conductivity, the greater the relaxation time.

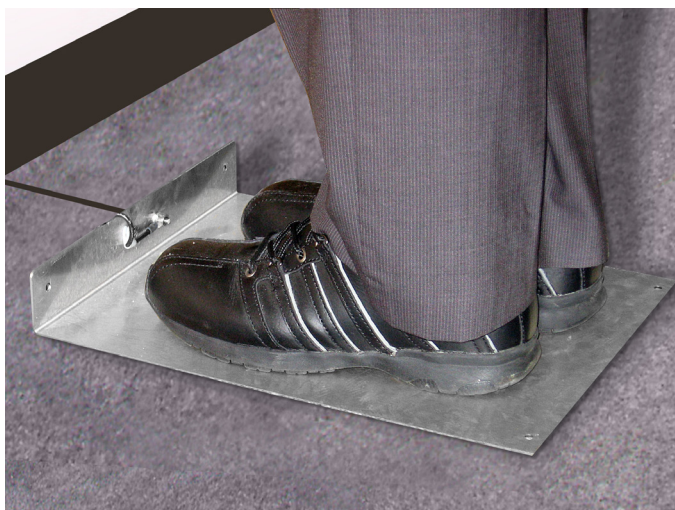
Stopping charge accumulation on plant personnel is trouble-free and dependent on both wearing the correct footwear and ability to test the properties of the footwear before entering a hazardous area. Prior to commencing with the tank cleaning operation an electrical resistance test would have been recommended.

The Sole-Mate™ II tester from Newson Gale provides a time efficient and cost effective method of ensuring personnel operating in hazardous areas are wearing static dissipative shoes that are capable of limiting electrostatic charge accumulation on their bodies. The system tests the condition and measures the resistance of footwear to ensure static is capable of dissipating from personnel through their shoes to ground.

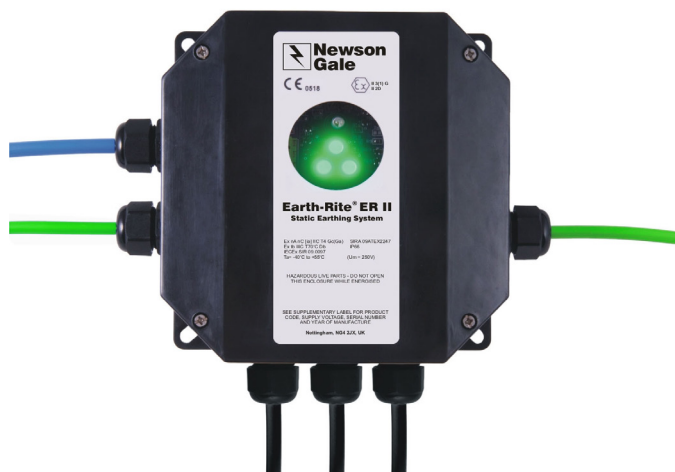
The Earth-Rite® PLUS™ grounding system from Newson Gale combines a simple visual GO/NO GO via a traffic light model (red/green) of indication with interlock control capability. Interlocking with the process is the most effective means of controlling the risks of ignition caused by static electricity during operations. Conductive objects like storage tanks, skids, IBCs and rail cars can accumulate hazardous levels of electrostatic charge that could discharge static sparks with energies far in excess of a vast range of combustible gases, liquids or vapours. The ignition of combustible atmospheres by static electricity can be mitigated by ensuring that such objects are grounded, and the Earth-Rite PLUS system continuously monitors the connection to ground ensuring static is dissipated safely throughout the operation. If the connection to ground is broken during the operation then the red NO GO ground connection LED will show and the interlock contacts will open. The Earth-Rite PLUS system demonstrates the full range of ATEX and IECEx certification for all gas and liquid groups. It also ensures there is a 10 Ohms or less connection between the tank and the product transfer system.
