ODC Daily Coaling Plan

20/08/2025

THIESS

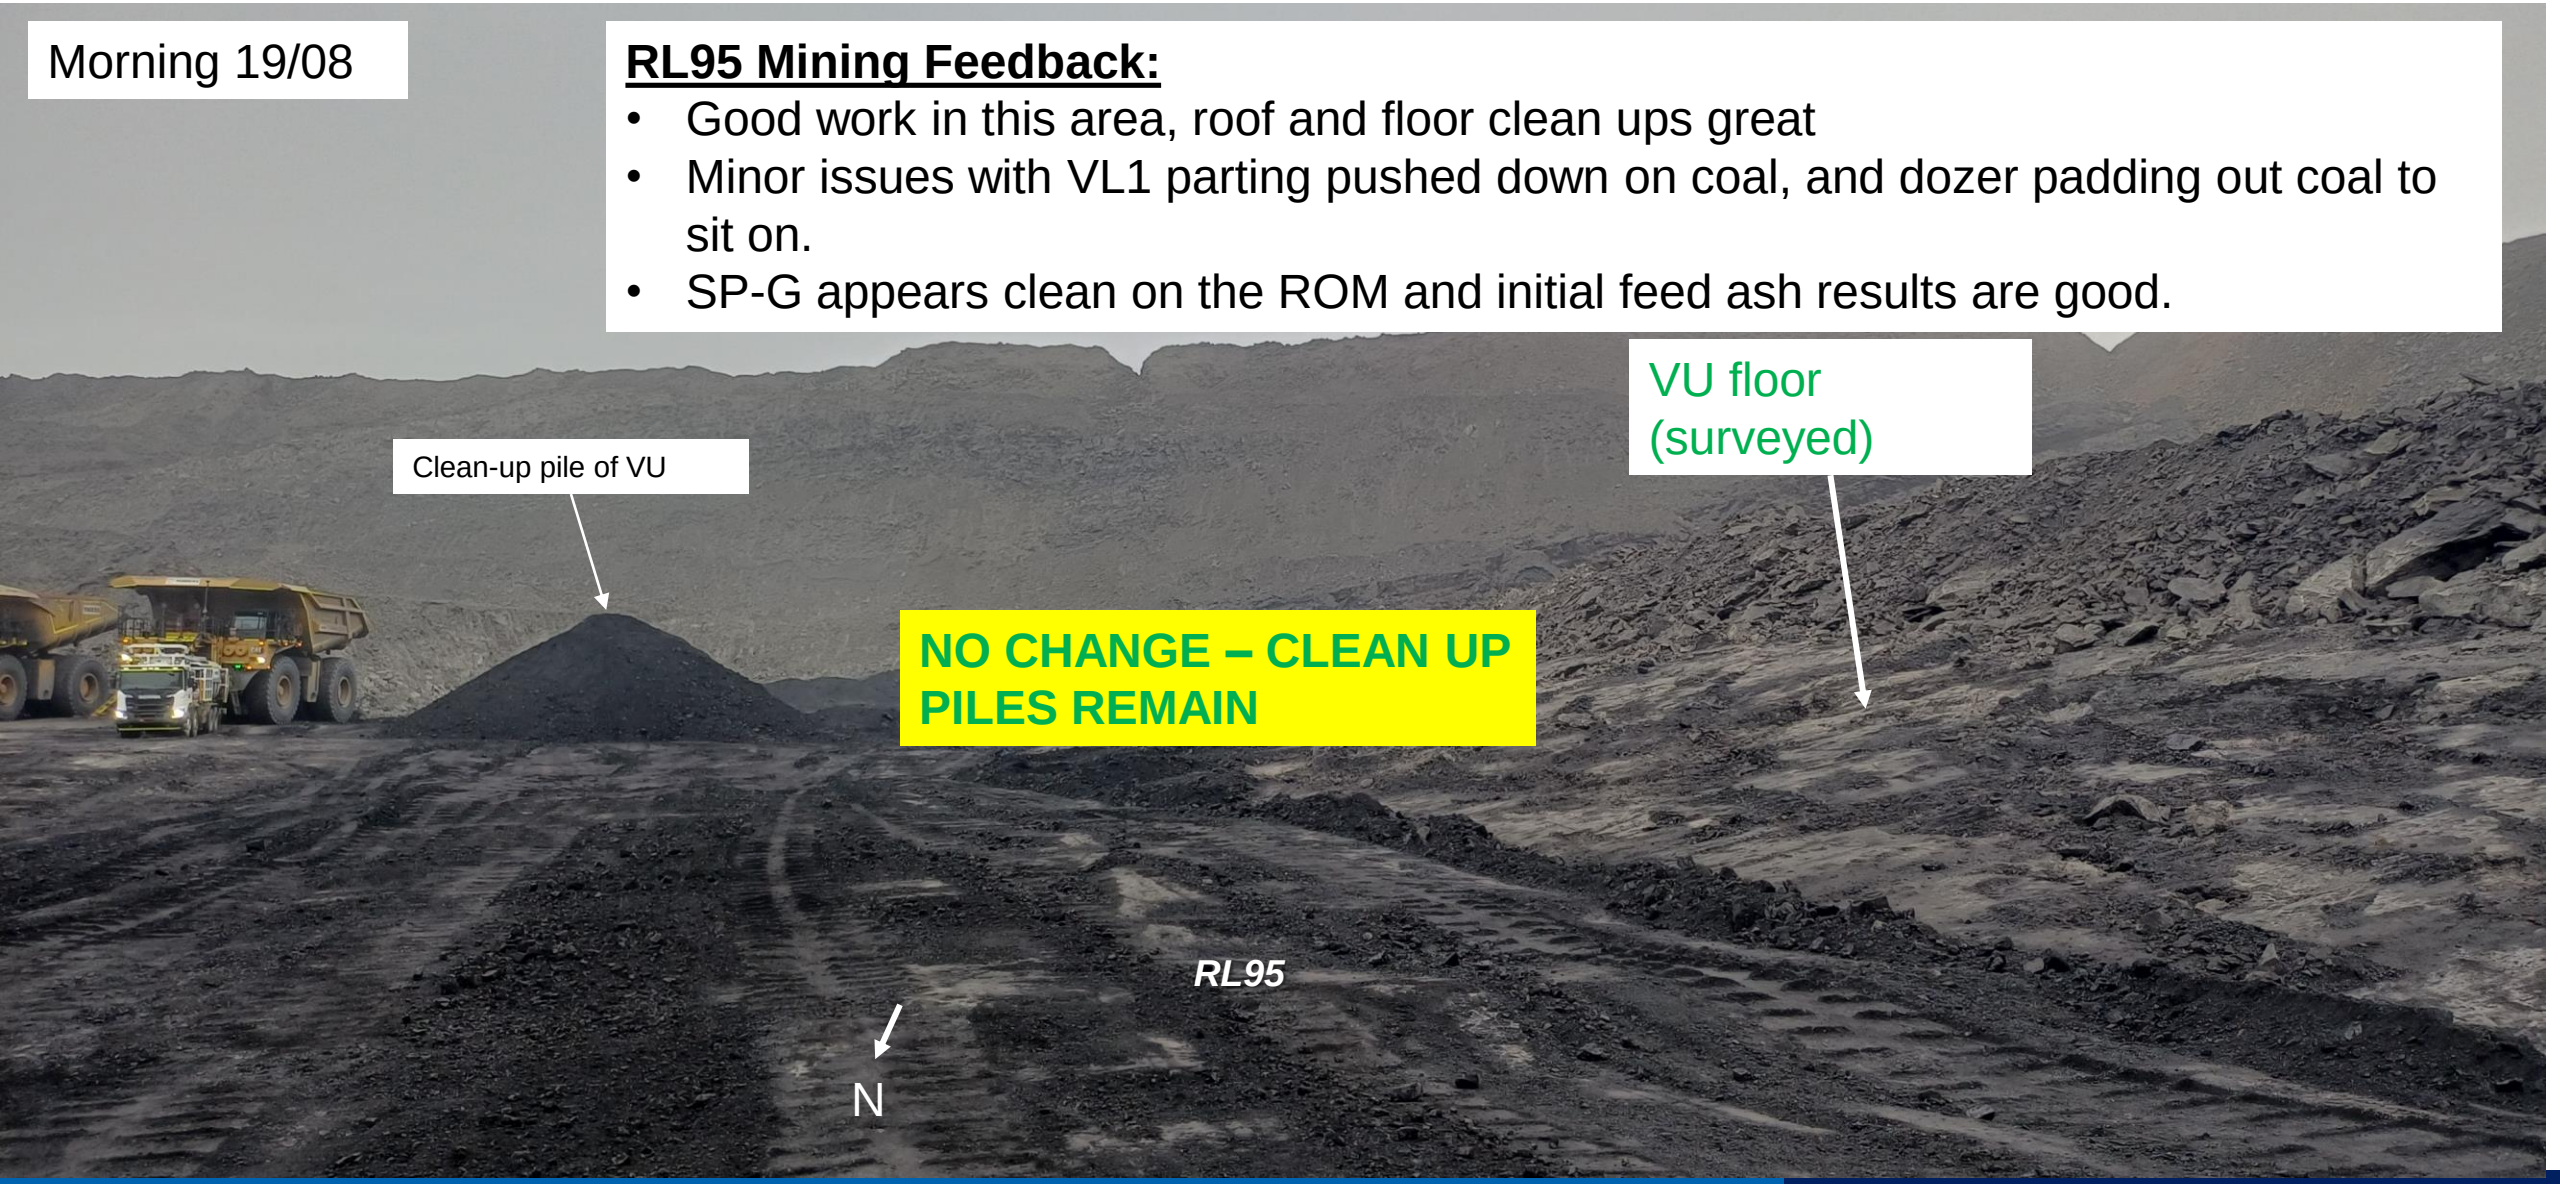
T03/S01

Morning 19/08

RL95 Mining Feedback:

- Good work in this area, roof and floor clean ups great
- Minor issues with VL1 parting pushed down on coal, and dozer padding out coal to sit on.
- SP-G appears clean on the ROM and initial feed ash results are good.

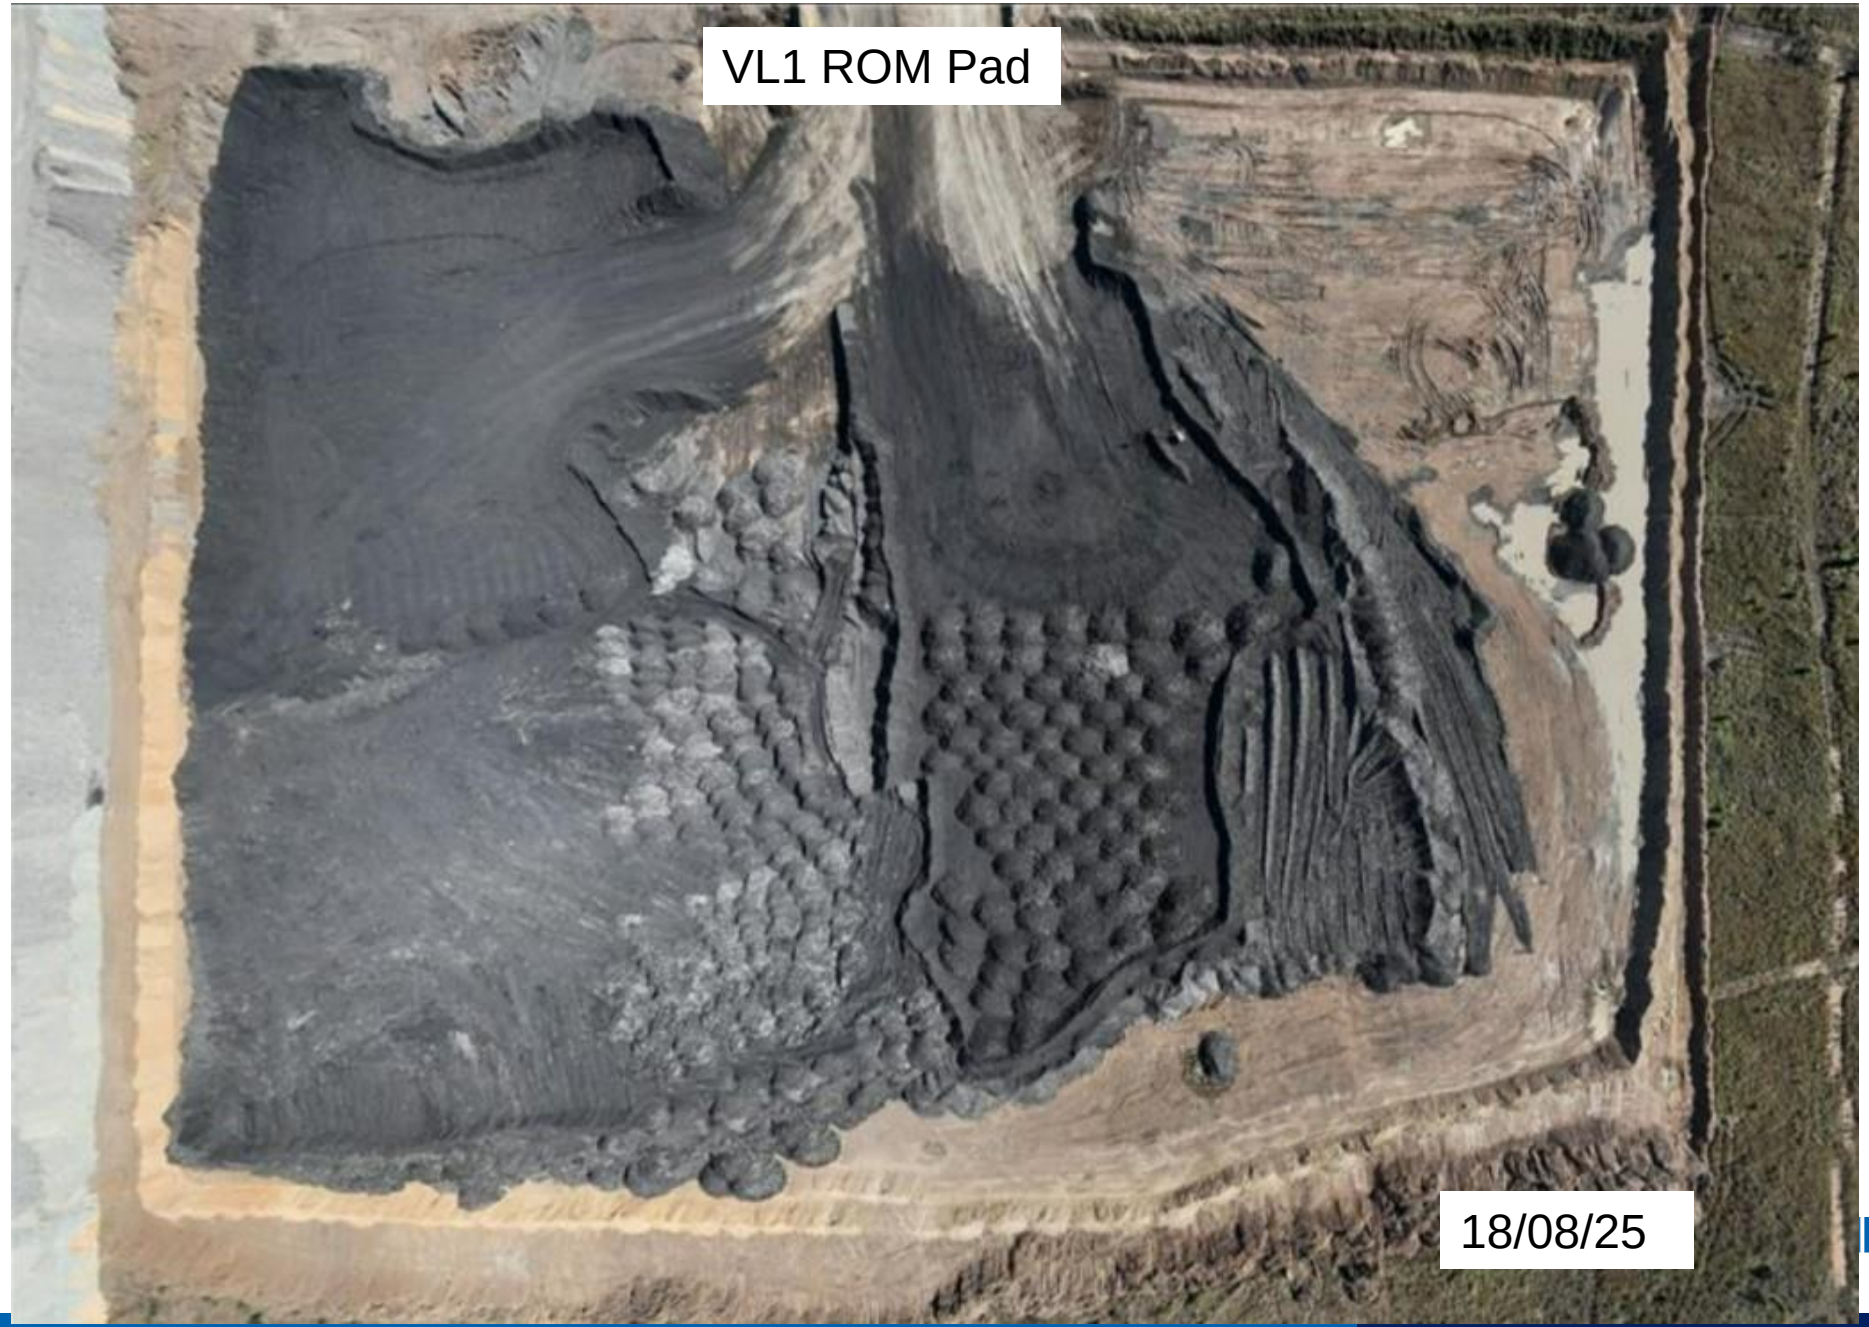
ROM

SP-O VU T04
SP-P LL2 T04
SP-Q LL3 T04
East
SP-B LL1 T05
SP-N VU T03
SP-B LL1 T04
West
These were tipped next to each other, please demarcate and maintain separation between Terraces in future
Tip future T04 LL1 on west
SP-A VU T05
SP-M LL3 T03
N
20/08/25
