Case Study

Risk of Electrostatic Ignition during FIBC Discharging Operations

Source: "Static Hazards Using Flexible Intermediate Bulk Containers for Powder Handling", Laurence G. Britton, (1993)

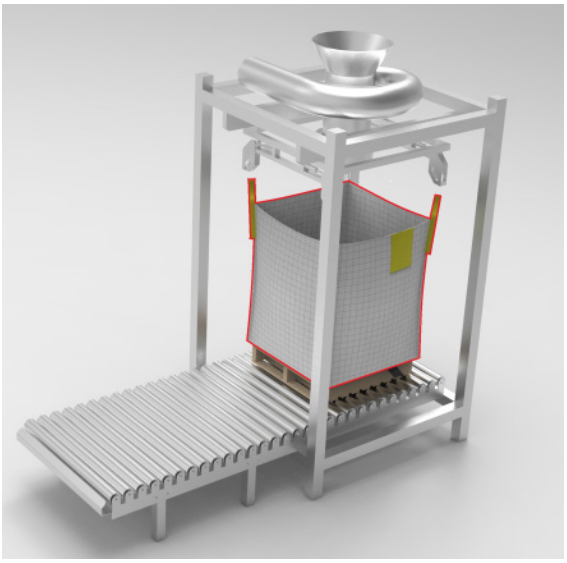
Unfortunately, this incident involved the same operator and was not dissimilar to the first. The main difference being the FIBC was designed with an internal conductive aluminium liner bonded to the polypropylene in the spout. This was connected to an external grounding tab to which a grounding clamp was to be connected by the operator. The FIBC was suspended over the tank as before, and after applying the grounding clamp the discharge spout was pushed through the port in the tank manway so that it is extended 10-12 inches inside the tank. The draw cord was then cut to open the spout and release resin into the tank. The FIBC was not opened at the top to vent the contents and mitigate drawing vapour into the FIBC. On this occasion flow was delayed and the operator "puffed" the FIBC to free the flow. Within 10 seconds of flow a flash occurred. Failure to vent the FIBC was not believed to be a contributing factor as there was no fire or explosion inside it.

In the event of an ignition during an FIBC operation, plant personnel that are usually within close proximity are likely to be caught in the flames. The operator once again was in the vicinity of the FIBC but not touching it. As a result he received second and third degree burns to his stomach and face.

The sprinkler system installed above the tank did not emit water; however, pallets of resin bags were singed at a distance of 20 – 30ft from the tank. A major hazard in any explosion is when material is dispersed into the general plant area and a secondary ignition occurs. Although the hinged lid was closed there was again no provision for venting either the purge gas or the air entrained into the tank by the powder flow. A significant displacement of flammable vapour therefore took place into the operating area.

Unlike the first incident, in Incident B it was reported – but not conclusively determined, that a grounding connection had not been properly made ensuring continuity to earth to dissipate static charge. However, it was not possible to completely ascertain whether this was the case as the grounding clamp was unavailable for examination. As a result, an FIBC operational error causing loss of continuity could not be ruled out since the FIBC involved was destroyed in the fire. Although polypropylene has a unique blend of qualities and characteristics that make it an ideal material for the construction of FIBCs; it is also highly flammable and susceptible to ignition via a spark discharge. If we are to generalise failures for FIBC operations, these typically occur due to manufacturing defects, operator error or disabling continuity to a verified earth via a grounding clamp.

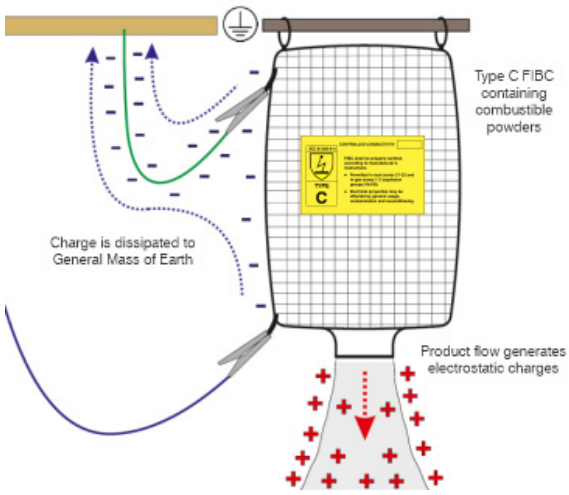
In these incidents electrostatic charge had been allowed to accumulate because the FIBC was isolated from ground, whether this was through the negligent actions of the plant operator or inconclusive grounding methods. As grounding wasn't achieved, charge was allowed to accumulate. Had grounding been accomplished via a Type C bag with either passive (single pole clamp and cable) or through active means (monitoring systems), connection to a true earth ground would've been verified and charge subsequently dissipated. In accordance with industry guidelines such as NFPA 77 "Recommended Practice on Static Electricity" and IEC 61340-4-4, "Electrostatics – Part 4-4: Standard test methods for specific applications – Electrostatic classification of flexible intermediate bulk containers (FIBC)" the resistance through the bag should be less than 10^7 Ohms (10 meg-ohm) for NFPA 77 and 1×10^8 Ohms (100 meg-ohm) for IEC 61340-4-4.

Given the magnitude of charge that can build up on bags, an active grounding system is the recommended – and safer choice.

This is because the system can determine whether or not the bag's construction complies with the relevant standards and will also ensure the bag is grounded for the duration of the filling/emptying operation.
