NewsonGale
HOERBIGER Safety Solutions

Case Study

Drawing Toluene into an Ungrounded Bucket

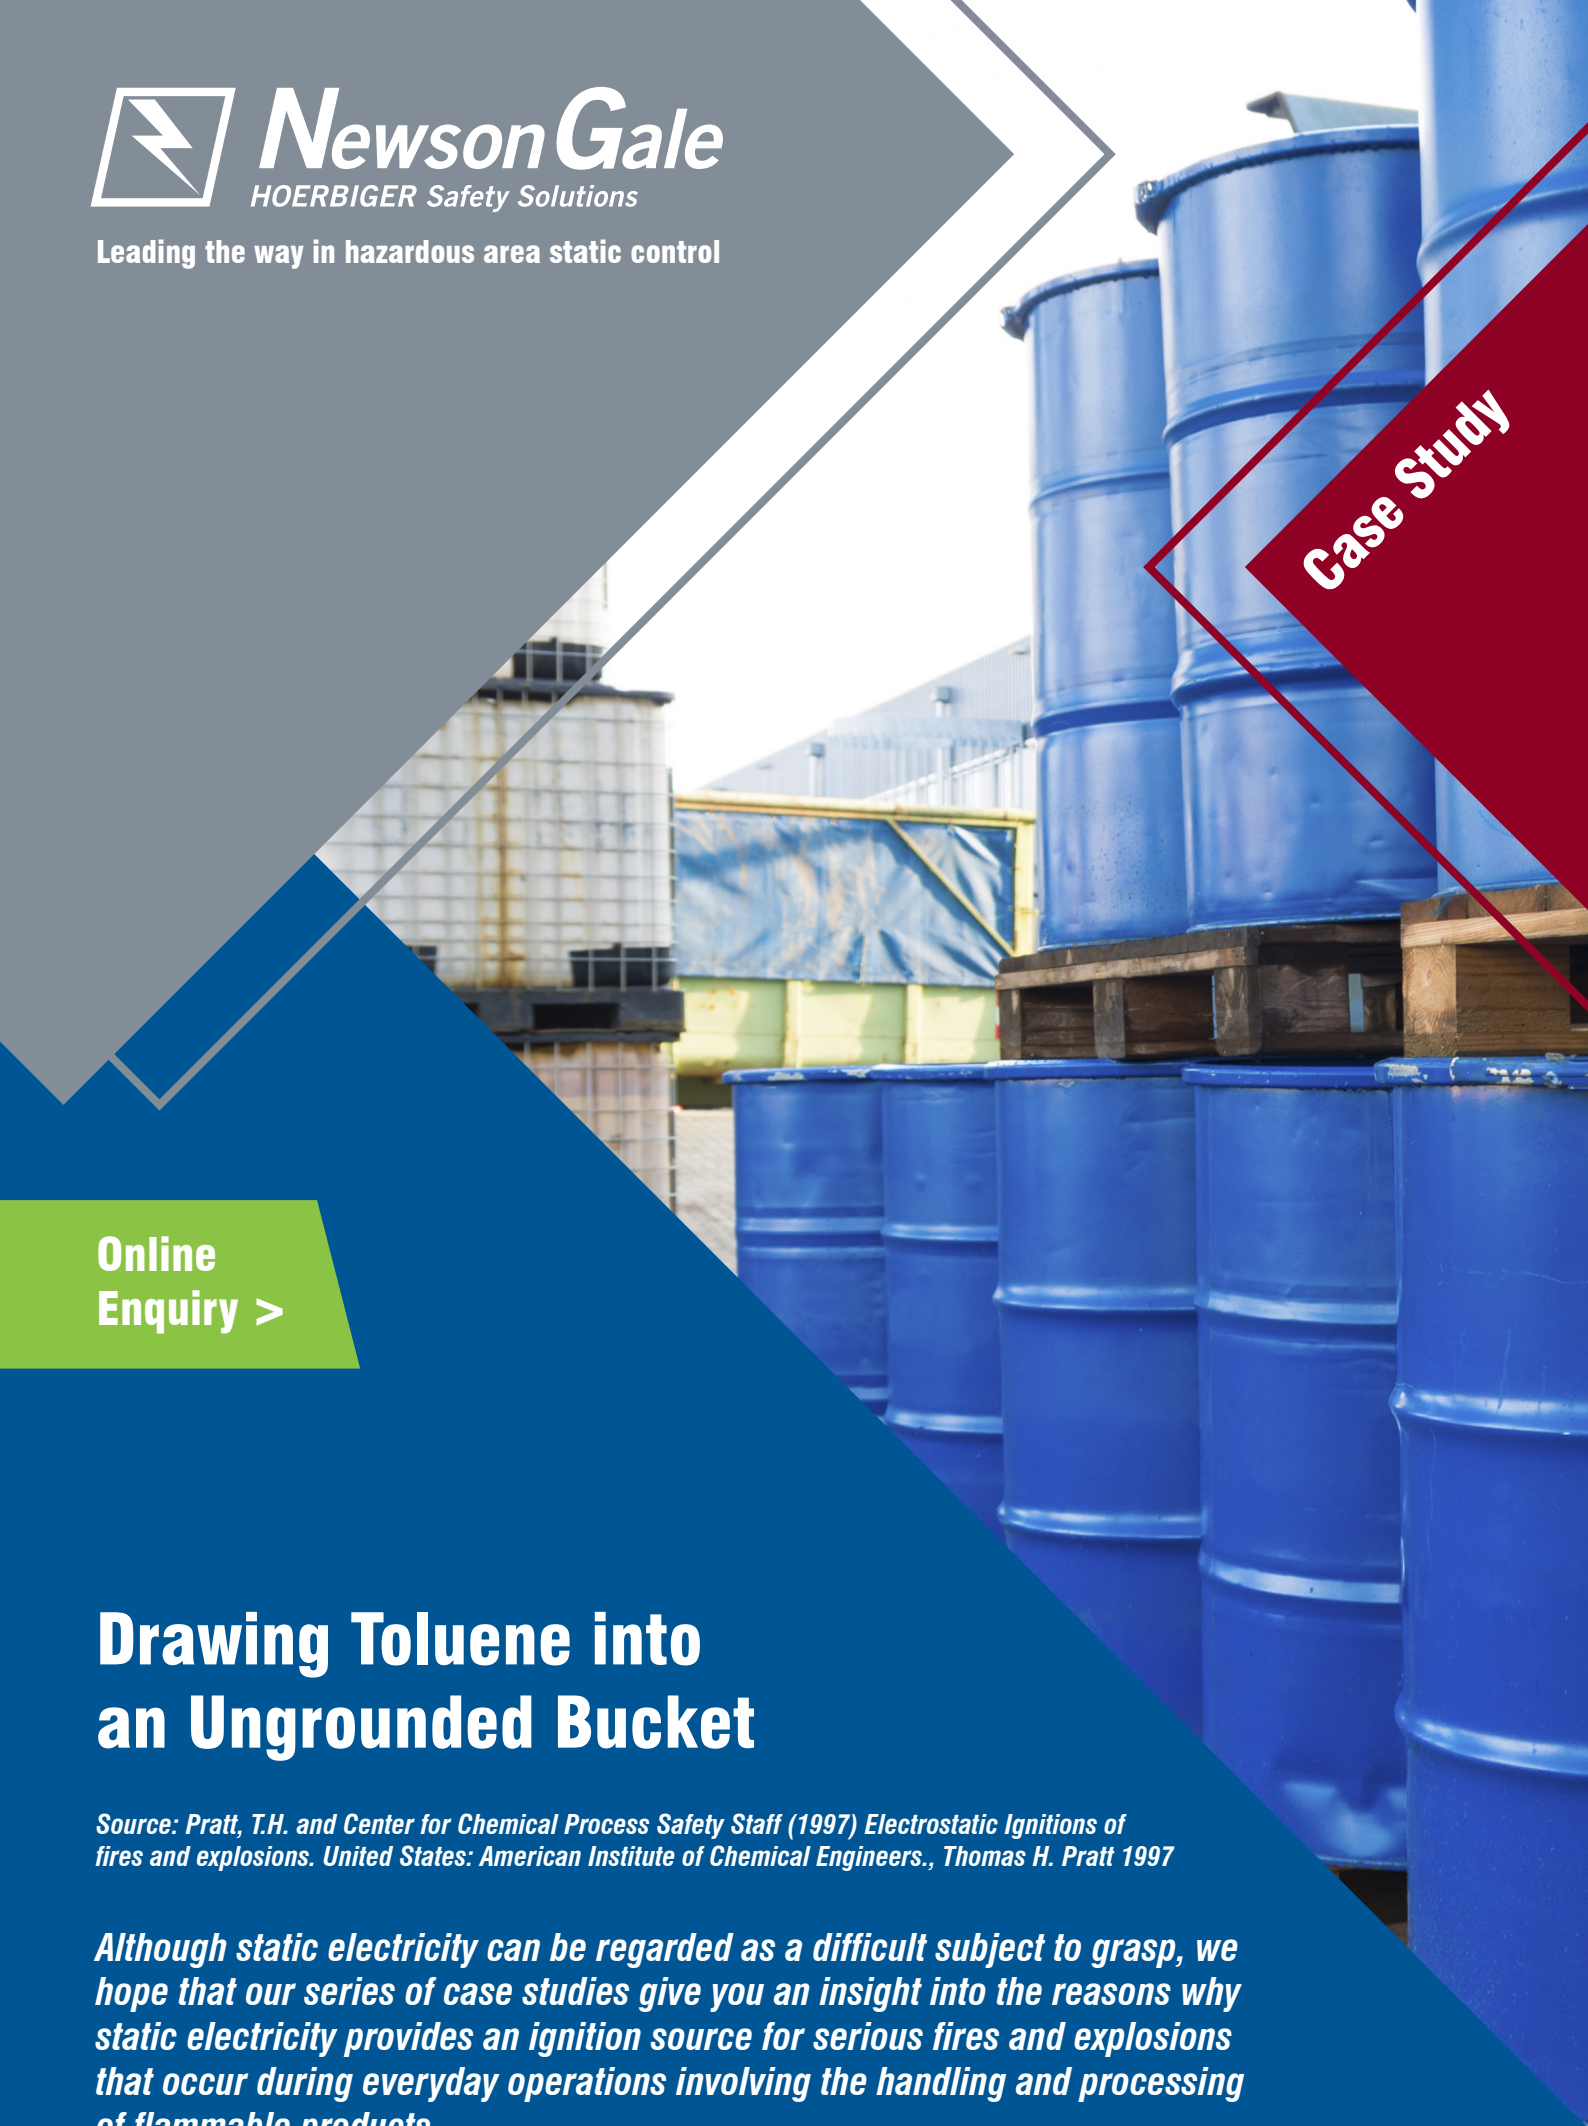
In this scenario, an operator opened a valve to draw toluene into a metal bucket with toluene from an overhead tank by gravity flow at approximately 5 gallons per minute. The operator hung a metal bucket with a wire bail and plastic handle over a globe valve. The plastic handle on the bail isolated the metal bucket from ground.

Metal bucket with wire bail hung over globe valve

On opening the valve, the operator backed away from the bucket allowing the toluene to flow as he had previously done several times. Within a few moments the toluene had ignited causing the operator to immediately leave the scene returning with a small fire extinguisher, which proved inadequate to put the fire out. The operator then left the scene returning with a larger fire extinguisher, however by the time he had returned the fire was out of control and he was unable to close the valve to prevent the flow of toluene to the bucket which was already over flowing.

As a result, discharge from the operator could be ruled out as a cause of the incident and the scenario of a streaming current was considered.

The streaming current was found to be in the order of 0.01 μA were it not for the presence of the in-line filter. The residence time of the toluene between the in-line filter and the exit of the pipe was less than a second, much shorter than the recommended 30 seconds; therefore, a reasonable estimate of the streaming current at the exit of the pipe can be calculated around 0.1 μA. In any case, an estimate for the streaming current can be assumed to be between 0.1 μA and 0.01 μA.

The first place to start is to determine why electrostatic charge was "permitted" to accumulate on the bucket. In this case electrostatic charge accumulated on the bucket because it was electrically isolated from the general mass of earth. Had the bucket been connected to a true earth ground charge would not have been accumulated on its surface. Instead excess electrostatic charges would simply have found their way to earth. So in accordance with industry guidelines like NFPA 77 and IEC TS 60079-32-1, the isolated bucket should have had a connection to a verified ground (in this case the process vessel) with a resistance of 10 ohms or less.

"Temporary connections can be made using bolts, pressure-type earth (ground) clamps, or other special clamps. Pressure-type clamps should have sufficient pressure to penetrate any protective coating, rust, or spilled material to ensure contact with the base metal with an interface resistance of less than 10 Ω."

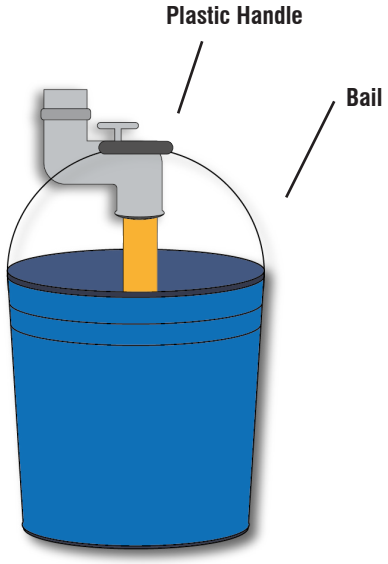
With the breakdown strength of air at 3 x 10^6 V/m a spark from the bucket could easily jump across a gap of 50 mm (1.96") meaning it was probable discharge from the wire of the bail to the body of the globe valve could occur.

With the MIE of toluene calculated to be 0.24 mJ a potential discharge with energy using the most conservative assumption of 2.25 mJ is still sufficiently high enough to ignite the flammable vapours produced by the toluene present in this process.

Both IEC TS 60079-32-1 (13.4.1) and NFPA 77 (7.4.1.6) & (7.4.1.4) state:
