FIRMSTONE
FLOORING SPECIALISTS

CASE STUDY

TOTAL FLOOR REFURBISHMENT

EASTERN CREEK

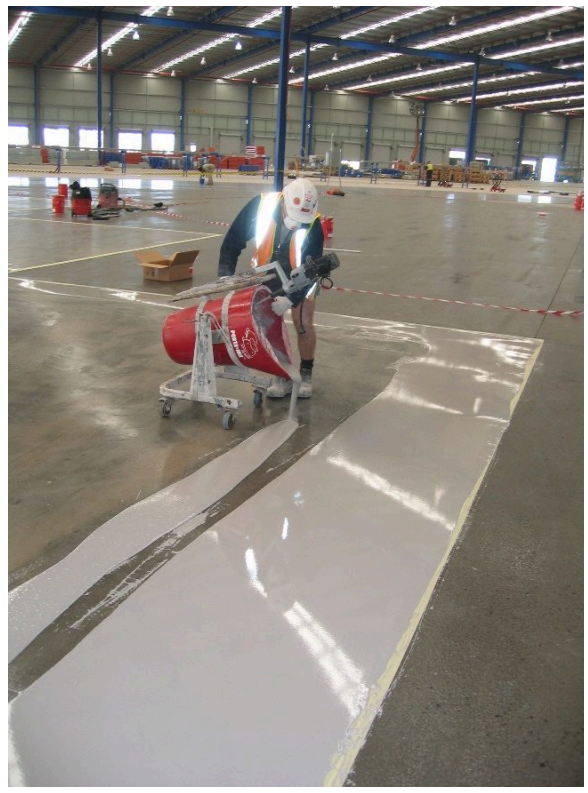
Failed concrete pour. Resurface existing to high standard.

1. Vacuum shotblast floor to remove loose concrete.
2. Apply epoxy primer.
3. Install 4mm self levelling epoxy system.
4. Saw cut joints and re-apply caulking.
