**InspectionType:** Visual Pre-Purchase Inspection

**InspectionAddress:** 20 Example Street, Example, QLD, 4000

Complies with Australian Standard AS4349.1-2007 Inspection of Buildings Part 1: Pre-purchase Inspections, Residential Buildings – Appendix "C".

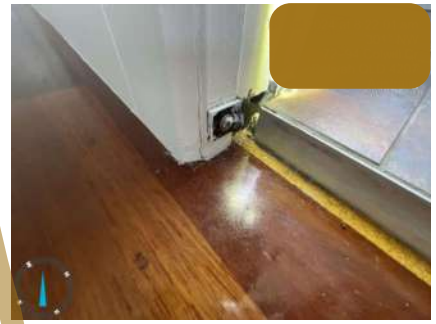
| Defect No: | 3 | Inspectors comments: | |

| Defect No: | 3 | Inspectors comments: | |
|---|---|---|---|
| Defect Category: | A - Damage<br>Choose an item. | | |
| Damage Category: | Appearance defect<br>Choose an item. | | |

| Defect No: | 3 | Inspectors comments: | |
|---|---|---|---|
| Defect: | Minor Defect | Recommendations:<br><br>Maintenance - Seek advice from a suitably qualified and experiences Maintenance person<br><br>Choose an item. | |

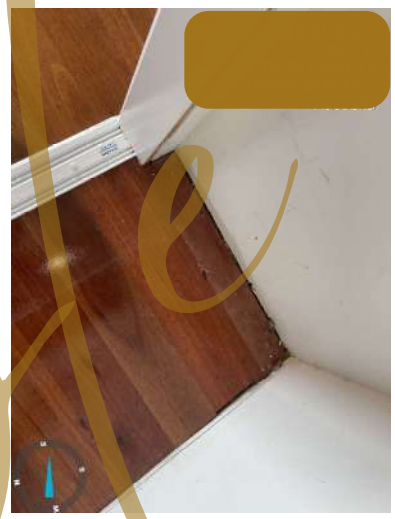
| Defect No: | 6 | Inspectors comments: | |

| Defect No: | 6 | Inspectors comments: | |
|---|---|---|---|
| Inspection Parts: | The Building Interior | - Aperture between water stop angle, opening and wall junctions. | |
| Defect Description: | Unsafe Condition<br>Choose an Item | | |
| Defect Category: | E - Operational<br>F - installations (including Omissions) | | |
| Damage Category: | Serviceability defect<br>Choose an item. | | |

| Defect No: | 6 | Inspectors comments: | |
|---|---|---|---|
| Defect: | Major Defect | Recommendations:<br><br>Tiler for advice on rectification in accordance with AS/NZ 3958.1<br><br>Sealant - Engage a suitably experience person to install sealant to required junctions in accordance with industry standards | |

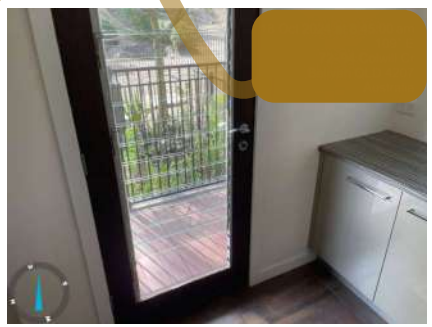
| Defect No: | 9 | Inspectors comments: | |

| Defect No: | 9 | Inspectors comments: | |
|---|---|---|---|
| Defect Description: | Loss of Utility<br>Choose an Item | | |
| Defect Category: | F - installations (including Omissions)<br>Choose an item. | | |
| Damage Category: | Appearance defect<br>Choose an item. | | |

| Defect No: | 9 | Inspectors comments: | |
|---|---|---|---|
| Defect: | Minor Defect | Recommendations:<br><br>Carpenter - Engage a suitably qualified and experienced carpenter for rectification advice in accordance with AS1684.2<br><br>Painter - Engage a suitably qualified painter for advice on repair and maintenance in accordance with AS 2311 | |

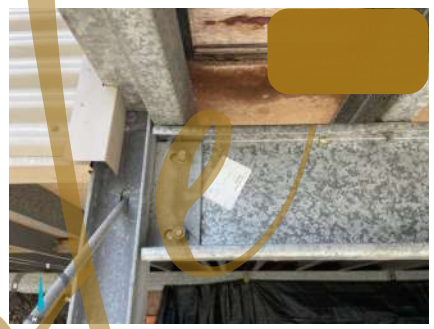
| Defect No: | 20 | Inspectors comments: | |

| Defect No: | 20 | Inspectors comments: | |
|---|---|---|---|
| Inspection Parts: | The Building Exterior | - Building elements are in contact with the natural ground. | |
| Defect Description: | Unsafe Condition<br>Further deterioration of the property | | |
| Defect Category: | E - Operational<br>F - installations (including Omissions) | | |
| Damage Category: | Structural defect<br>Serviceability defect | | |

| Defect No: | 20 | Inspectors comments: | |
|---|---|---|---|
| Defect: | Major Defect | Recommendations:<br><br>Structural Engineer - Seek advice from a suitably qualified and experienced Structural Engineer<br><br>Structural Landscaper - Seek advice from a suitably qualified and experienced structural landscaper | |

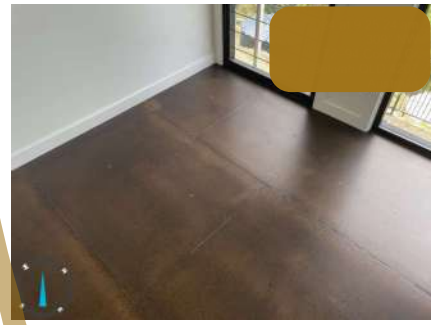
| Defect No: | 25 | Inspectors comments: | |

| Defect No: | 25 | Inspectors comments: | |
|---|---|---|---|
| Damage Category: | Structural defect<br>Serviceability defect | | |
| Crack Category: | < 1.0mm = Damage Category 1 | | |

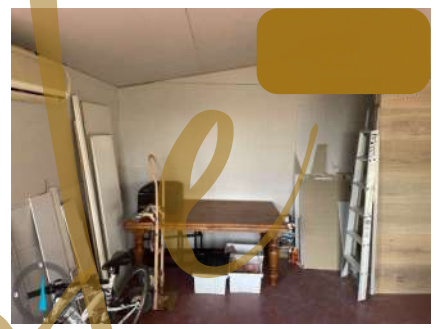
| Defect No: | 32 | Inspectors comments: | |

| Defect No: | 32 | Inspectors comments: | |
|---|---|---|---|
| Inspection Parts: | The Site | - Large amounts of vegetation debris built up against external cladding of shed.<br>- Opening in wall is not sealed correctly. | |
